ARA-TR-98-4589.1-1

## **Explosive Tests For Evaluation of the Glass Fragment Mitigation Characteristics of 3M Security Window Films**

**by: Joseph L. Smith, Director of Security Engineering  
Steven C. Lofton, Blast/Security Engineer  
Scott R. Swatzell, Blast/Security Engineer**

**Prepared for: 3M  
Specified Construction Products Division  
3M Center Bldg. 225-4S-08  
St. Paul, MN 55144**

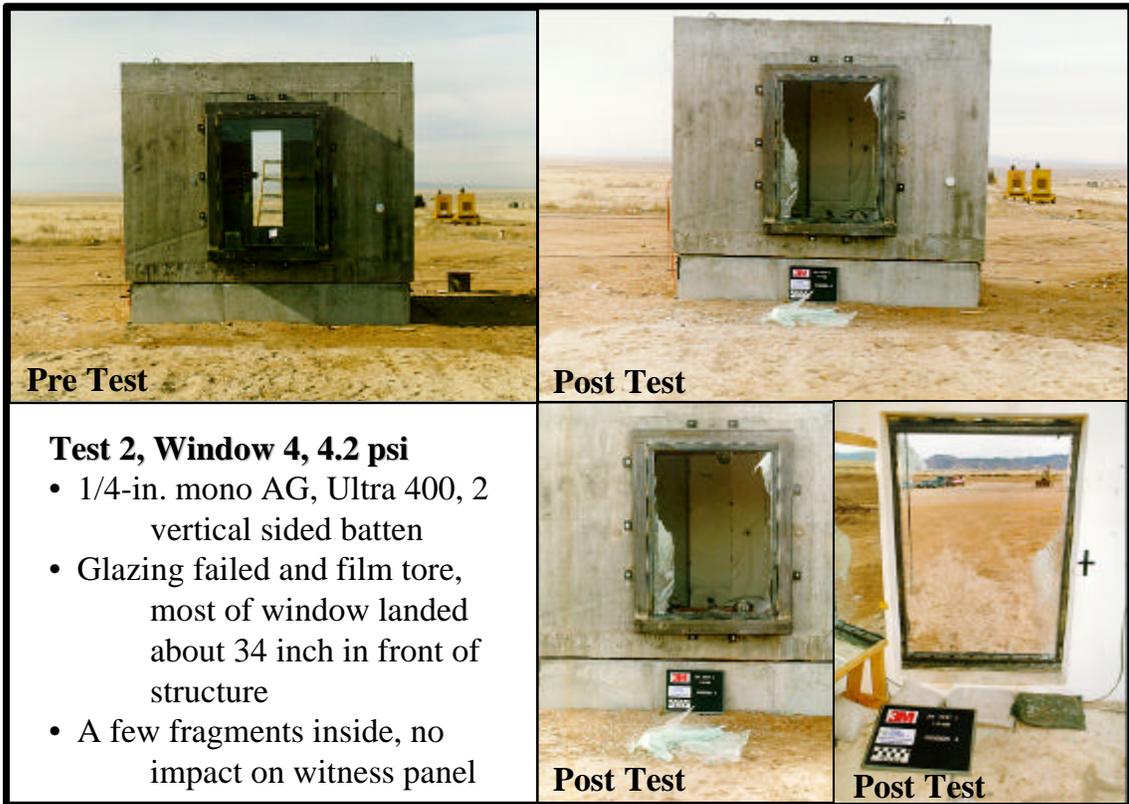
- 1/4-in. mono AG, Ultra 400, 2 vertical sided batten
- Glazing failed and film tore, most of window landed about 34 inch in front of structure
- A few fragments inside, no impact on witness panel

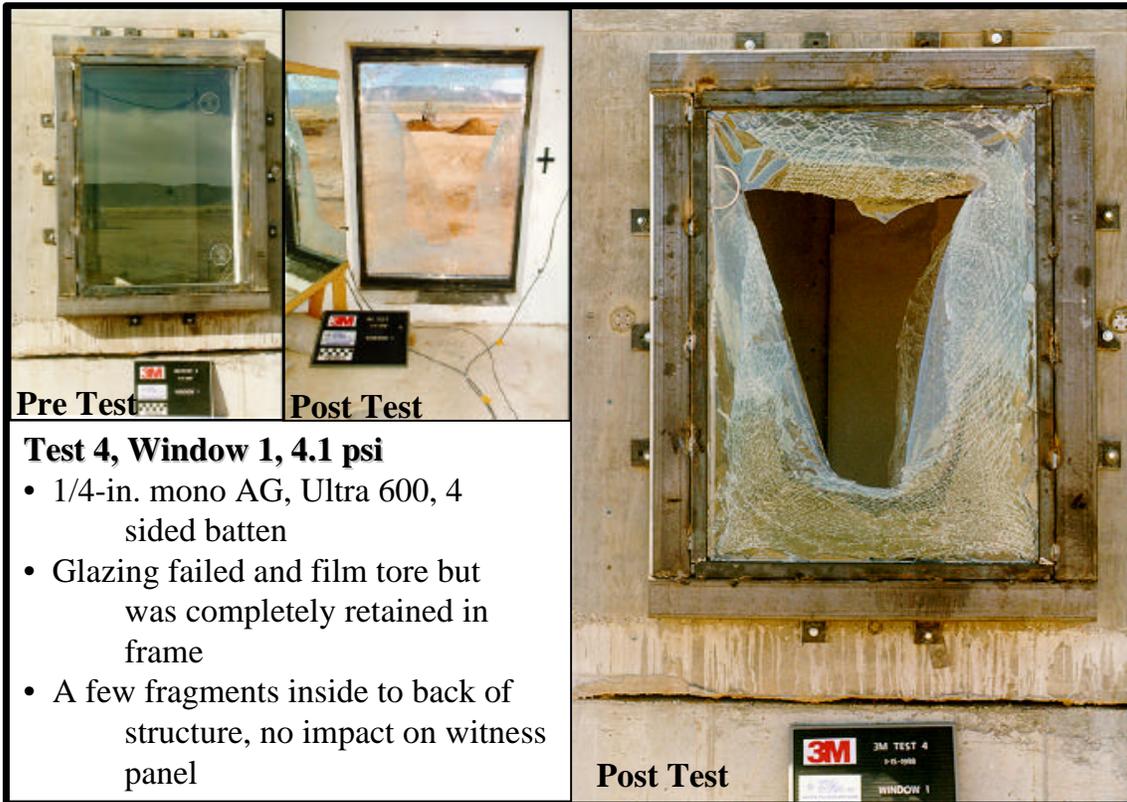
- 1/4-in. mono AG, Ultra 600, 4 sided batten
- Glazing failed and film tore but was completely retained in frame
- A few fragments inside to back of structure, no impact on witness panel

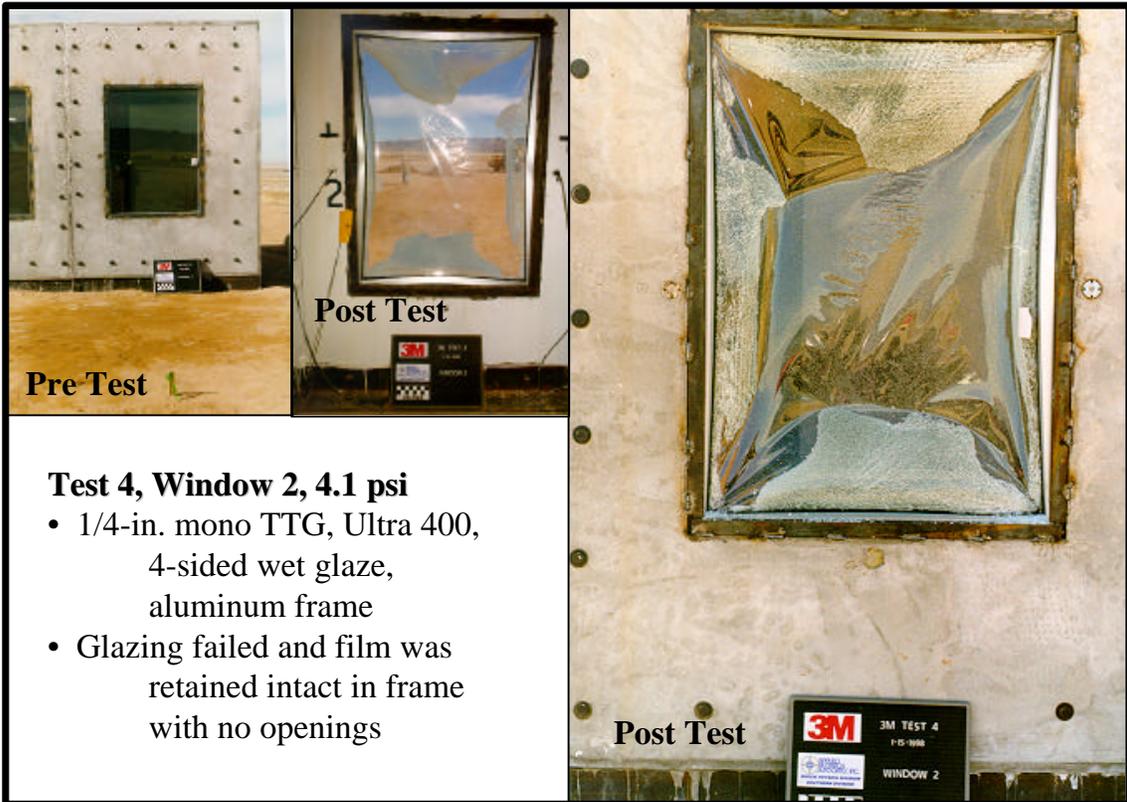
- 1/4-in. mono TTG, Ultra 400, 4-sided wet glaze, aluminum frame
- Glazing failed and film was retained intact in frame with no openings

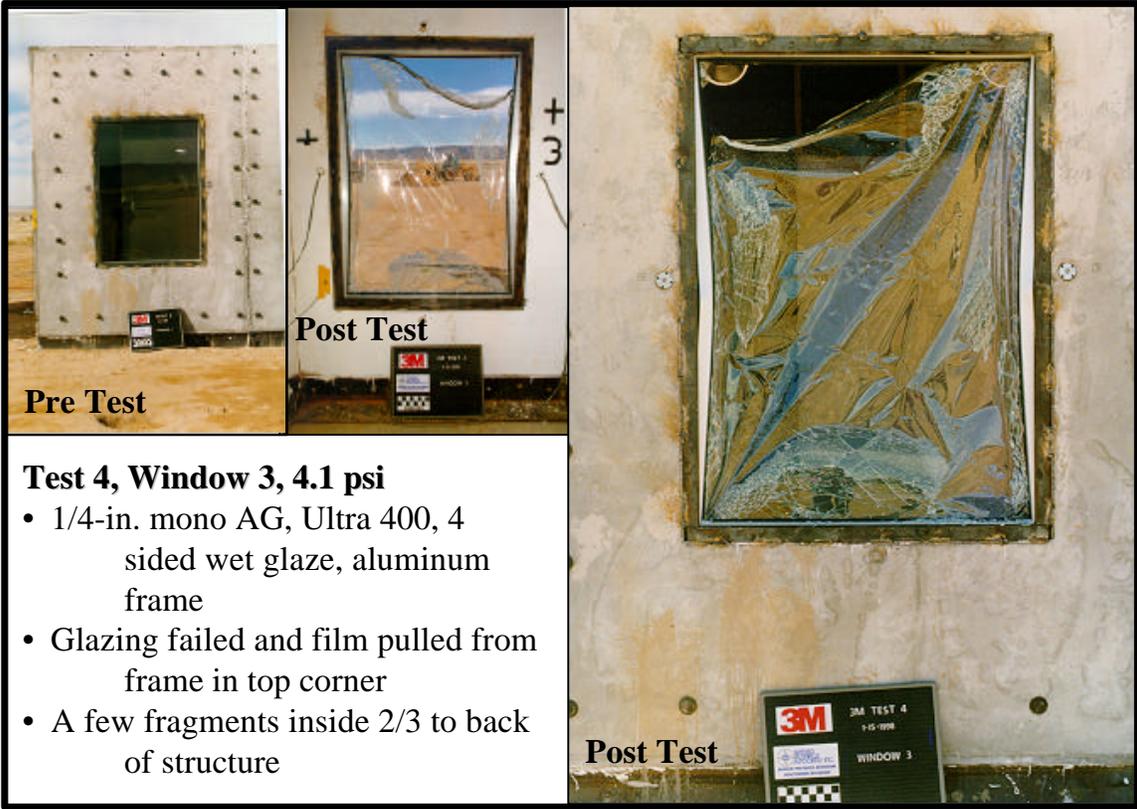
- 1/4-in. mono AG, Ultra 400, 4 sided wet glaze, aluminum frame
- Glazing failed and film pulled from frame in top corner
- A few fragments inside 2/3 to back of structure

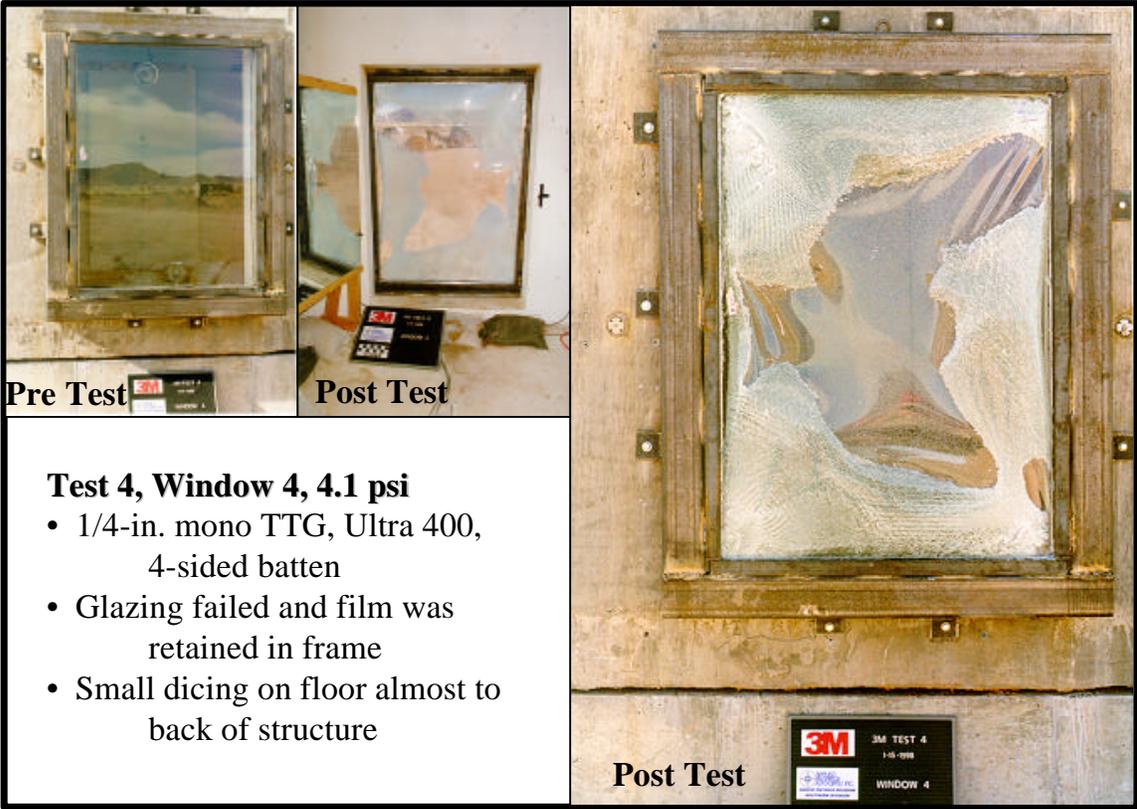
- 1/4-in. mono TTG, Ultra 400, 4-sided batten
- Glazing failed and film was retained in frame
- Small dicing on floor almost to back of structure

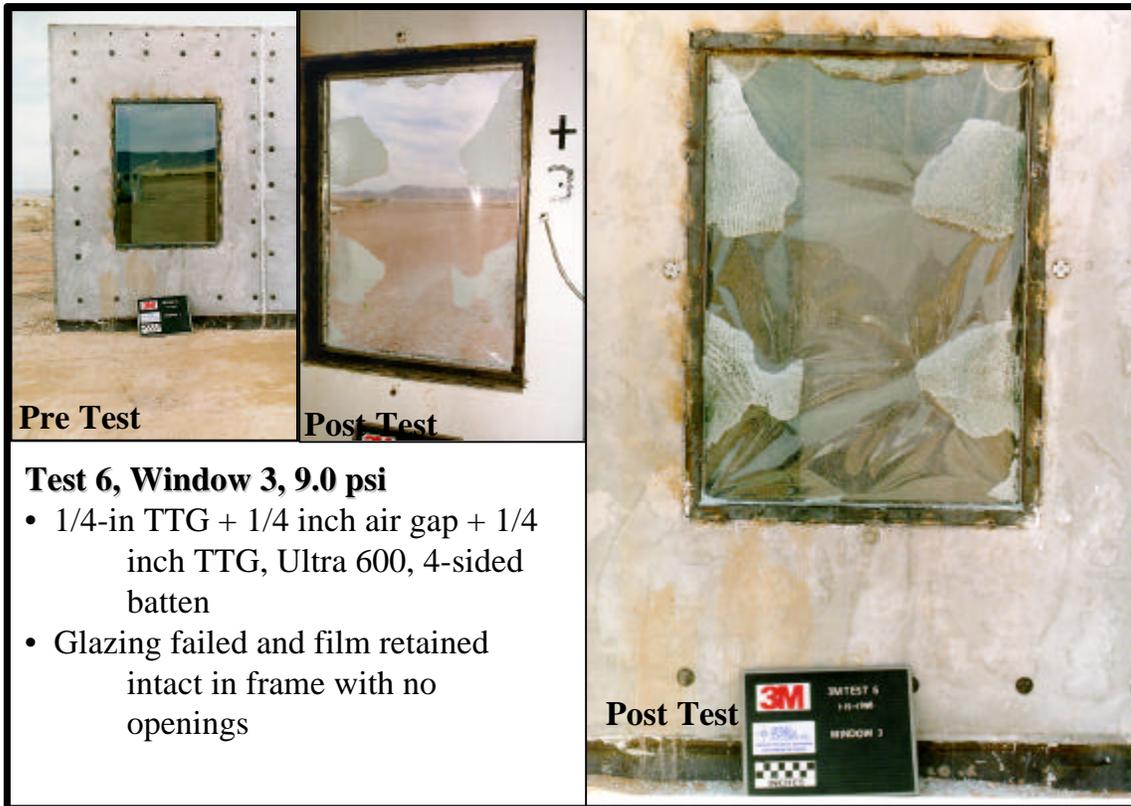
- 1/4-in TTG + 1/4 inch air gap + 1/4 inch TTG, Ultra 600, 4-sided batten
- Glazing failed and film retained intact in frame with no openings

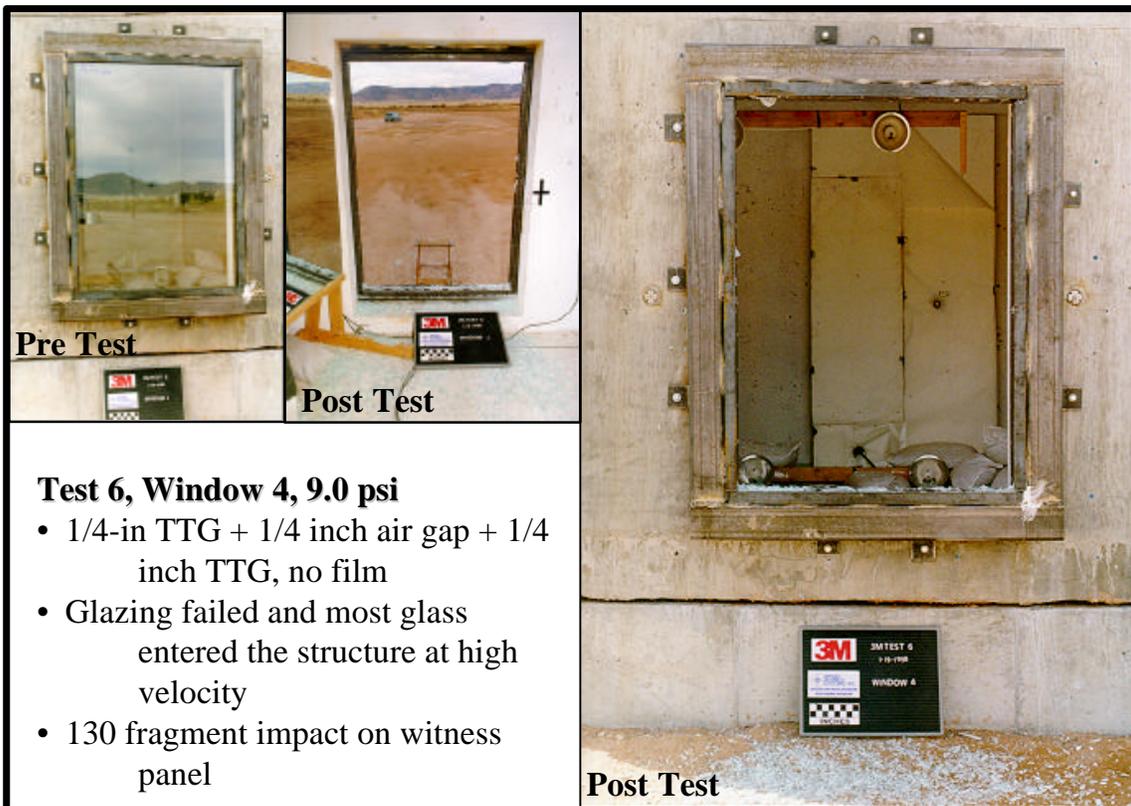
- 1/4-in TTG + 1/4 inch air gap + 1/4 inch TTG, no film
- Glazing failed and most glass entered the structure at high velocity
- 130 fragment impact on witness panel

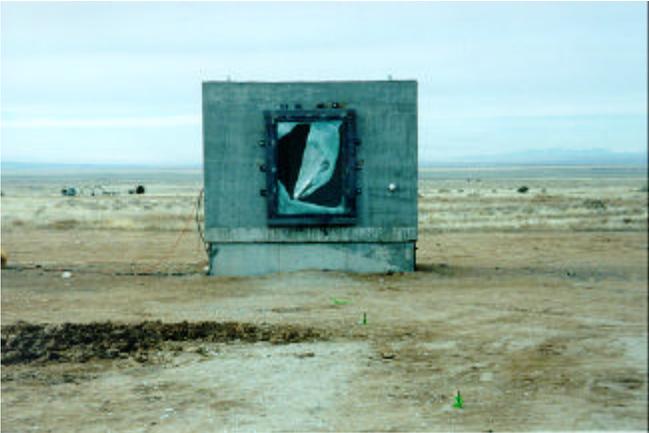
Figure 4.2. Exterior posttest view of window 1, test 2 (3M SD T2 post 45.tif).

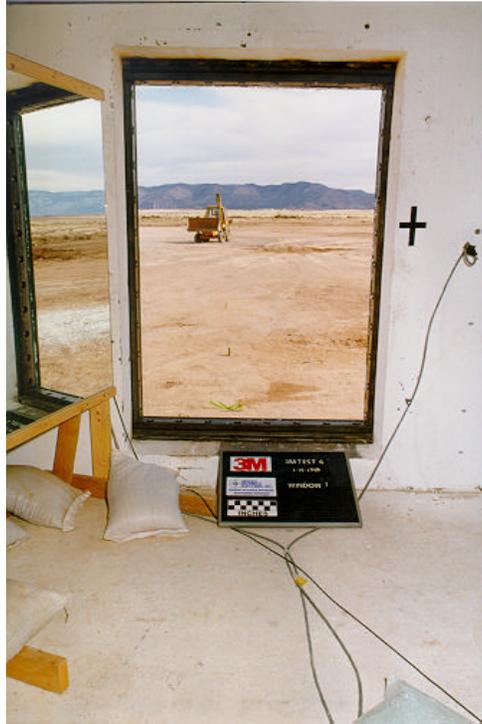
Figure 8.2. Interior posttest view of window 1 fragmentation near the front of the structure, test 6 (3M T6 post 19.tif).

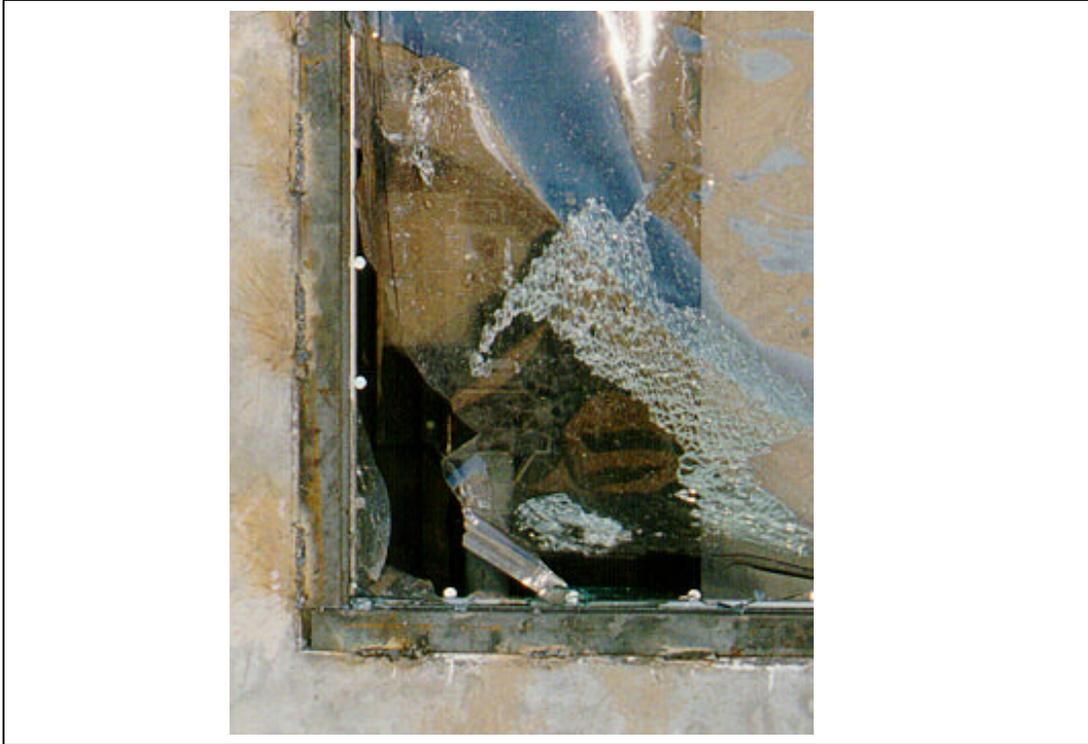
Figure A.36. Test 1. Posttest, exterior view of window 3. View of bottom left corner (3M T1 POST 08b.tif).

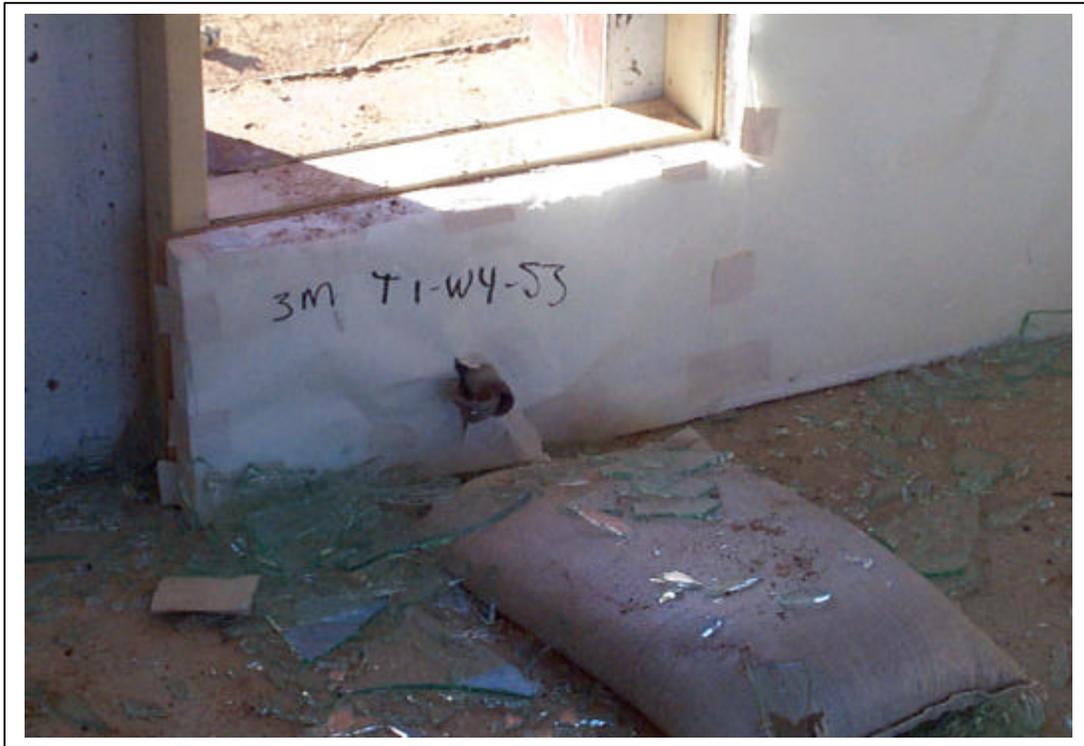
Figure A.46. Test 1. Posttest view of glass debris on the South Structure floor (test1\_47.jpg).

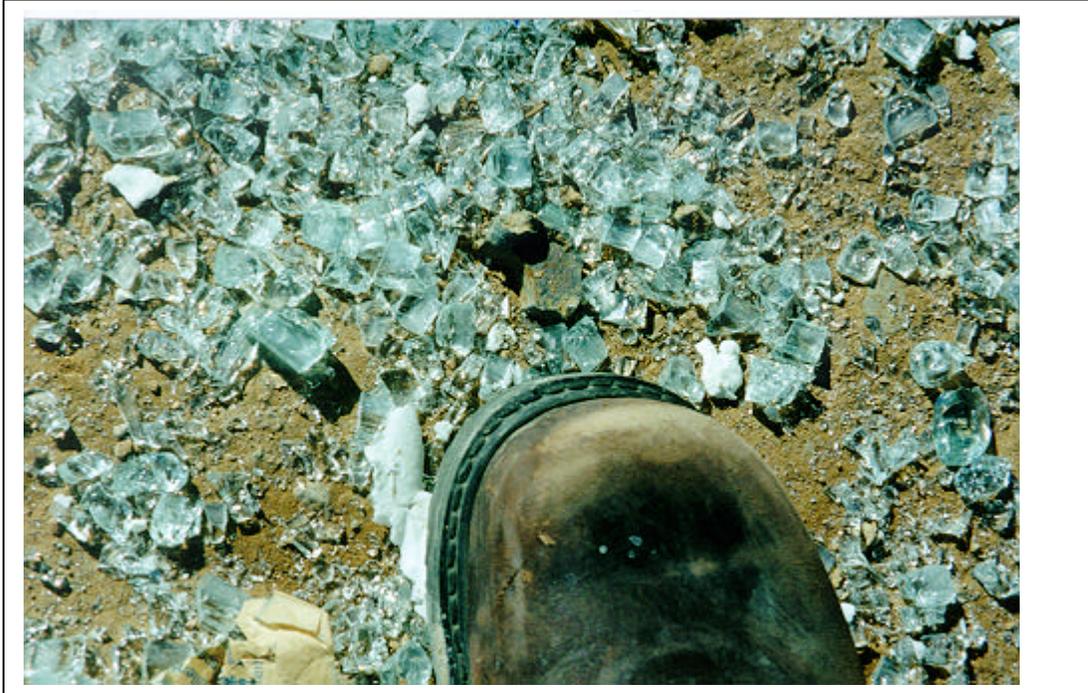
Figure A.169. Test 5. Possible projectile found near the front of the structure containing window 3 (3M sd T5 post02.tif).
