ARA-TR-03-16095.1

Explosive Tests for the Evaluation of 3M Corporation Window Systems

**Applied Research Associates, Inc.
Security Engineering Group
119 Monument Place
Vicksburg, MS 39180**

November 2003

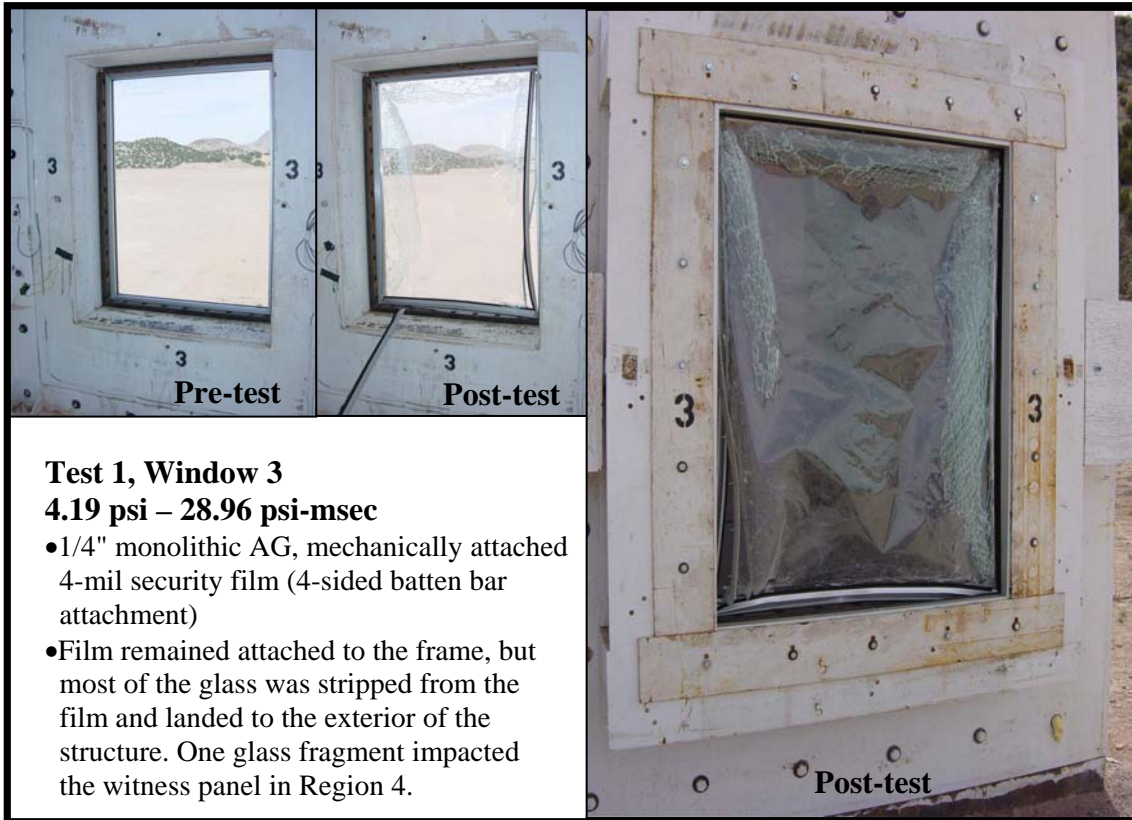
Test 1, Window 3

4.19 psi – 28.96 psi-msec

- 1/4" monolithic AG, mechanically attached 4-mil security film (4-sided batten bar attachment)
- Film remained attached to the frame, but most of the glass was stripped from the film and landed to the exterior of the structure. One glass fragment impacted the witness panel in Region 4.

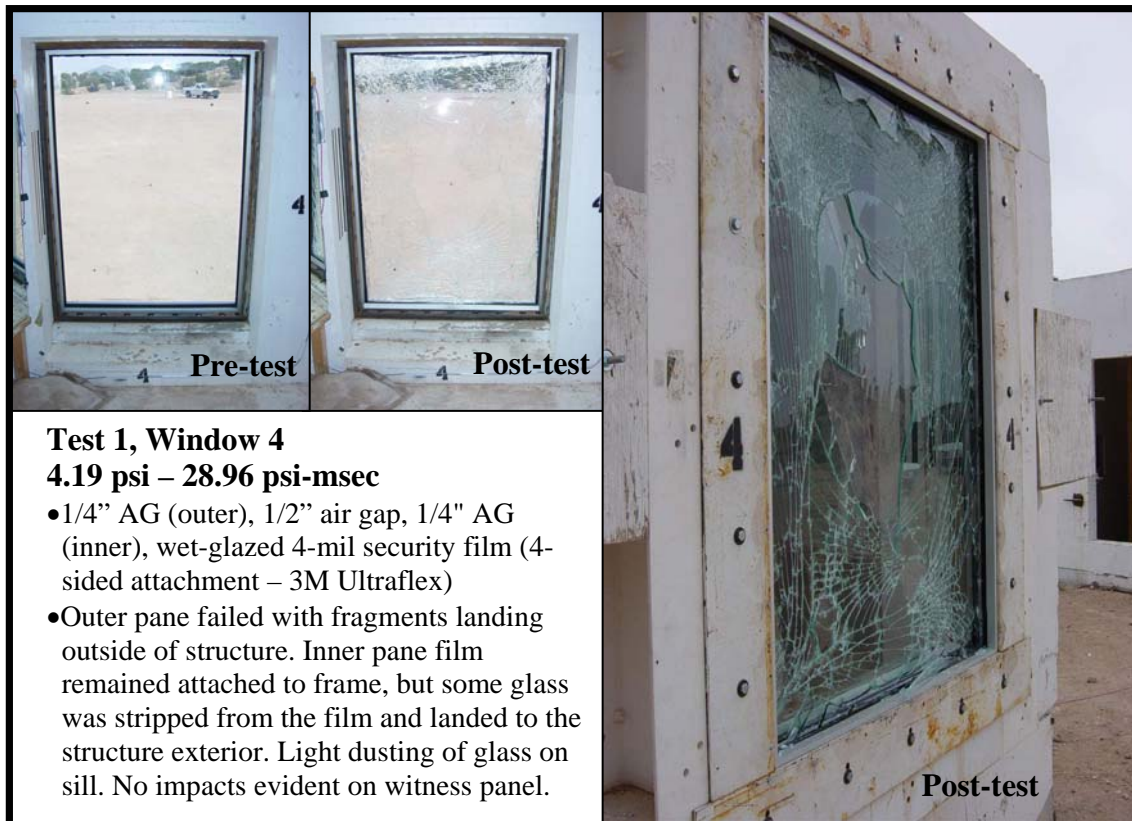
Test 1, Window 4

4.19 psi – 28.96 psi-msec

- 1/4" AG (outer), 1/2" air gap, 1/4" AG (inner), wet-glazed 4-mil security film (4-sided attachment – 3M Ultraflex)
- Outer pane failed with fragments landing outside of structure. Inner pane film remained attached to frame, but some glass was stripped from the film and landed to the structure exterior. Light dusting of glass on sill. No impacts evident on witness panel.

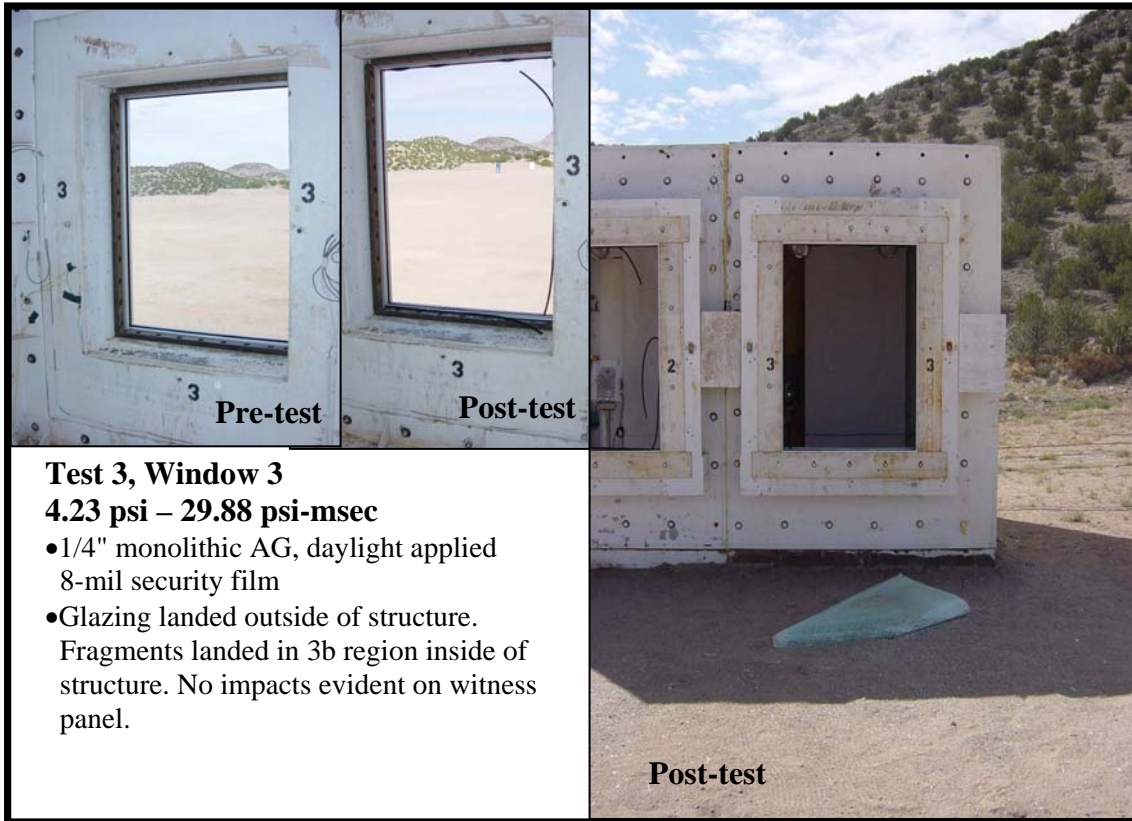
Test 3, Window 3

4.23 psi – 29.88 psi-msec

- 1/4" monolithic AG, daylight applied 8-mil security film
- Glazing landed outside of structure. Fragments landed in 3b region inside of structure. No impacts evident on witness panel.

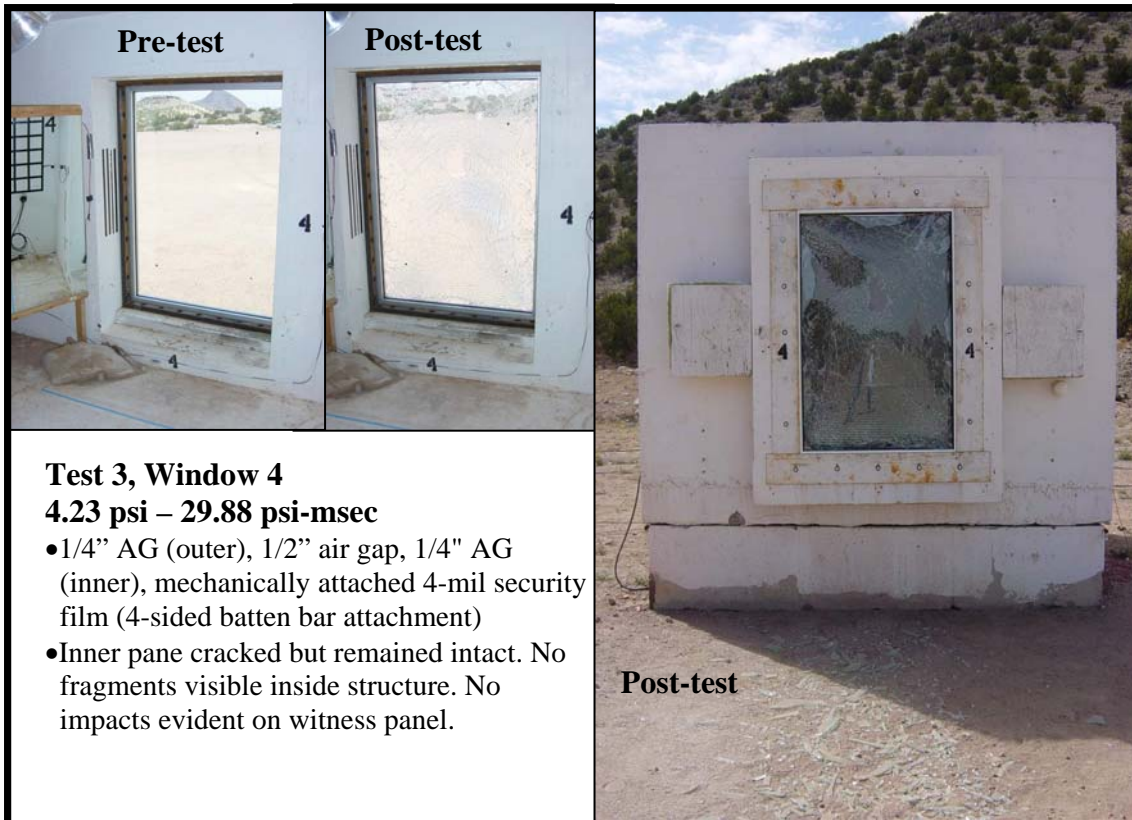
Test 3, Window 4

4.23 psi – 29.88 psi-msec

- 1/4" AG (outer), 1/2" air gap, 1/4" AG (inner), mechanically attached 4-mil security film (4-sided batten bar attachment)
- Inner pane cracked but remained intact. No fragments visible inside structure. No impacts evident on witness panel.

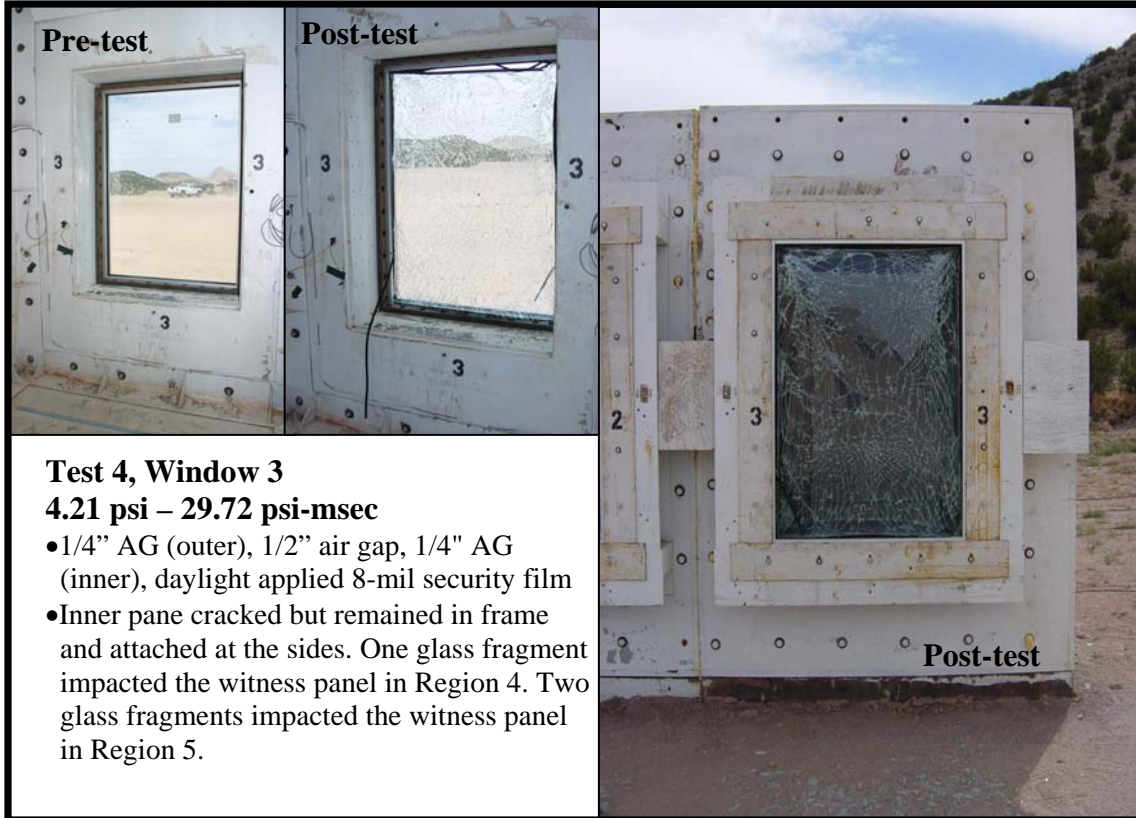
Test 4, Window 3

4.21 psi – 29.72 psi-msec

- 1/4" AG (outer), 1/2" air gap, 1/4" AG (inner), daylight applied 8-mil security film
- Inner pane cracked but remained in frame and attached at the sides. One glass fragment impacted the witness panel in Region 4. Two glass fragments impacted the witness panel in Region 5.

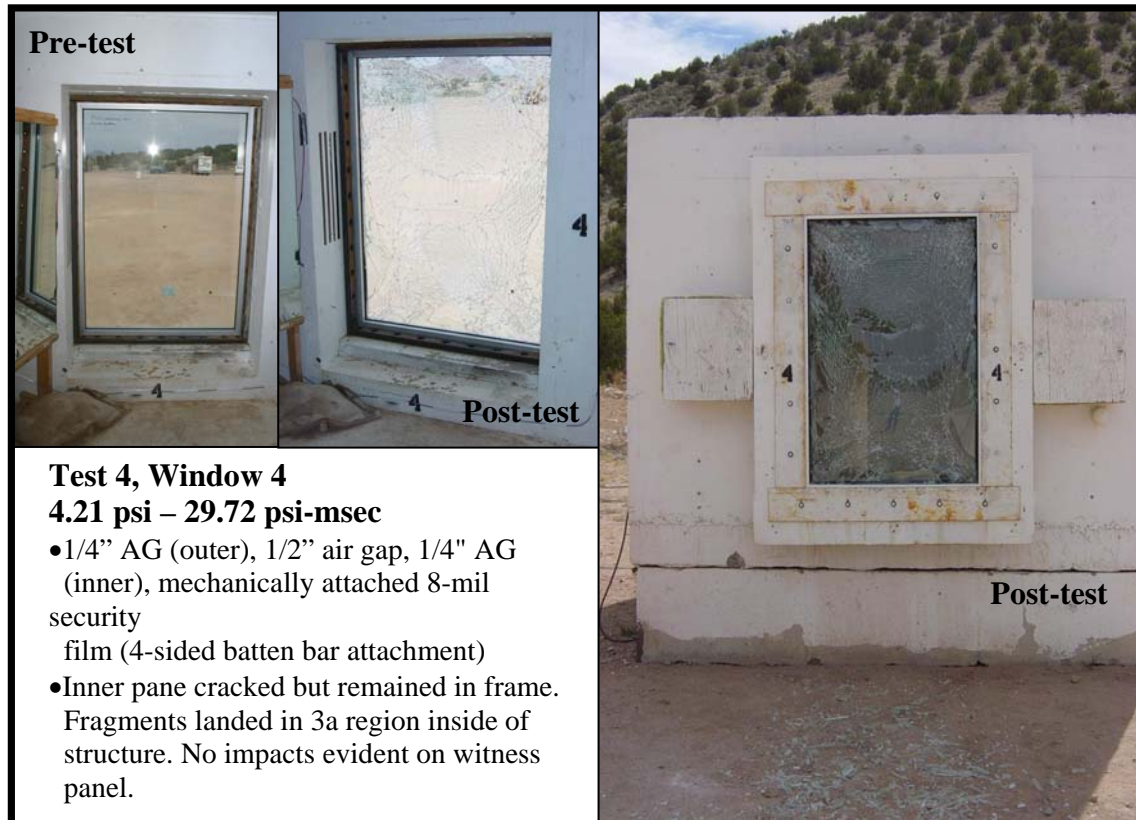
Test 4, Window 4

4.21 psi – 29.72 psi-msec

- 1/4" AG (outer), 1/2" air gap, 1/4" AG (inner), mechanically attached 8-mil security film (4-sided batten bar attachment)
- Inner pane cracked but remained in frame. Fragments landed in 3a region inside of structure. No impacts evident on witness panel.

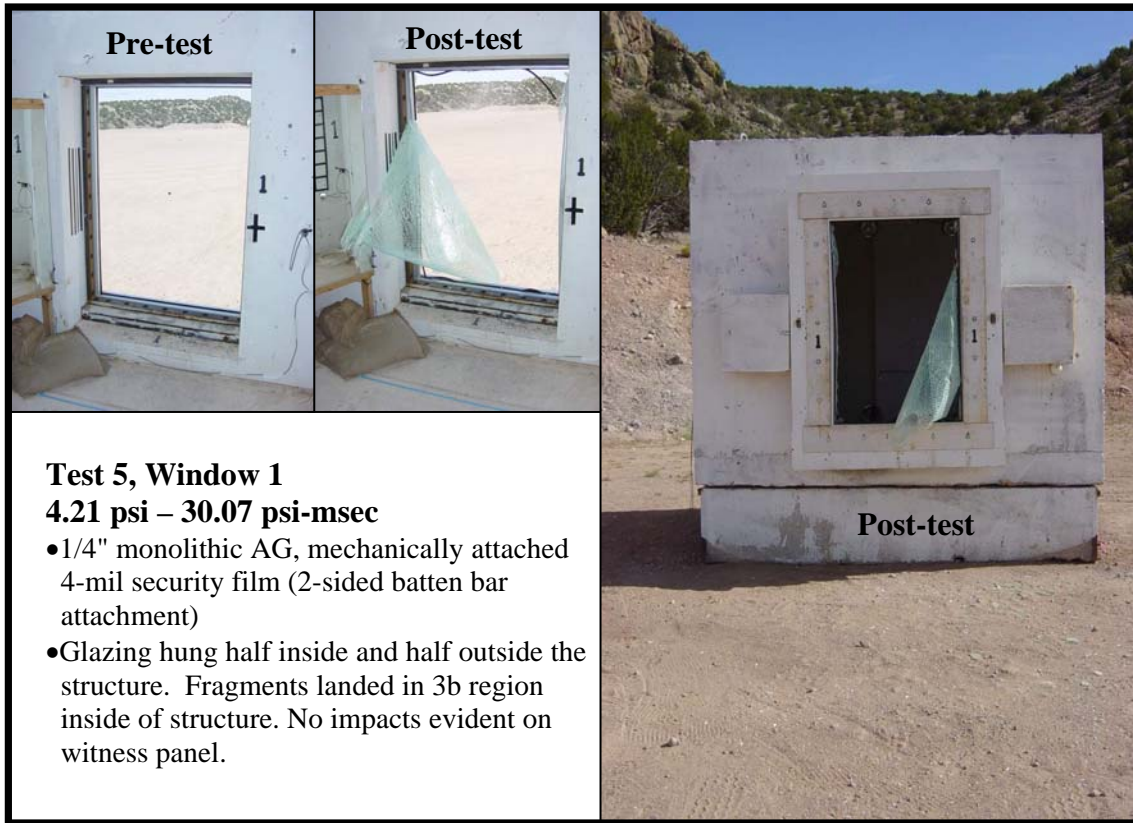
Test 5, Window 1

4.21 psi – 30.07 psi-msec

- 1/4" monolithic AG, mechanically attached 4-mil security film (2-sided batten bar attachment)
- Glazing hung half inside and half outside the structure. Fragments landed in 3b region inside of structure. No impacts evident on witness panel.

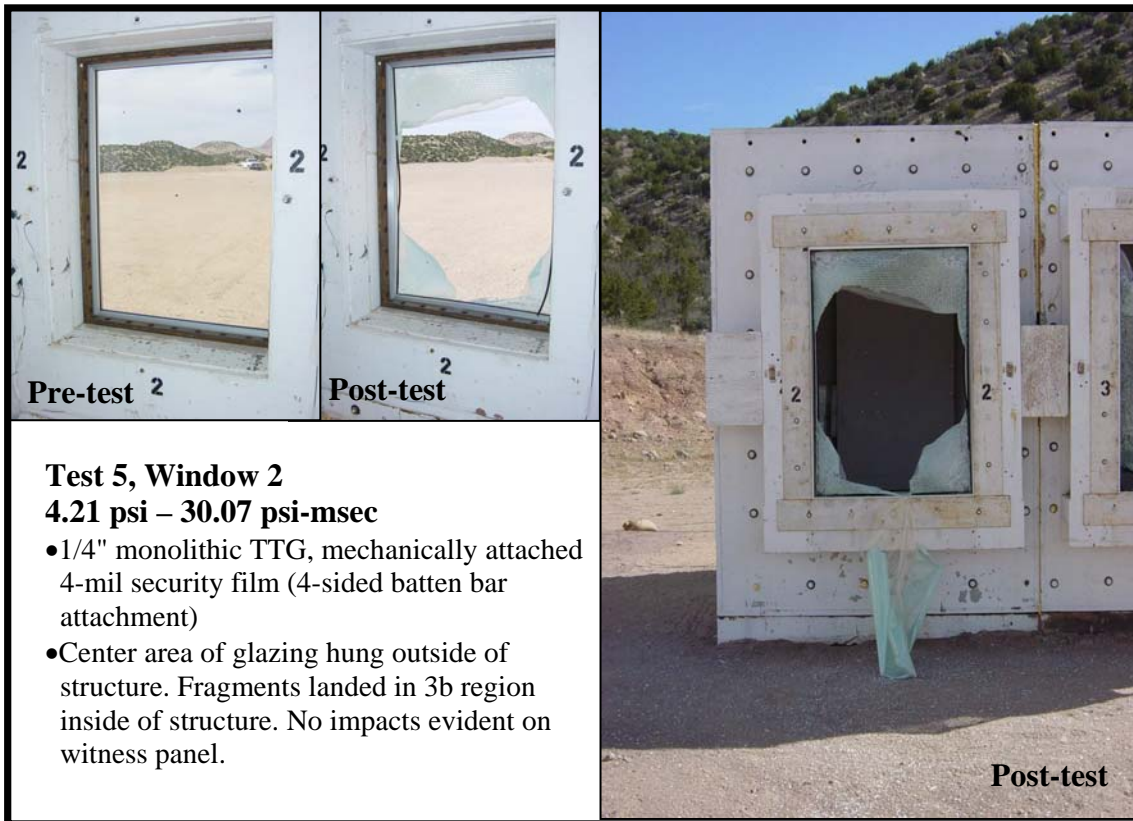
Test 5, Window 2

4.21 psi – 30.07 psi-msec

- 1/4" monolithic TTG, mechanically attached 4-mil security film (4-sided batten bar attachment)
- Center area of glazing hung outside of structure. Fragments landed in 3b region inside of structure. No impacts evident on witness panel.

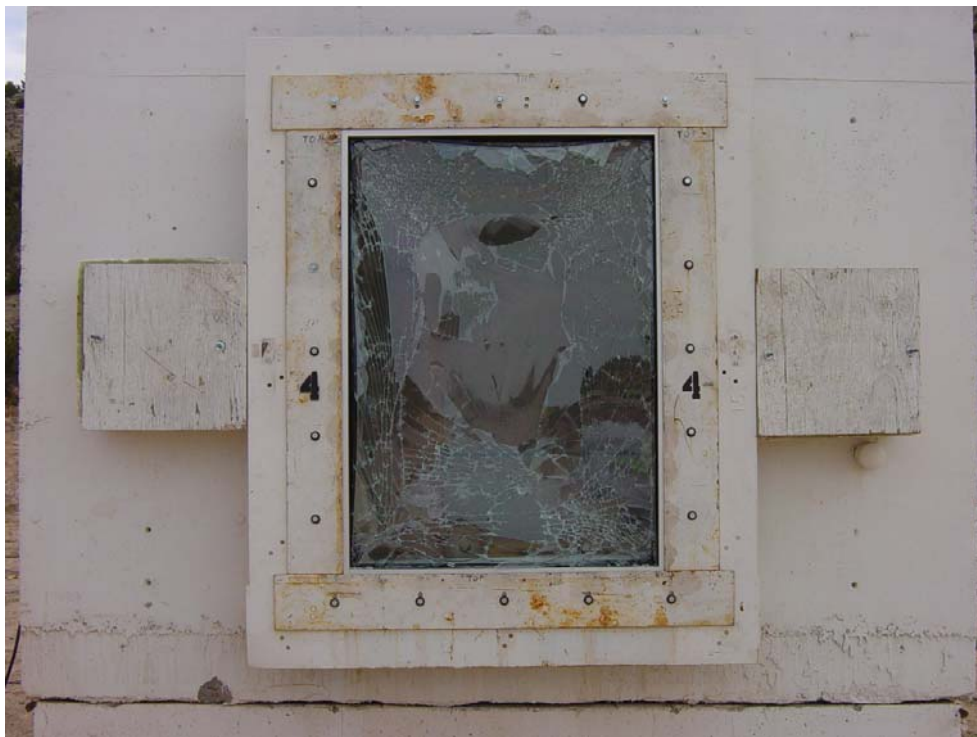
Figure 3-12 Exterior post-test view of window 4. (DSC04084.jpg)

Rating: GSA Condition 2

Outer pane failed with fragments landing outside of structure. Inner pane film remained attached to the frame, but some of the glass was stripped from the film and landed to the exterior of the structure. Light dusting of glass on sill. No visible frame deformation. No impacts evident on witness panel.

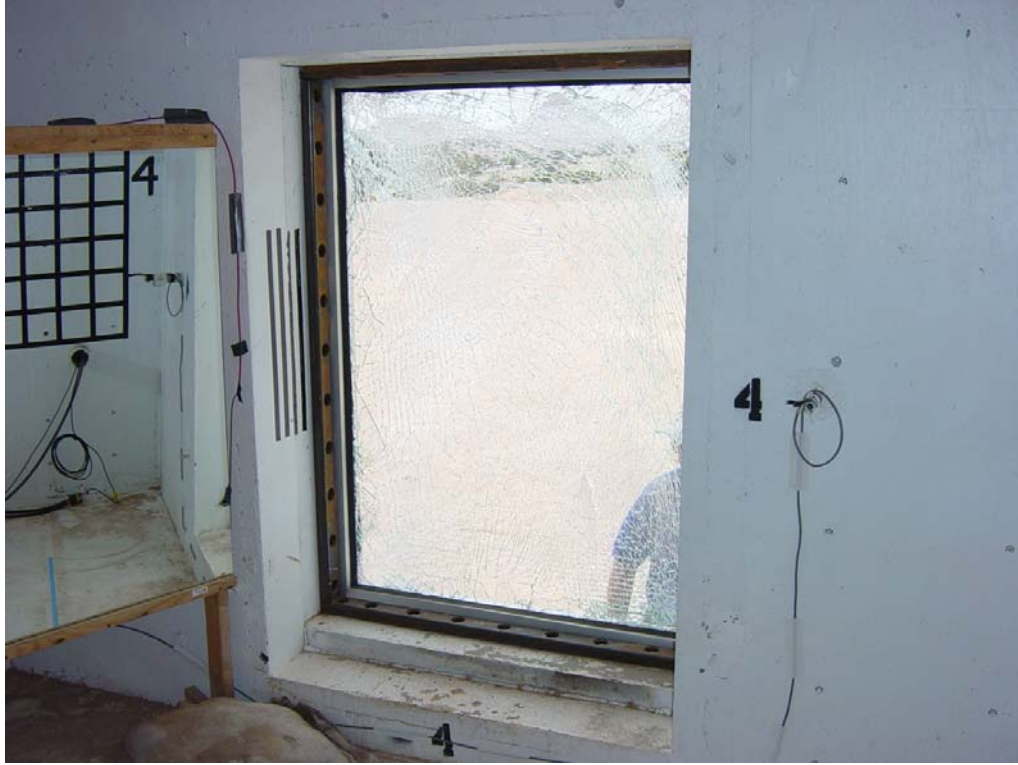
Figure 3-26 Interior post-test view of window 4. (DSC04217.jpg)

Rating: GSA Condition 2

Outer pane failed with fragments landing outside of structure. Inner pane cracked but remained attached to frame. No fragments visible inside structure. Slight deformation at bottom of frame. No impacts evident on witness panel.

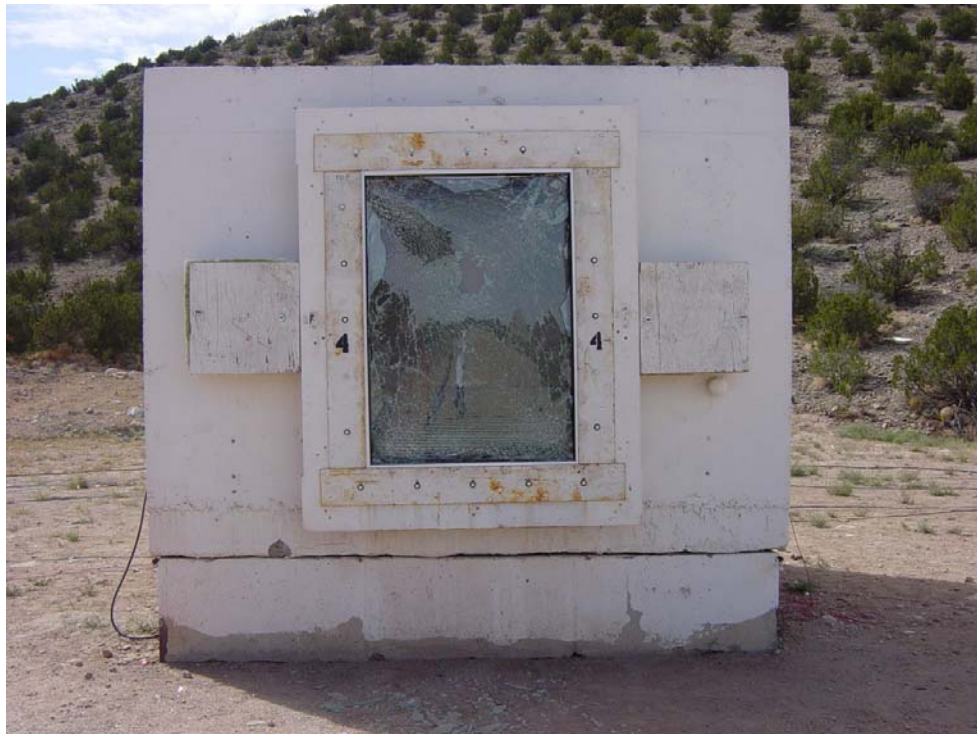
Figure 3-38 Exterior post-test view of window 4. (DSC04330.jpg)

Rating: GSA Condition 2

Outer pane failed with fragments landing outside of structure. No visible frame deformation. Inner pane cracked but remained attached to frame. No fragments visible inside structure. No impacts evident on witness panel.

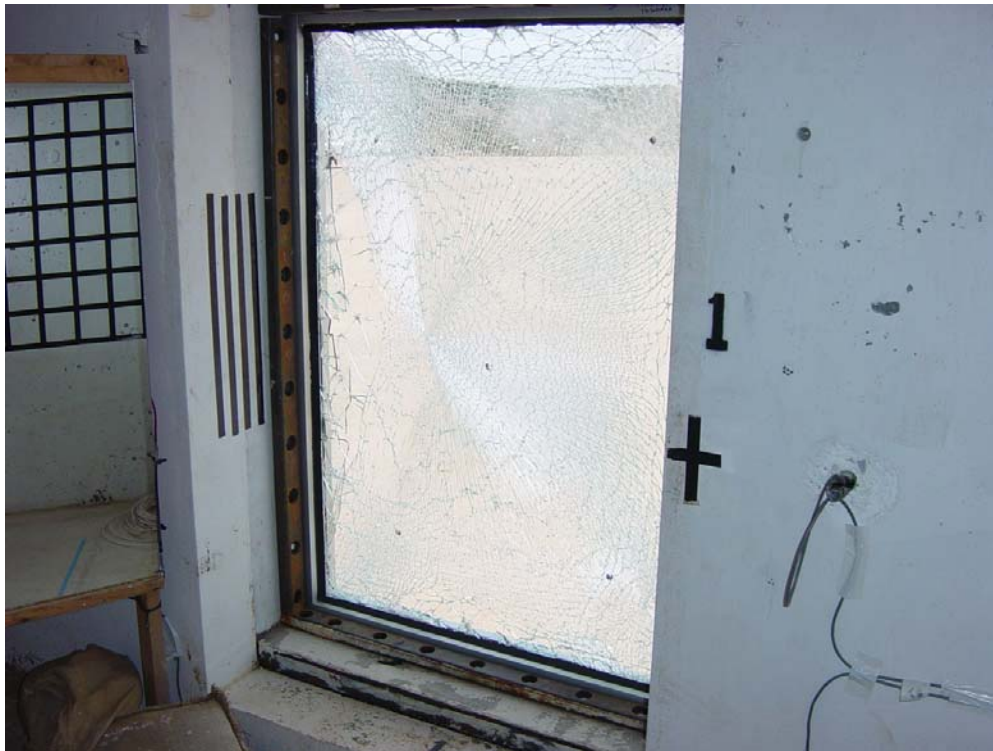
Figure 3-43 Interior post-test view of window 1. (DSC04355.jpg)

Rating: GSA Condition 2

Outer pane failed with fragments landing outside of structure. No visible frame deformation. Inner pane cracked but remained in frame. Light dusting of glass on sill. No impacts evident on witness panel.

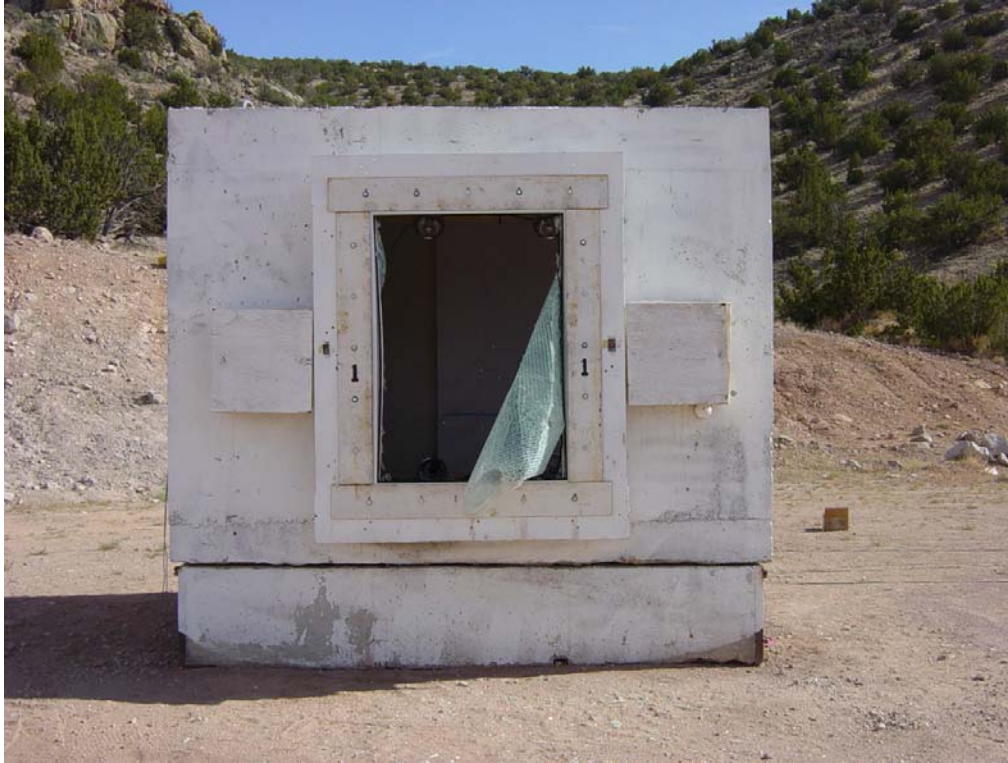
Figure 3-55 Exterior post-test view of window 1. (DSC04508.jpg)

Rating: GSA Condition 3b

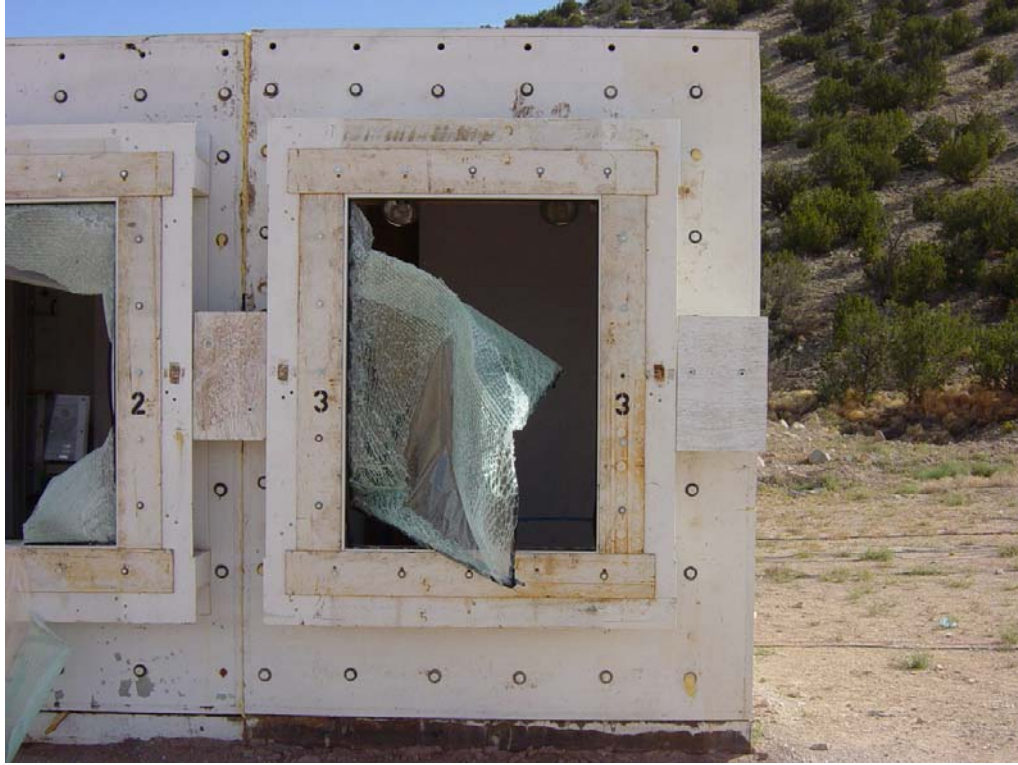
Figure 3-61 Exterior post-test view of window 3. (DSC04493.jpg)

Rating: GSA Condition 5

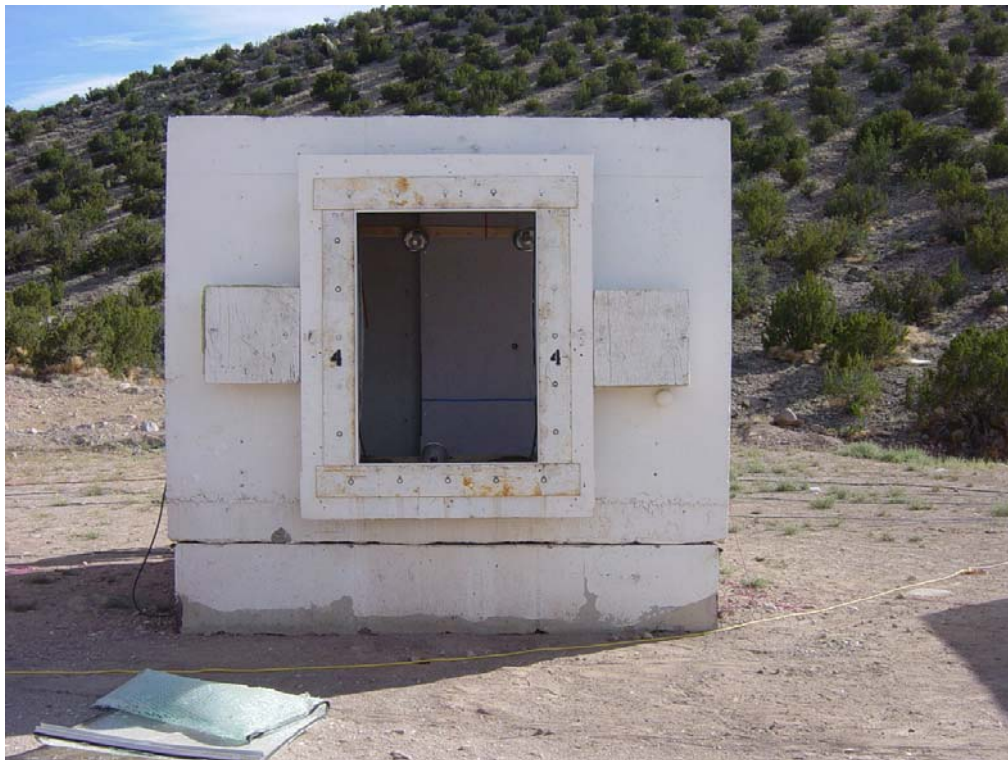
Figure 3-64 Exterior post-test view of window 4. (DSC04558.jpg)

Rating: GSA Condition 4
