# Report

## 3M: Anchored Safety Film Blast Tests

22 October 2007

Revision D: 21 Oct 2009

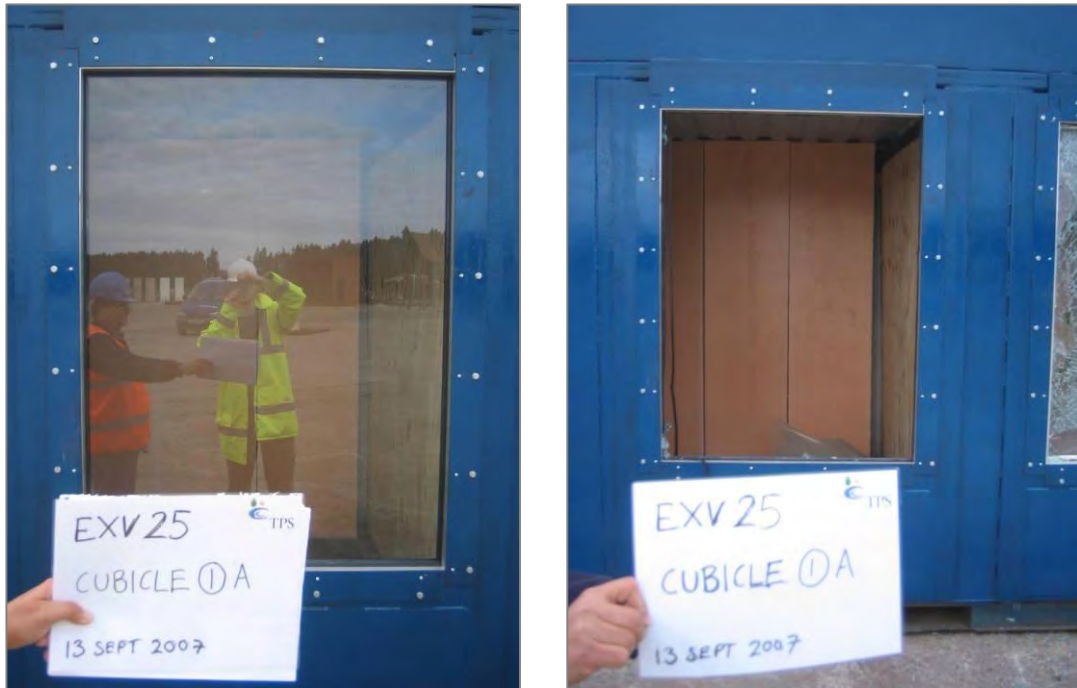
### 8.2.1 Window 1 (Location 1A)

The window shattered and was thrown inwards by the blast load. The film remained intact and was found adjacent the witness panel at the back of the test cubicle. The silicone tore along all four edges.

Due to the large number of high hazard fragments impacting on the witness pack this system has been given an ISO EXV rating of F (High Hazard).

##### **Rating ISO EXV (F)**

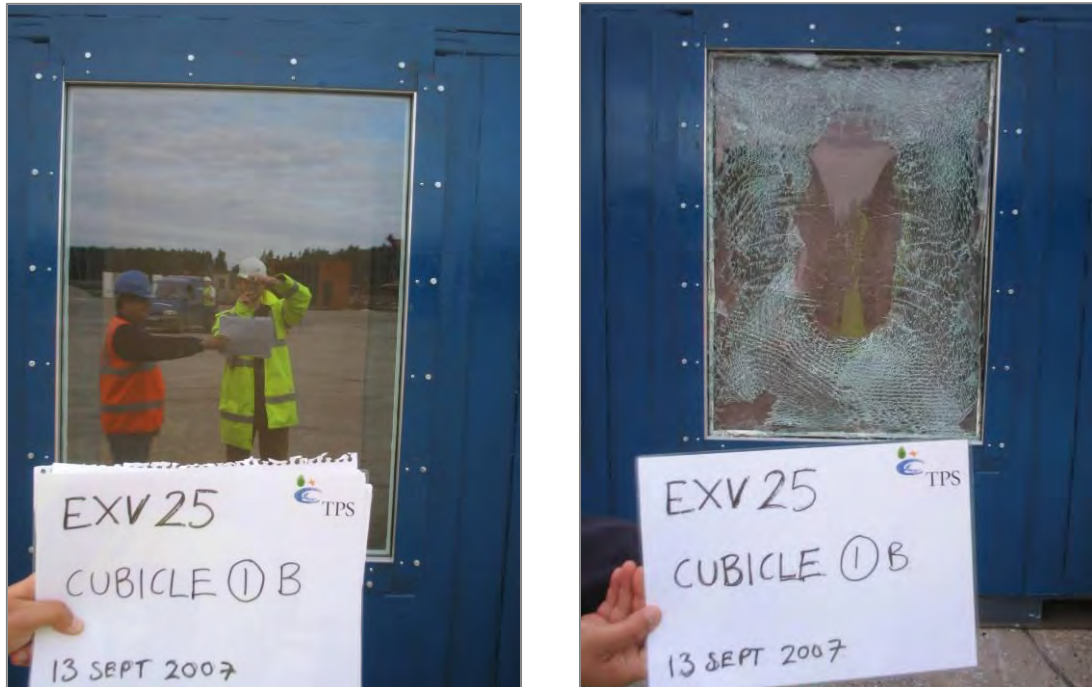
### 8.2.2 Window 2 (Location 1B)

The glazing fractured with the outer leaf shattering and being thrown outward towards the charge. The majority of the inner leaf remained attached to the film and the rest was thrown out of the test cubicle towards the charge location. Very few fragments were found within the test cubicle and no impacts were recorded on the witness panel.

Since the inner leaf of the glazing system shattered, however the majority of glass remained firmly in place and no significant fragments were found in the test cubicle or impacted on the witness panel. Thus, an ISO EXV rating of C (Minimal Hazard) was awarded.

**Rating: ISO EXV25(C)**

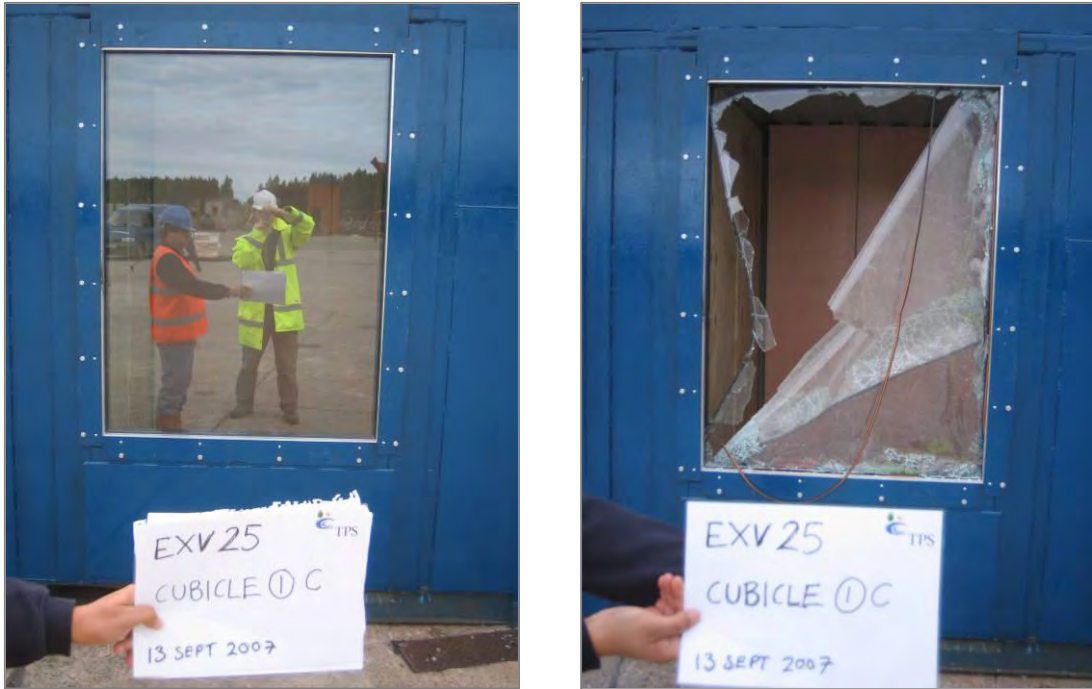
### 8.2.3 Window 3 (Location 1C)

The majority of the glazing fragments were thrown out of the test cubicle towards the charge location. However, significant fragments were found throughout the test cubicle and 9 impacts were recorded on the witness screen with one of these above 0.5 m (~1'10").

The glazing shattered with fragments landing throughout the cubicle and impacting the witness pack up to 0.5 m (~1'10") above the ground, hence an ISO EXV rating of E (Low Hazard) has been awarded.

**Rating: ISO EXV25(E)**

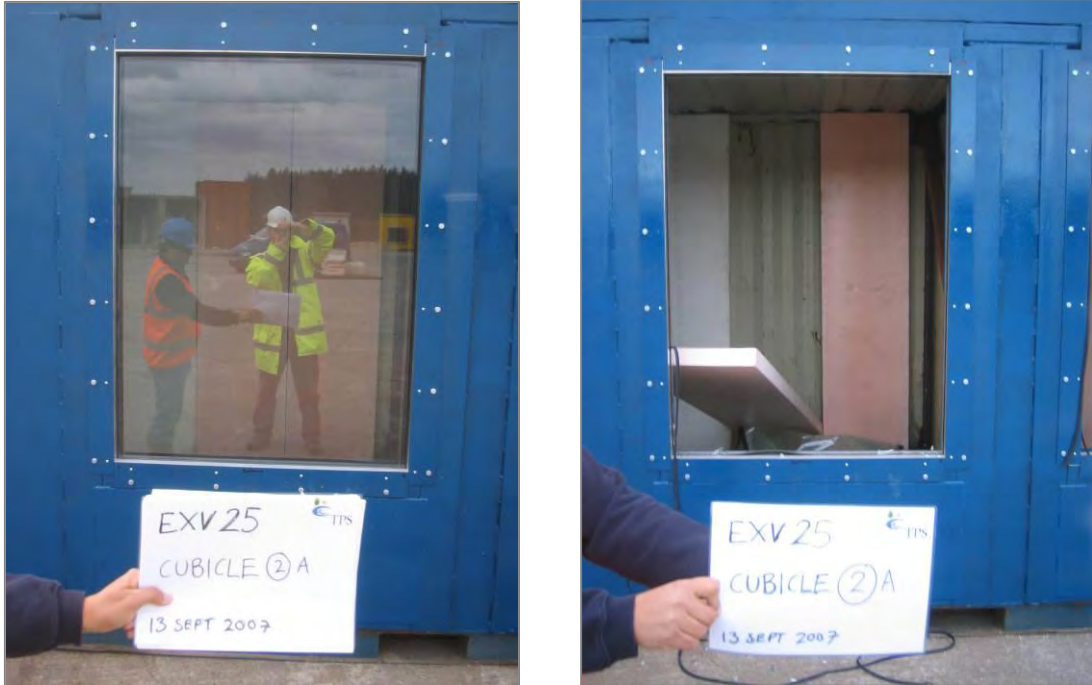
#### 8.2.4 Window 4 (Location 2A)

Significant fragments were found throughout the test cubicle and a large number of impacts were recorded on the witness panel, of which eight were above 0.5 m (1'10") and nine below.

Since significant sized fragments were found throughout the cubicle and many impacts were found on the witness pack, an ISO EXV rating of E (Low Hazard) was awarded.

**Rating: ISO EXV25(E)**

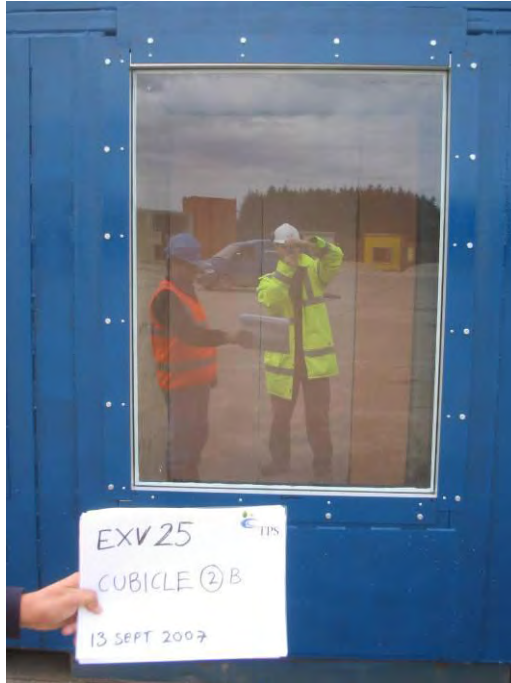
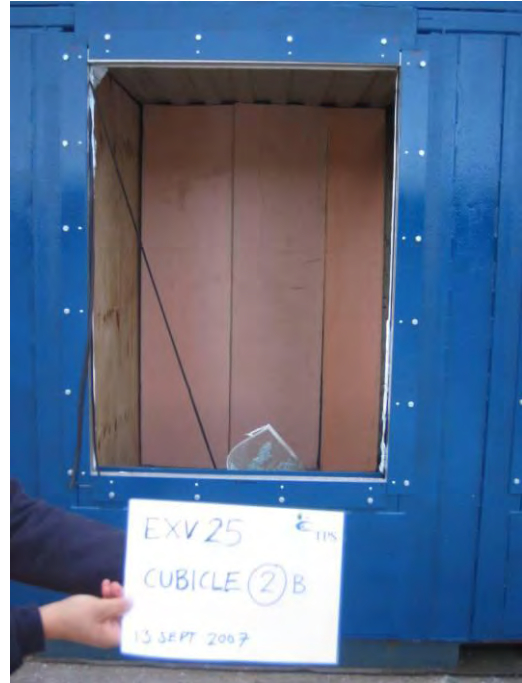
### 8.2.5 Window 5 (Location 2B)

The glazing shattered and was thrown inward. Significant fragments were found throughout the cubicle and several impacts were recorded on the witness pack. Of these impacts, five were recorded above 0.5 m and seven below.

Due to fragments found impacting the witness panel but less than ten above 0.5 m this system has been awarded an ISO EXV rating of E (Low hazard).

**Rating: ISO EXV25(E)**

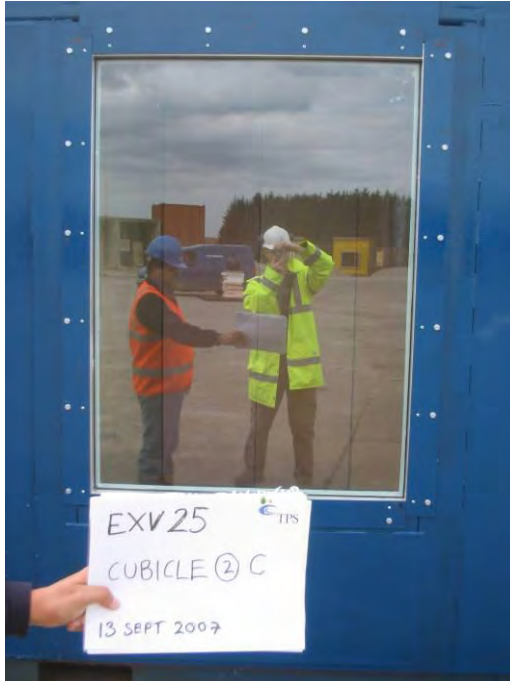
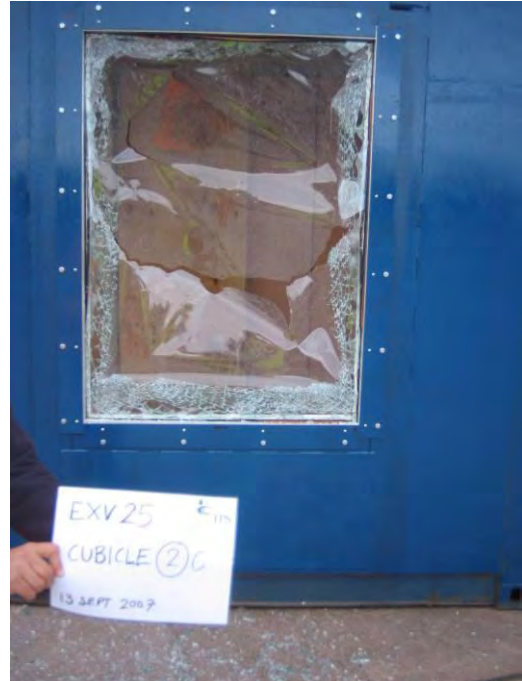
### 8.2.6 Window 6 (Location 2C)

The glazing shattered with the majority being thrown outside of the test cubicle, but some landed inside possibly travelling through the opening created by the tear in the film. Significant sized fragments were found even spread throughout the cubicle and three impacts were recorded on the witness pack below 0.5 m (1'10").

Due to glazing fragments landing inside the test cubicle and impacting the witness pack an ISO EXV rating of E (Low hazard) has been awarded.

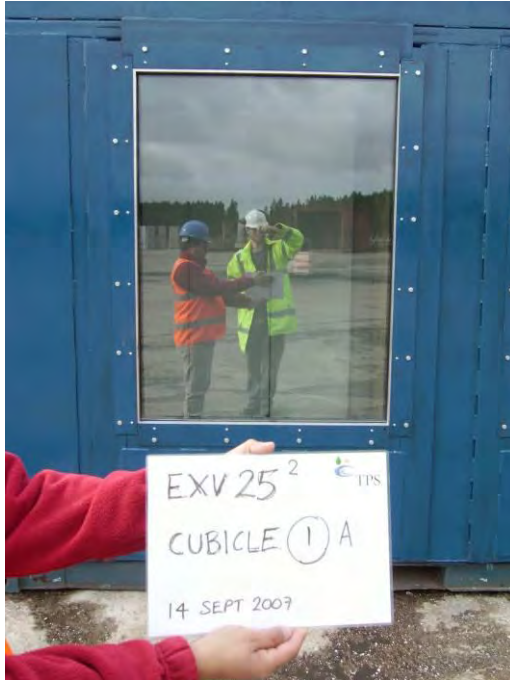
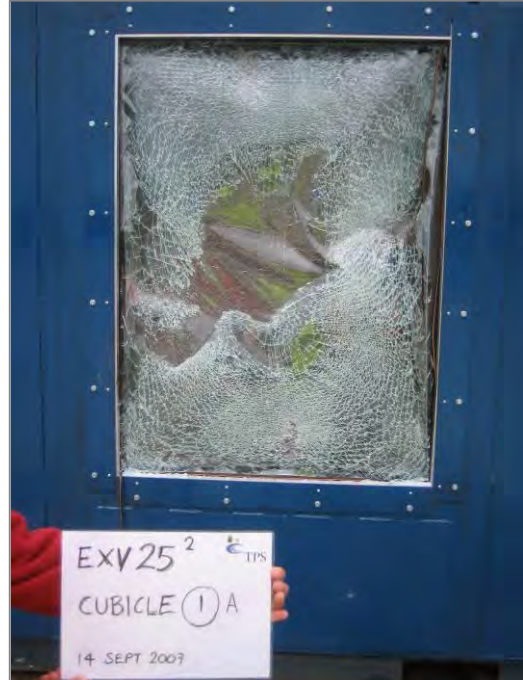
### 8.3.1 Window 1 (Location 1A)

The outer leaf fractured and was projected outwards towards the charge location. The majority of the inner leaf was shattered but retained by the film and the rest was also thrown outwards. Six rateable fragments were found greater than 1 m (3'3") into the cubicle with a total unified length of approximately 260 mm ( $\sim 10$ " ).

Although the inner face remained in place, fragments with unified dimension greater than 250 mm ( $\sim 10$ " ) were found greater than 1m (3'3") into the cubicle; hence an ISO EXV rating of E (Low Hazard) was awarded.

**Rating: ISO EXV25(E)**

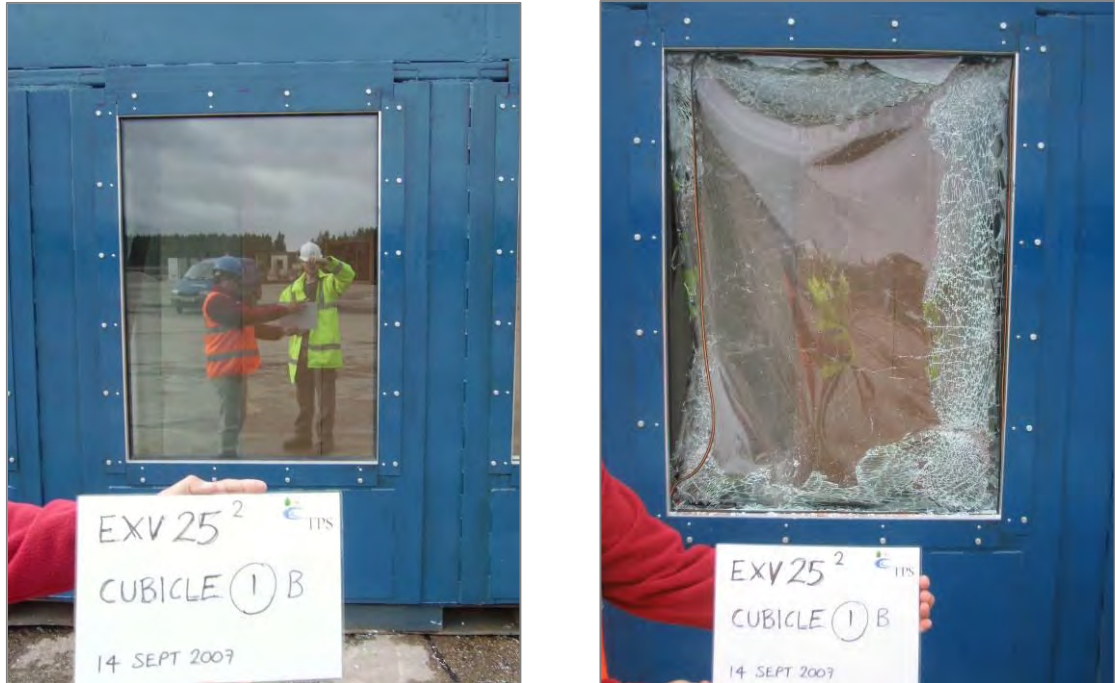
### 8.3.2 Window 2 (Location 1B)

Both leaves of glazing fractured under the blast load, with the majority of fragments being projected out of the test cubicle towards the charge location. The film was undamaged and retained some of the glazing close to the edges on the inner leaf. The glazing spacer pulled 200 mm (8") away from the frame on the left side for about 50% of the length. The external gasket detached from the left hand side of the frame. The silicone tore along the most of the left hand edge of unit and several small tears were recorded along the top and bottom edges.

The majority of the glazing fragments were projected outward but significant amounts were found within the cubicle up to 1m (~3'3") from the window. Several fragments were found beyond 1m and had a total unified length of approximate 380 mm (~15"). No impacts were recorded on the witness pack.

Since the glazing was observed to fracture and significant amounts of fragments were found greater than 1m (~3'3") into the test cubicle a ISO EXV rating of E (Low Hazard) has been awarded.

**Rating: ISO EXV25(E)**

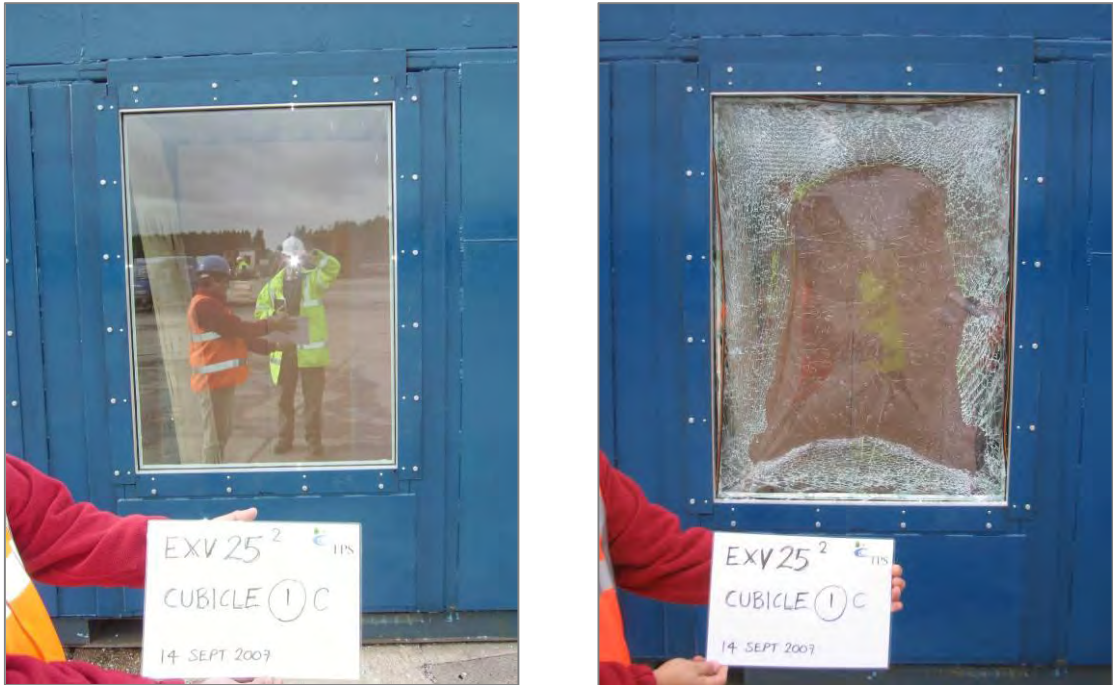
### 8.3.3 Window 3 (Location 1C)

Both the inner and outer leaves were observed to fracture under the blast load with the majority of the glazing fragments being projected outwards. No rips or tears were recorded on the film, which remained securely fixed in the frame. The glazing spacer was pulled out of the frame by approximately 10 mm (1/3") on by the right and left sides.

The glazing in both leaves shattered and was thrown outwards. No fragments were recorded within the test cubicle and no impacts were found on the witness pack.

Since the film held a large proportion of the inner leaf in the frame and no fragments or impacts were recorded within the test cubicle, an ISO EXV rating of C (Minimal Hazard) was awarded.

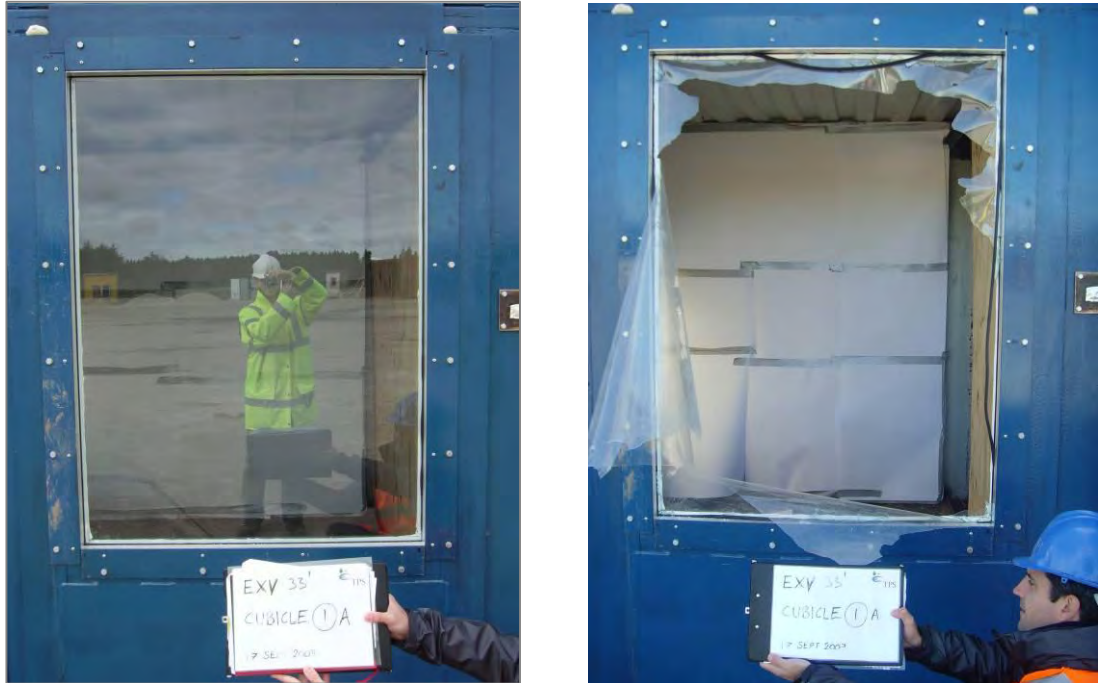
#### 8.4.1 Window 1 (Location 1A)

The glazing shattered and a large number of fragments entered to cubicle. The film was found to be torn in several places with some pieces broken off and thrown within the cubicle. The external gasket was detached for approximately 500 mm (20") along the top edge of the frame.

A large number of glazing fragments were thrown within the cubicle with a large concentration located on the left hand side. After studying the high speed video, this is observed to be as a result of the film tearing and dropping the fragments towards the left side of the cubicle. A significant number of fragments were found at a distance greater than 1 m (3'3") into the test cubicle. Two impacts were recorded above 0.5 m (~1'10") on the witness panel.

**Rating: ISO EXV33(E)**

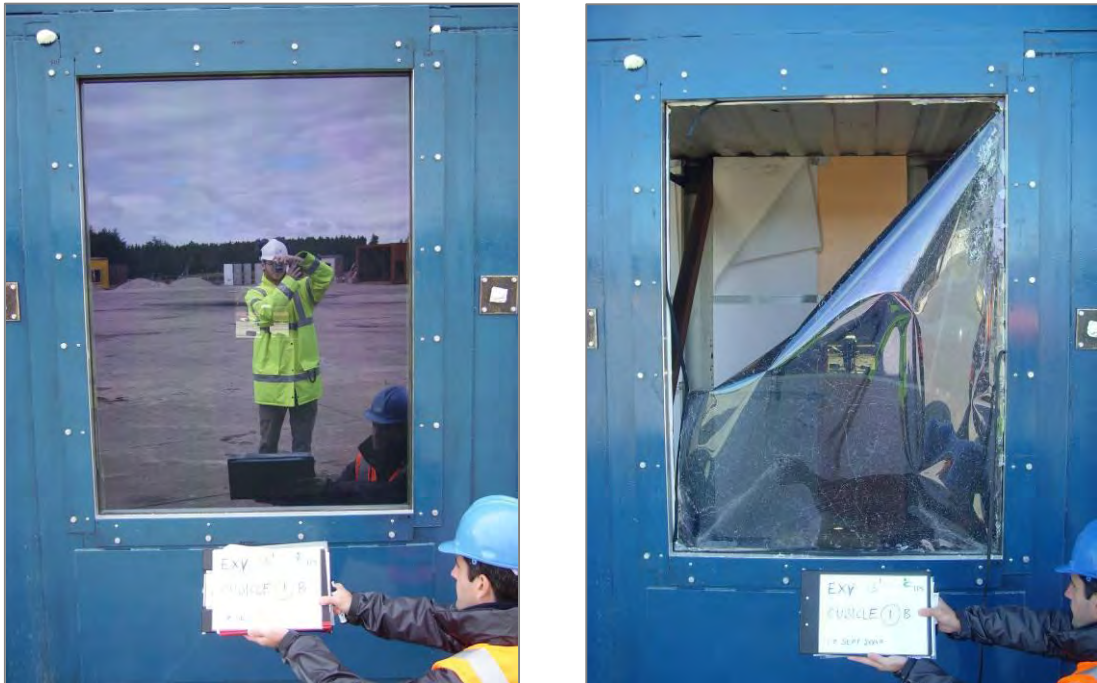
#### 8.4.2 Window 2 (Location 1B)

**Rating: ISO EXV33(D)**

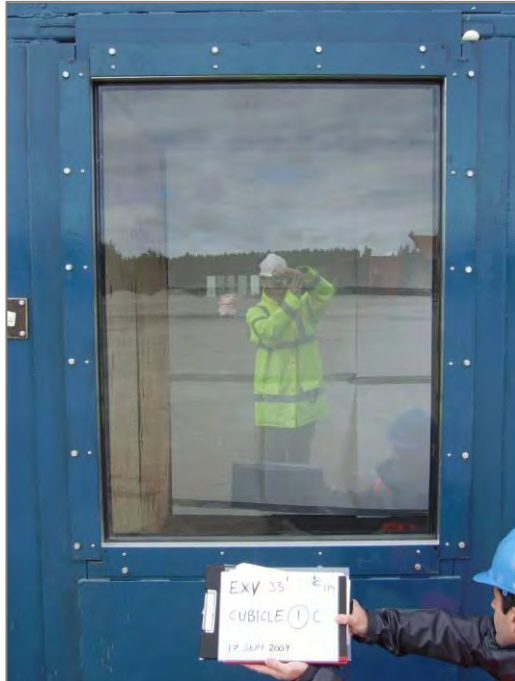
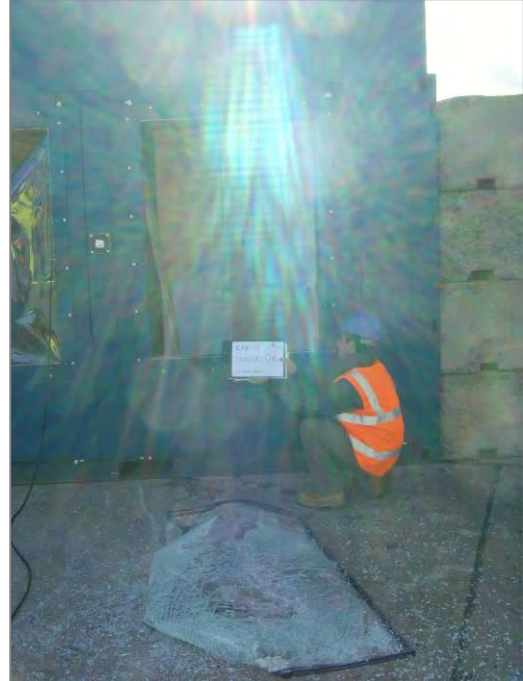
### 8.4.3 Window 3 (Location 1C)

**Rating: ISO EXV33(D)**

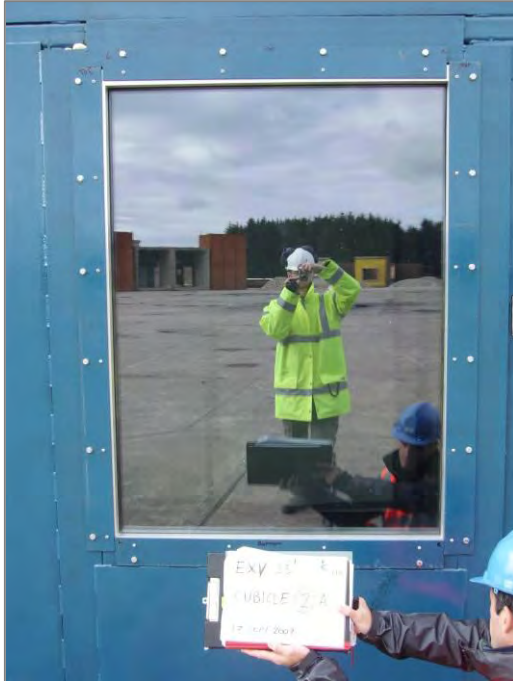
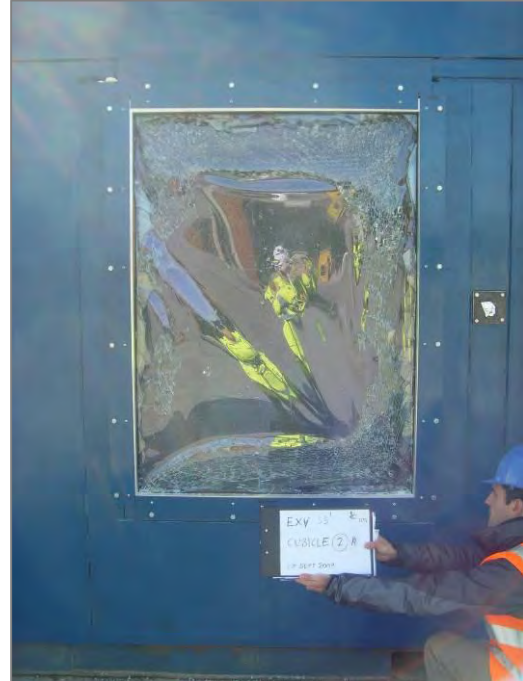
#### 8.4.4 Window 4 (Location 2A)

**Rating: ISO EXV33(C)**

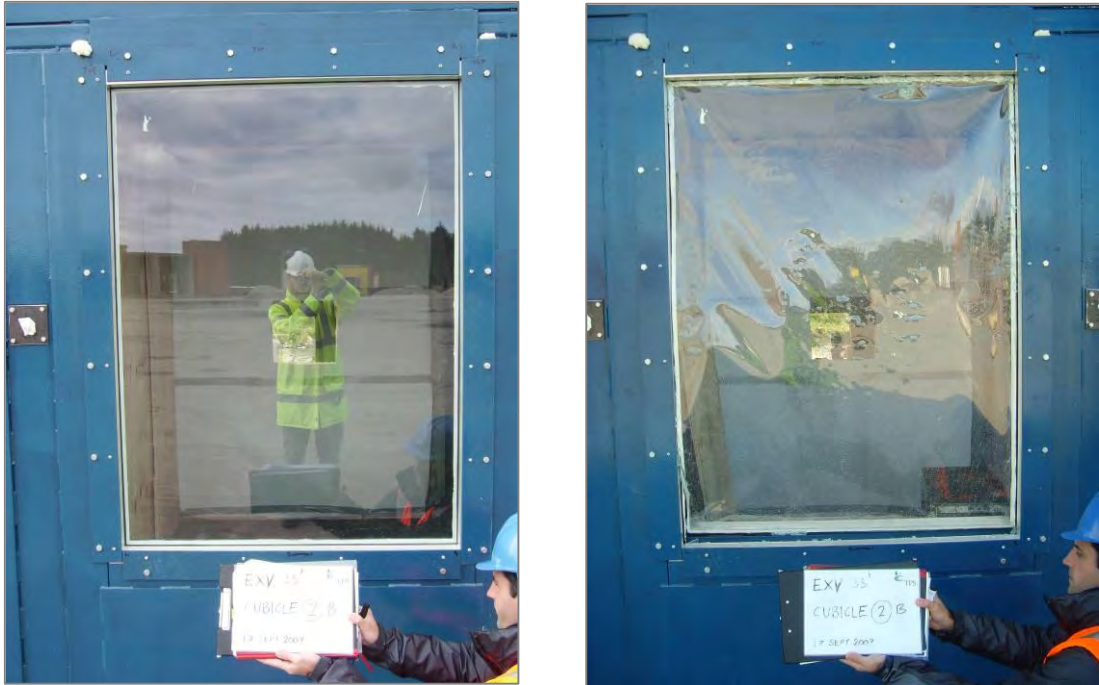
#### 8.4.5 Window 5 (Location 2B)

**Rating: ISO EXV33(E)**

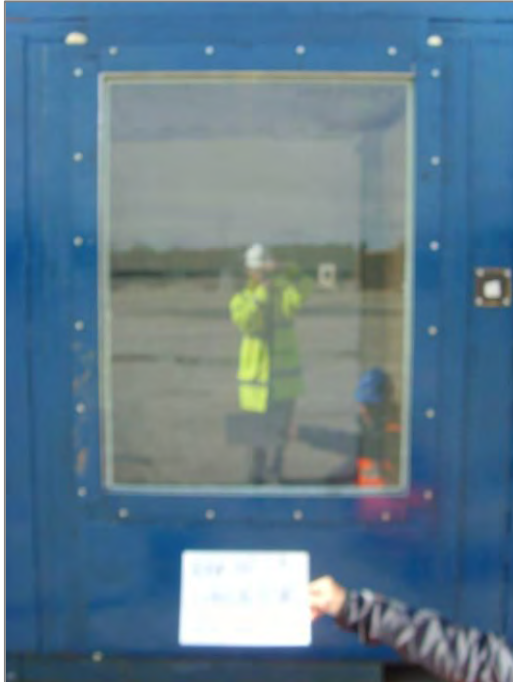
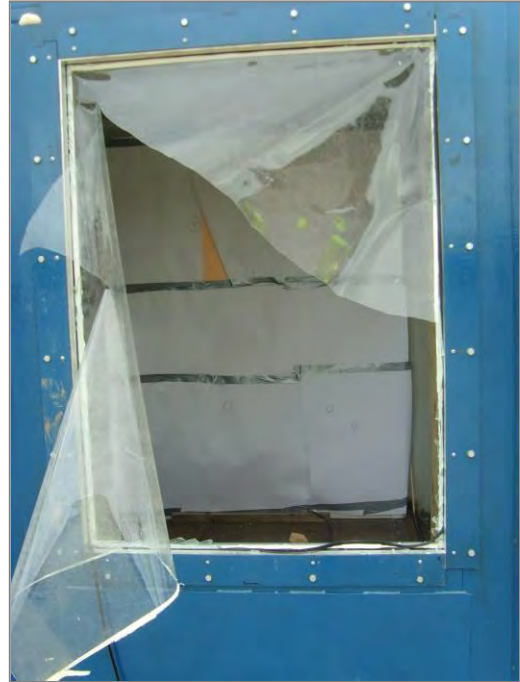
### 8.5.1 Window 1 (Location 1A)

**Rating: ISO EXV33 (E)**

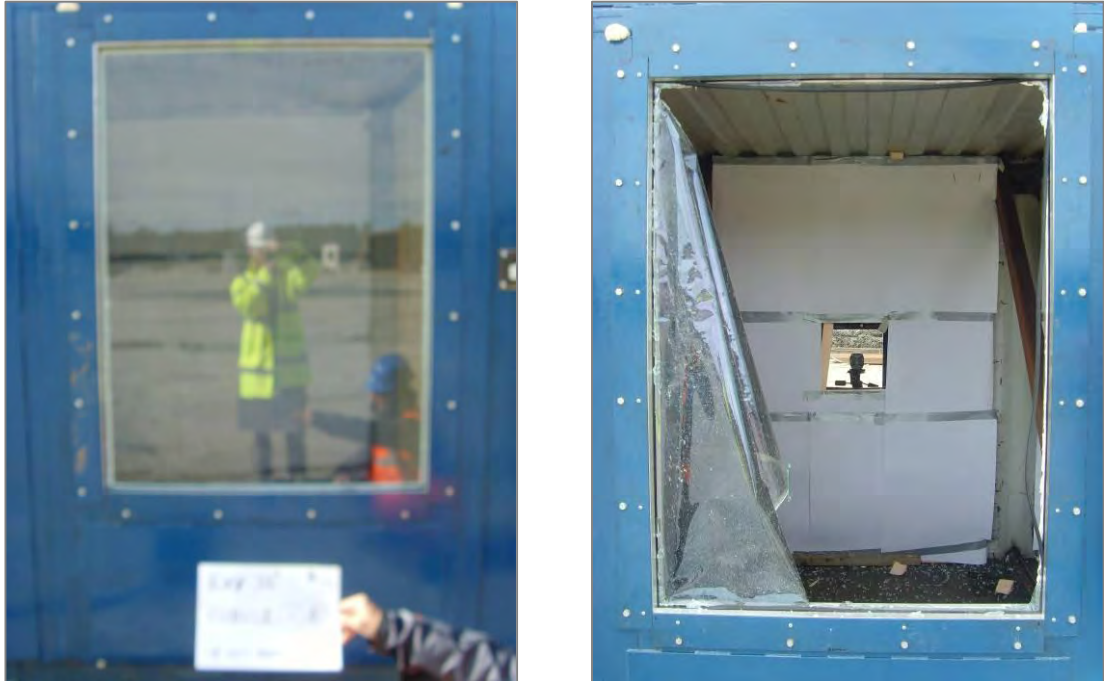
### 8.5.2 Window 2 (Location 1B)

**Rating: ISO EXV33 (E)**

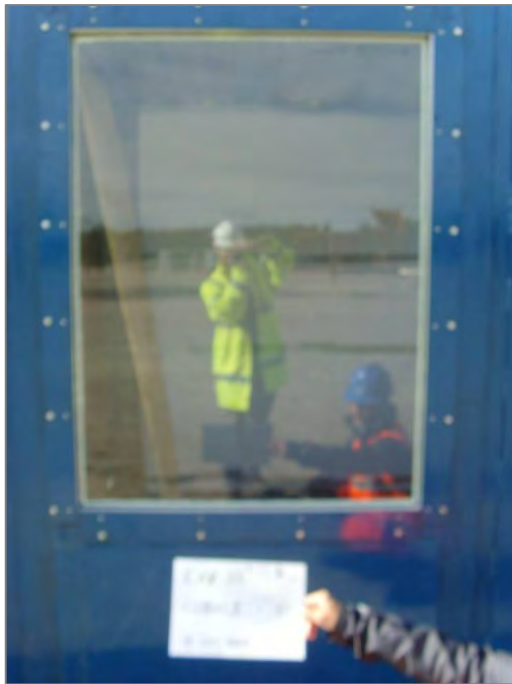
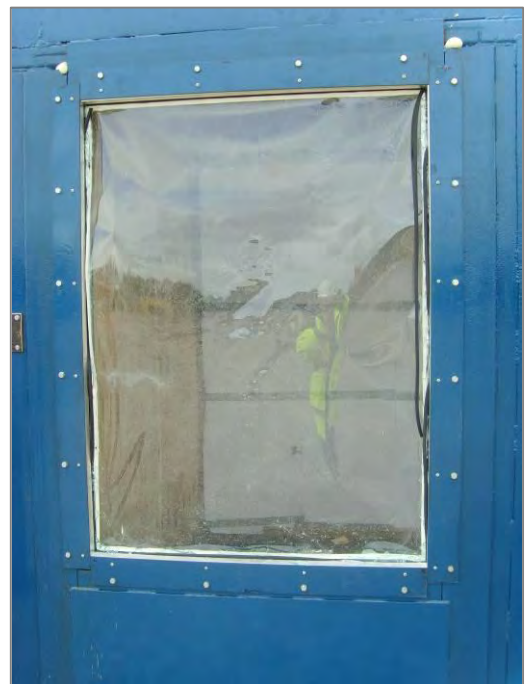
### 8.5.3 Window 3 (Location 1C)

**Rating: ISO EXV33 (E)**

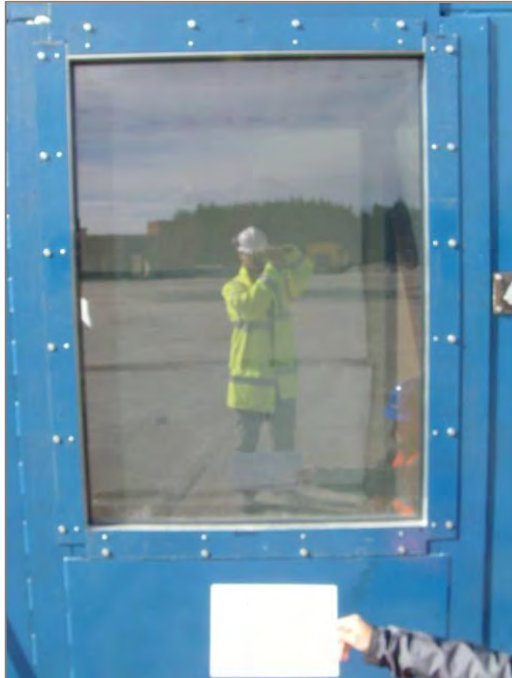
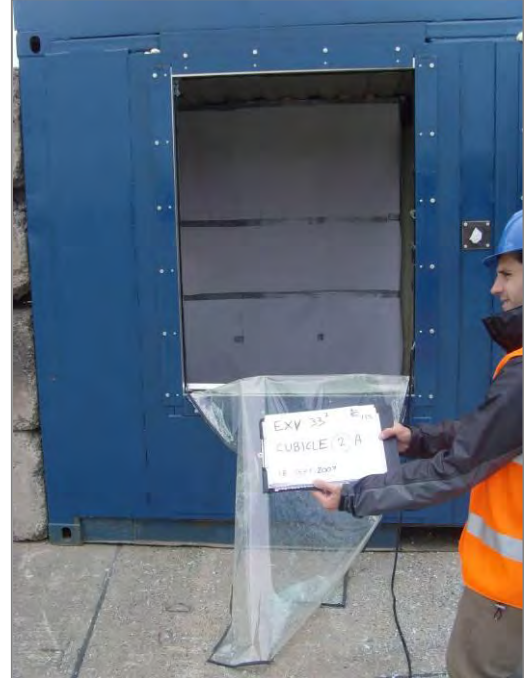
#### 8.5.4 Window 4 (Location 2A)

**Rating: ISO EXV33 (D)**

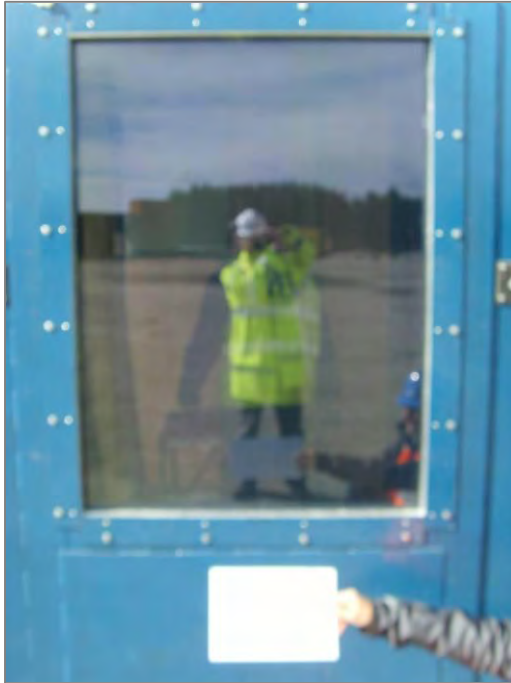
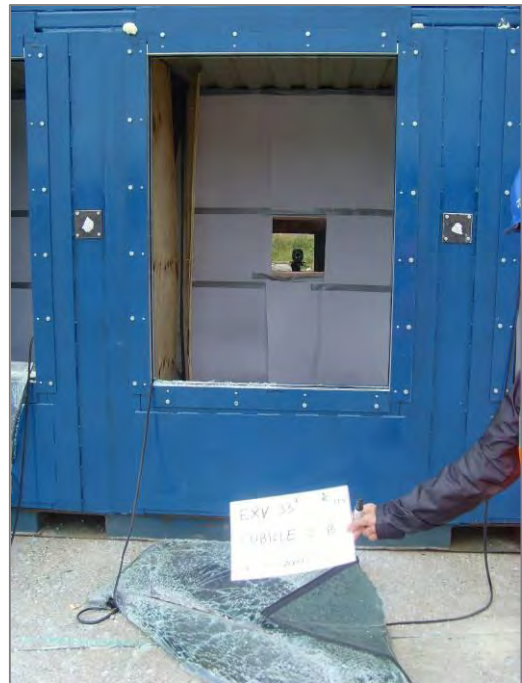
### 8.5.5 Window 5 (Location 2B)

**Rating: ISO EXV33 (E)**

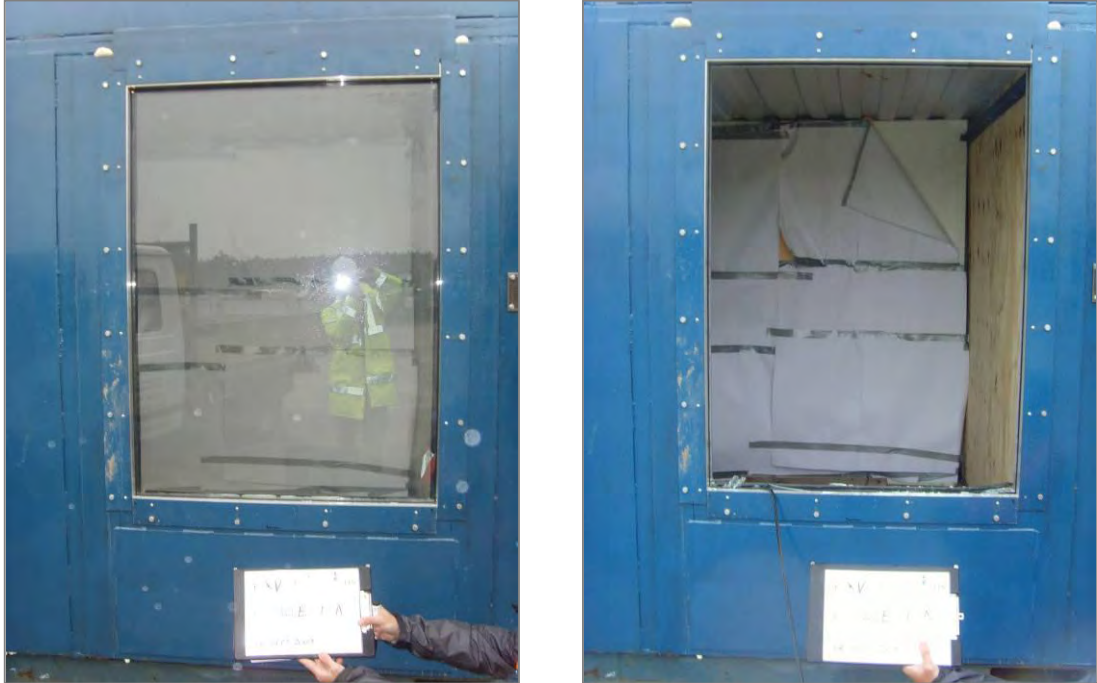
### 8.6.1 Window 1 (Location 1A)

**Rating: ISO EXV33(E)**

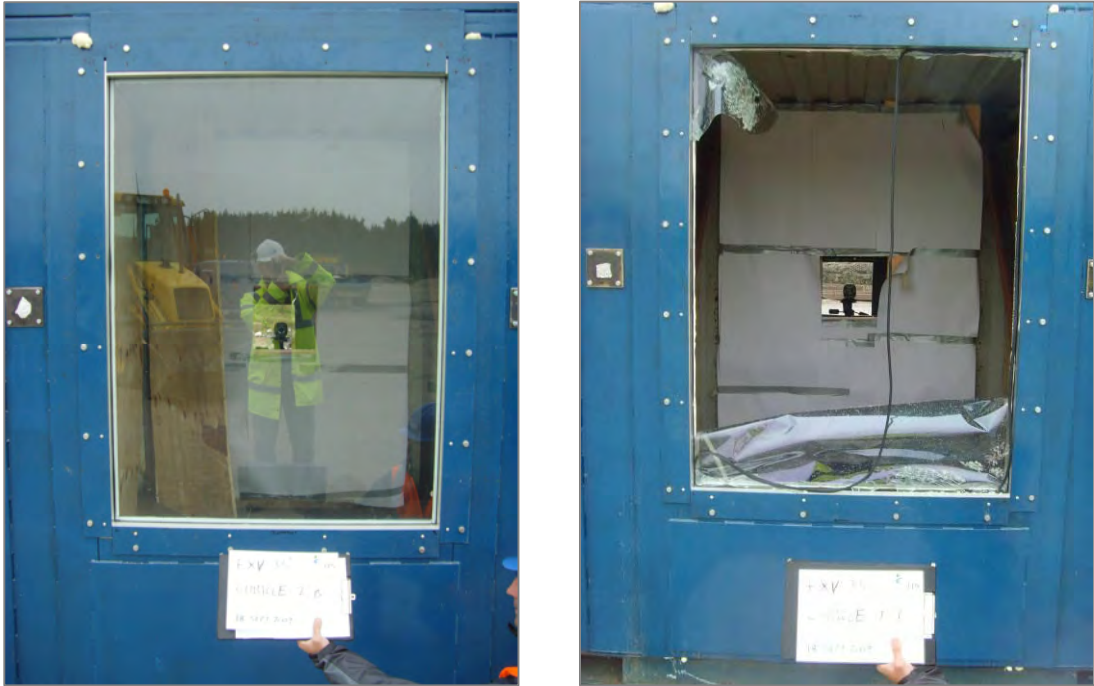
### 8.6.2 Window 2 (Location 1B)

**Rating: ISO EXV33(E)**

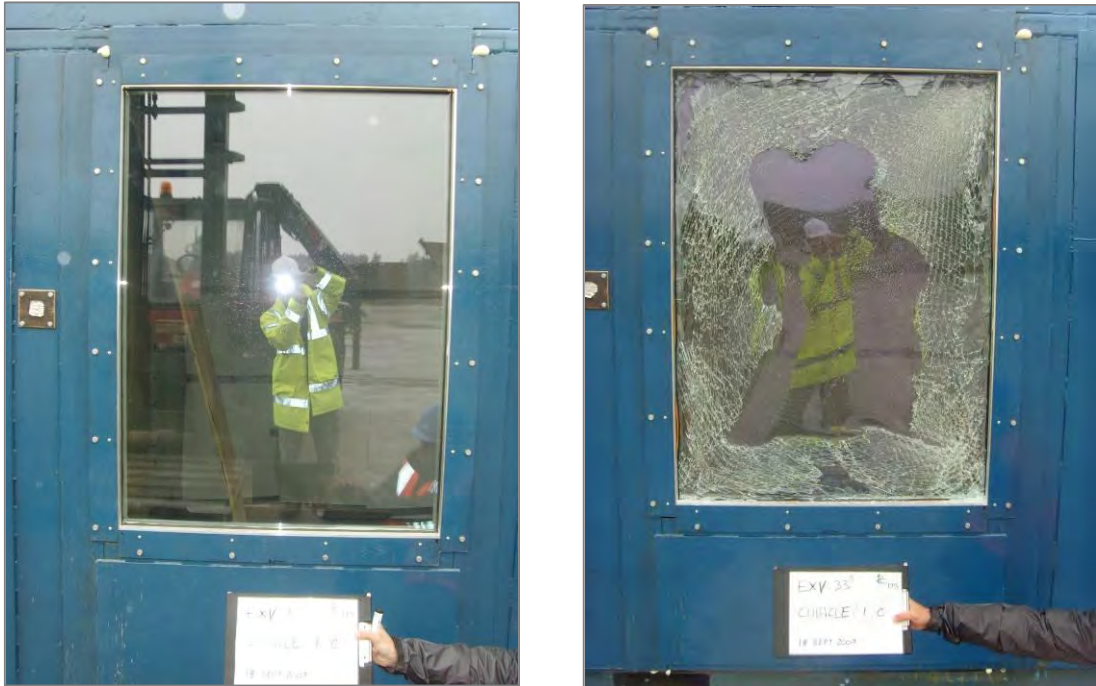
### 8.6.3 Window 3 (Location 1C)

**Rating: ISO EXV33(C)**

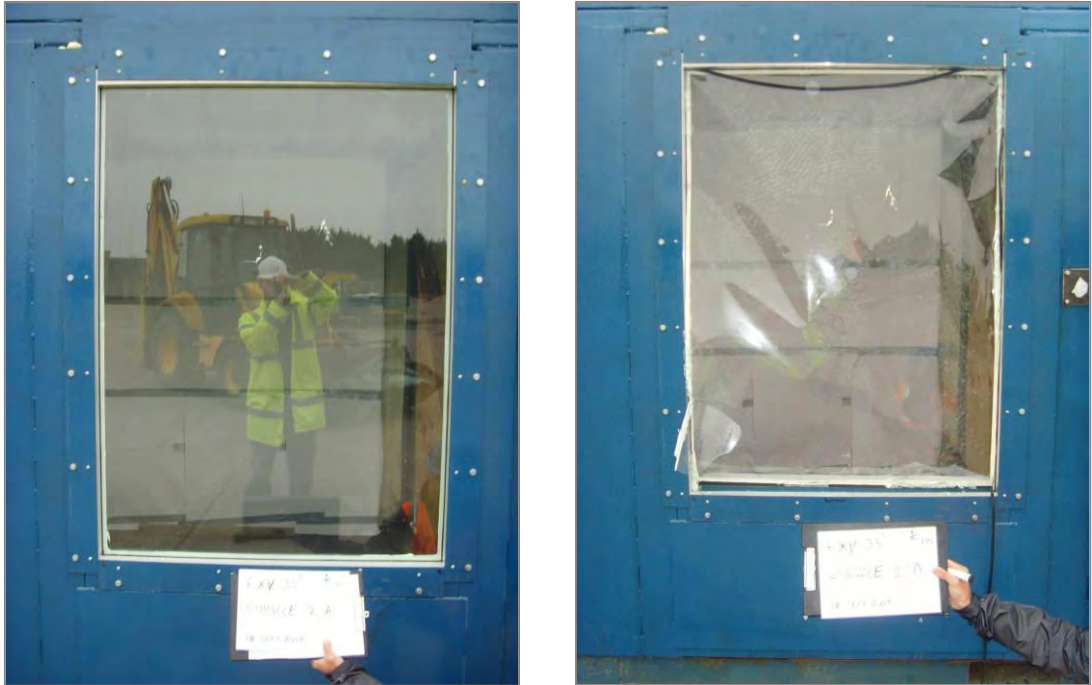
#### 8.6.4 Window 4 (Location 2A)

**Rating: ISO EXV33(E)**

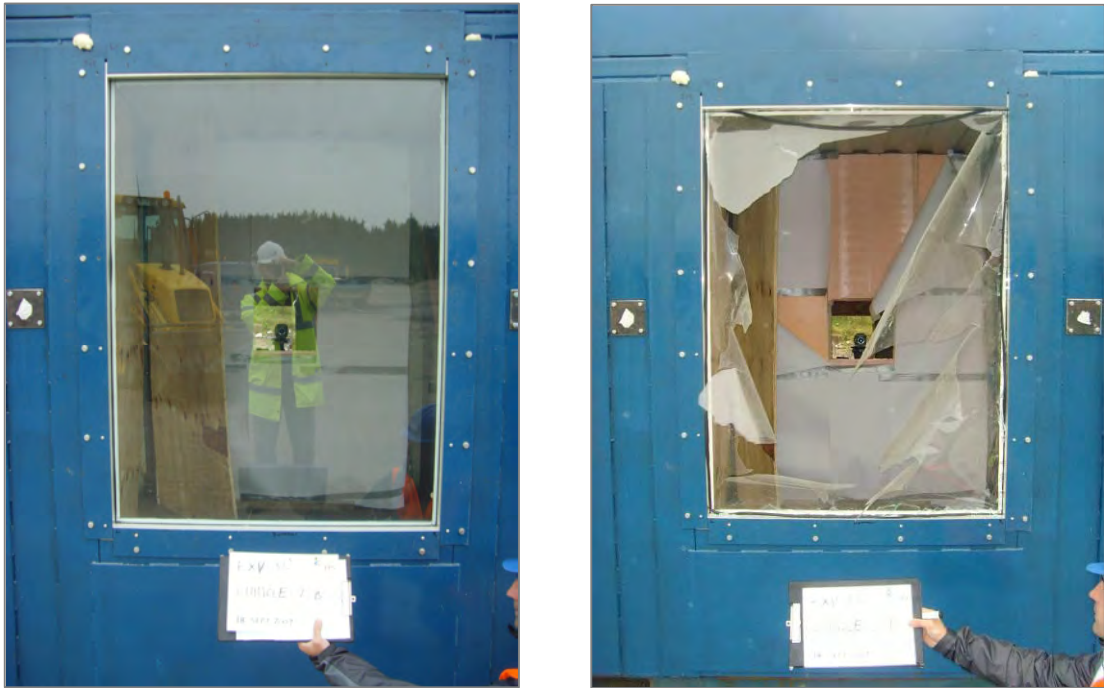
### 8.6.5 Window 5 (Location 2B)

**Rating: ISO EXV33(F)**

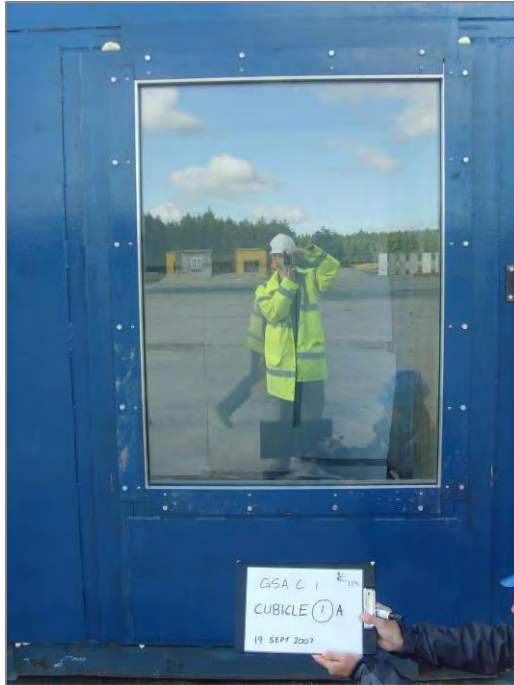
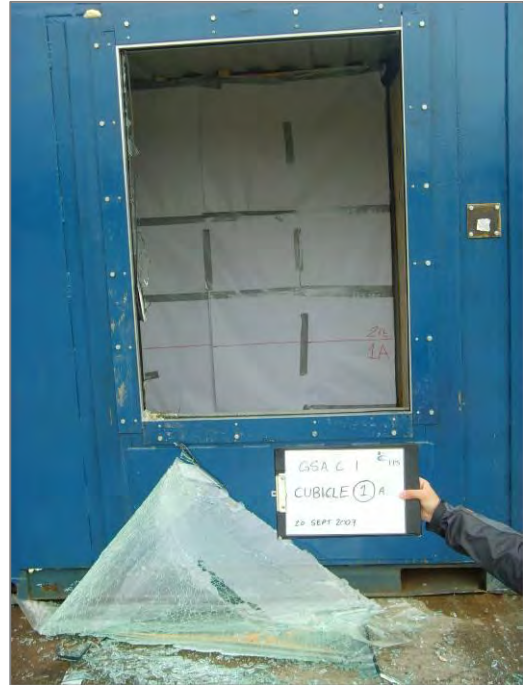
### 8.7.1 Window 1 (Location 1A)

**Rating: GSA C 3b**

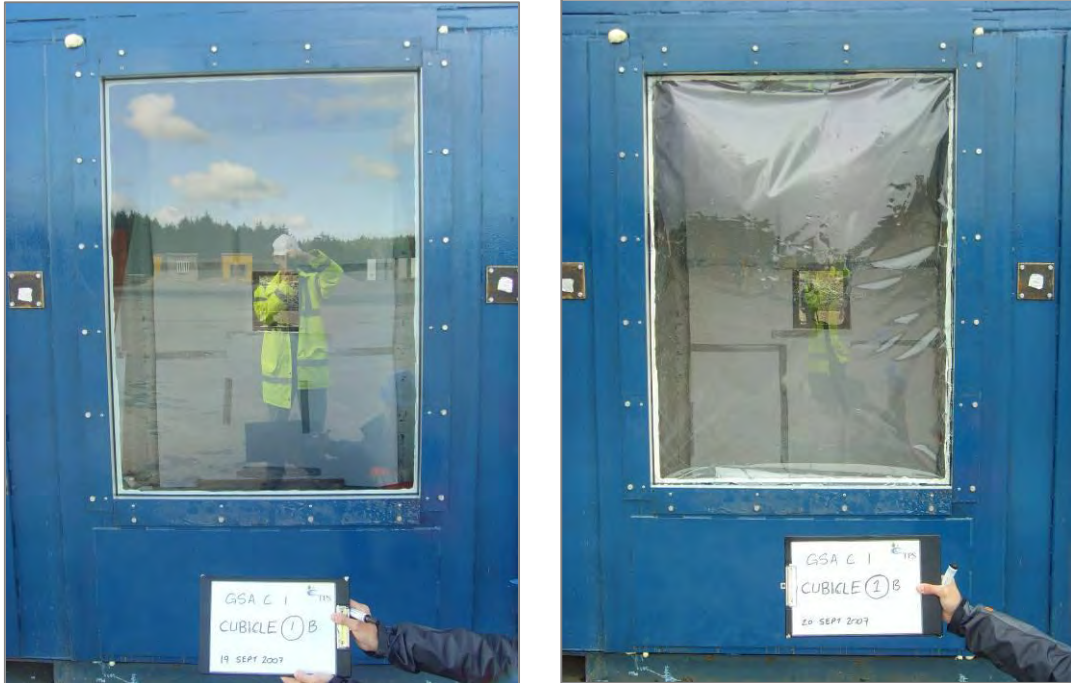
### 8.7.2 Window 2 (Location 1B)

**Rating: GSA C 2**

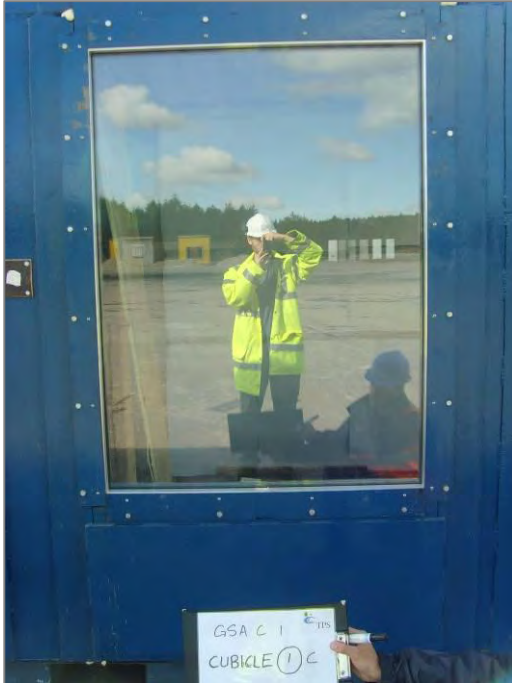
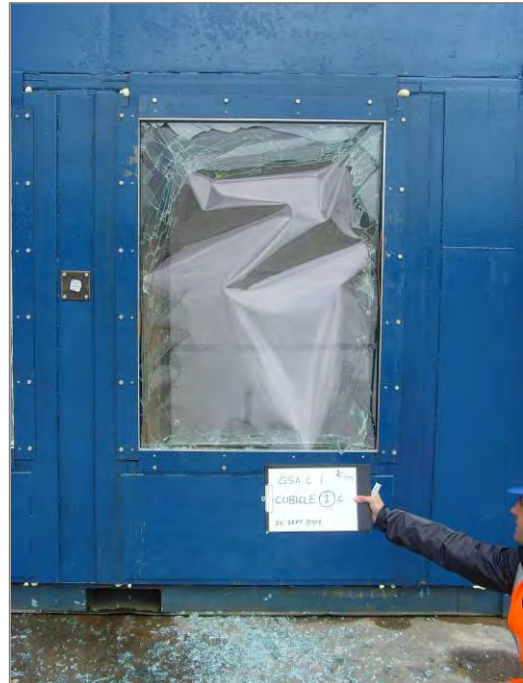
### 8.7.3 Window 3 (Location 1C)

**Rating: GSA C 3b**

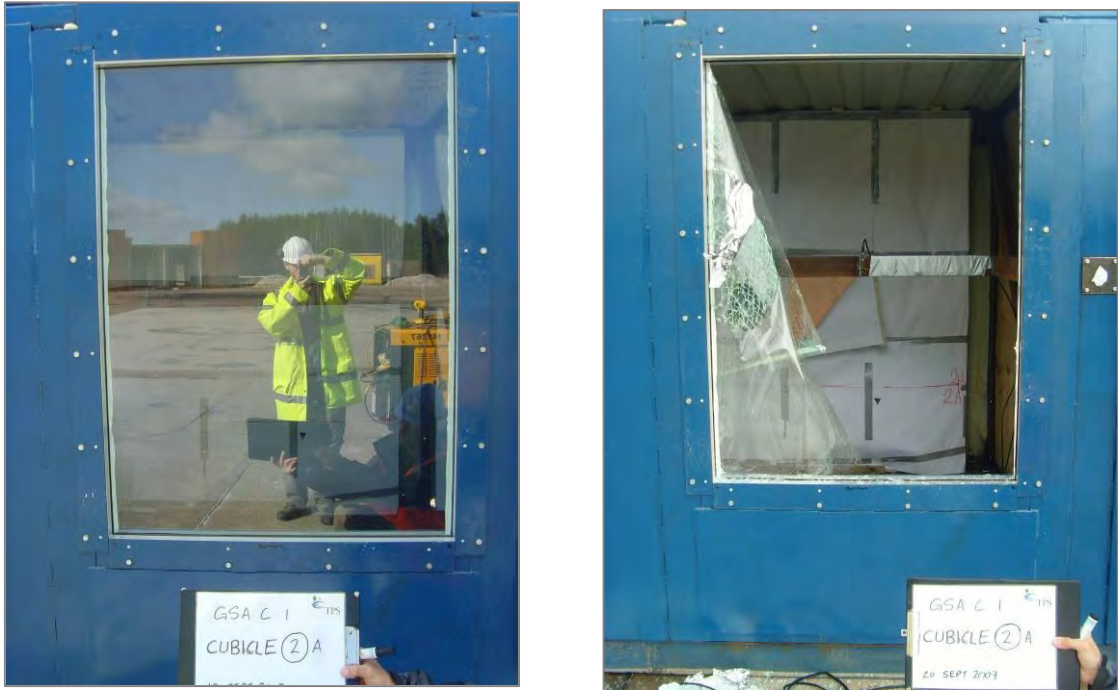
#### 8.7.4 Window 4 (Location 2A)

**Rating: GSA C 3b**
