# Report

## 3M: Anchored Safety Film Blast Tests

22 October 2007

Revision D: 21 Oct 2009

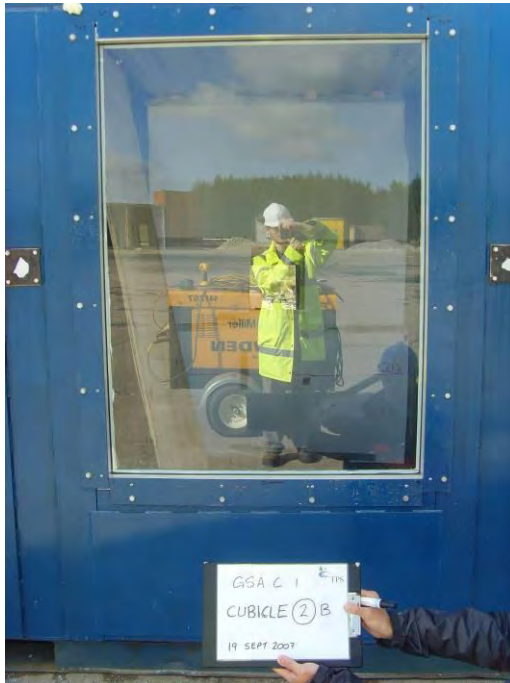
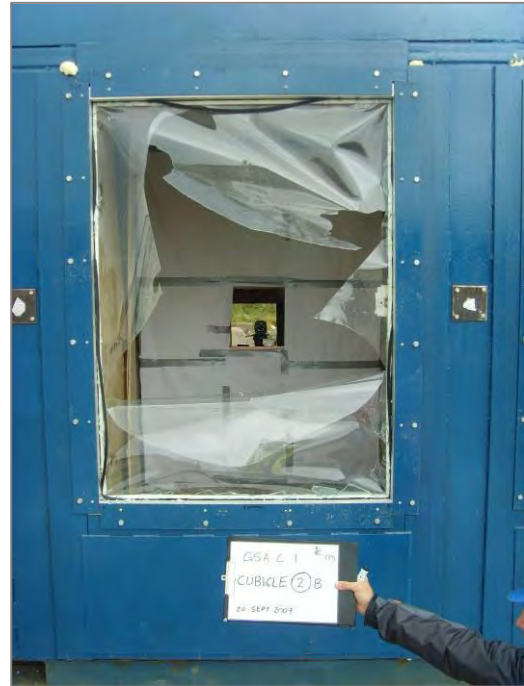
### 8.7.5 Window 5 (Location 2B)

**Rating: GSA C 4**
