**INDICATIVE FIRE TEST**

We have pleasure in enclosing the information obtained from the indicative fire test conducted on your behalf on the polyester film coated Georgian wired glass.

The purpose of the investigation was to provide an indication of the performance of polyester film coated Georgian wired glass when it is subjected on one face to the heating conditions specified in BS 476: Part 20: 1987.

6mm thick Georgian wired glass (1175mm x 1175mm) coated on the exposed face with 1 coat polyester film - 100um thick (1117mm x 1111mm).

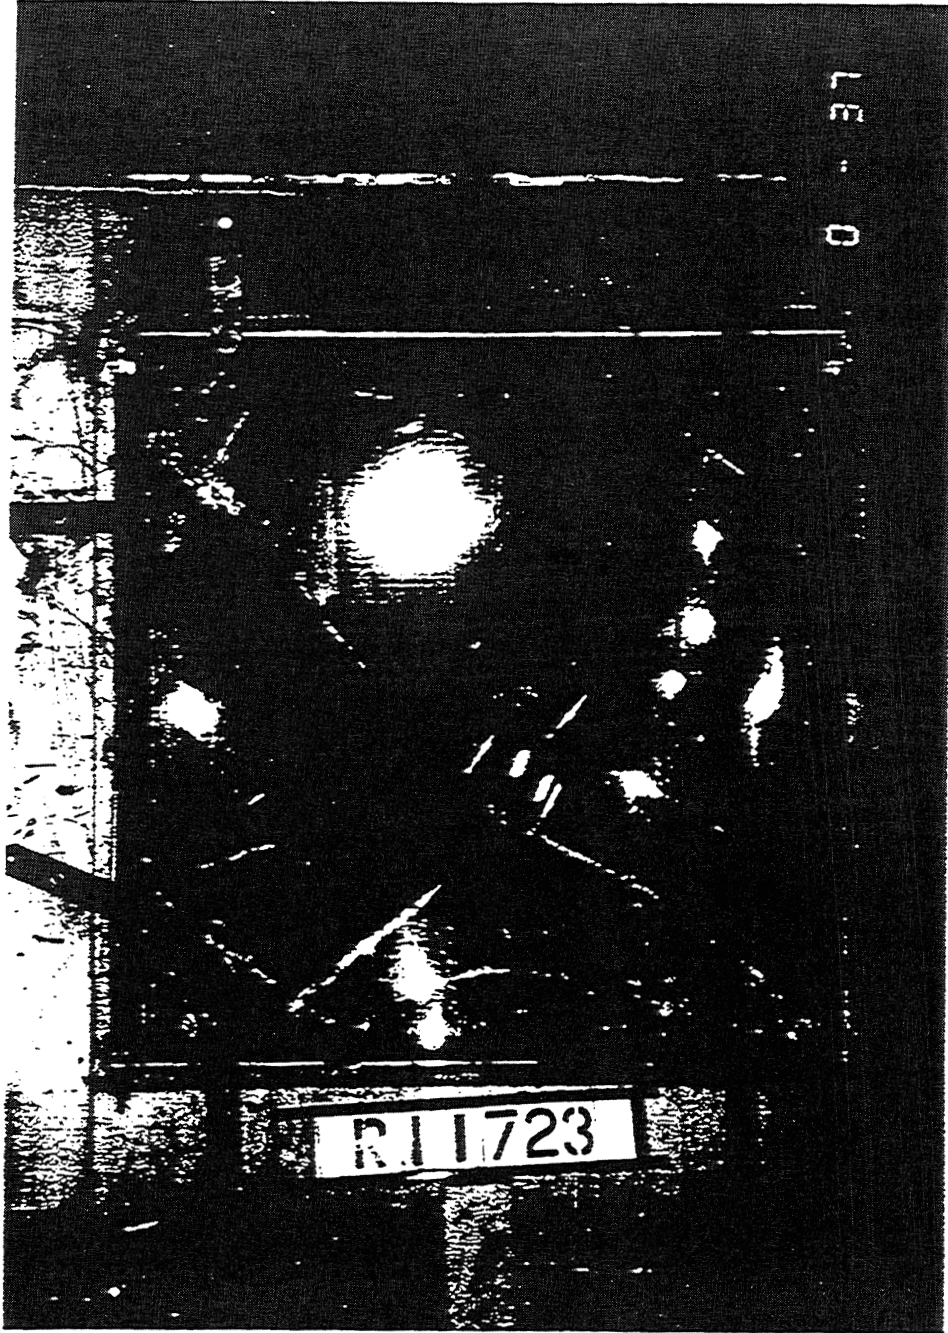
Plate 3

Time			
mins	secs		
35	00	E	No evidence of the polyester film was left on the exposed surface of the glazing.
35	00		The test was terminated.
