ARA-TR-04-16495-1

Explosive Testing for 3M Corporation

Final Report

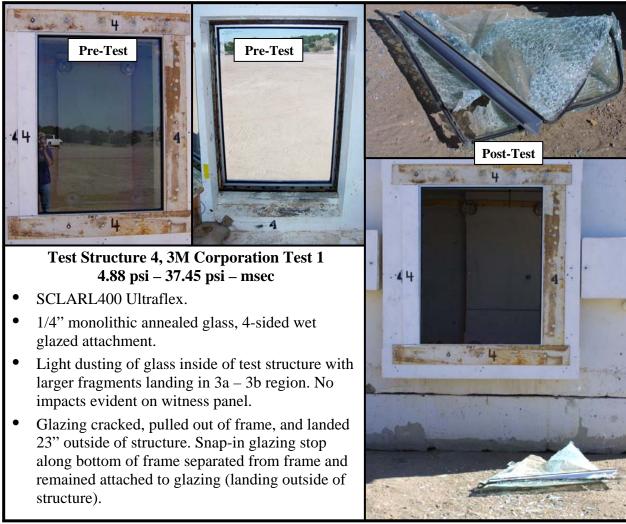
Figure E.5. Photographs and results of Test Structure 4, Test 1.

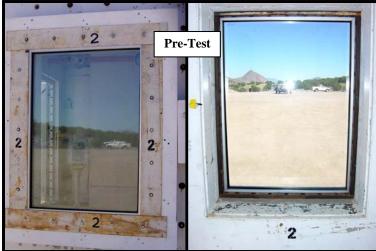
Test Structure 2, 3M Corporation Test 2 5.00 psi – 37.38 psi – msec

- IGU: 1/4" monolithic TTG (outer), 5/8" air gap, 1/4" monolithic TTG (inner), daylight applied Ultra600 film with vertical butt-splice down center of pane.

- Large quantities of glass fell both inside and outside of test structure. Glass fragments landed in 3a 3b region inside of test structure. Impacts on witness panel appeared to be caused by a piece of window frame that entered test structure. The dry glazing attached to the frame also looks to have caused a very small secondary impact and black discoloration on the witness panel.

- The exterior pane shattered with fragments falling both inside and outside of the test structure. Interior pane cracked, separated along vertical window film seam, pulled out of frame and landed outside of test structure. Half of the interior pane landed 10 1/2" outside of test structure and the other half landed 34" outside of test structure. A piece of frame entered the structure and appeared to impact the witness panel.

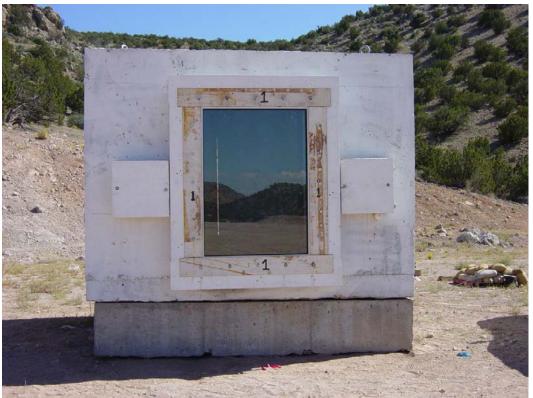
Figure 3.2. Exterior pre-test view of Window 1.

A pre-test photo of the window is shown in Figure 3.2 and post test photos are shown in Figure 3.3 and Figure 3.4.

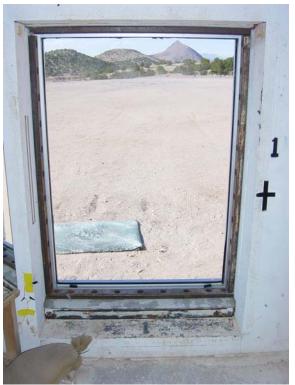
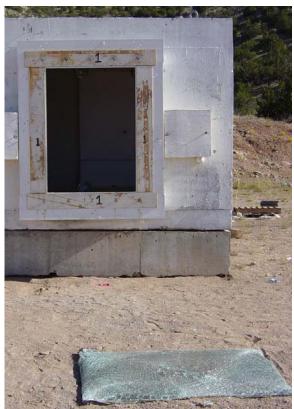
Glazing cracked, pulled out of frame, and landed 119" outside of structure. No visible damage to frame. There was also a light dusting of glass inside of test structure with larger fragments landing in 3a - 3b region. No impacts evident on witness panel.

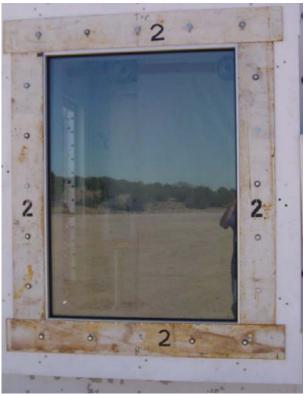
Figure 3.5. Exterior pre-test view of Window 2.

A pre-test photo of the window is shown in Figure 3.5 and post test photos are in Figure 3.6 and Figure 3.7.

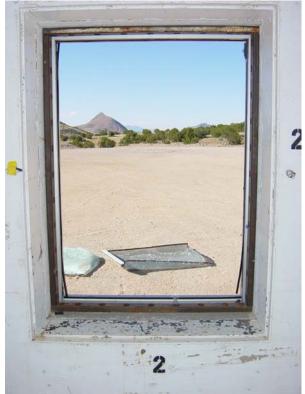
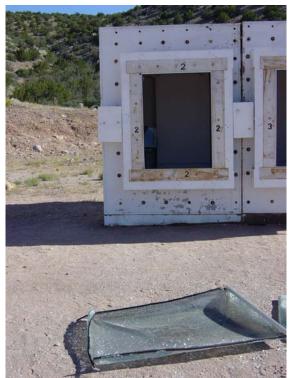
Glazing cracked, pulled out of frame, and landed 148" outside of structure. Snap-in glazing stop along bottom of frame separated from frame and remained attached to glazing (landing outside of structure). There was also a light dusting of glass inside of test structure with larger fragments landing in 3a - 3b region. No impacts evident on witness panel.

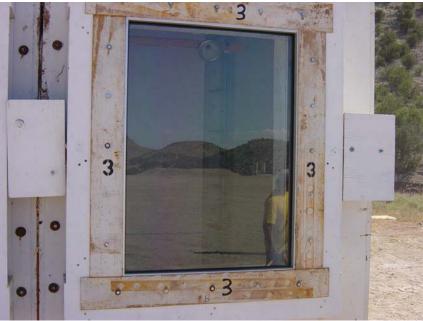
Figure 3.8. Exterior pre-test view of Window 3.

A pre-test photo of the window is shown in Figure 3.8 and post test photos are in Figure 3.9 and Figure 3.10.

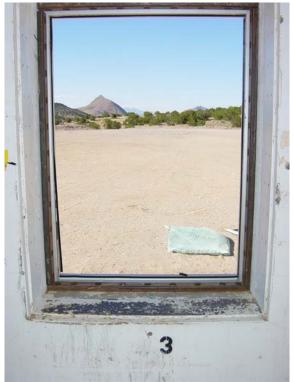
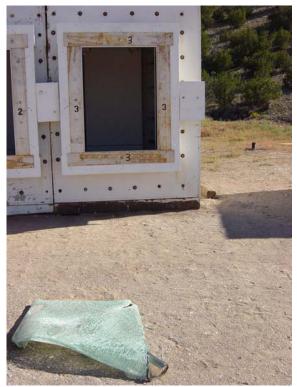
Glazing cracked, pulled out of frame, and landed 146" outside of structure. Snap-in glazing stop along bottom of frame separated from frame and remained attached to glazing (landing outside of structure). There was also a light dusting of glass inside of test structure with larger fragments landing in 3a - 3b region. No impacts evident on witness panel.

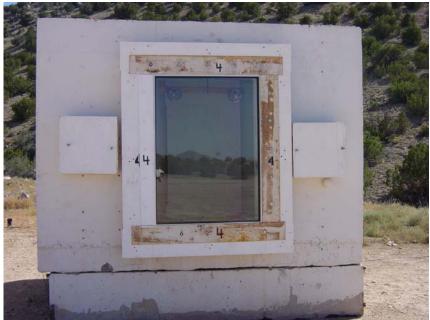
Figure 3.11. Exterior pre-test view of Window 4.

A pre-test photo of the window is shown in Figure 3.11 and post test photos are in Figure 3.12 and Figure 3.13.

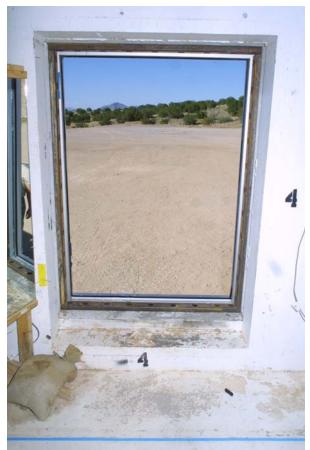
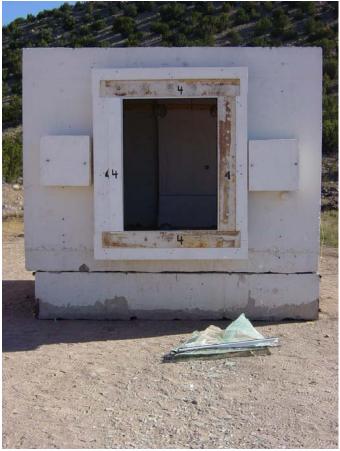
Glazing cracked, pulled out of frame, and landed 23" outside of structure. Snap-in glazing stop along bottom of frame separated from frame and remained attached to glazing (landing outside of structure). There was also a light dusting of glass inside of test structure with larger fragments landing in 3a - 3b region. No impacts evident on witness panel.

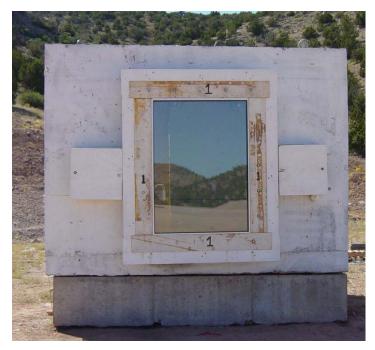
Figure 3.15. Exterior pre-test view of Window 1.

A pre-test photo of the window is shown in Figure 3.15 and post test photos are shown in Figure 3.16 and Figure 3.17.

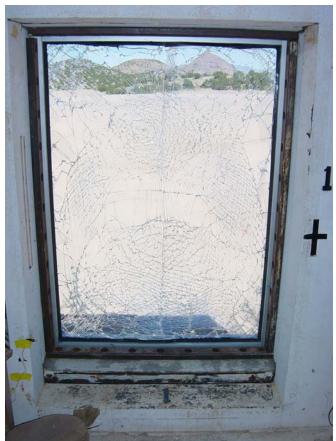
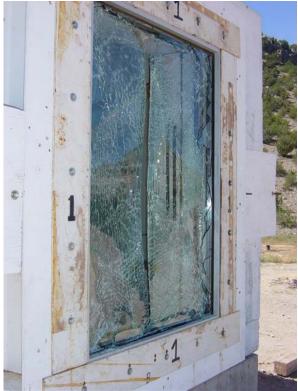
Exterior pane shattered and landed outside of structure. Interior pane cracked and separated along vertical window film seam, but glazing remained in frame. Wet-glazed attachment remained intact. No visible damage to frame. Large glass fragments landed outside of structure and light dusting of glass inside of test structure with larger fragments landing in 3a - 3b region. No impacts evident on witness panel.

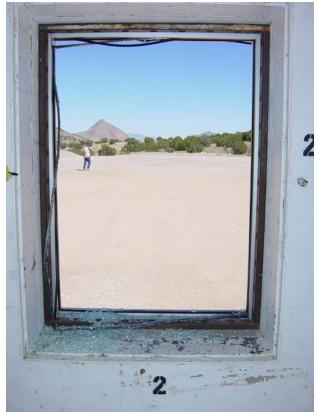
Figure 3.19. Interior post-test view of Window 2.

The exterior pane shattered with fragments falling both inside and outside of the test structure. Interior pane cracked, separated along vertical window film seam, pulled out of frame and landed outside of test structure. Half of the interior pane landed 10 1/2" outside of test structure and the other half landed 34" outside of test structure. A piece of frame entered the structure and appeared to impact the witness panel. The dry glazing attached to the frame also looks to have caused a very small secondary impact and black discoloration on the witness panel. Large quantities of glass fell both inside and outside of test structure. Glass fragments landed in 3a - 3b region inside of test structure. One impact on witness panel appeared to be caused by a piece of window frame that entered test structure.

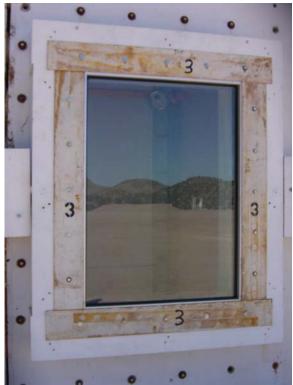
Figure 3.21. Exterior pre-test view of Window 3.

A pre-test photo of the window is shown in Figure 3.21 and post test photos are shown in Figure 3.22 and Figure 3.23.

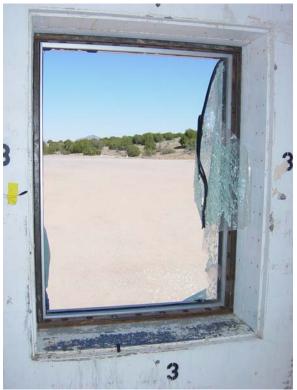
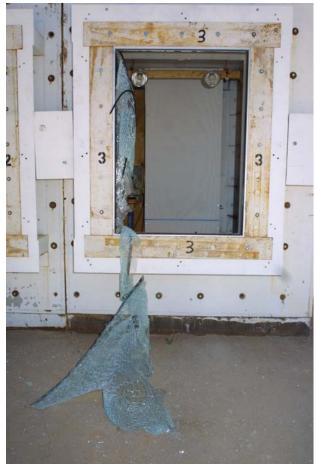
Glazing cracked and pulled out of frame along the right jamb, head and sill. Window film tore along the left jamb which left the majority of the glazing hanging outside of the test structure just below the window opening. No visible damage to frame. There was also a light dusting of glass inside of test structure with larger fragments landing in 3a - 3b region. No impacts evident on witness panel.

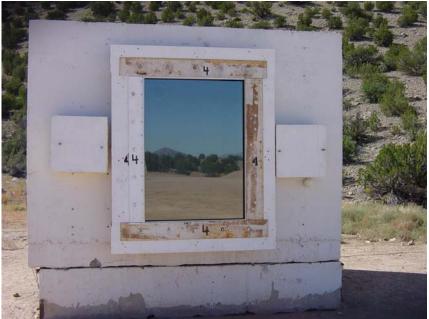
Figure 3.24. Exterior pre-test view of Window 4.

A pre-test photo of the window is shown in Figure 3-24 and post test photos are shown in Figure 3-25 and Figure 3-26.

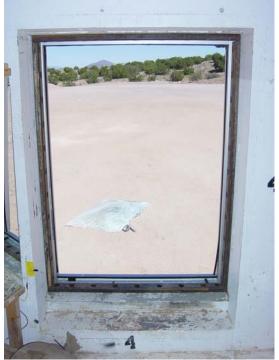
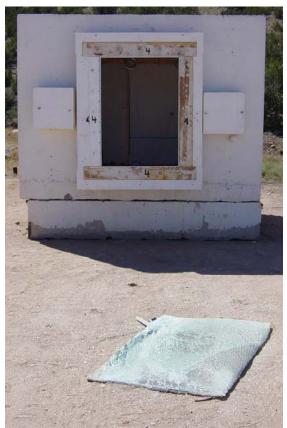
Glazing cracked, pulled out of frame, and landed 145" outside of test structure. No visible damage to frame. There was also a light dusting of glass inside of test structure with larger fragments landing in 3a - 3b region. No impacts evident on witness panel
