**ASTM F1642-04/GSA TS01
TEST REPORT**

Report No.: A9873.02-122-12

PRODUCT TYPE: Blast Resistant Double Pane Windows in Aluminum Frames

SPECIFICATION: ASTM F 1642-04, *Standard Test Method for Glazing and Glazing Systems Subject to Airblast Loading.*

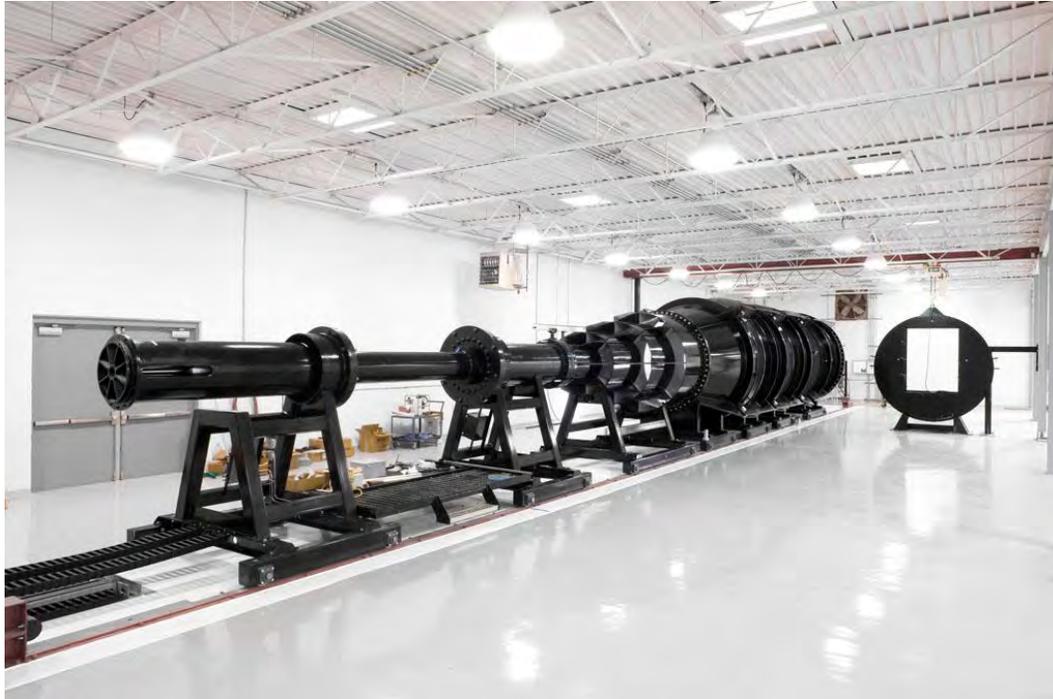
Figure #1
 Shock Tube and Test Facility

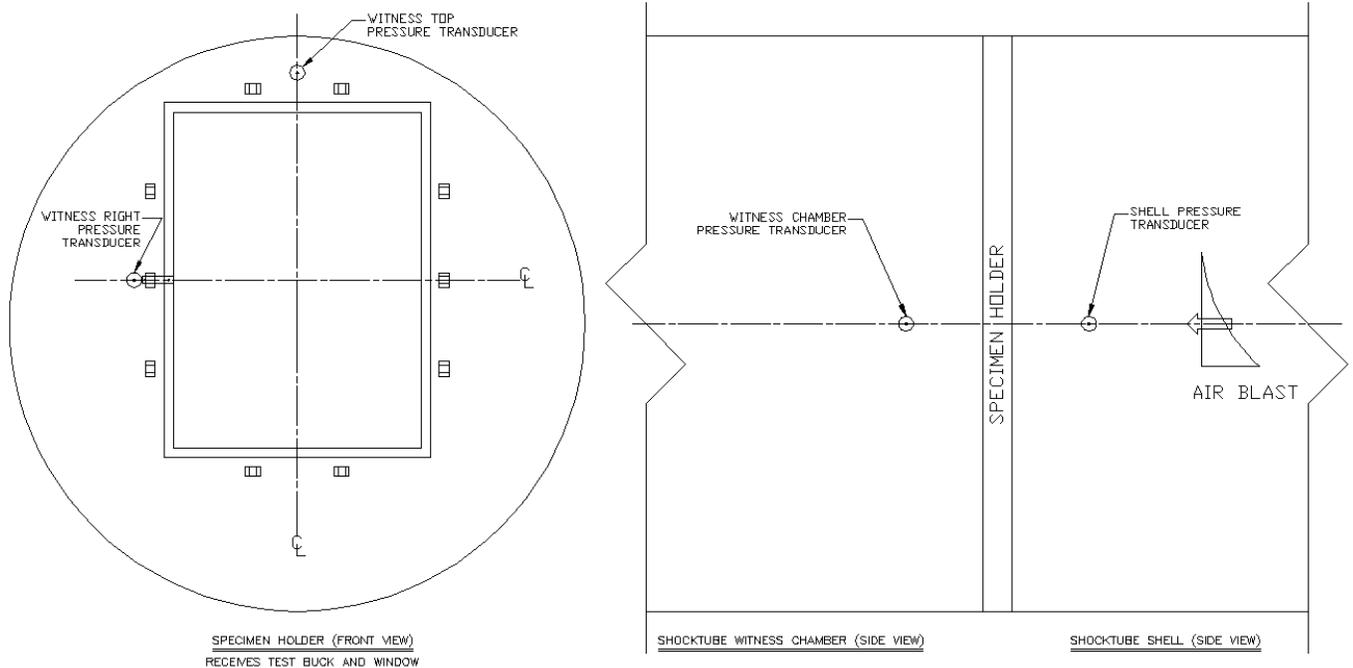
Figure #2
 Pressure Sensor Locations

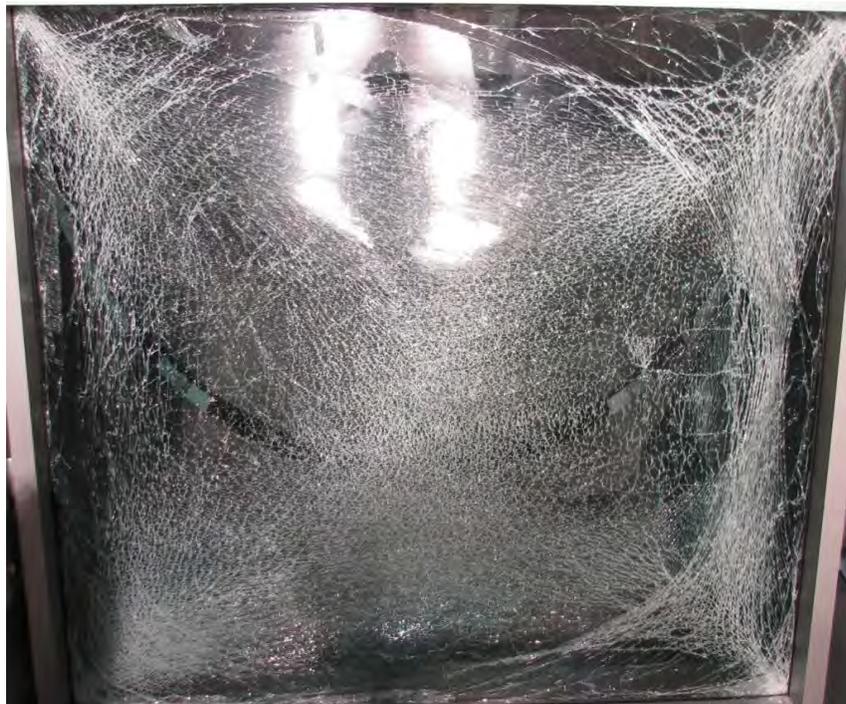
Photo No. 2
Post-test Specimen #1, Interior

Glazing Response	
Exterior Lite	Fractured
Interior Lite	Fractured
Glazing Pullout Length and Location	None
Glazing Tearing	None

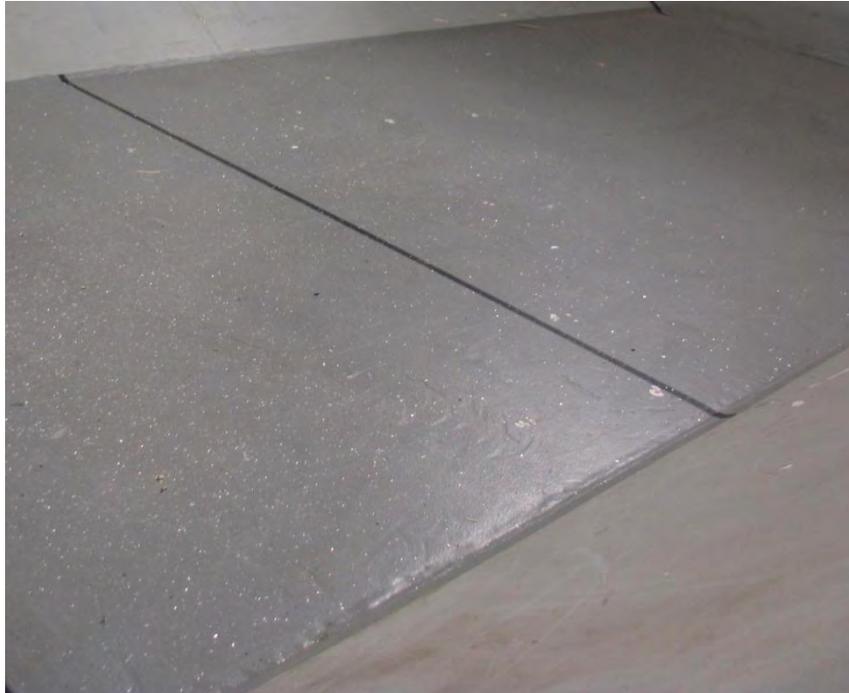
Photo No. 3
Post-test Specimen #1, Witness Chamber

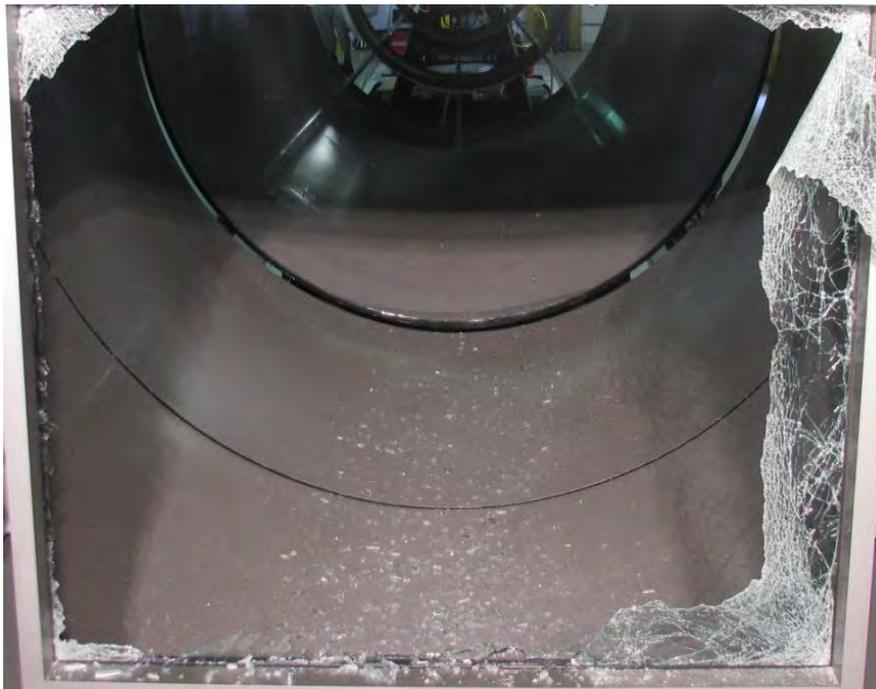
Photo No. 8
Post-test Specimen #3, Interior

Glazing Response	
Exterior Lite	Fractured
Interior Lite	Fractured
Glazing Pullout Length and Location	100% Full DLO perimeter
Glazing Tearing	None

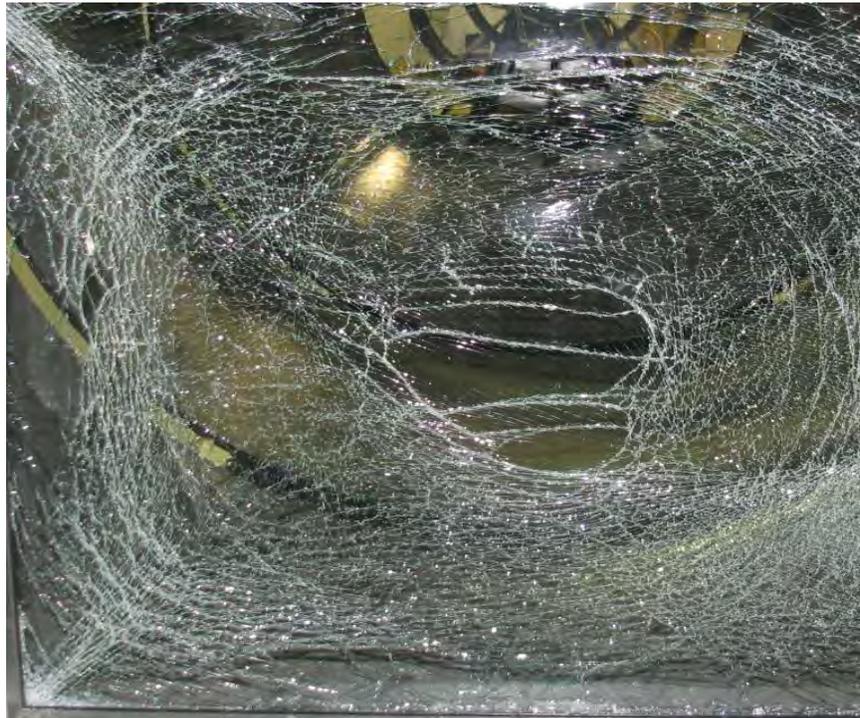
Photo No. 11
Post-test Specimen #4, Interior

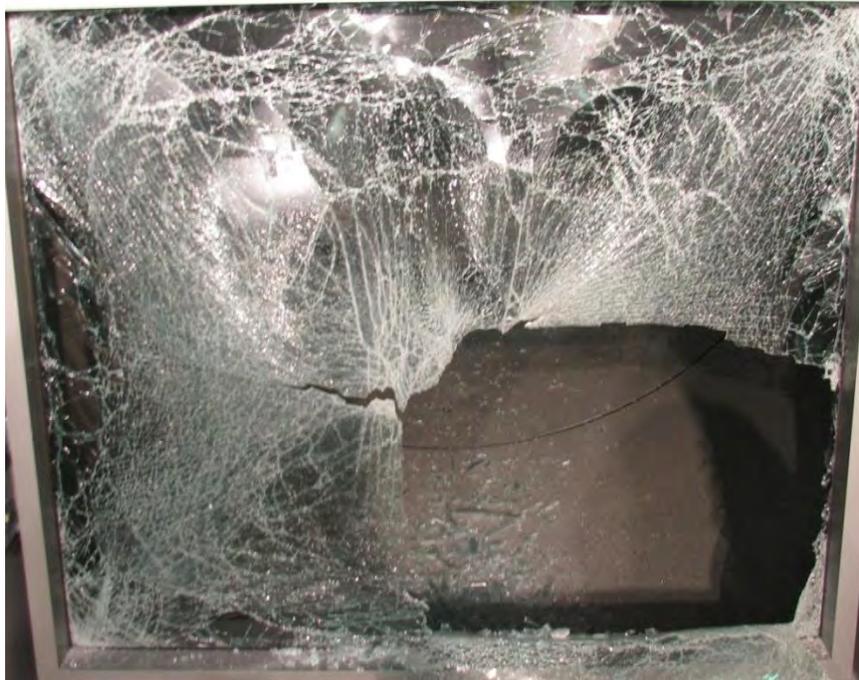
Photo No. 14
Post-test Specimen #5, Interior

Glazing Response	
Exterior Lite	Fractured
Interior Lite	Fractured
Glazing Pullout Length and Location	None
Glazing Tearing	Horizontal tear full width at center Vertical tear half height at center

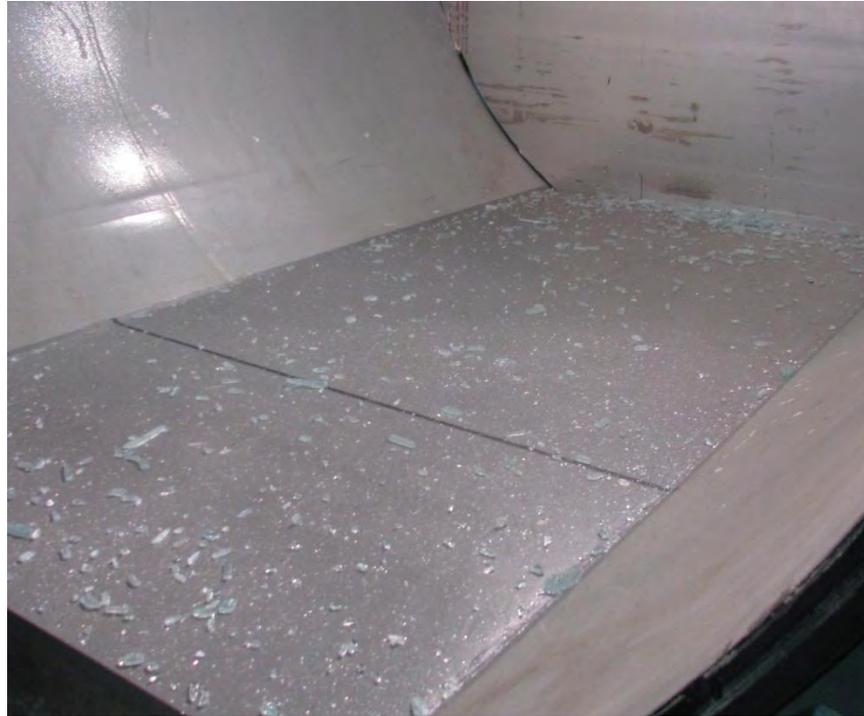
Photo No. 15
Post-test Specimen #5, Witness Chamber

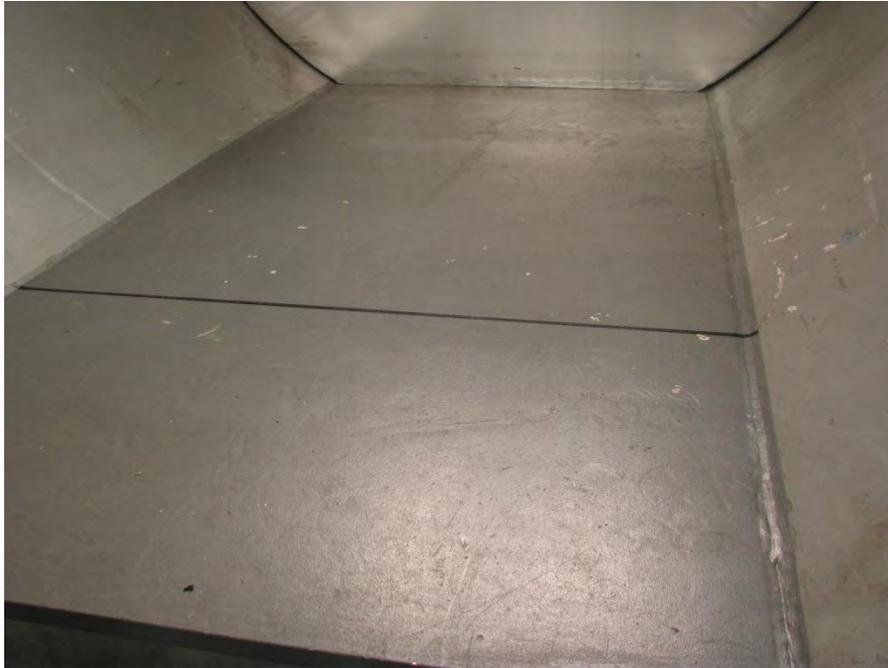
Photo No. 36
Post-test Specimen #12, Witness Chamber

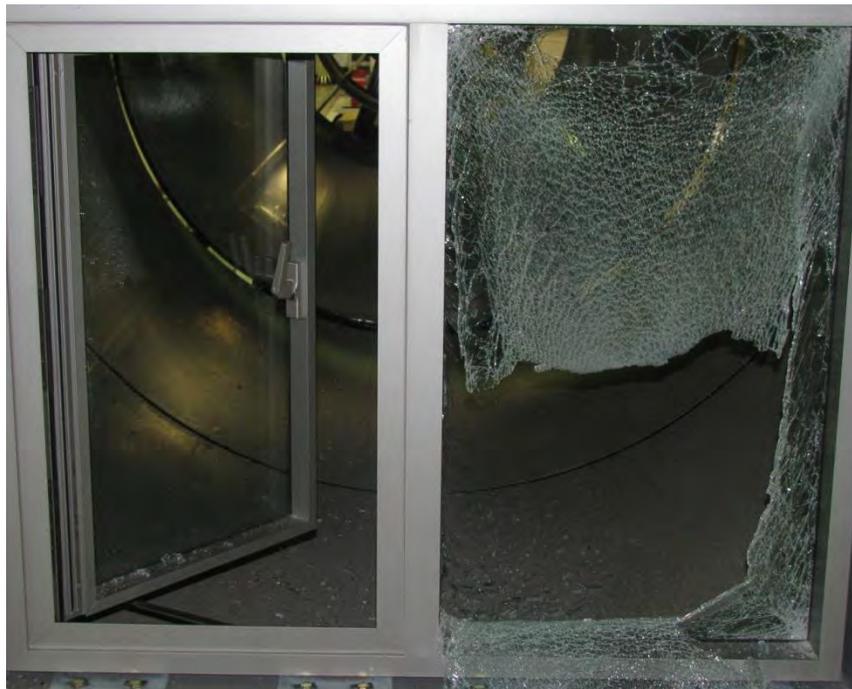
Photo No. 38
Post-test Specimen #13, Interior

Glazing Response	
Exterior Lite	Sash Unbroken Fixed Fractured
Interior Lite	Sash Unbroken Fixed Fractured
Glazing Pullout Length and Location	None
Glazing Tearing	Full length horizontal tear at center Full length vertical tear at mullion

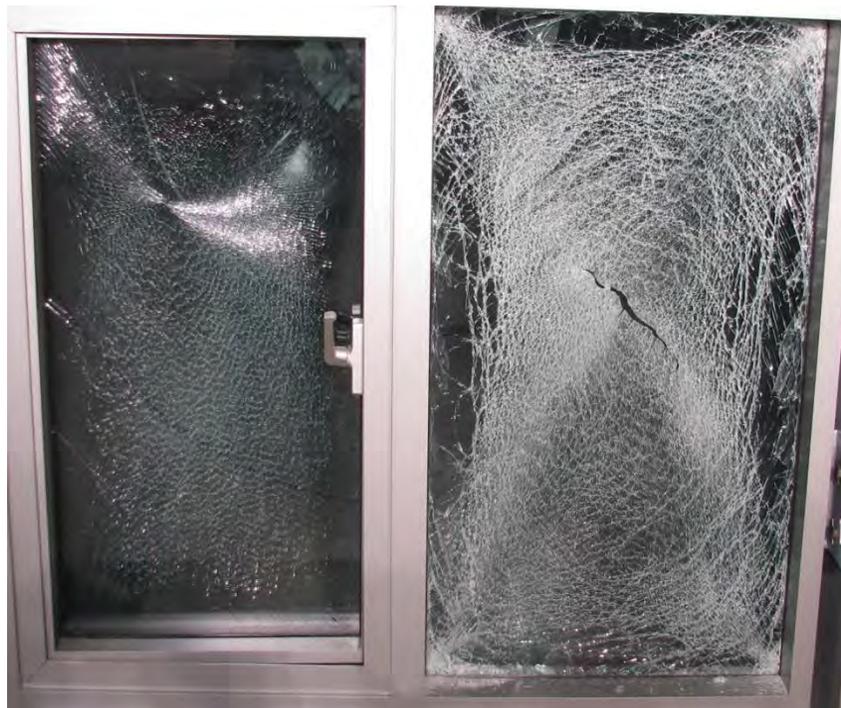
Photo No. 44
Post-test Specimen #15, Interior

Glazing Response	
Exterior Lite	Fixed Fractured Sash Unbroken
Interior Lite	Fixed Fractured Sash Fractured
Glazing Pullout Length and Location	None
Glazing Tearing	13" tear in fixed lite

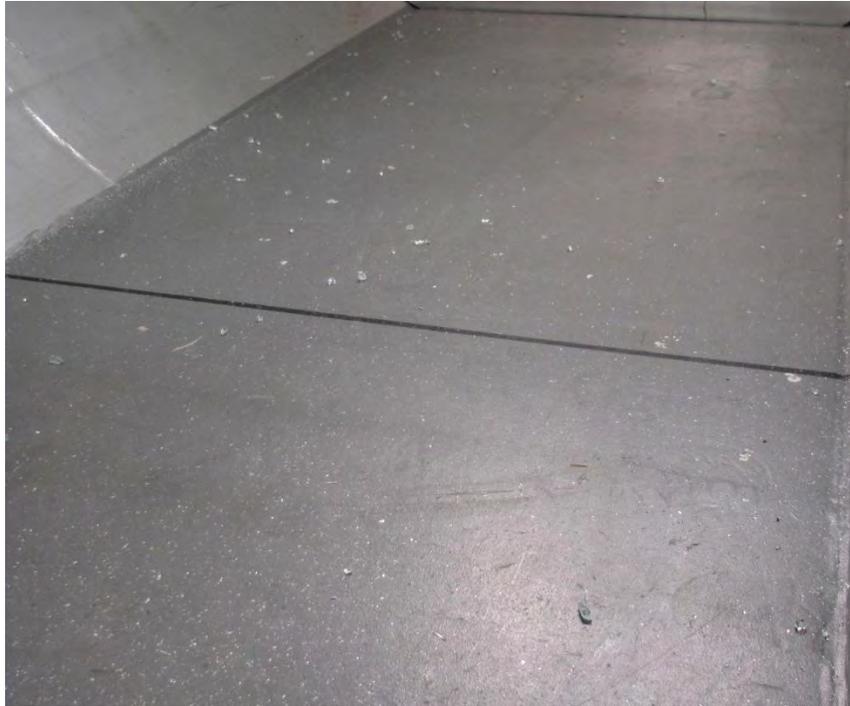
Photo No. 45
Post-test Specimen #15, Witness Chamber

Witness Chamber Results
Multiple impacts observed above the 24" mark. No penetrations into the second layer of the witness panel.
