ASTM F1642-04/GSA TS01 TEST REPORT

PRODUCT TYPE: Fragment Retention Film on 1/4" Single Pane Glass and
1" Insulated Glass Units with Film Attachment System

SERIES/MODEL: 3M™ Safety Neutral S35 Safety and Security Window Film

Report No.: E1272.02-119-12
Test Completion Date: 12/19/14
Report Date: 02/27/15
Test Record Retention Date: 12/19/18

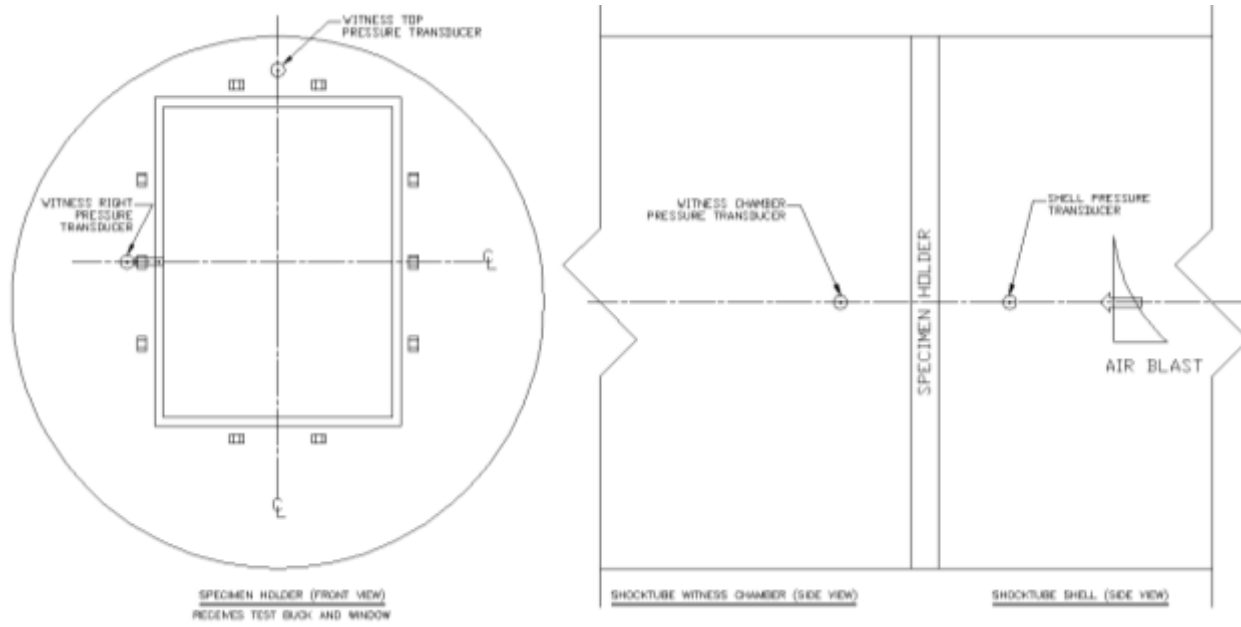
Figure #2
Pressure Sensor Locations

3.1 Data Acquisition: In accordance with ASTM F 1642-04 and GSA TS01, four reflective pressure transducers are utilized to record data at a 1MHz sample rate. Two reflective pressure transducers are located on the specimen holder at the top and right side (when viewed from the interior). A third pressure transducer is located on the shell to the exterior of the specimen, and a fourth is located in the witness chamber, directly to the interior of the specimen holder. A sketch of the specimen holder and corresponding reflective pressure sensor locations are provided in Figure #2 of Appendix A.

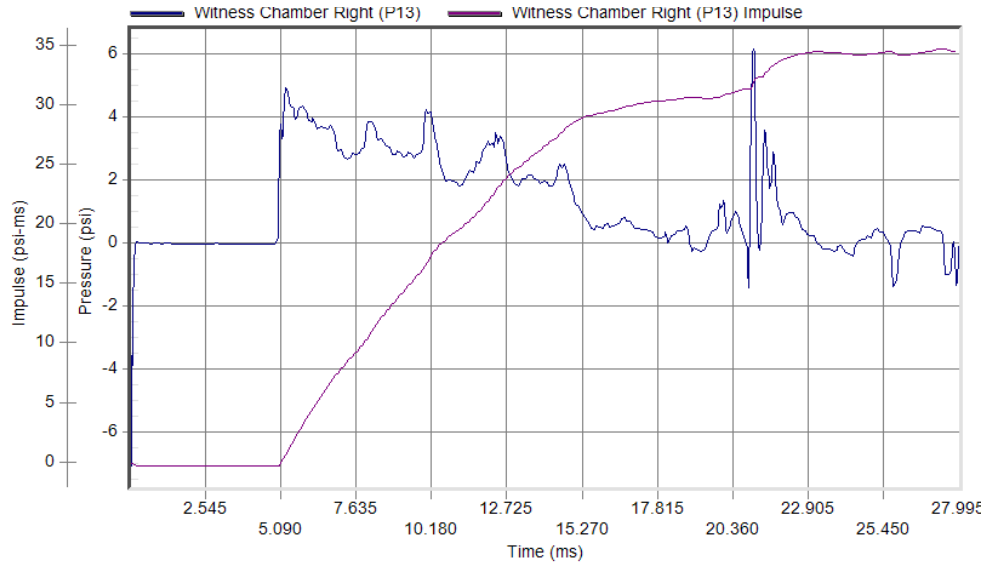
Peak Pressure: 6.17 psi at 21.07 ms
Duration: 0.15 ms

Peak Positive Phase Duration	
Top Duration	11.72 msec
Right Duration	0.15 msec ¹
Shell Duration	13.40 msec
Average Duration	12.56 msec

¹ Spurious data, not used to calculate average.

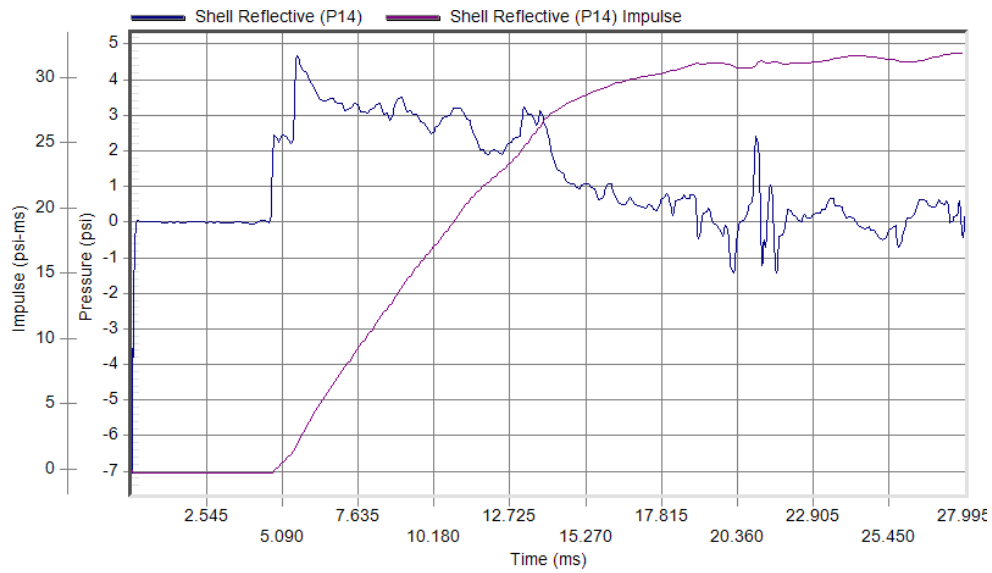
Peak Pressure: 4.75 psi at 5.60 ms
Duration: 13.40 ms

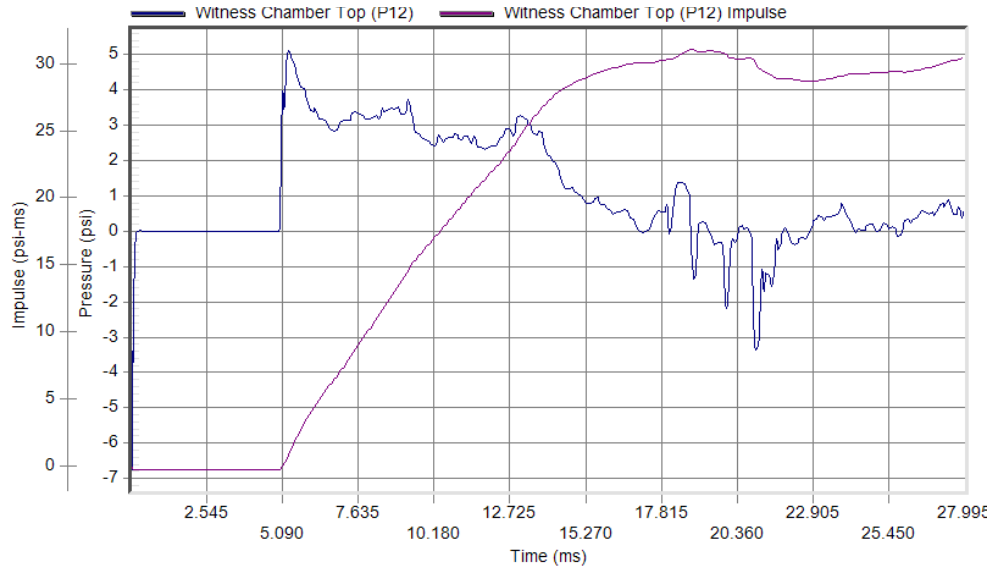
Peak Pressure: 5.16 psi at 5.32 ms
Duration: 11.72 ms

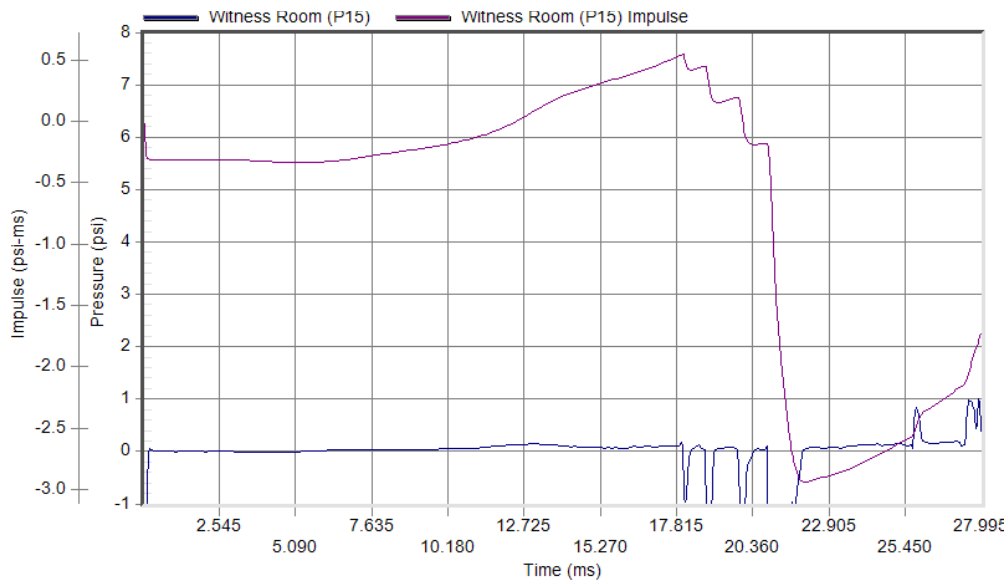
Peak Pressure: 1.04 psi at 27.61 ms
Duration: 0.00 ms

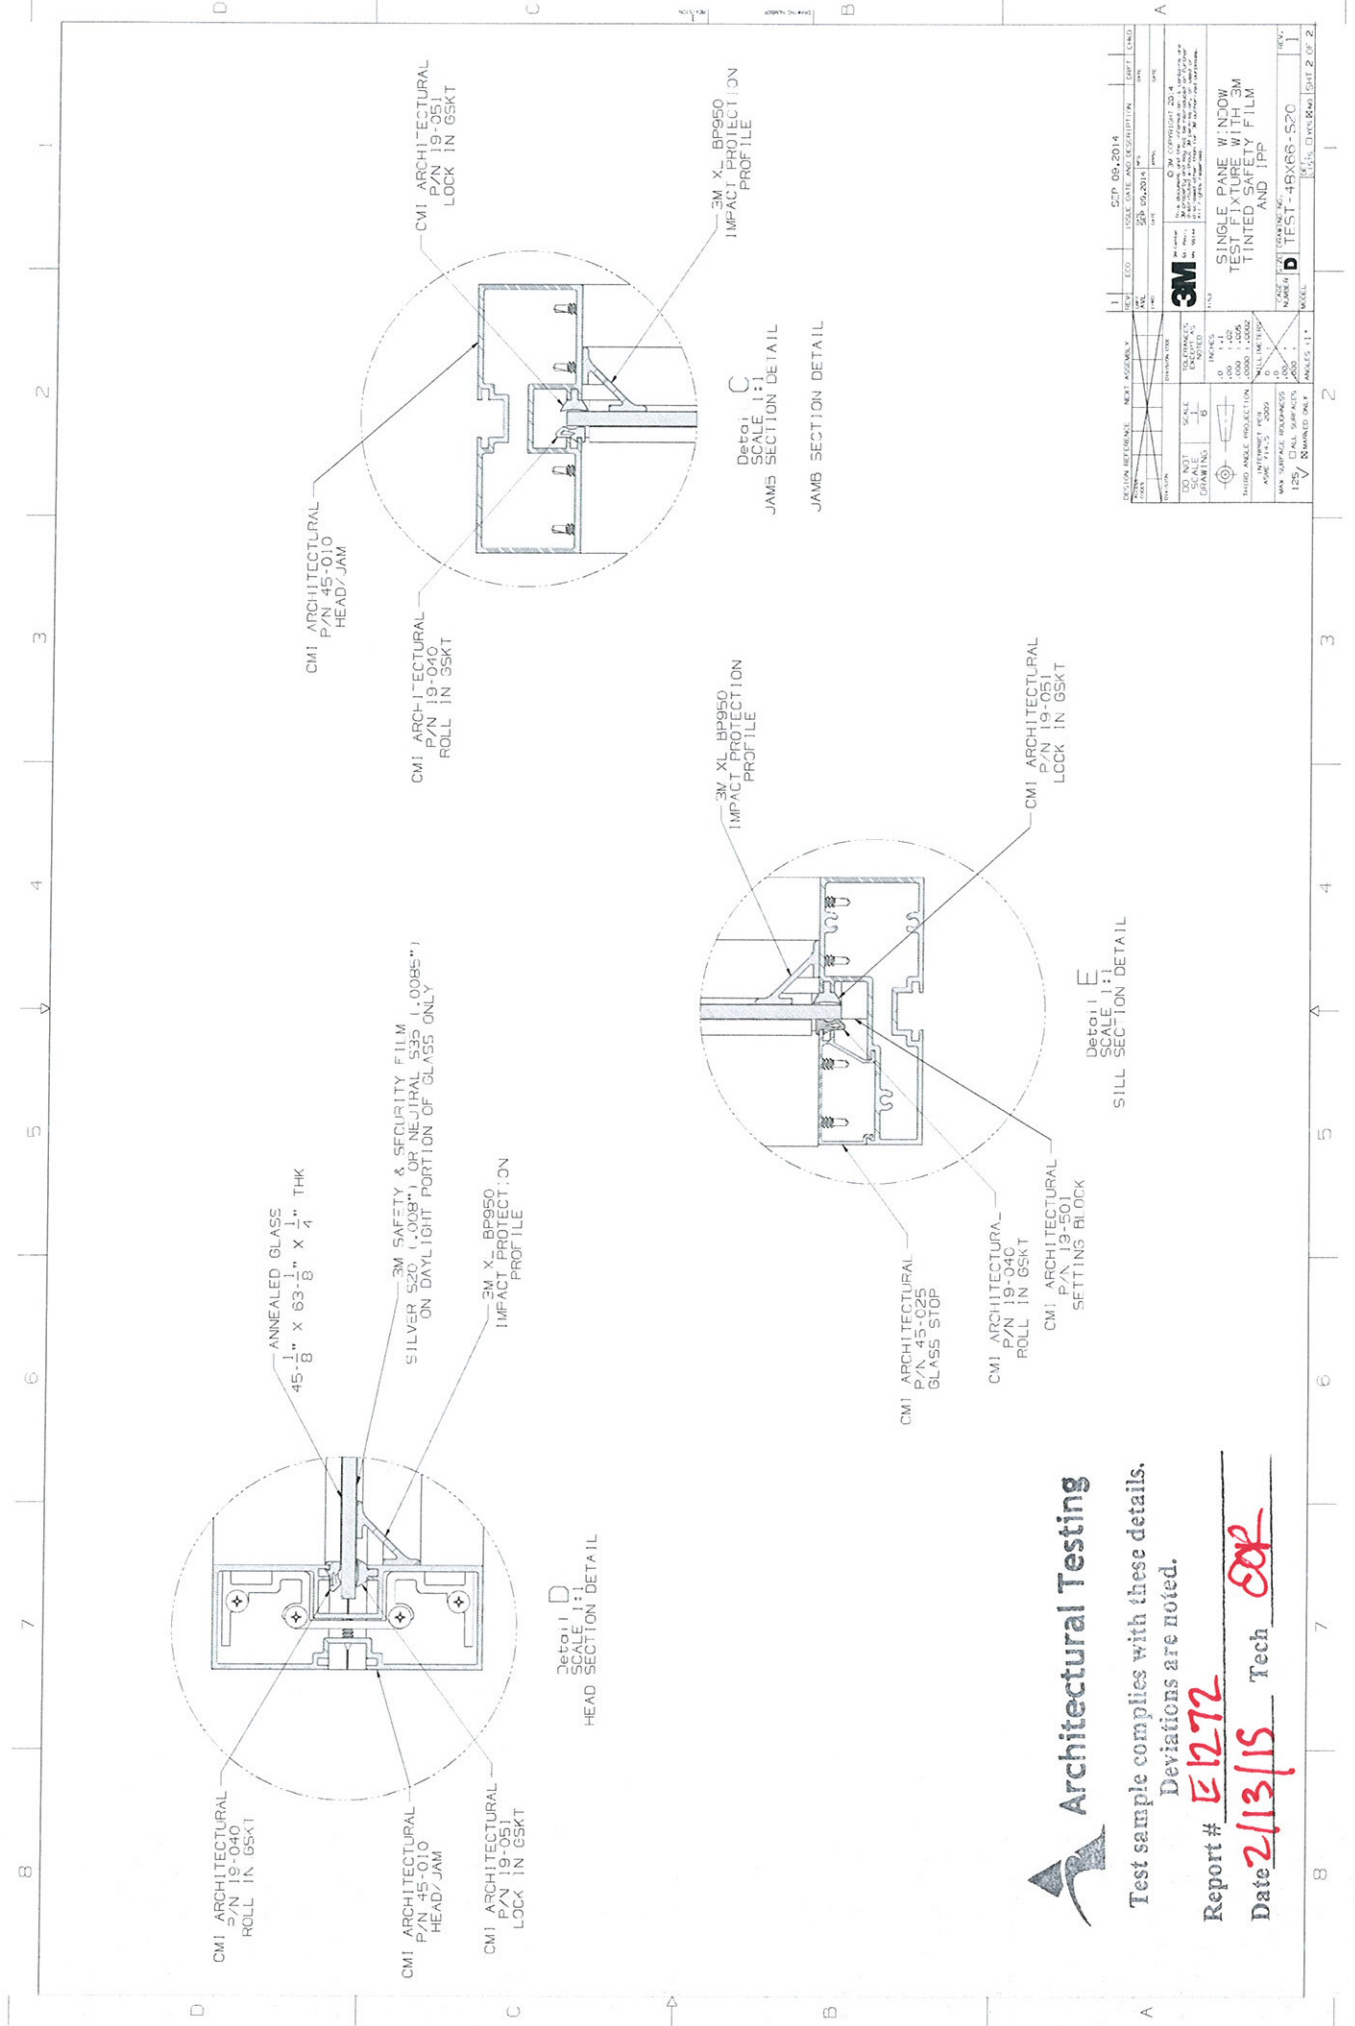
Detail D
SCALE 1:1
HEAD SECTION DETAIL

Detail C
SCALE 1:1
JAMB SECTION DETAIL
