ASTM F1642-12/GSA TS01 TEST REPORT

Report No.: D0345.02-119-12

PRODUCT TYPE:
Fragment Retention Film on Single Pane Annealed Glass with 3M™ Impact Protection
Adhesive

SERIES/MODEL: 3M™ Safety S80, Safety and Security Window Film

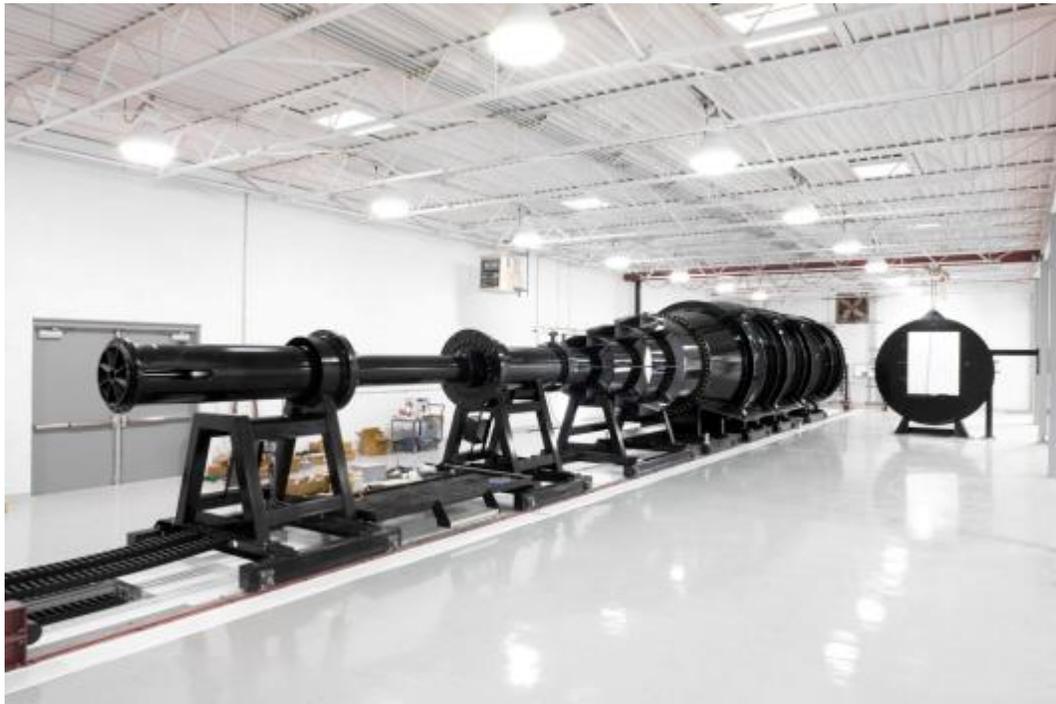
Figure #1
Shock Tube and Test Facility

- 1.4 Test Dates:** 10/15/2013 and 10/16/2013
- 1.5 Test Facility:** Architectural Testing, Inc.'s shock tube is housed in a 10,000 square foot state-of-the-art test facility located in York, Pennsylvania. Blast loadings are produced on the specimen to simulate the effects of a high explosive charge at a specified standoff distance. Shock waves are generated by the sudden rupturing of a thin aluminum membrane. The shock wave expands as it travels down the tube, and impacts the target with a specific positive pressure and impulse. A photograph of the shock tube is provided in Figure #1 of Appendix A.

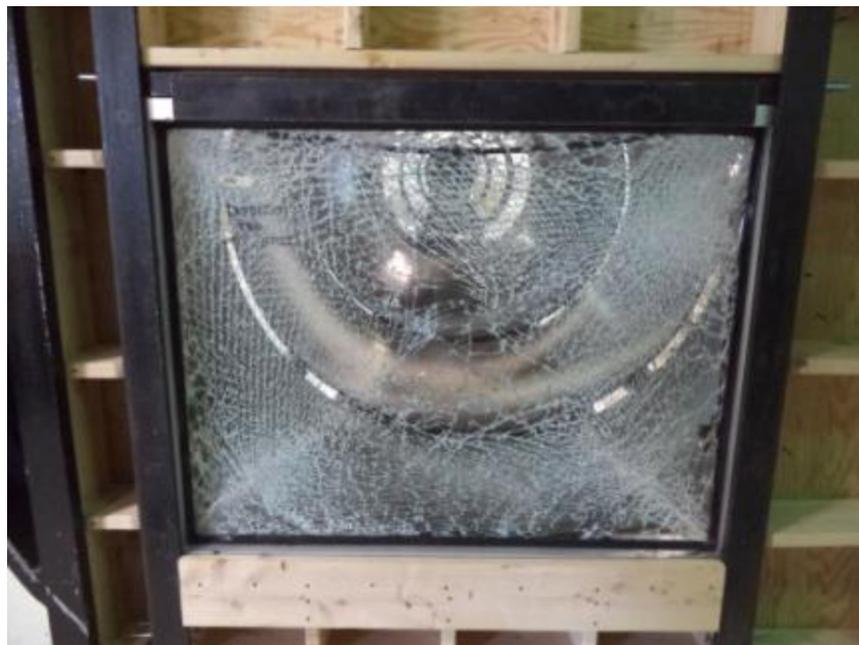
Photo No. 2
Post-test Specimen #1, Interior

Description	Results
Ambient Temperature	68 °F
Glazing Temperature	68 °F
ASTM Hazard Rating	Minimal Hazard
GSA Performance Condition	3b
Peak Positive Pressure	
Top Pressure	6.58 psi
Right Pressure	6.58 psi
Shell Pressure	6.04 psi
Average Pressure	6.40 psi
Witness Chamber Pressure	0.44 psi
Peak Positive Phase Duration	
Top Duration	13.54 msec
Right Duration	13.61 msec
Shell Duration	13.22 msec
Average Duration	13.46 msec
Peak Positive Phase Impulse	
Top Impulse	42 psi*msec
Right Impulse	41 psi*msec
Shell Impulse	41 psi*msec
Average Impulse	41 psi*msec
Glazing Response	
Lite	Fractured
Glazing Pullout Length and Location	None
Glazing Tearing	1" at sill corner

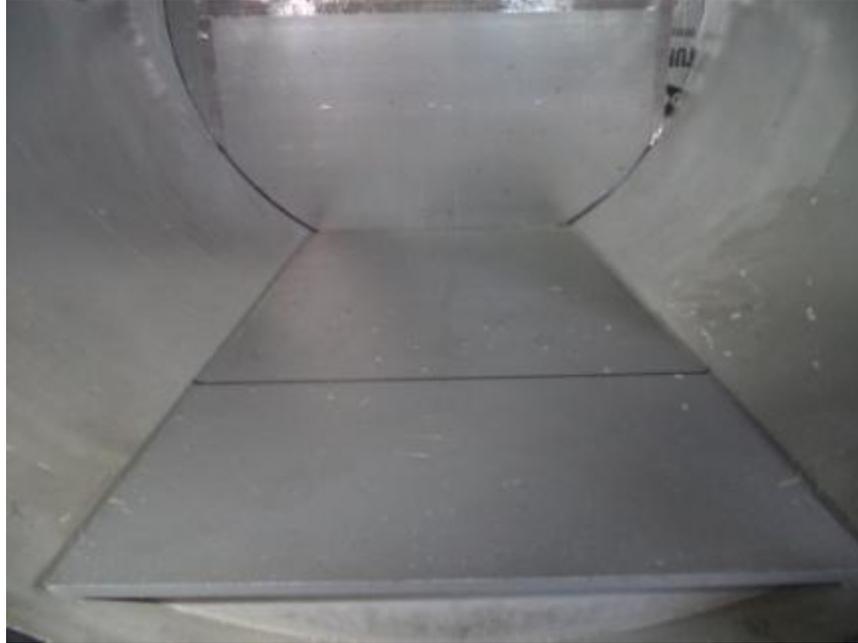
Photo No. 3
Post-test Specimen #1, Witness Chamber

Witness Chamber Results
The glazing fractured but was fully retained in the frame. Two slivers were located 35-1/4" and 50-1/2" from the specimen on the witness chamber floor. Two sliver indents were located at a height of 9-1/2" and 32-3/8" on the witness panel

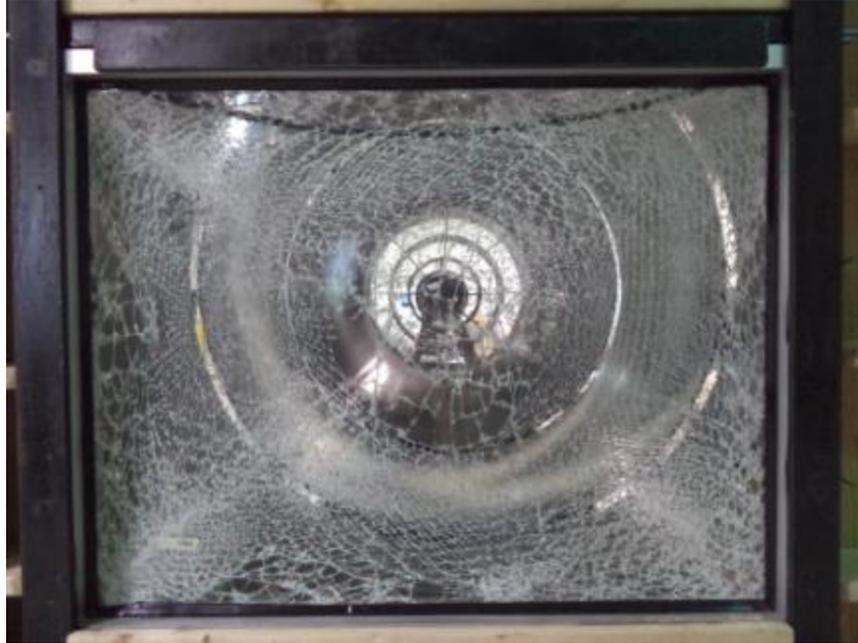
Photo No. 5
Post-test Specimen #2, Interior

Description	Results
Ambient Temperature	68 °F
Glazing Temperature	68 °F
ASTM Hazard Rating	No Hazard
GSA Performance Condition	2
Peak Positive Pressure	
Top Pressure	6.67 psi
Right Pressure	7.06 psi
Shell Pressure	6.13 psi
Average Pressure	6.62 psi
Witness Chamber Pressure	0.41 psi
Peak Positive Phase Duration	
Top Duration	13.52 msec
Right Duration	13.91 msec
Shell Duration	13.63 msec
Average Duration	13.69 msec
Peak Positive Phase Impulse	
Top Impulse	40 psi*msec
Right Impulse	40 psi*msec
Shell Impulse	40 psi*msec
Average Impulse	40 psi*msec
Glazing Response	
Lite	Fractured
Glazing Pullout Length and Location	None
Glazing Tearing	None

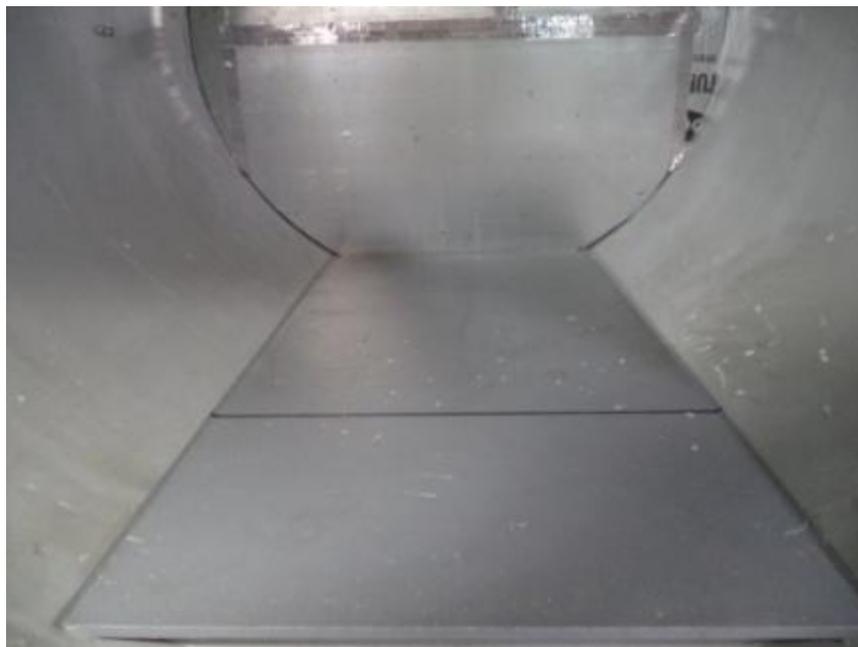
Photo No. 6
Post-test Specimen #2, Witness Chamber

Witness Chamber Results
The glazing fractured but was fully retained in the frame. A dusting of glass was deposited on the witness chamber floor with no markings on the witness panel.

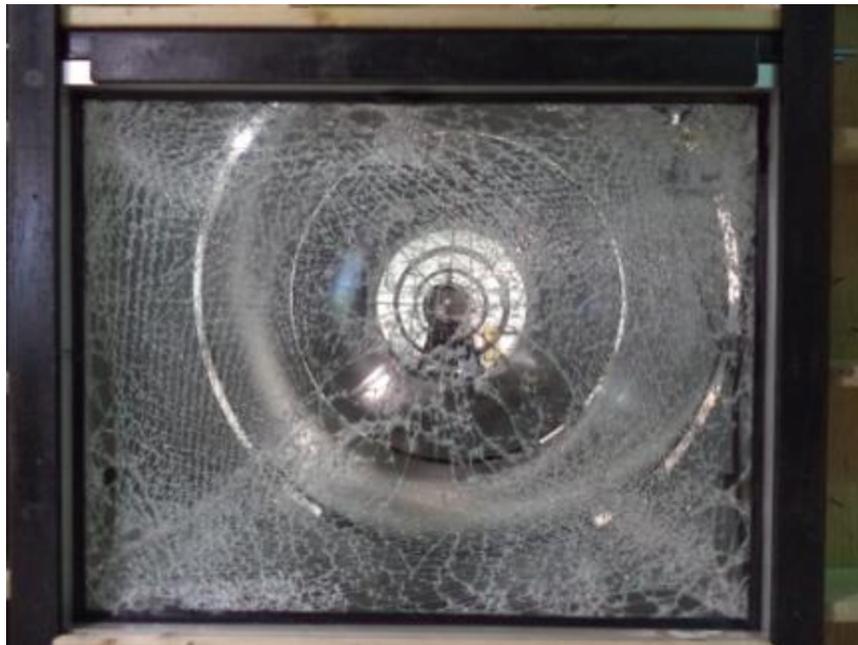
Photo No. 8
Post-test Specimen #3, Interior

Description	Results
Ambient Temperature	71 °F
Glazing Temperature	70 °F
ASTM Hazard Rating	Minimal Hazard
GSA Performance Condition	2
Peak Positive Pressure	
Top Pressure	6.42 psi
Right Pressure	6.75 psi
Shell Pressure	6.07 psi
Average Pressure	6.41 psi
Witness Chamber Pressure	0.40 psi
Peak Positive Phase Duration	
Top Duration	13.49 msec
Right Duration	13.26 msec
Shell Duration	13.20 msec
Average Duration	13.32 msec
Peak Positive Phase Impulse	
Top Impulse	41 psi*msec
Right Impulse	41 psi*msec
Shell Impulse	41 psi*msec
Average Impulse	41 psi*msec
Glazing Response	
Lite	Fractured
Glazing Pullout Length and Location	4-1/2" along the head
Glazing Tearing	None
