**ASTM F1642-12/GSA TS01 TEST REPORT**

**3M COMPANY**

**PRODUCT:** Fragment Retention Film on 1/4" Single Pane Glass and  
1" Insulated Glass Units with Film Attachment System

**SERIES/MODEL:** 3M™ Safety Silver S20 Safety and Security Window Film

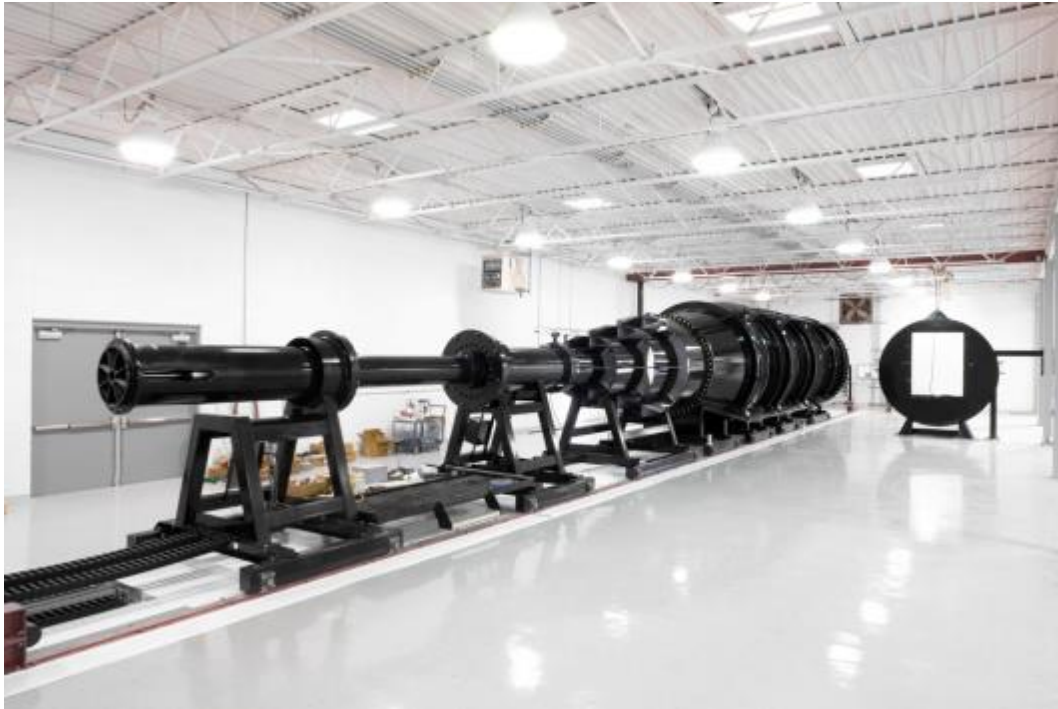
**Figure #1**  
**Shock Tube and Test Facility**

**3.6 Test Facility:** Intertek-ATI's shock tube is housed in a 10,000 square foot state-of-the-art test facility located in York, Pennsylvania. Blast loadings are produced on the specimen to simulate the effects of a high explosive charge at a specified standoff distance. Shock waves are generated by the sudden rupturing of a thin aluminum membrane. The shock wave expands as it travels down the tube, and impacts the target with a specific positive pressure and impulse. A photograph of the shock tube is provided in Figure #1 of Appendix A.

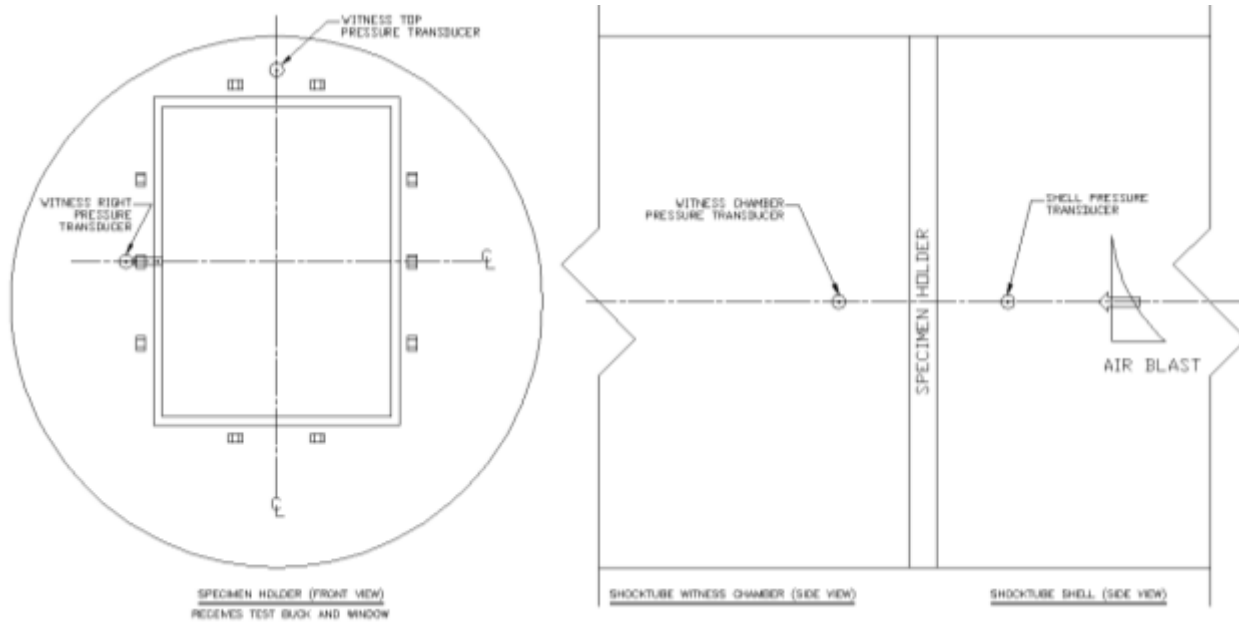
**Figure #2**  
**Pressure Sensor Locations**

**3.9 Data Acquisition:** In accordance with ASTM F1642-12 and GSA TS01, four reflective pressure transducers are utilized to record data at a 1MHz sample rate. Two reflective pressure transducers are located on the specimen holder at the top and right side (when viewed from the interior). A third pressure transducer is located on the shell to the exterior of the specimen, and a fourth is located in the witness chamber, directly to the interior of the specimen holder. A sketch of the specimen holder and corresponding reflective pressure sensor locations are provided in Figure #2 of Appendix A.

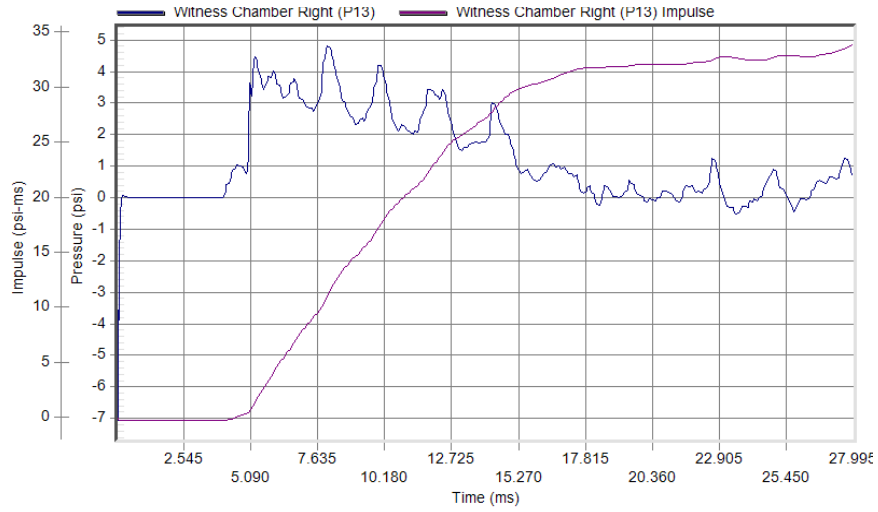
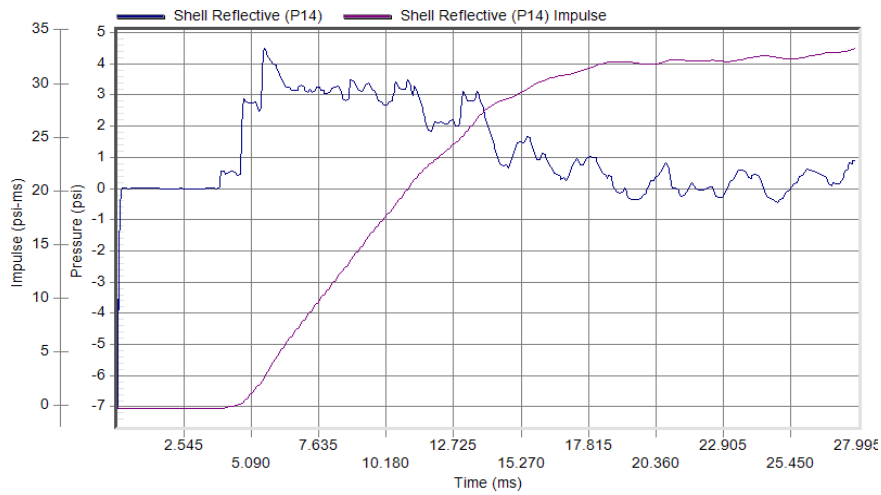
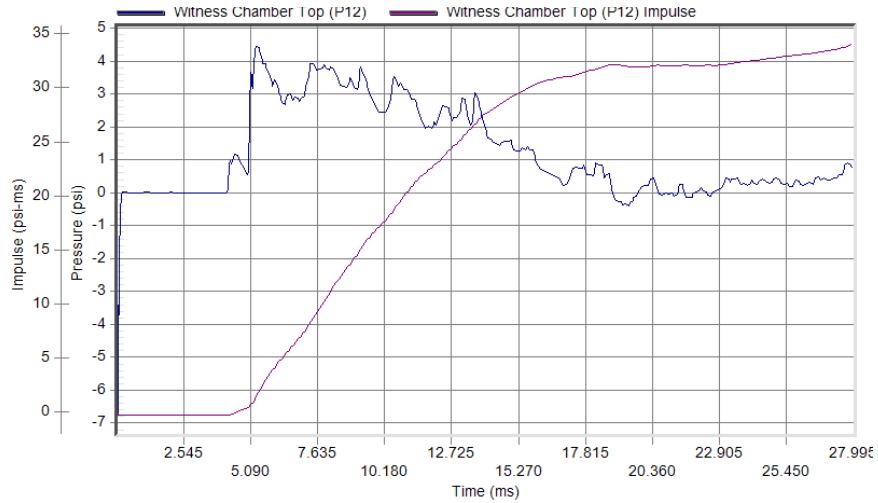
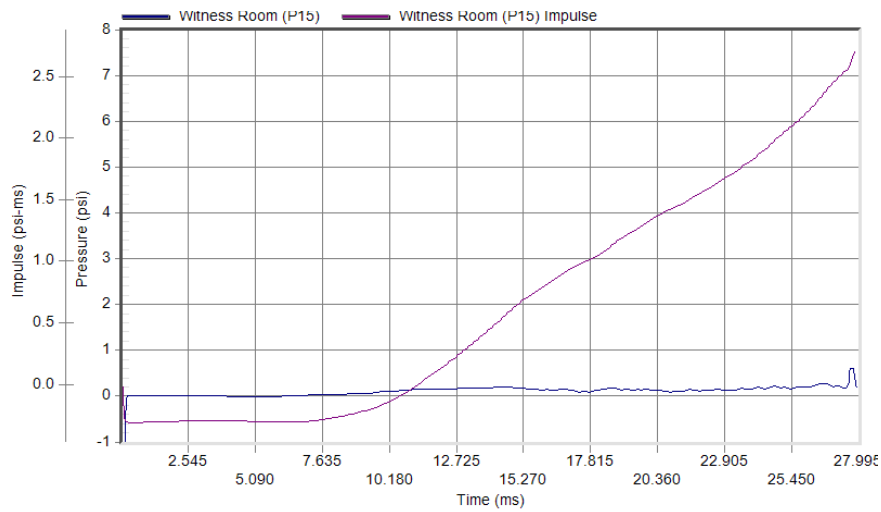
## Specimen #1

Peak Pressure: 4.86 psi at 8.04 ms  
Duration: 10.12 ms

Peak Pressure: 4.54 psi at 5.60 ms  
Duration: 13.17 ms

Peak Pressure: 4.52 psi at 5.35 ms  
Duration: 13.50 ms

Peak Pressure: 0.64 psi at 27.74 ms  
Duration: 0.00 ms

<b>Peak Positive Pressure</b>	
Top Pressure	4.52psi
Right Pressure	4.86 psi
Shell Pressure	4.54 psi
<b>Average Pressure</b>	4.64 psi
Witness Chamber Pressure	0.64 psi

<b>Peak Positive Phase Duration</b>	
Top Duration	13.50 msec
Right Duration	10.12 msec
Shell Duration	13.17 msec
<b>Average Duration</b>	12.26 msec

<b>Peak Positive Phase Impulse</b>	
Top Impulse	32 psi*msec
Right Impulse	32 psi*msec
Shell Impulse	32 psi*msec
<b>Average Impulse</b>	32 psi*msec

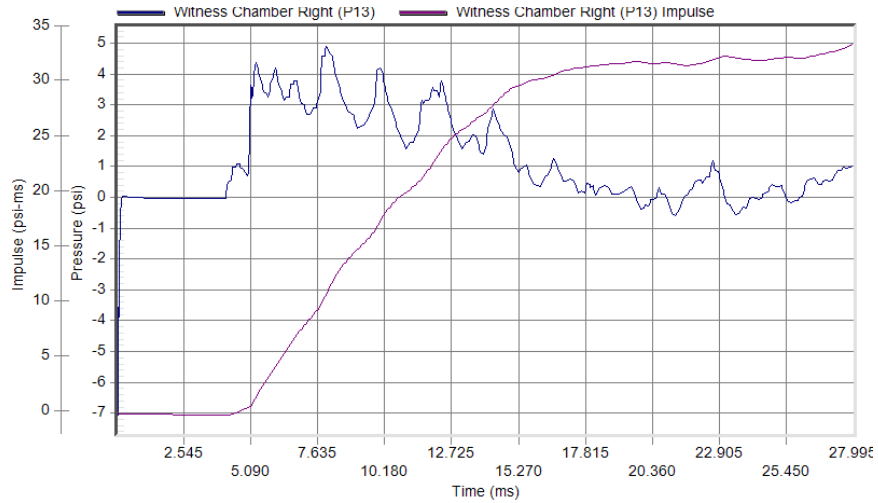
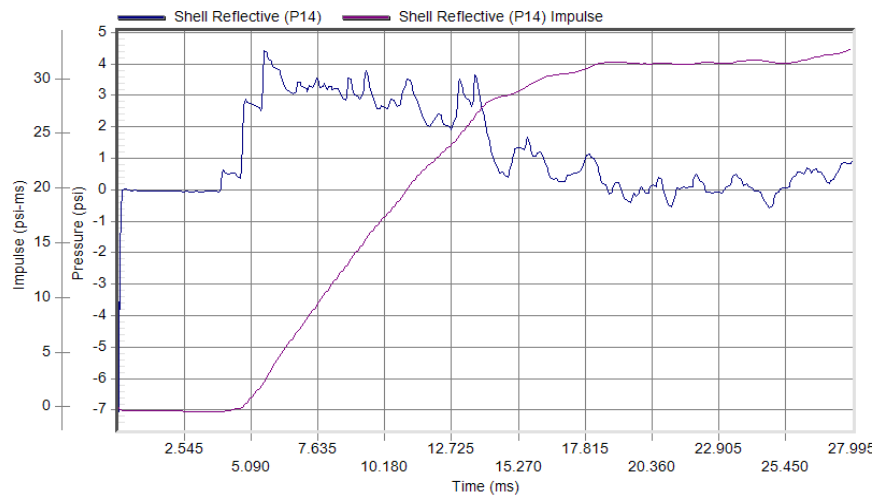
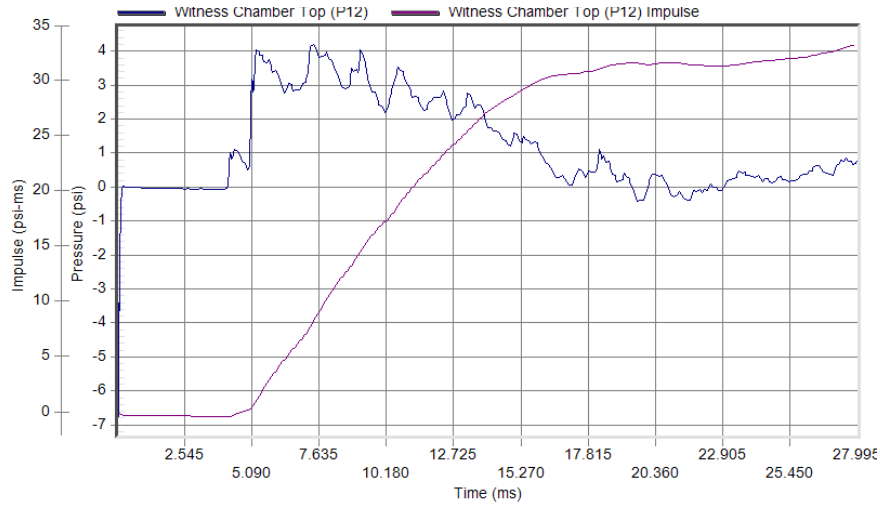
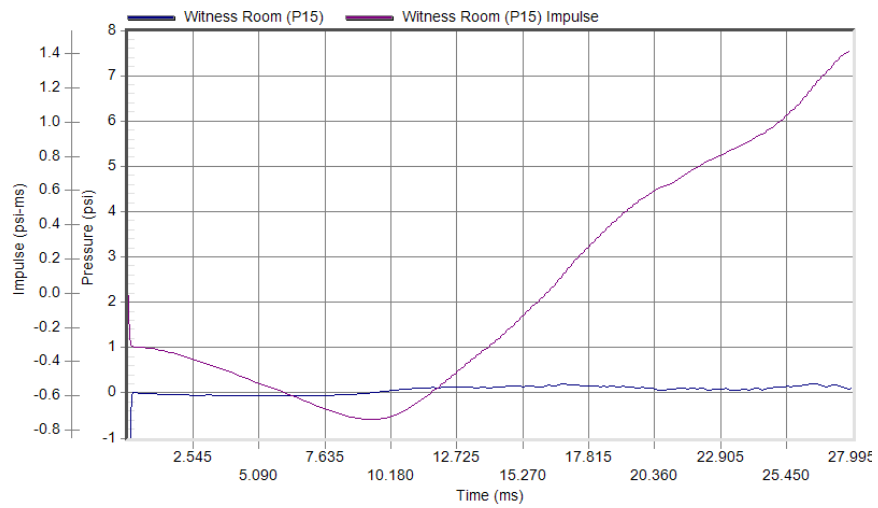
## Specimen #2

Peak Pressure: 4.98 psi at 7.98 ms  
Duration: 11.74 ms

Peak Pressure: 4.50 psi at 5.64 ms  
Duration: 13.00 ms

Peak Pressure: 4.21 psi at 7.39 ms  
Duration: 12.08 ms

Peak Pressure: 0.20 psi at 26.46 ms  
Duration: 0.00 ms

<b>Peak Positive Pressure</b>	
Top Pressure	4.21 psi
Right Pressure	4.98 psi
Shell Pressure	4.50 psi
<b>Average Pressure</b>	<b>4.56 psi</b>
Witness Chamber Pressure	0.20 psi

<b>Peak Positive Phase Duration</b>	
Top Duration	12.08 msec
Right Duration	11.74 msec
Shell Duration	13.00 msec
<b>Average Duration</b>	<b>12.27 msec</b>

<b>Peak Positive Phase Impulse</b>	
Top Impulse	32 psi*msec
Right Impulse	32 psi*msec
Shell Impulse	31 psi*msec
<b>Average Impulse</b>	<b>32 psi*msec</b>

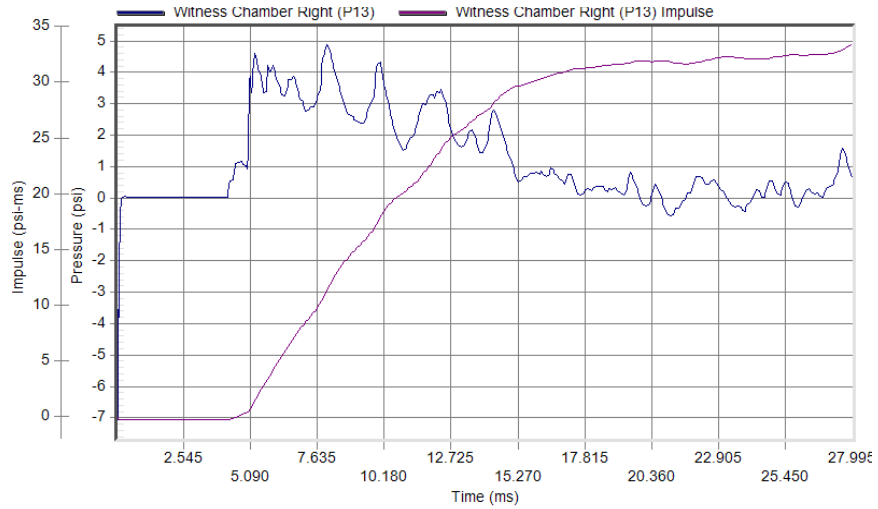
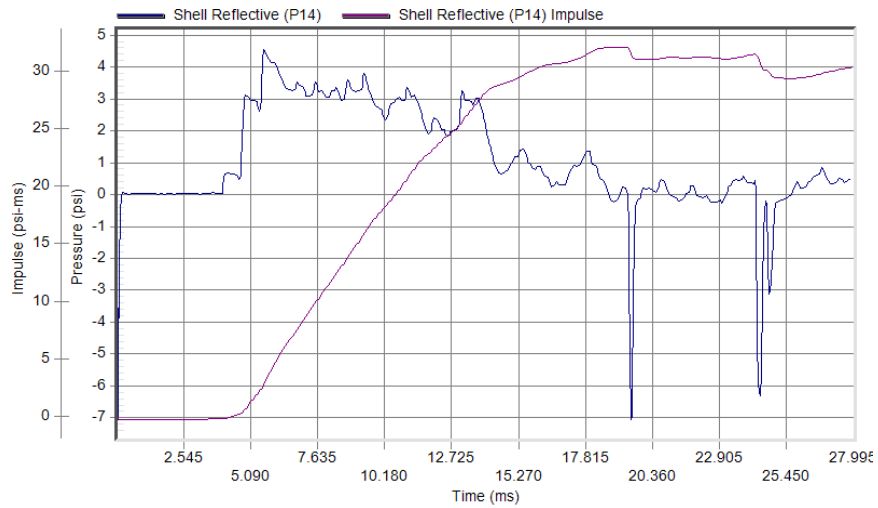
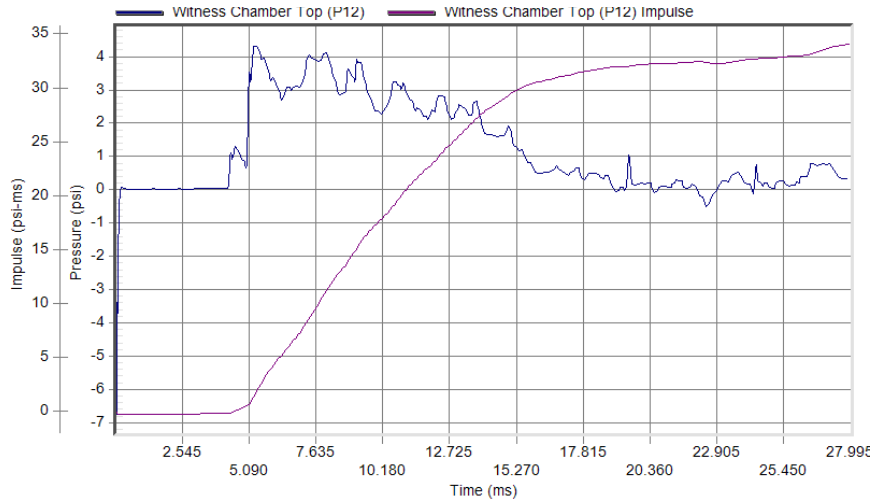
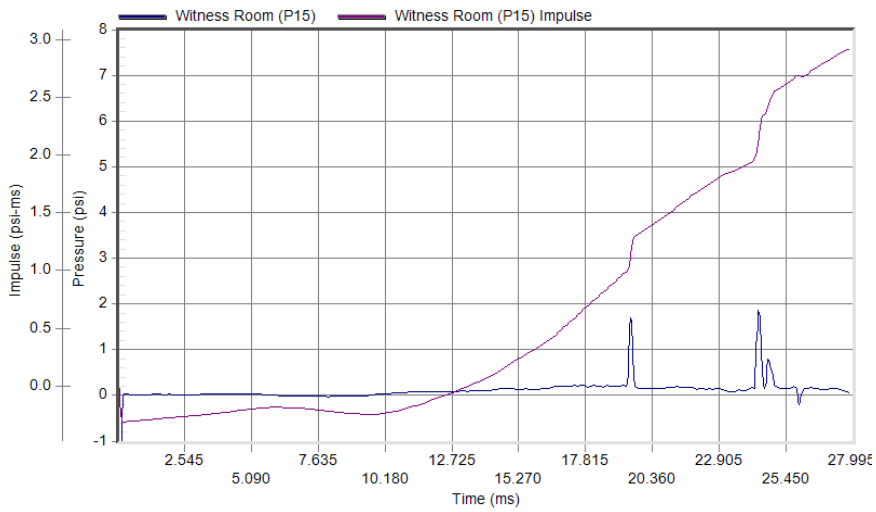
### Specimen #3

Peak Pressure: 4.89 psi at 8.05 ms  
Duration: 11.84 ms

Peak Pressure: 4.62 psi at 5.62 ms  
Duration: 13.08 ms

Peak Pressure: 4.39 psi at 5.32 ms  
Duration: 13.67 ms

Peak Pressure: 1.92 psi at 24.43 ms  
Duration: 1.48 ms

<b>Peak Positive Pressure</b>	
Top Pressure	4.39 psi
Right Pressure	4.89 psi
Shell Pressure	4.62 psi
<b>Average Pressure</b>	<b>4.63 psi</b>
Witness Chamber Pressure	1.92 psi

<b>Peak Positive Phase Duration</b>	
Top Duration	13.67 msec
Right Duration	11.84 msec
Shell Duration	13.08 msec
<b>Average Duration</b>	<b>12.86 msec</b>

<b>Peak Positive Phase Impulse</b>	
Top Impulse	32 psi*msec
Right Impulse	32 psi*msec
Shell Impulse	32 psi*msec
<b>Average Impulse</b>	<b>32 psi*msec</b>

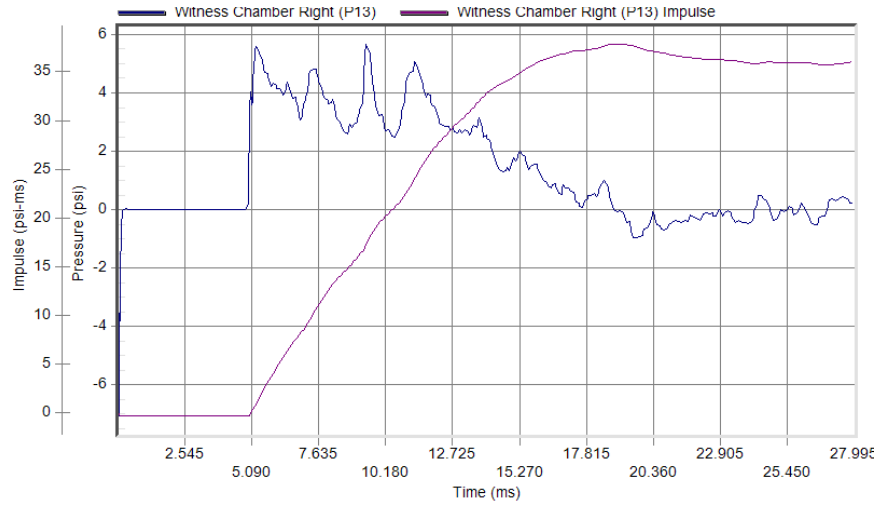
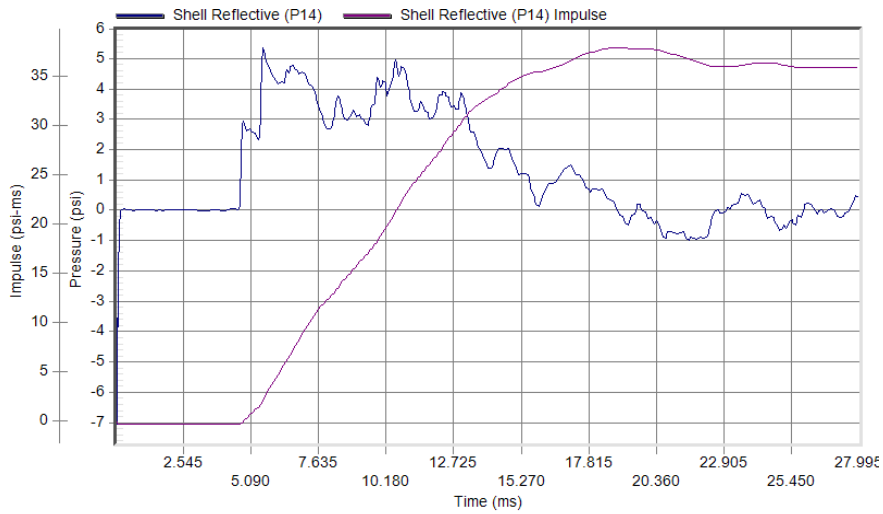
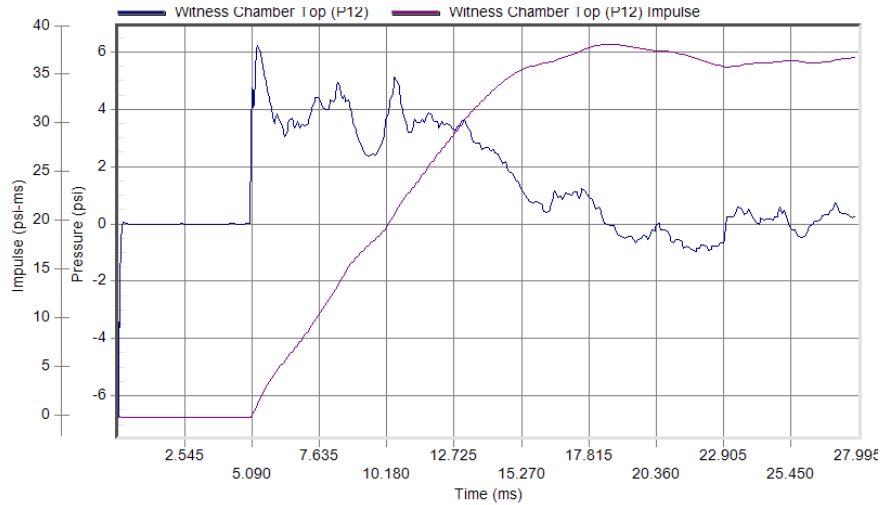
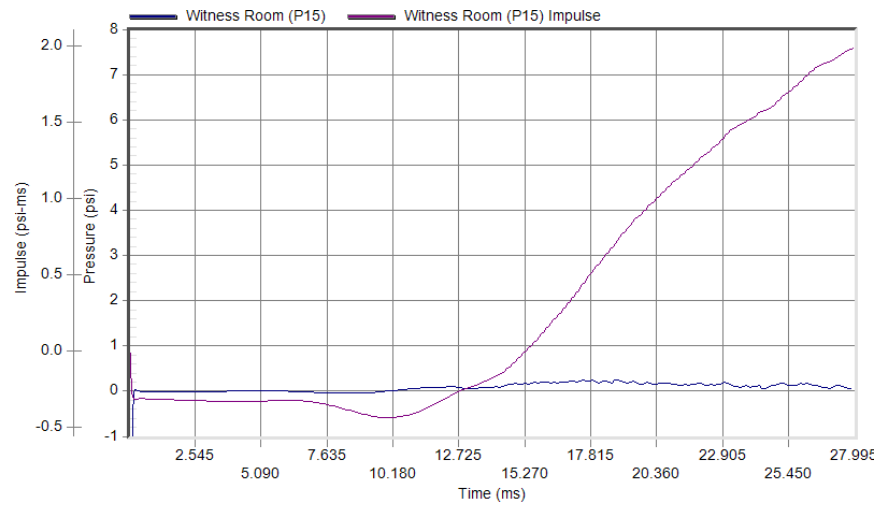
### Specimen #4

Peak Pressure: 5.67 psi at 5.28 ms  
Duration: 12.32 ms

Peak Pressure: 5.36 psi at 5.57 ms  
Duration: 13.30 ms

Peak Pressure: 6.28 psi at 5.31 ms  
Duration: 13.09 ms

Peak Pressure: 0.26 psi at 18.80 ms  
Duration: 0.00 ms

<b>Peak Positive Pressure</b>	
Top Pressure	6.28 psi
Right Pressure	5.67 psi
Shell Pressure	5.36 psi
<b>Average Pressure</b>	<b>5.77 psi</b>
Witness Chamber Pressure	0.26 psi

<b>Peak Positive Phase Duration</b>	
Top Duration	13.09 msec
Right Duration	12.32 msec
Shell Duration	13.30 msec
<b>Average Duration</b>	<b>12.90 msec</b>

<b>Peak Positive Phase Impulse</b>	
Top Impulse	38 psi*msec
Right Impulse	38 psi*msec
Shell Impulse	38 psi*msec
<b>Average Impulse</b>	<b>38 psi*msec</b>

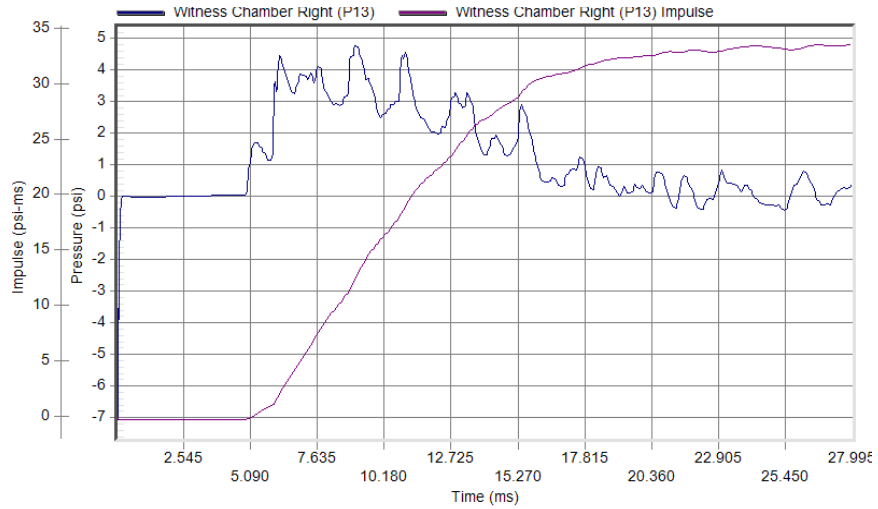
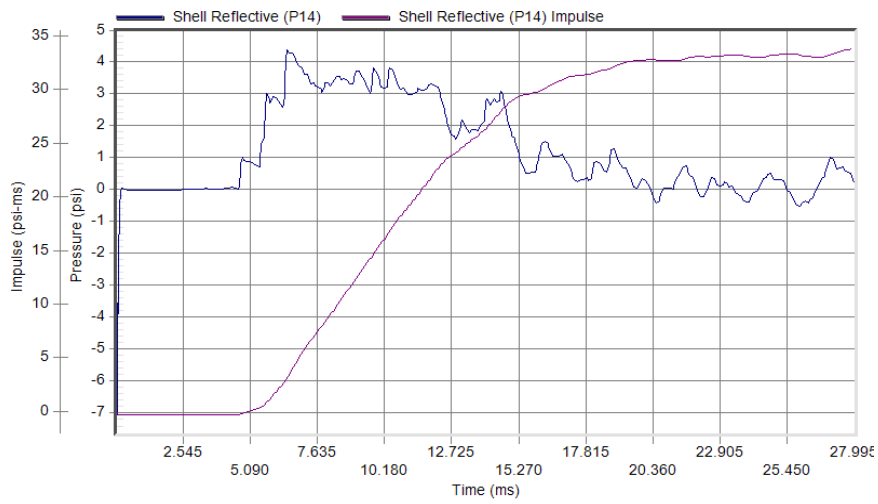
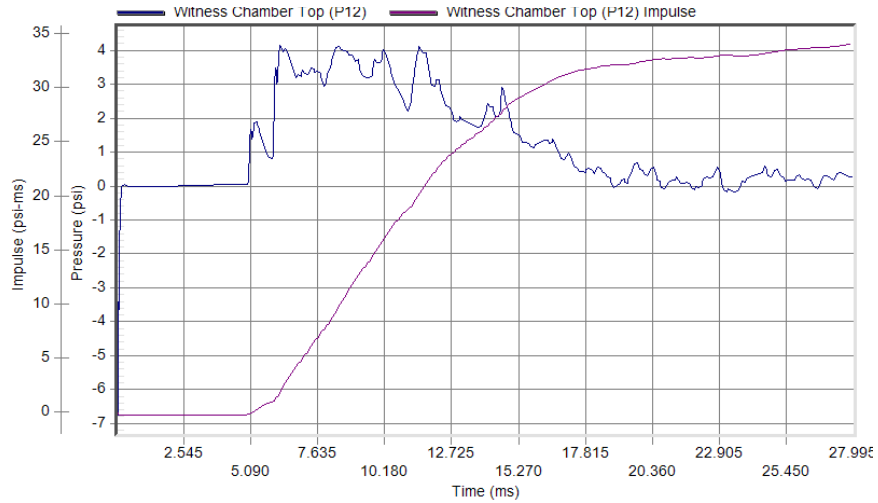
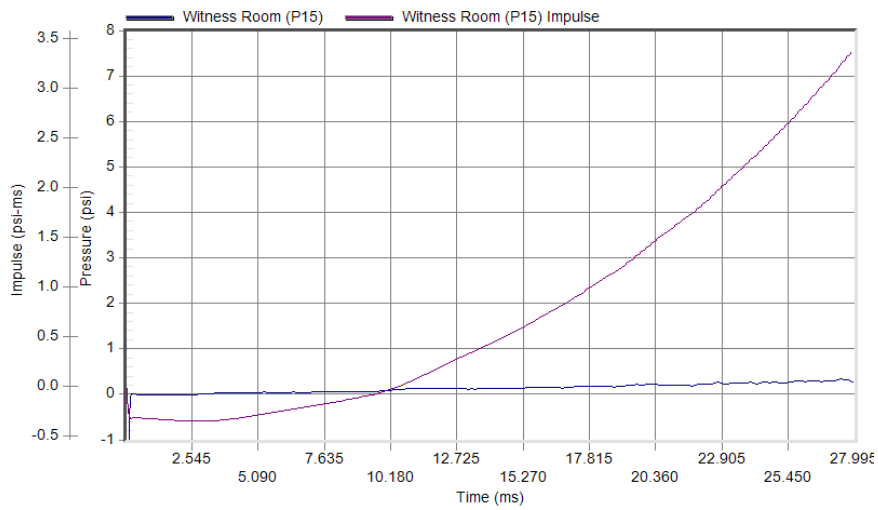
### Specimen #5

Peak Pressure: 4.82 psi at 9.09 ms  
Duration: 10.04 ms

Peak Pressure: 4.42 psi at 6.51 ms  
Duration: 13.14 ms

Peak Pressure: 4.19 psi at 6.22 ms  
Duration: 12.61 ms

Peak Pressure: 0.35 psi at 27.43 ms  
Duration: 0.00 ms

<b>Peak Positive Pressure</b>	
Top Pressure	4.19 psi
Right Pressure	4.82 psi
Shell Pressure	4.42 psi
<b>Average Pressure</b>	<b>4.48 psi</b>
Witness Chamber Pressure	0.35 psi

<b>Peak Positive Phase Duration</b>	
Top Duration	12.61 msec
Right Duration	10.04 msec
Shell Duration	13.14 msec
<b>Average Duration</b>	<b>11.93 msec</b>

<b>Peak Positive Phase Impulse</b>	
Top Impulse	32 psi*msec
Right Impulse	32 psi*msec
Shell Impulse	33 psi*msec
<b>Average Impulse</b>	<b>32 psi*msec</b>

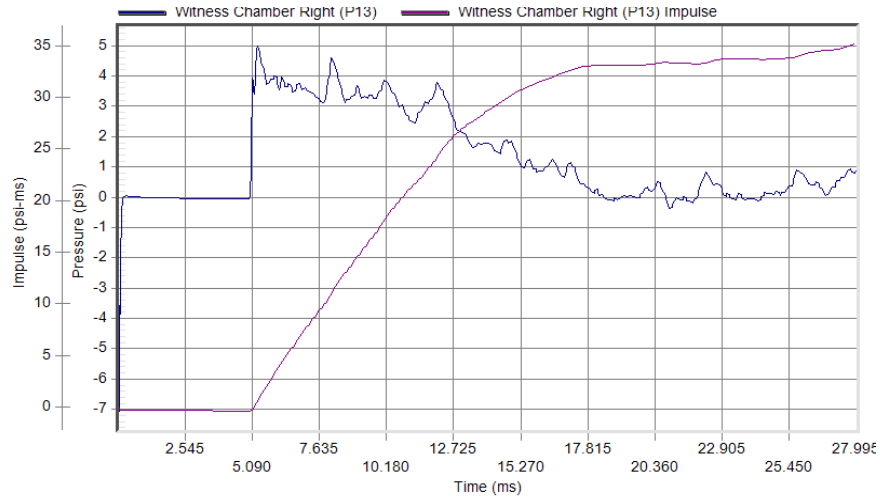
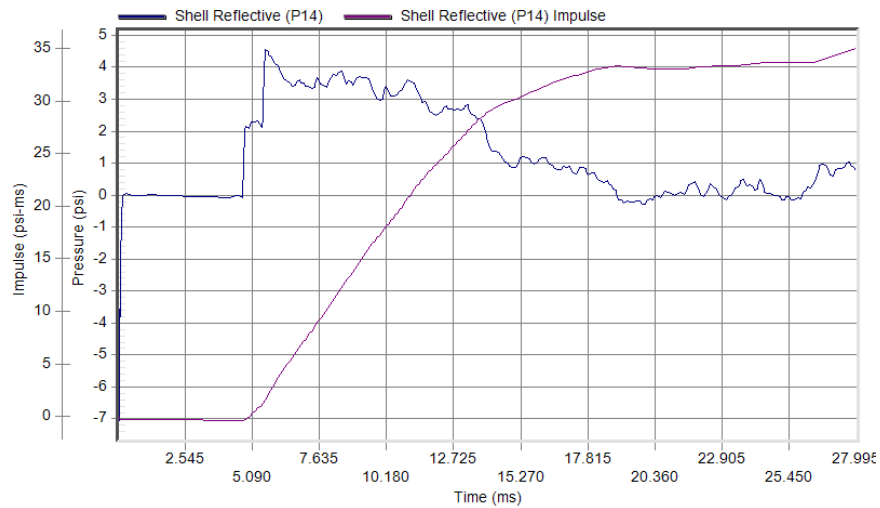
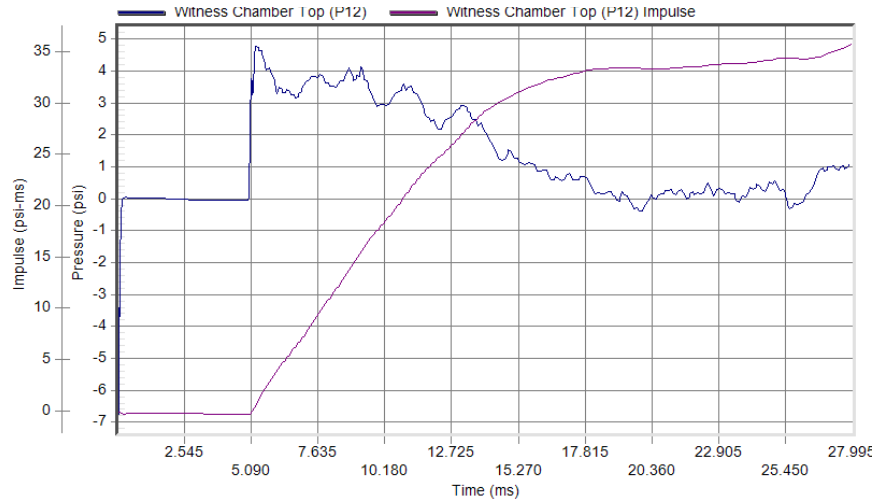
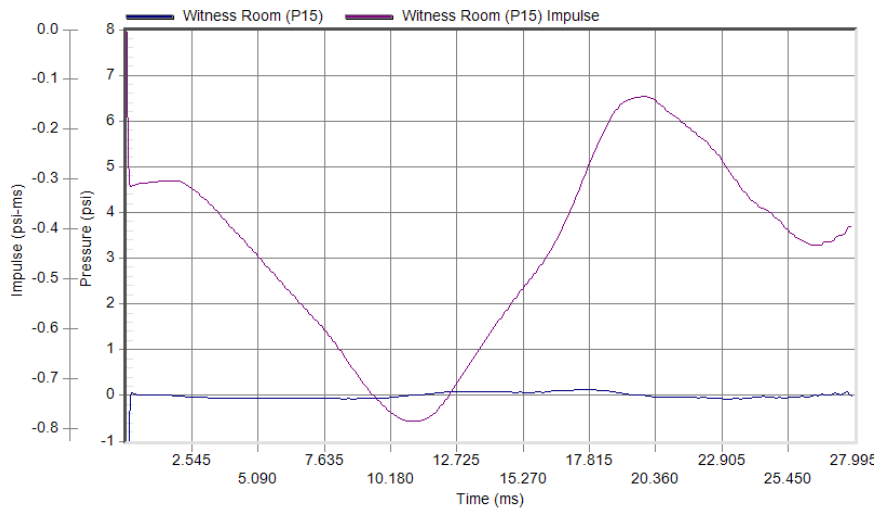
## Specimen #6

Peak Pressure: 5.07 psi at 5.32 ms  
Duration: 13.09 ms

Peak Pressure: 4.60 psi at 5.64 ms  
Duration: 13.28 ms

Peak Pressure: 4.85 psi at 5.31 ms  
Duration: 13.64 ms

Peak Pressure: 0.14 psi at 17.39 ms  
Duration: 2.47 ms

<b>Peak Positive Pressure</b>	
Top Pressure	4.85 psi
Right Pressure	5.07 psi
Shell Pressure	4.60 psi
<b>Average Pressure</b>	<b>4.84 psi</b>
Witness Chamber Pressure	0.14 psi

<b>Peak Positive Phase Duration</b>	
Top Duration	13.64 msec
Right Duration	13.09 msec
Shell Duration	13.28 msec
<b>Average Duration</b>	<b>13.34 msec</b>

<b>Peak Positive Phase Impulse</b>	
Top Impulse	33 psi*msec
Right Impulse	33 psi*msec
Shell Impulse	33 psi*msec
<b>Average Impulse</b>	<b>33 psi*msec</b>

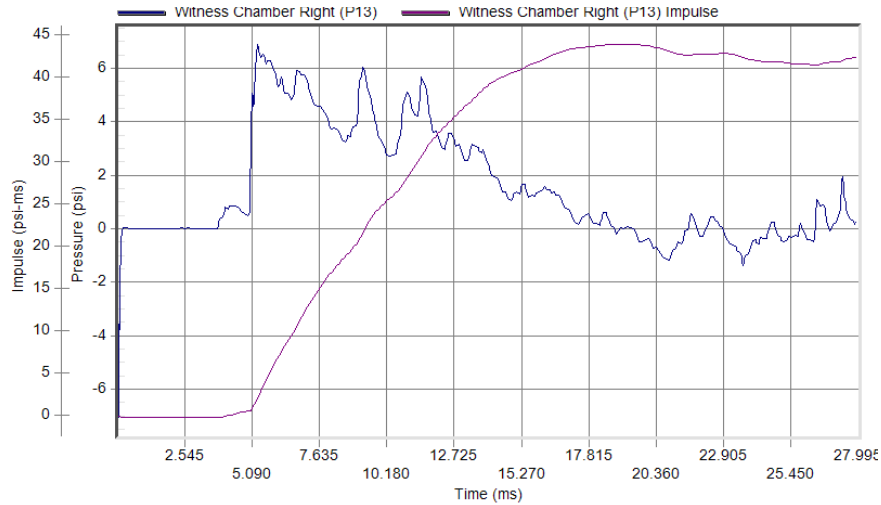
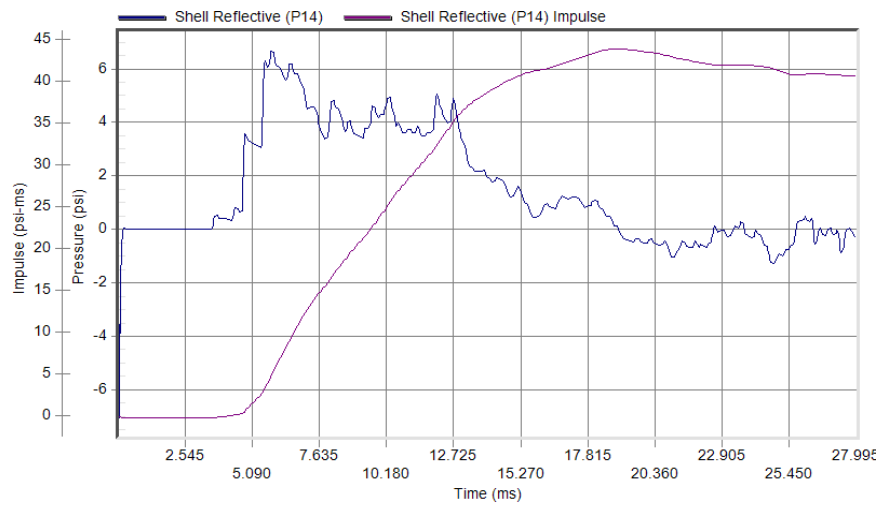
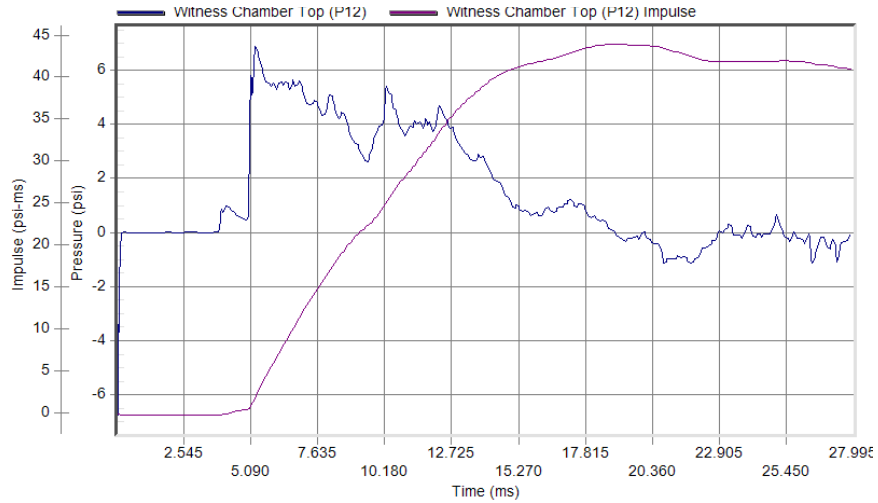
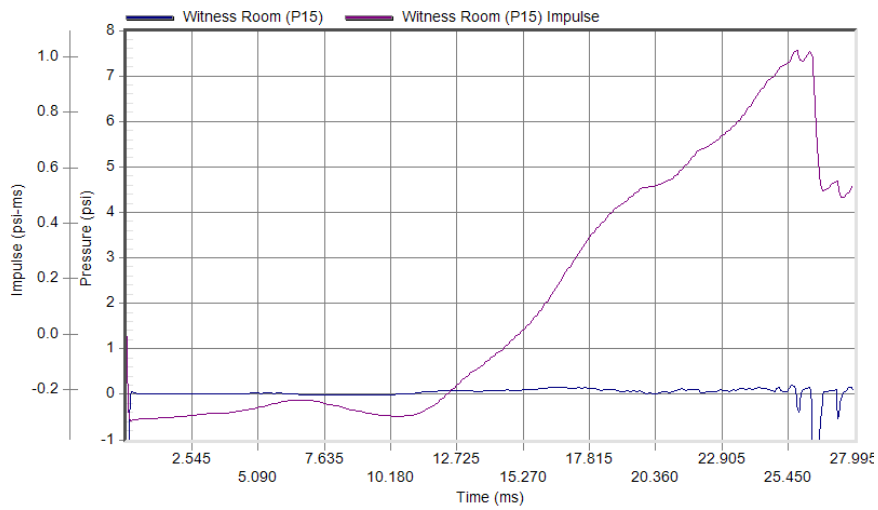
## Specimen #7

Peak Pressure: 6.90 psi at 5.31 ms  
Duration: 13.37 ms

Peak Pressure: 6.75 psi at 5.85 ms  
Duration: 13.10 ms

Peak Pressure: 6.97 psi at 5.31 ms  
Duration: 13.51 ms

Peak Pressure: 0.23 psi at 25.73 ms  
Duration: 0.03 ms

<b>Peak Positive Pressure</b>	
Top Pressure	6.97 psi
Right Pressure	6.90 psi
Shell Pressure	6.75 psi
<b>Average Pressure</b>	<b>6.87 psi</b>
Witness Chamber Pressure	0.23 psi

<b>Peak Positive Phase Duration</b>	
Top Duration	13.51 msec
Right Duration	13.37 msec
Shell Duration	13.10 msec
<b>Average Duration</b>	<b>13.32 msec</b>

<b>Peak Positive Phase Impulse</b>	
Top Impulse	44 psi*msec
Right Impulse	44 psi*msec
Shell Impulse	44 psi*msec
<b>Average Impulse</b>	<b>44 psi*msec</b>

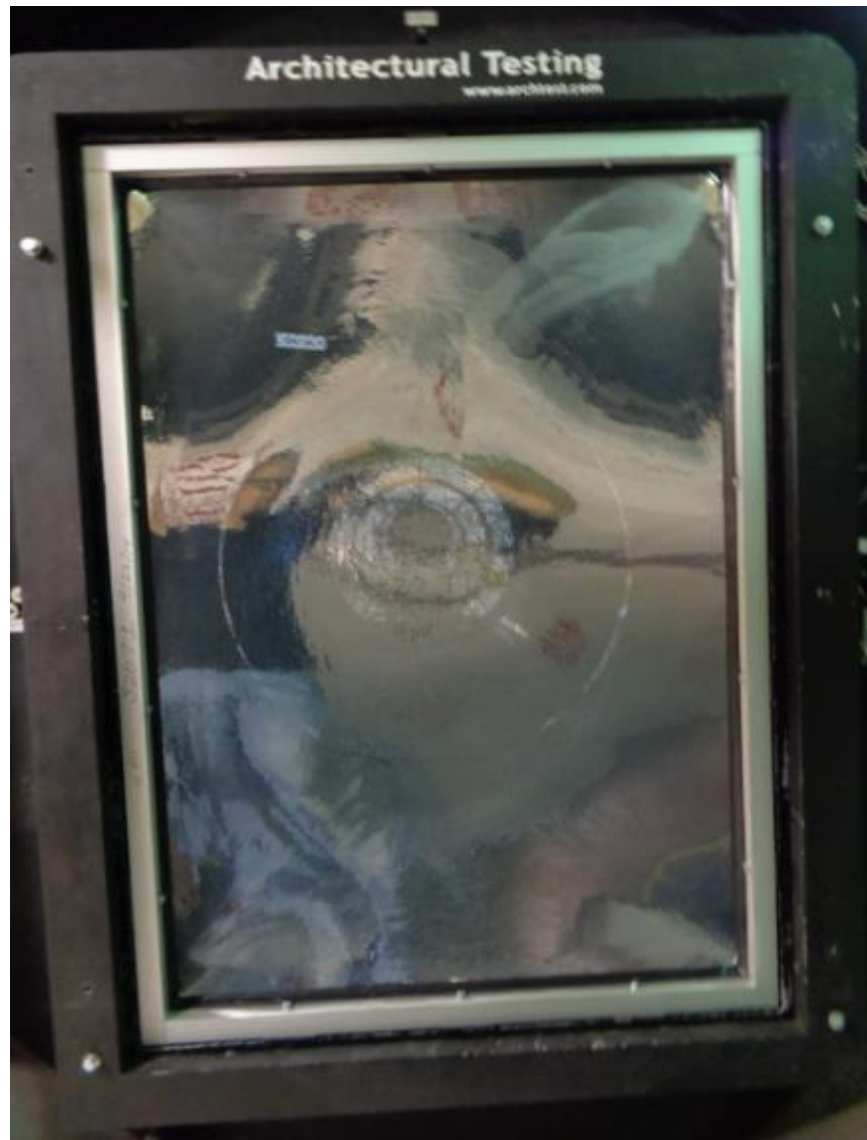
**Photo No. 2**  
**Post-test Specimen #1, Interior**

<b>Glazing Response</b>	
Lite	Fractured
Glazing Pullout Length and Location	None
Glazing Tearing	None

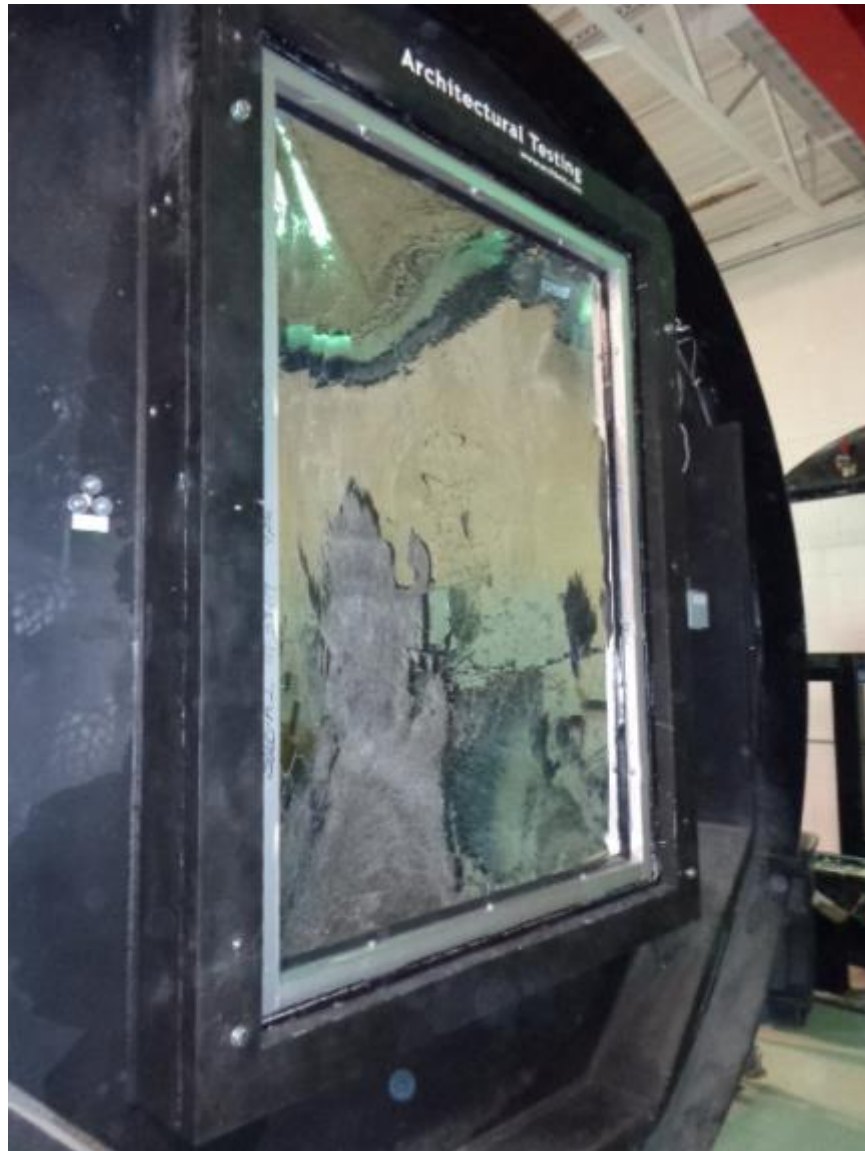
**Photo No. 5**  
**Post-test Specimen #2, Interior**

<b>Glazing Response</b>	
Lite	Fractured
Glazing Pullout Length and Location	None
Glazing Tearing	1-1/4" at center

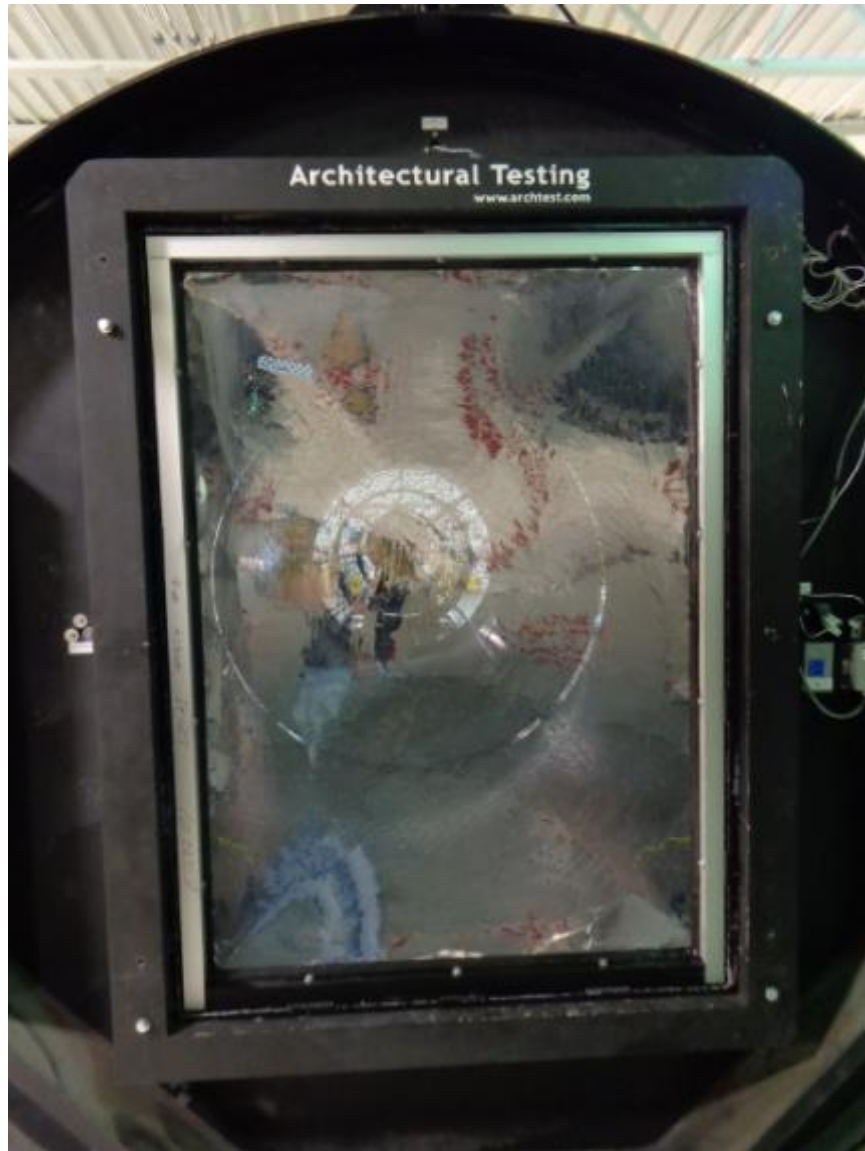
**Photo No. 8**  
**Post-test Specimen #3, Interior**

<b>Glazing Response</b>	
Lite	Fractured
Glazing Pullout Length and Location	None
Glazing Tearing	1" and 2" at head

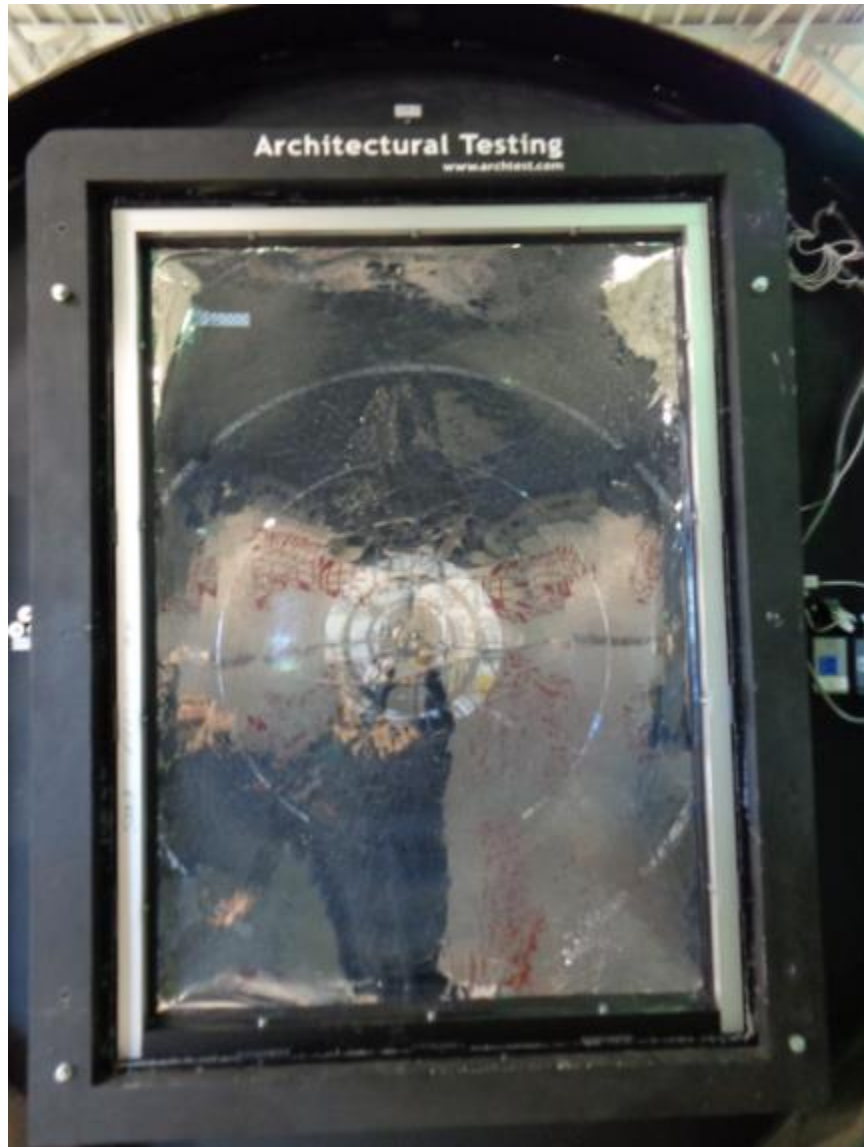
**Photo No. 11**  
**Post-test Specimen #4, Interior**

<b>Glazing Response</b>	
Lite	Fractured
Glazing Pullout Length and Location	None
Glazing Tearing	3-3/4" tear in film

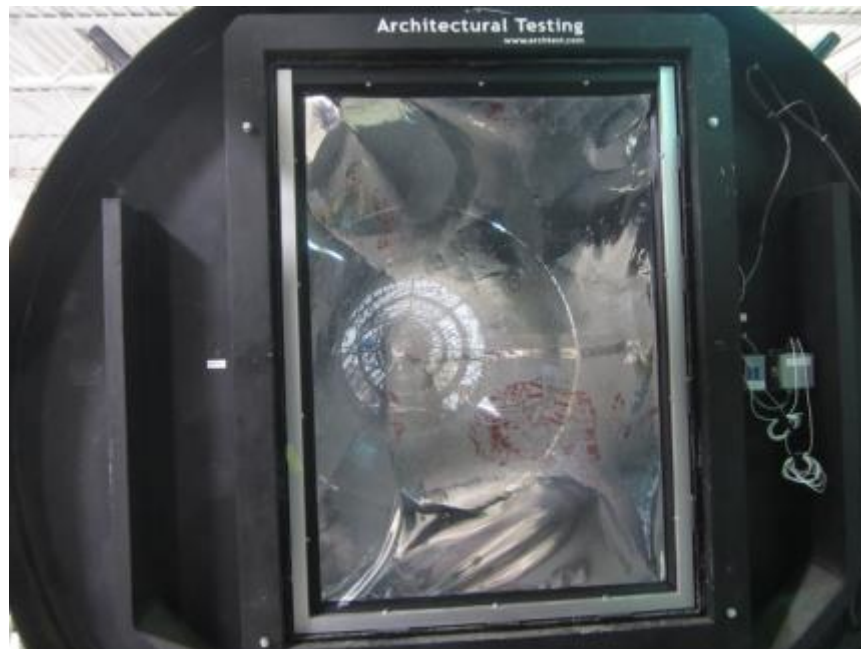
**Photo No. 14**  
**Post-test Specimen #5, Interior**

<b>Glazing Response</b>	
Lite	Fractured
Glazing Pullout Length and Location	None
Glazing Tearing	3/16" and 1/4" at sill corner

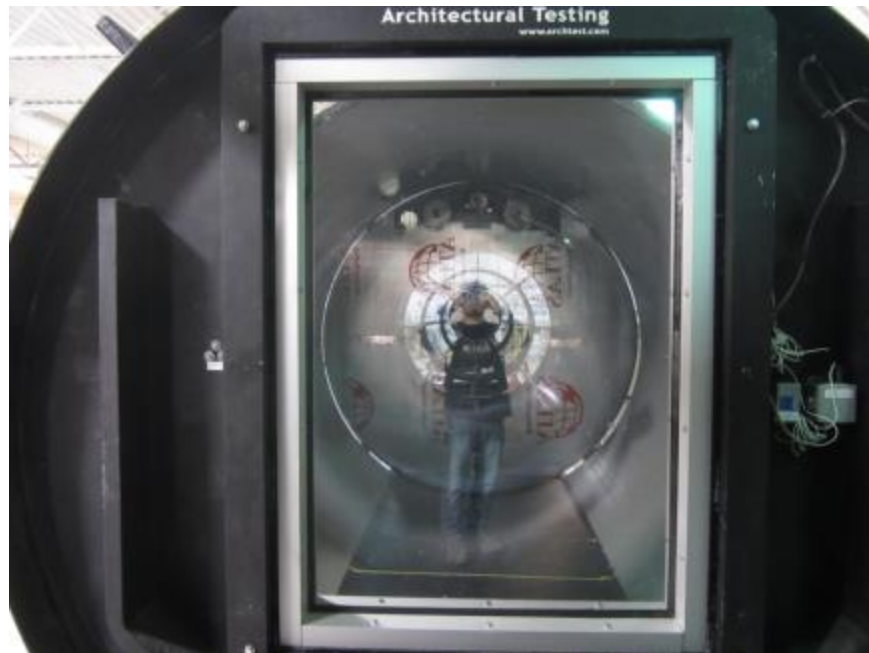
**Photo No. 17**  
**Post-test Specimen #6, Interior**

<b>Glazing Response</b>	
Exterior Lite	Unbroken
Interior Lite	Unbroken
Glazing Pullout Length and Location	None
Glazing Tearing	None

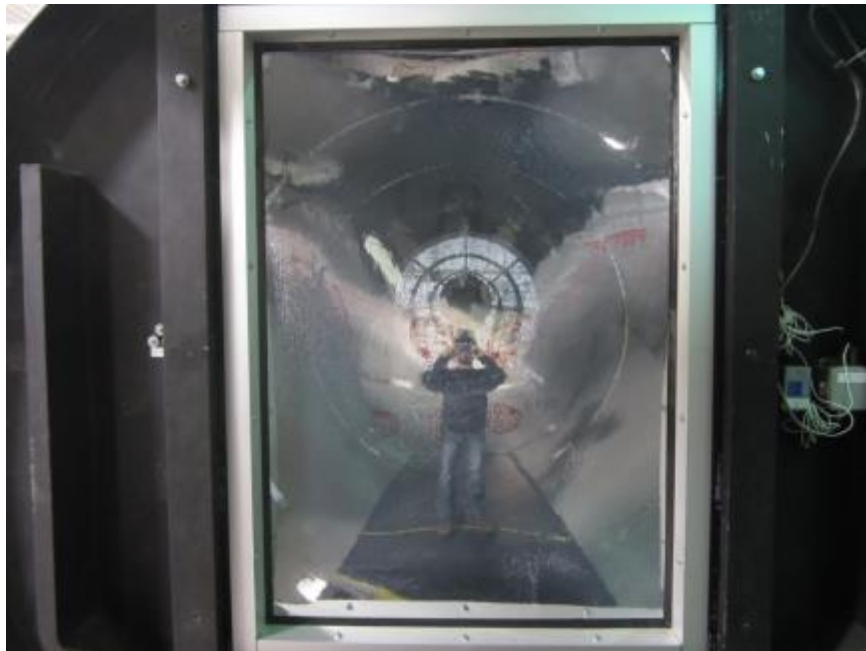
**Photo No. 20**  
**Post-test Specimen #7, Interior**

<b>Glazing Response</b>	
Exterior Lite	Shattered
Interior Lite	Fractured
Glazing Pullout Length and Location	None
Glazing Tearing	None
