**ASTM F1642-12/GSA TS01 TEST REPORT**

**3M COMPANY**

**PRODUCT:** Fragment Retention Film on 1/4" Single Pane Glass and  
1" Insulated Glass Units with Film Attachment System

**SERIES/MODEL:** 3M™ Safety Silver S20 Safety and Security Window Film

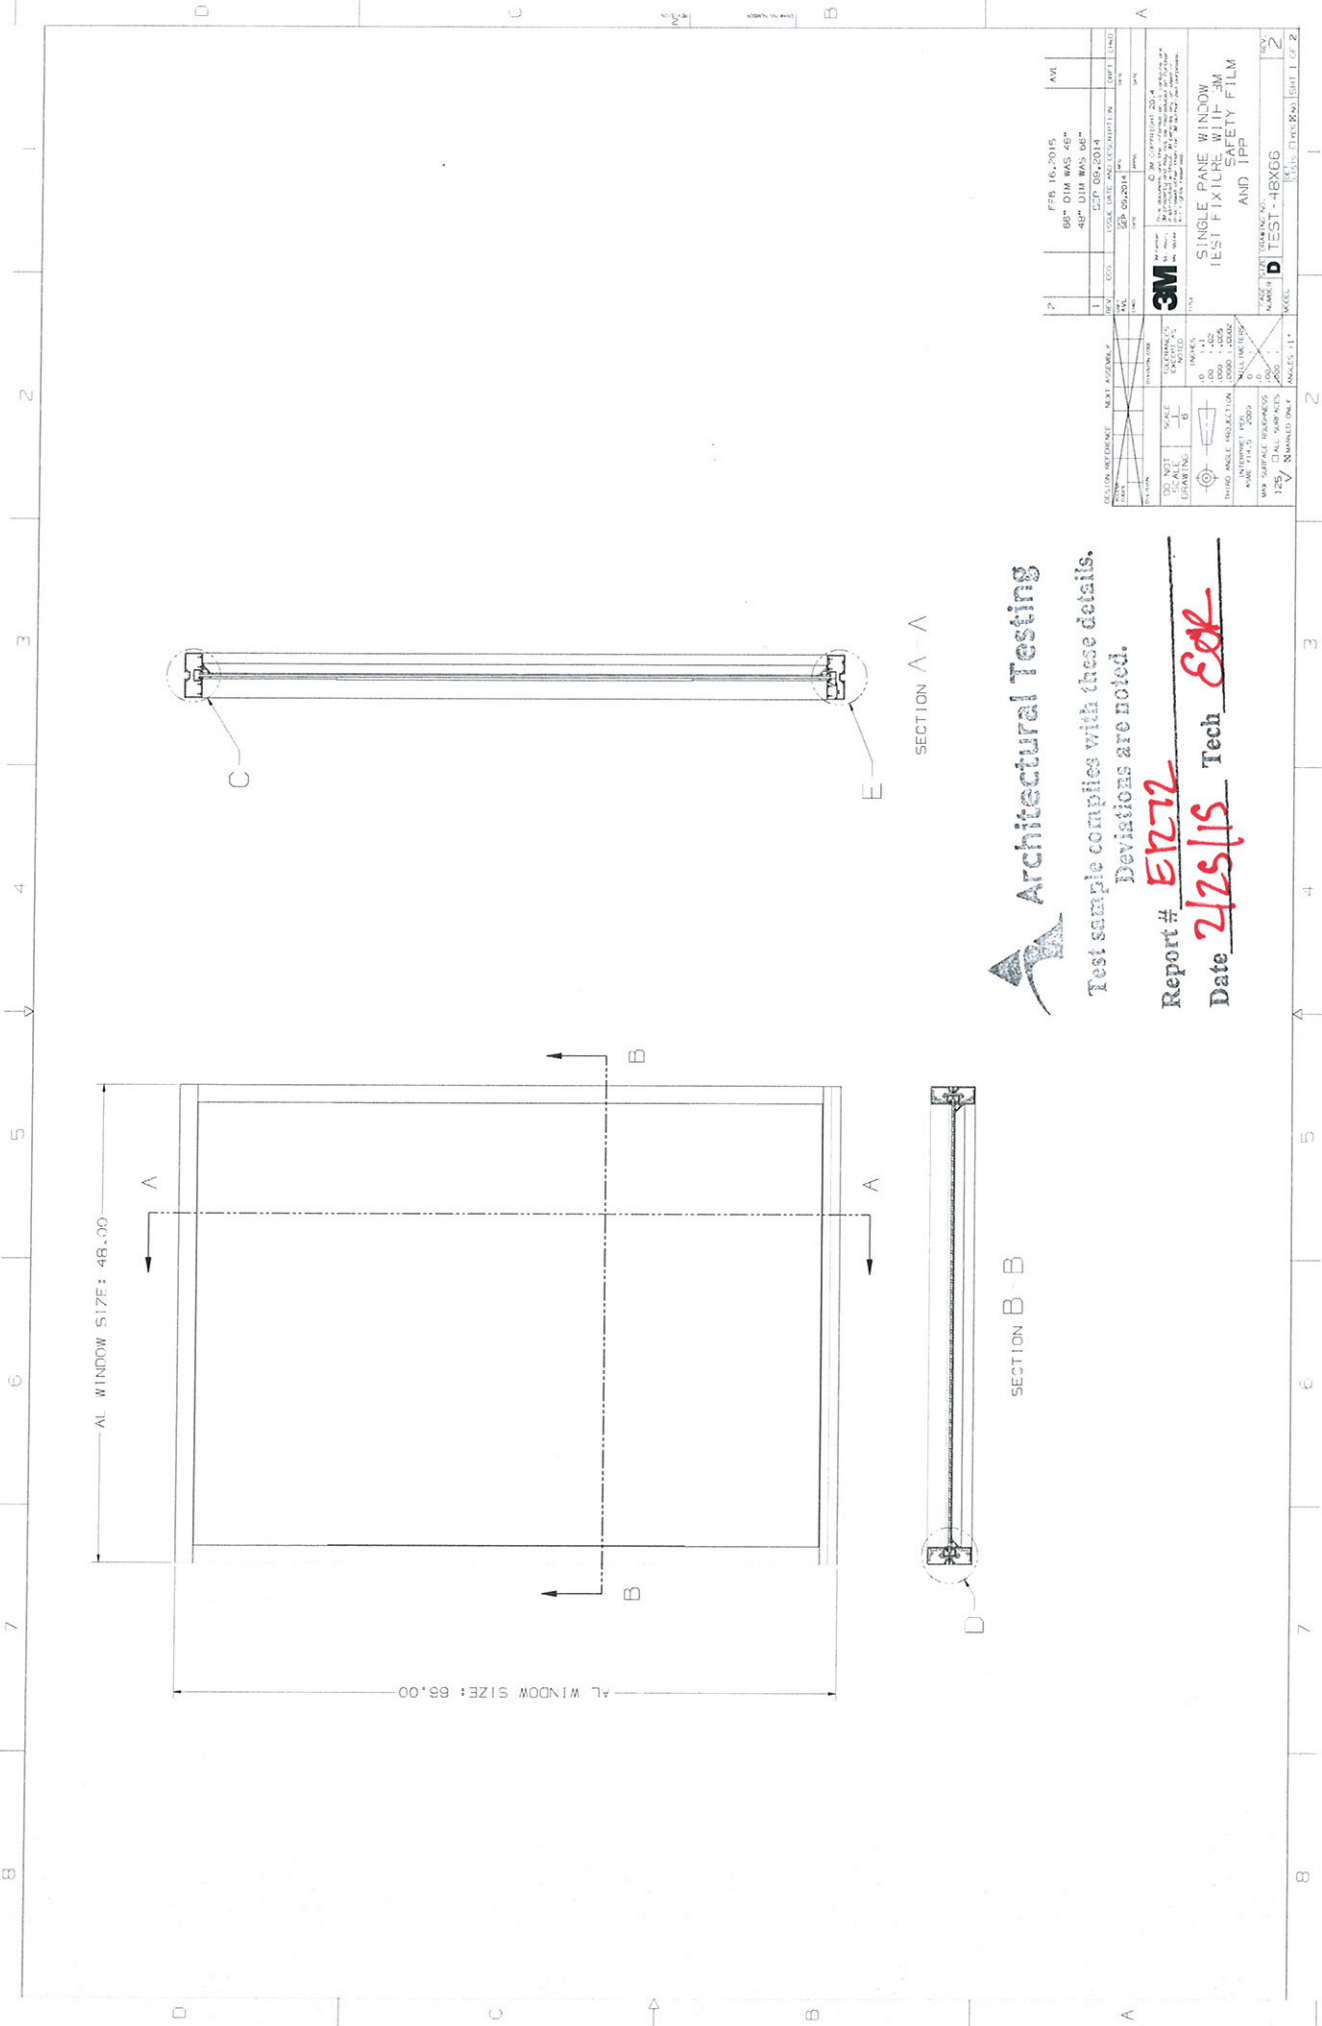
SINGLE PANE WINDOW  
TEST FIXTURE WITH 3M  
SAFETY FILM  
AND IPP

AL WINDOW SIZE: 48.00

AL WINDOW SIZE: 66.00

SECTION A - A

SECTION B - B

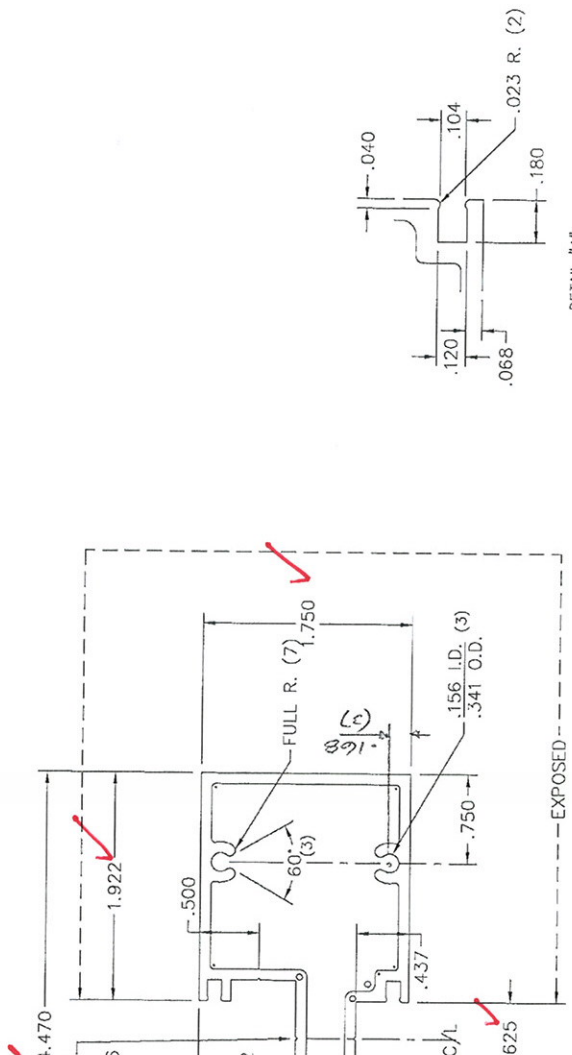
DETAIL "A"  
2 x SIZE

<b>sapa:</b>		CARD #
sapa Extrusions, Inc.		CRM-44 350
DETAIL 14-7122		SCALE
CUSTOMER		FULL & NOTED
CMI ARCHITECTURAL PRODUCTS		DATE
2800 FREEWAY BOULEVARD		7-29-98
SUITE 205		LAST REVISION
MINNEAPOLIS, MN 55430		DRAWN
APPLICATION		Michael Bryson
F.C. SILL 1/4"		JOB
CUSTOMER NUMBER		45-018
