ASTM F1642-12/GSA TS01 TEST REPORT

Report No.: D0345.03-119-12

PRODUCT TYPE: Fragment Retention Film on Single Pane Annealed Glass with 3M™
Impact Protection Profile

SERIES/MODEL: 3M™ Ultra S600, Safety and Security Film

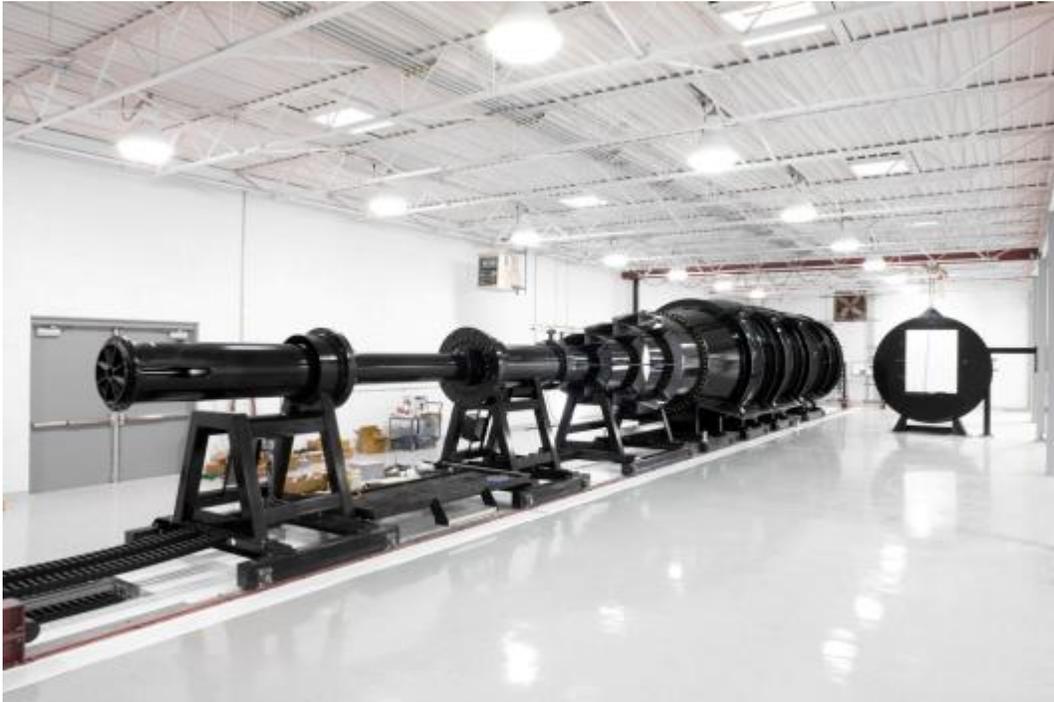
Figure #1
Shock Tube and Test Facility

- 1.4 Test Dates:** 09/03/2013 and 09/04/2013
- 1.5 Test Facility:** Architectural Testing, Inc.'s shock tube is housed in a 10,000 square foot state-of-the-art test facility located in York, Pennsylvania. Blast loadings are produced on the specimen to simulate the effects of a high explosive charge at a specified standoff distance. Shock waves are generated by the sudden rupturing of a thin aluminum membrane. The shock wave expands as it travels down the tube, and impacts the target with a specific positive pressure and impulse. A photograph of the shock tube is provided in Figure #1 of Appendix A.

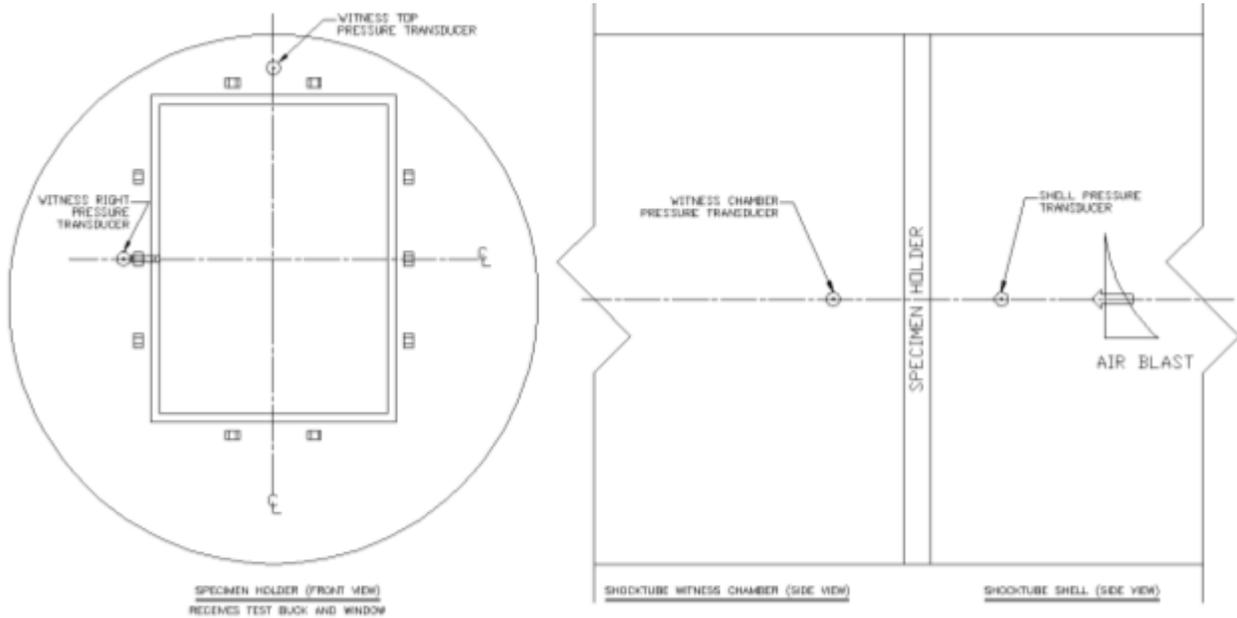
Figure #2
Pressure Sensor Locations

1.8 Data Acquisition: In accordance with ASTM F 1642-04 and GSA TS01, four reflective pressure transducers are utilized to record data at a 1MHz sample rate. Two reflective pressure transducers are located on the specimen holder at the top and right side (when viewed from the interior). A third pressure transducer is located on the shell to the exterior of the specimen, and a fourth is located in the witness chamber, directly to the interior of the specimen holder. A sketch of the specimen holder and corresponding reflective pressure sensor locations are provided in Figure #2 of Appendix A.

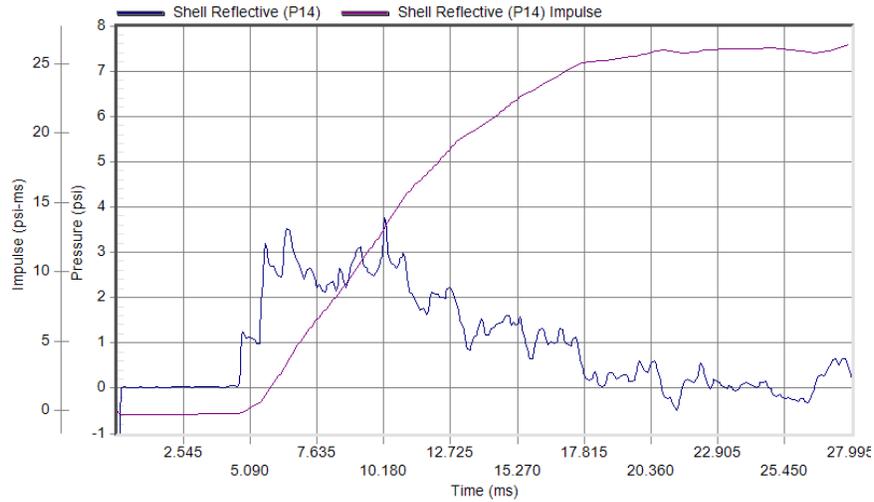
Peak Pressure: 3.80 psi at 10.23 ms
 Duration: 8.18 ms

| Description | Results |
|---|---|
| Shell Pressure | 3.80 psi |
| Shell Duration | 8.18 msec |

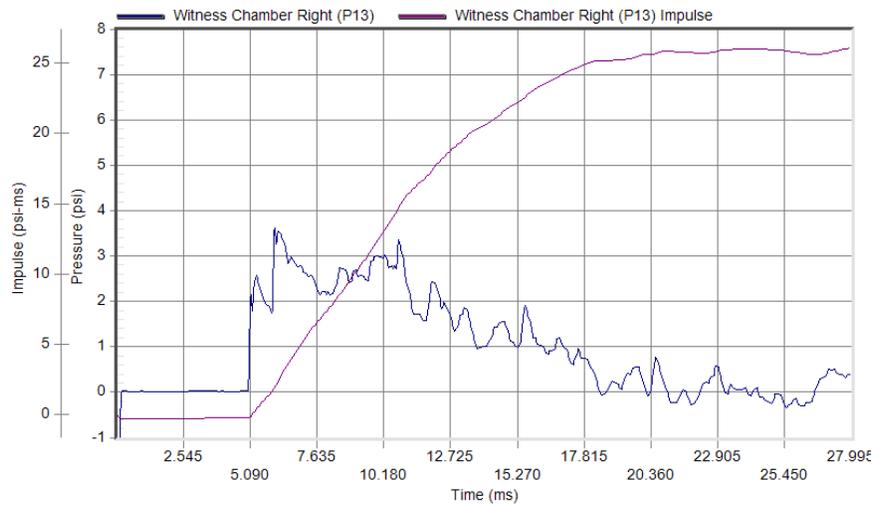
Peak Pressure: 3.64 psi at 6.03 ms
 Duration: 12.36 ms

| Description | Results |
|---|---|
| Right Pressure | 3.64 psi |
| Right Duration | 12.36 msec |

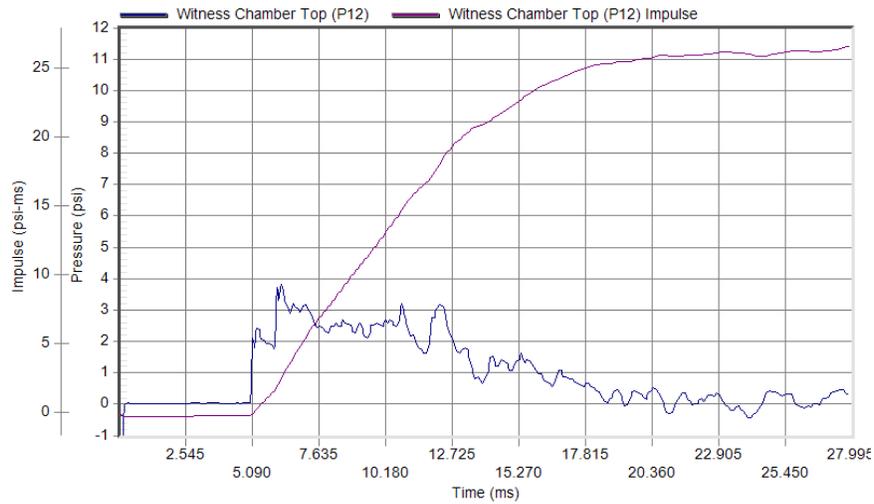
Peak Pressure: 3.81 psi at 6.19 ms
 Duration: 13.09 ms

| Description | Results |
|---|---|
| Top Pressure | 3.81 psi |
| Top Duration | 13.09 msec |

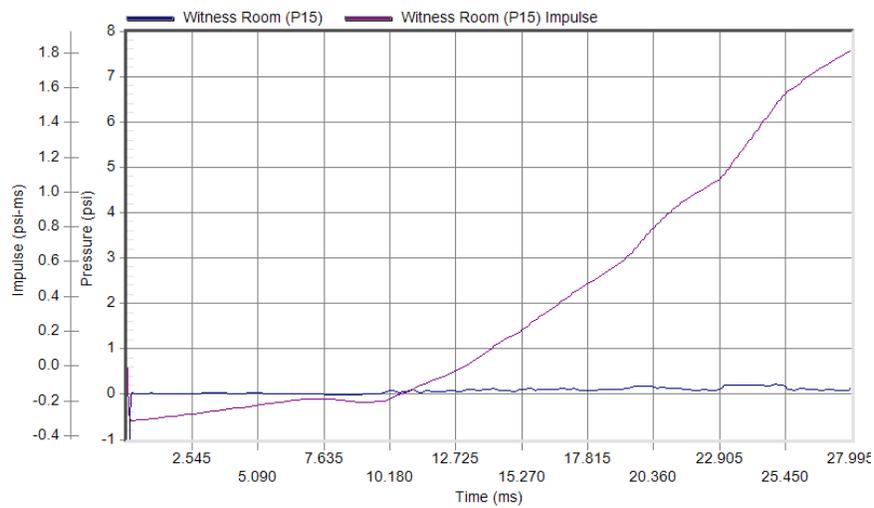
Peak Pressure: 0.22 psi at 25.10 ms
 Duration: 0.00 ms

| Description | Results |
|---|---|
| Witness Chamber Pressure | 0.22 psi |

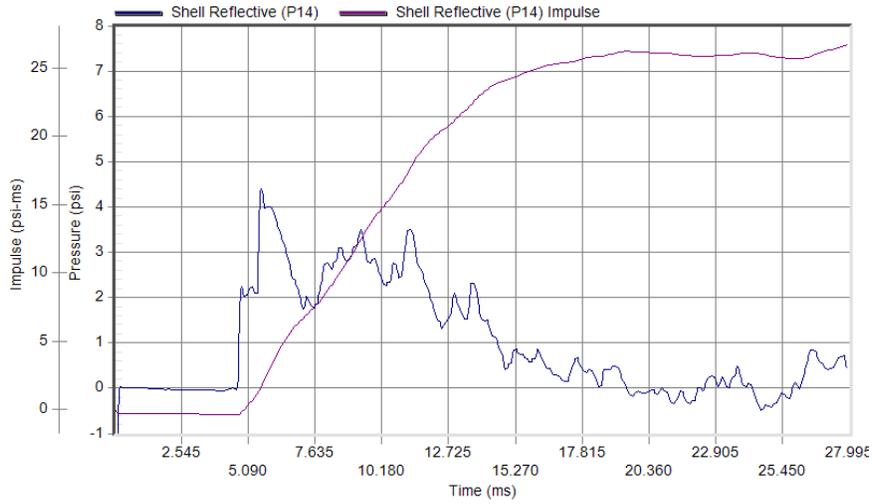
Peak Pressure: 4.40 psi at 5.60 ms
Duration: 12.84 ms

| Description | Results |
|---|---|
| Shell Pressure | 4.40 psi |
| Shell Duration | 12.84 msec |

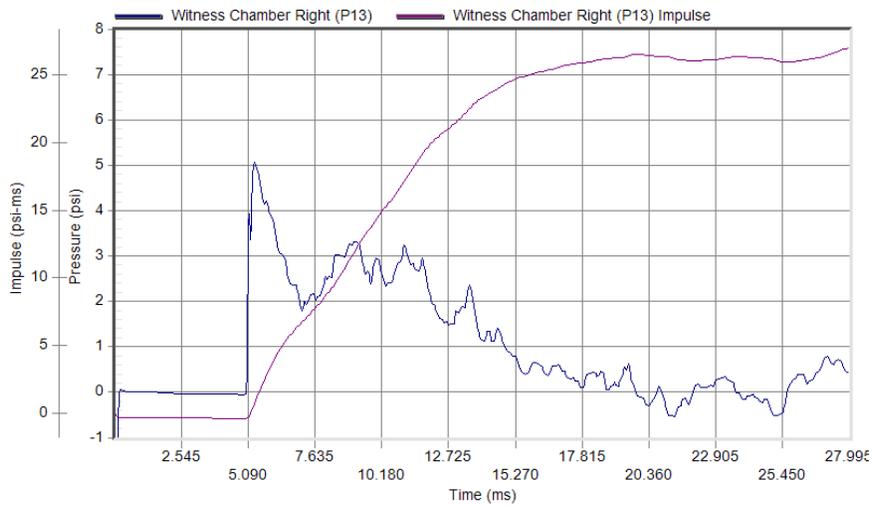
Peak Pressure: 5.11 psi at 5.35 ms
Duration: 13.39 ms

| Description | Results |
|---|---|
| Right Pressure | 5.11 psi |
| Right Duration | 13.39 msec |

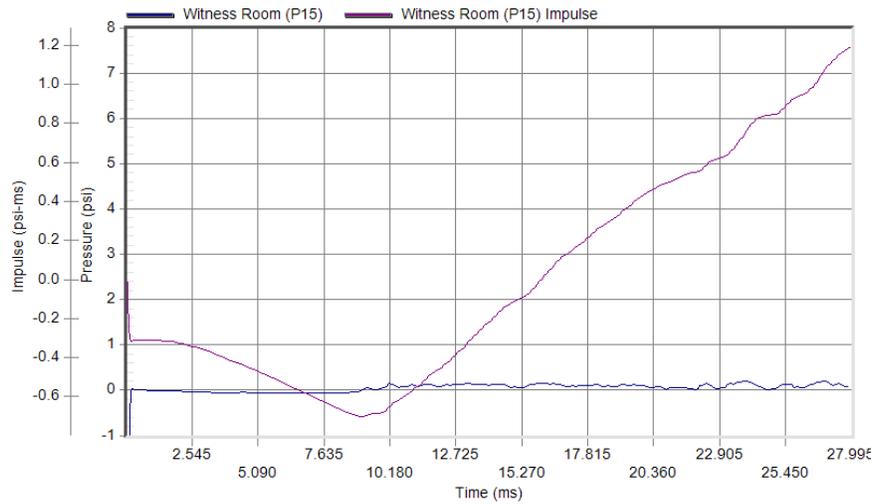
Peak Pressure: 0.22 psi at 26.94 ms
 Duration: 0.00 ms

| Description | Results |
|---|---|
| Witness Chamber Pressure | 0.22 psi |

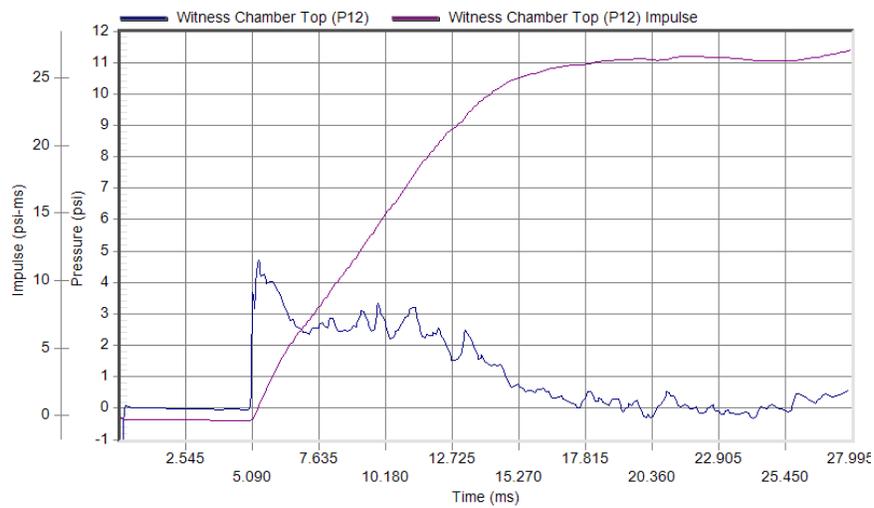
Peak Pressure: 4.74 psi at 5.32 ms
 Duration: 12.14 ms

| Description | Results |
|---|---|
| Top Pressure | 4.74 psi |
| Top Duration | 12.14 msec |

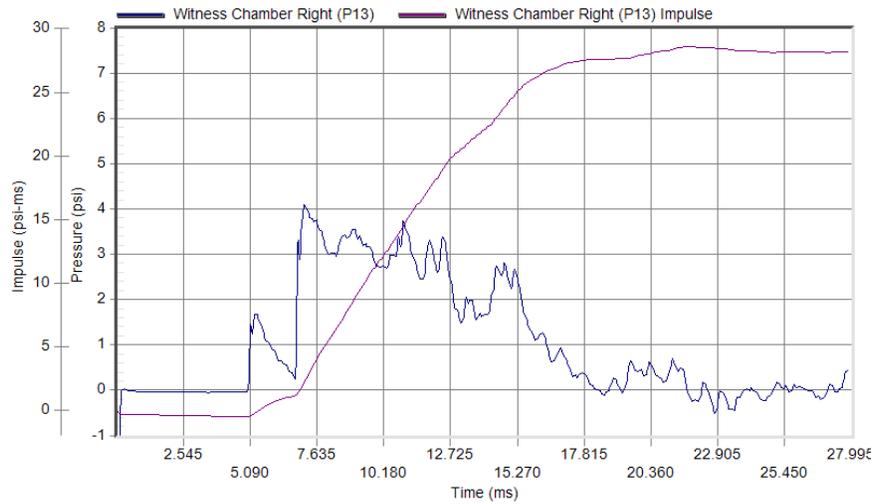
Peak Pressure: 4.11 psi at 7.17 ms
Duration: 11.05 ms

| Description | Results |
|---|---|
| Right Pressure | 4.11 psi |

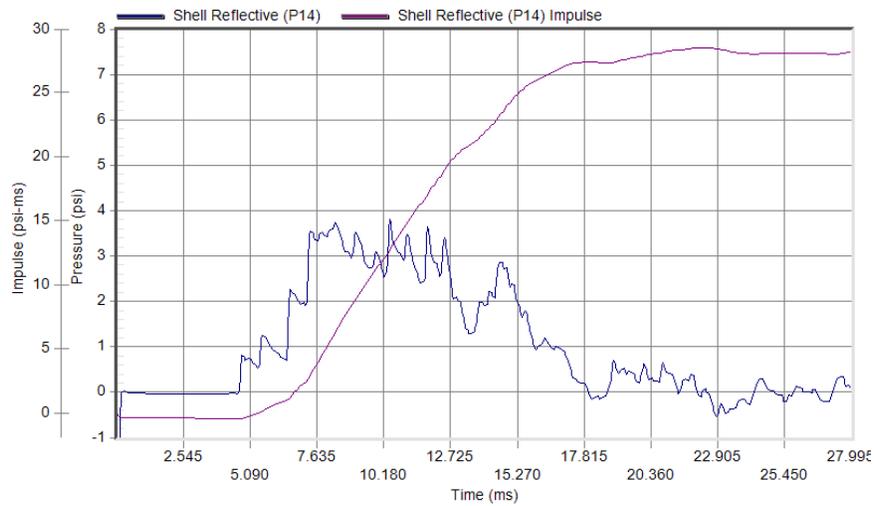
Peak Pressure: 3.80 psi at 10.43 ms
Duration: 7.53 ms

| Description | Results |
|---|---|
| Shell Pressure | 3.80 psi |

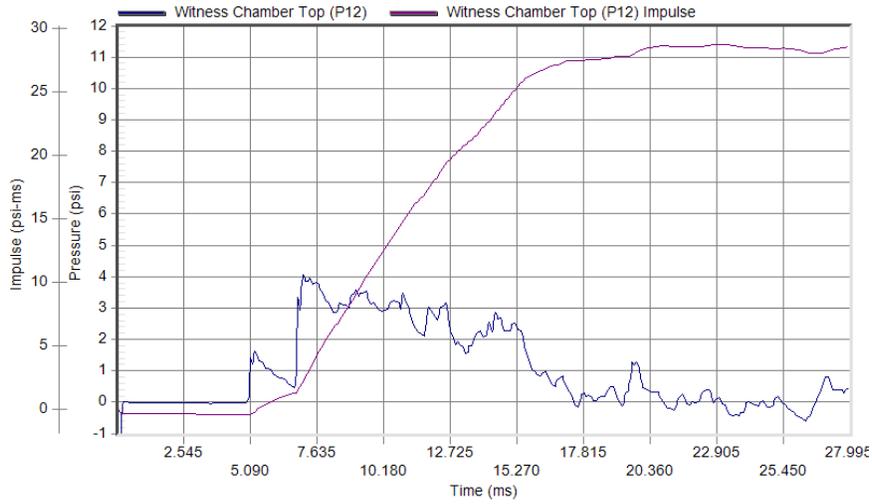
Peak Pressure: 4.09 psi at 7.13 ms
Duration: 10.30 ms

| Description | Results |
|---|---|
| Top Pressure | 4.09 psi |

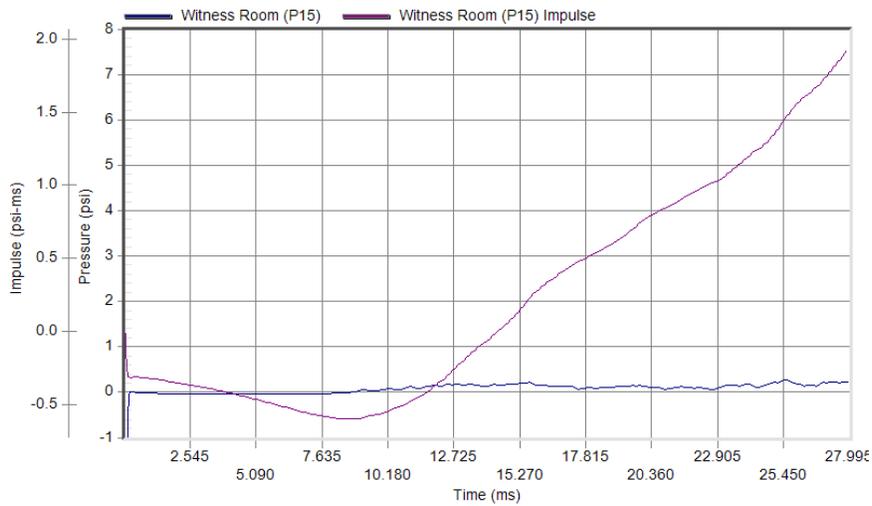
Peak Pressure: 0.28 psi at 25.45 ms
Duration: 0.00 ms

| Description | Results |
|---|---|
| Witness Chamber Pressure | 0.28 psi |

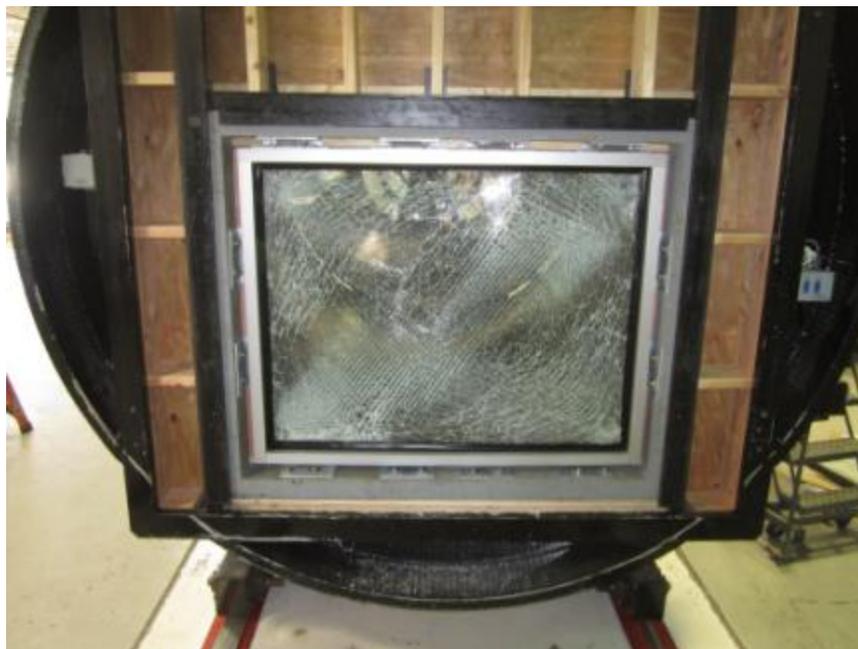
Photo No. 2
Post-test Specimen #1, Interior

| Description | Results |
|---|---|
| Glazing Breakage | Fractured |

| Witness Chamber Results |
|--|
| The glazing fractured but was fully retained in the frame. There was a small amount of glazing dust and shards found on the witness chamber floor. There were two fragment indents located at a height of 14" and 19" as well as a sliver perforation at a height of 10 in on the witness panel. |

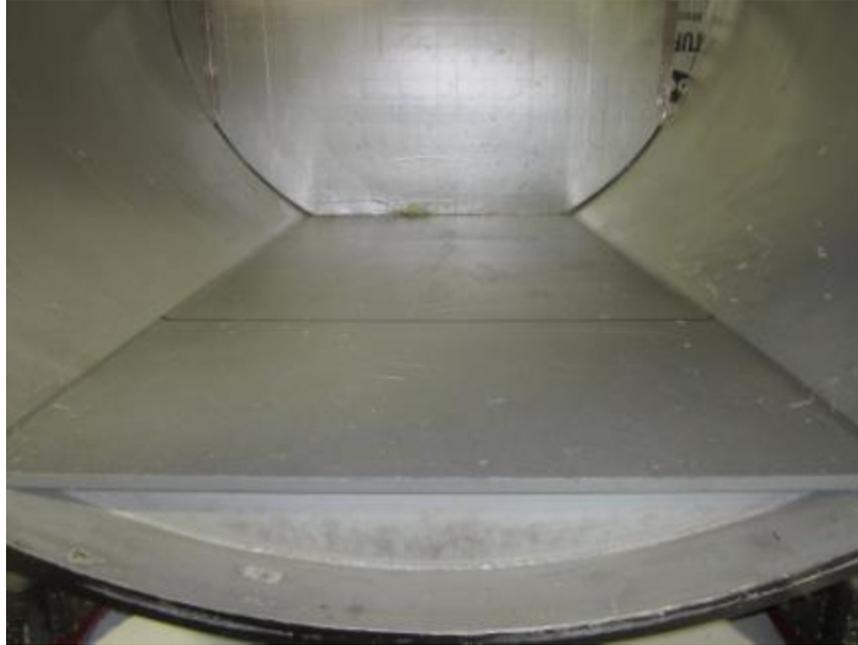
Photo No. 3
Post-test Specimen #1, Witness Chamber

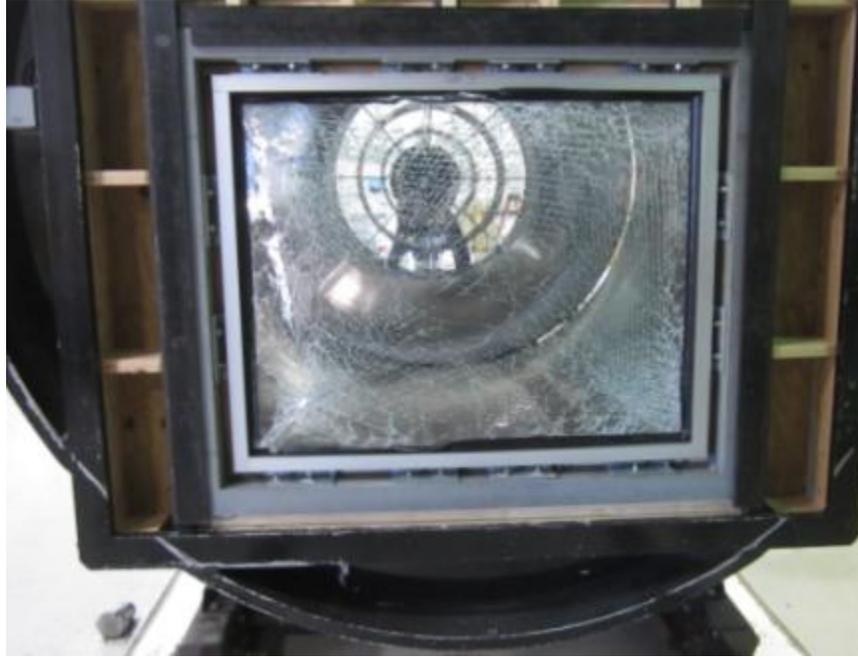
Photo No. 5
Post-test Specimen #2, Interior

| Description | Results |
|---|---|
| Glazing Pullout Length and Location | 20 in total between head and sill |
| Glazing Tearing | 1 in on lower left corner |

| Witness Chamber Results |
|---|
| The glazing fractured but was fully retained in the frame. There were no fragments found on the witness chamber floor or the witness panel. |

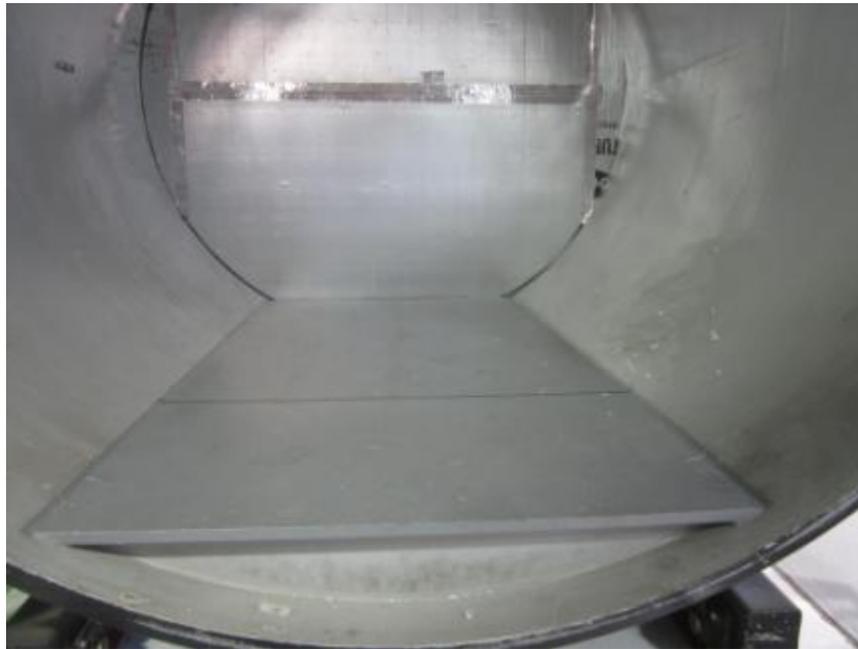
Photo No. 6
Post-test Specimen #2, Witness Chamber

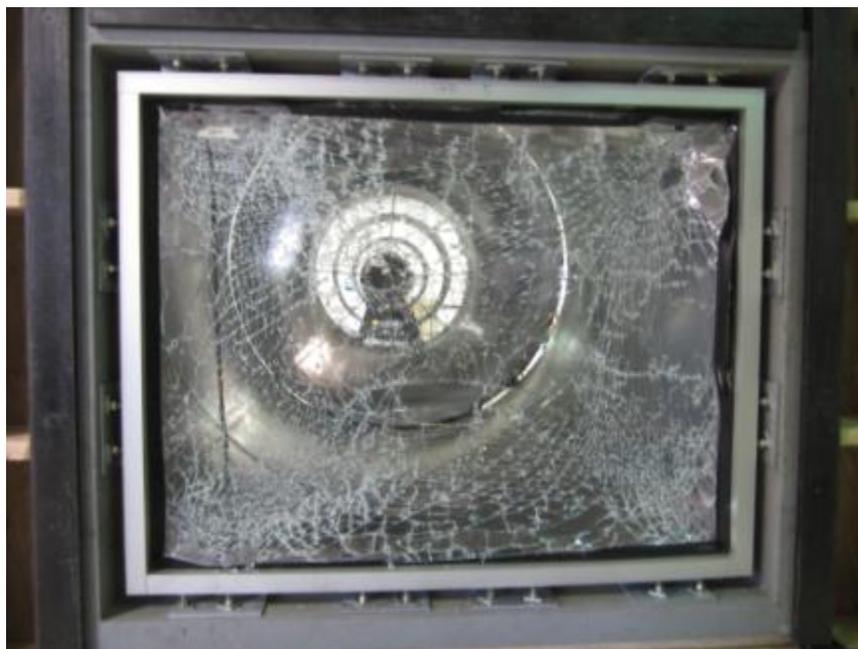
Photo No. 8
Post-test Specimen #3, Interior

| Description | Results |
|---|---|
| Glazing Pullout Length and Location | 31 in along head, 36 in along sill |
| Glazing Tearing | 10 in at head |

| Witness Chamber Results |
|--|
| The glazing fractured but was retained in the frame. There were seven fragments found on the floor at 11-1/2, 14, 18, 56, 58, 68 and 74 in inside the witness chamber with no markings on the witness panel. |

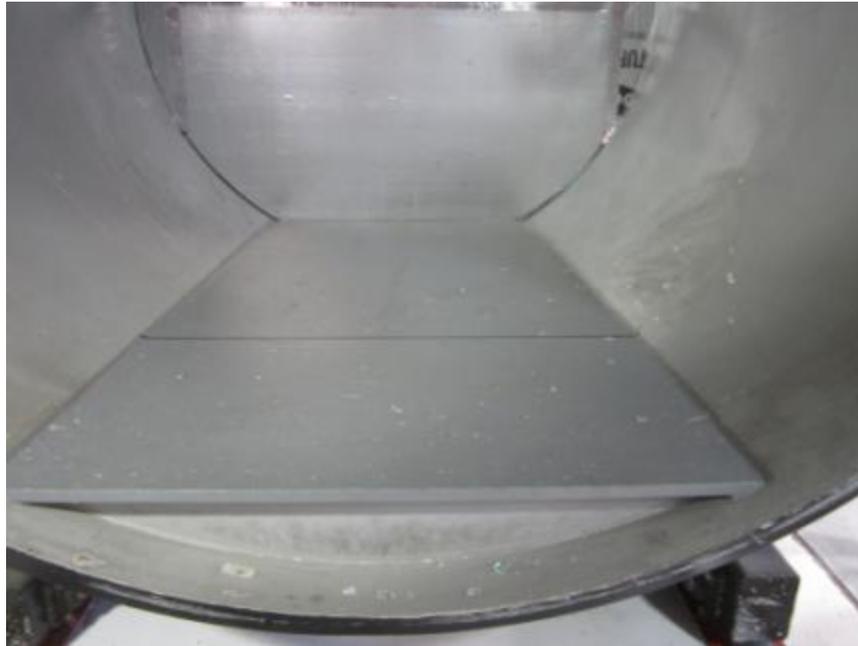
Photo No. 9
Post-test Specimen #3, Witness Chamber

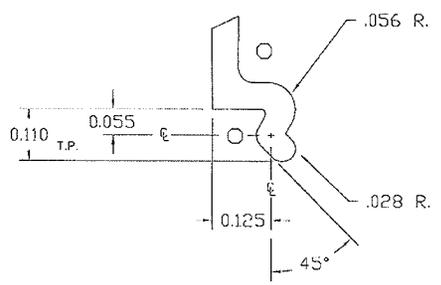
DETAIL
4 x Size

| | SILL STOP 1/4" TO 1" | DRAWN |

3.3 Glazing Method: All specimens utilized 1/4" thick clear annealed glass with a 6 mil micro-layered, tear resistant safety and security film adhered to the interior surface of the glass. The glass was channel glazed and secured at the exterior sill using extruded aluminum glazing stops. The glass was set against a kerf-mounted rubber gasket with a 1/2" glazing bite. The glass was secured in place from the interior using a 3M™ Impact Protection Profile, flexible-mechanical rubber gasket (IPP) (Reference Drawing 3M Window Test Fixture, Detail J).

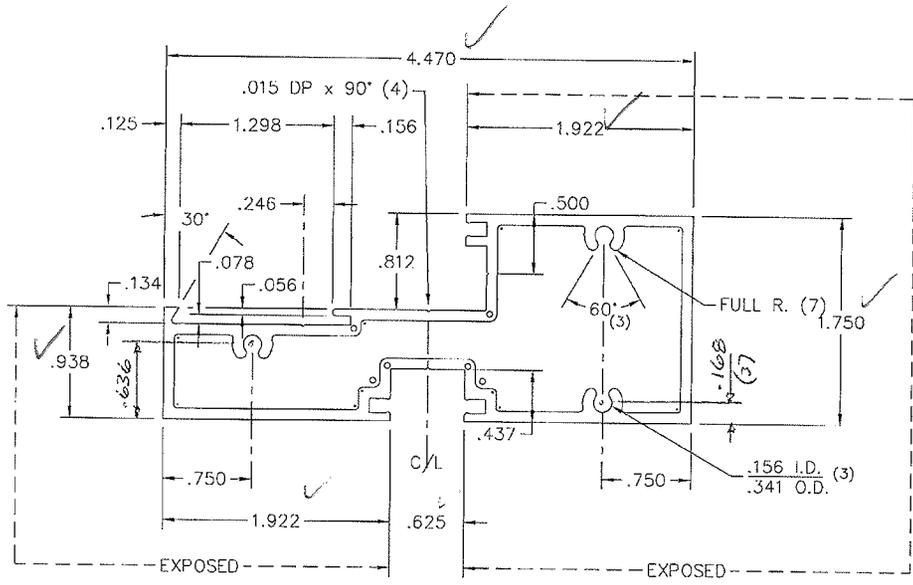
DETAIL "A"
2 x SIZE

APPLICATION F.G. SILL 1/4"

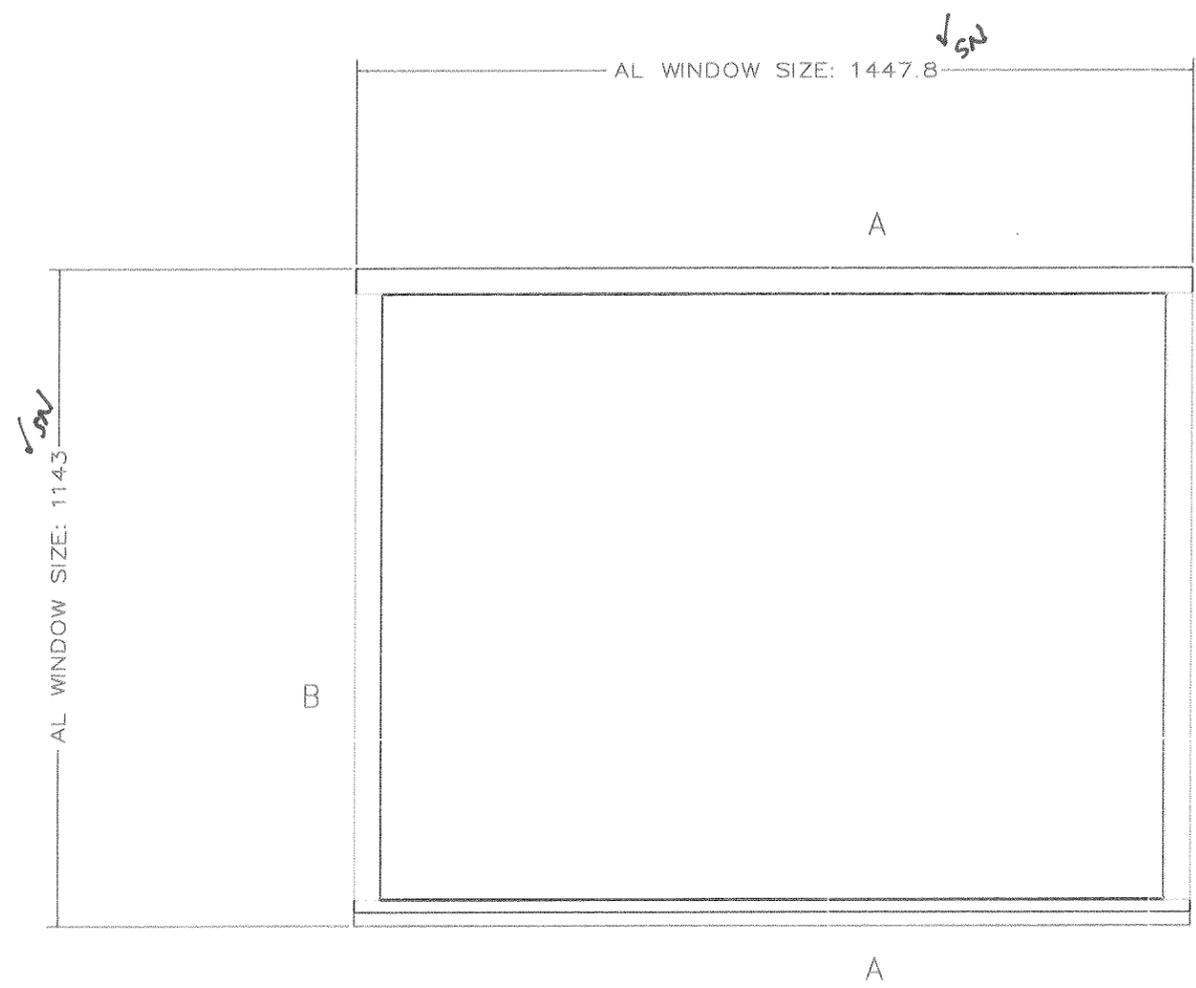
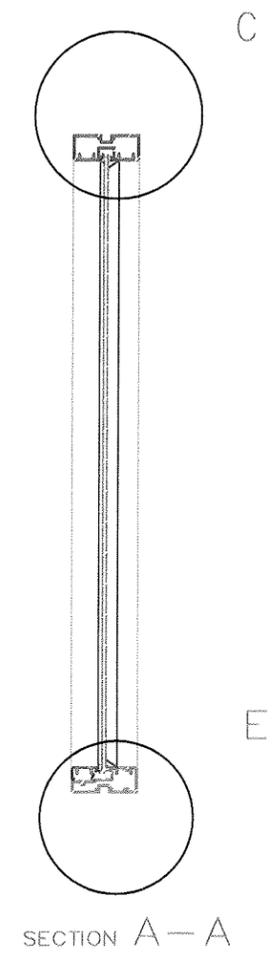
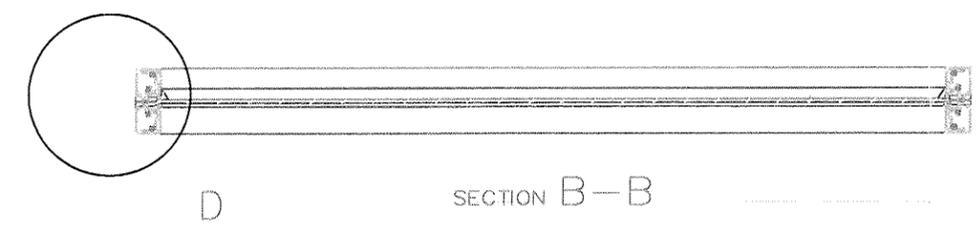
DLO: $53\frac{1}{2} \times 41\frac{1}{2}$

| Measured Dimensions | Width (inches) | Height (inches) |
|---|---|---|
| Overall Size | 57 | 45 |
| Fixed Day Lite Opening | 53-1/2 | 41-1/2 |

| | Joinery Type | Detail |
|---|---|---|
| All corners | Square Cut | Butted and secured using extruded aluminum shear blocks (Reference Drawing 3M window test fixture with IPA drawing detail D, P/N 45-101). |
