ASTM F1642-04 / GSA TS01 TEST REPORT

Report No.: D8934.01-119-12

3M COMPANY
St. Paul, Minnesota

Fragment Retention Film on 1" Double Pane Glass with Film Attachment Systems

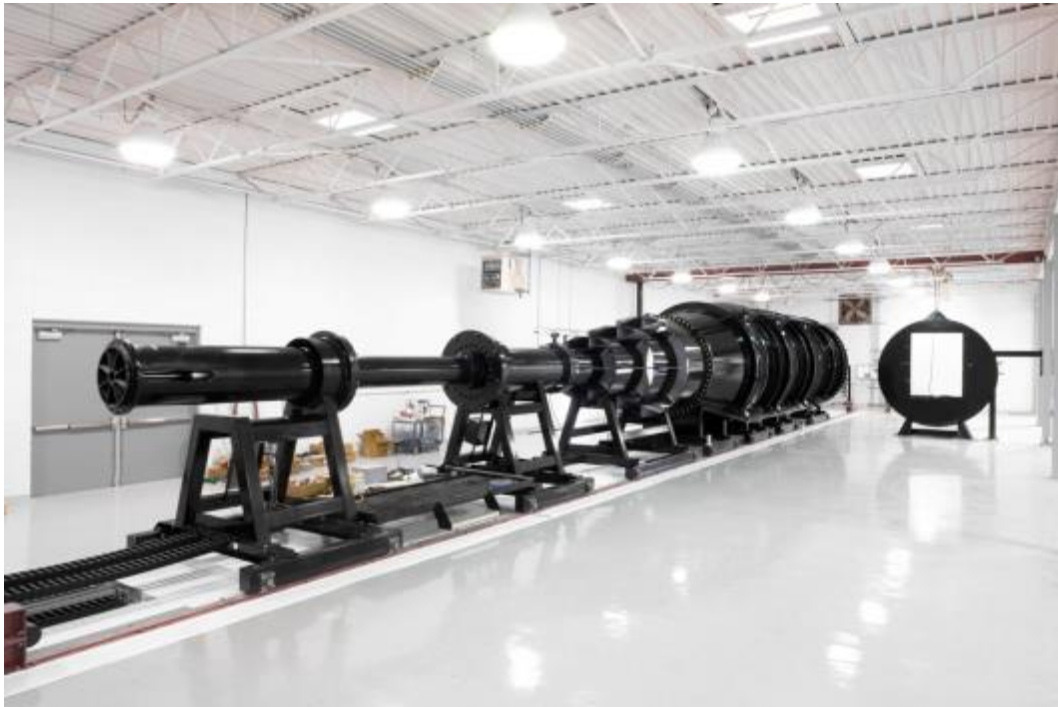
Figure #1
Shock Tube and Test Facility

3.5 Test Facility: Architectural Testing, Inc.'s shock tube is housed in a 10,000 square foot state-of-the-art test facility located in York, Pennsylvania. Blast loadings are produced on the specimen to simulate the effects of a high explosive charge at a specified standoff distance. Shock waves are generated by the sudden rupturing of a thin aluminum membrane. The shock wave expands as it travels down the tube, and impacts the target with a specific positive pressure and impulse. A photograph of the shock tube is provided in Figure #1 of Appendix A.

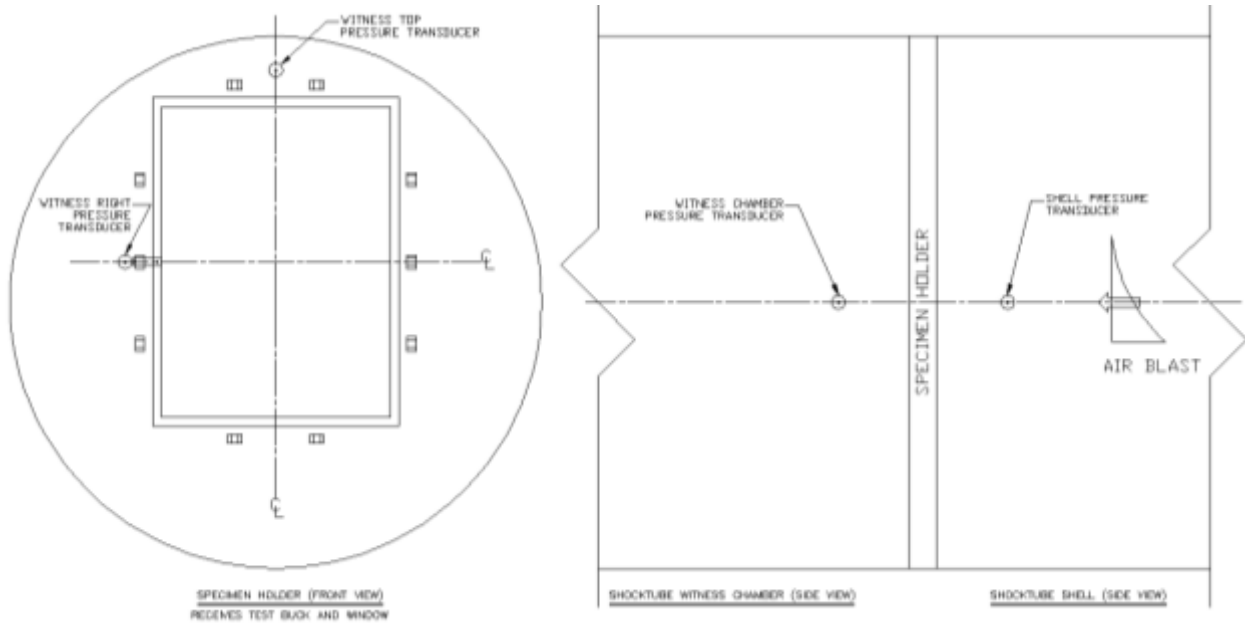
Figure #2
Pressure Sensor Locations

3.8 Data Acquisition: In accordance with ASTM F1642-04 and GSA TS01, four reflective pressure transducers are utilized to record data at a 1MHz sample rate. Two reflective pressure transducers are located on the specimen holder at the top and right side (when viewed from the interior). A third pressure transducer is located on the shell to the exterior of the specimen, and a fourth is located in the witness chamber, directly to the interior of the specimen holder. A sketch of the specimen holder and corresponding reflective pressure sensor locations are provided in Figure #2 of Appendix A.

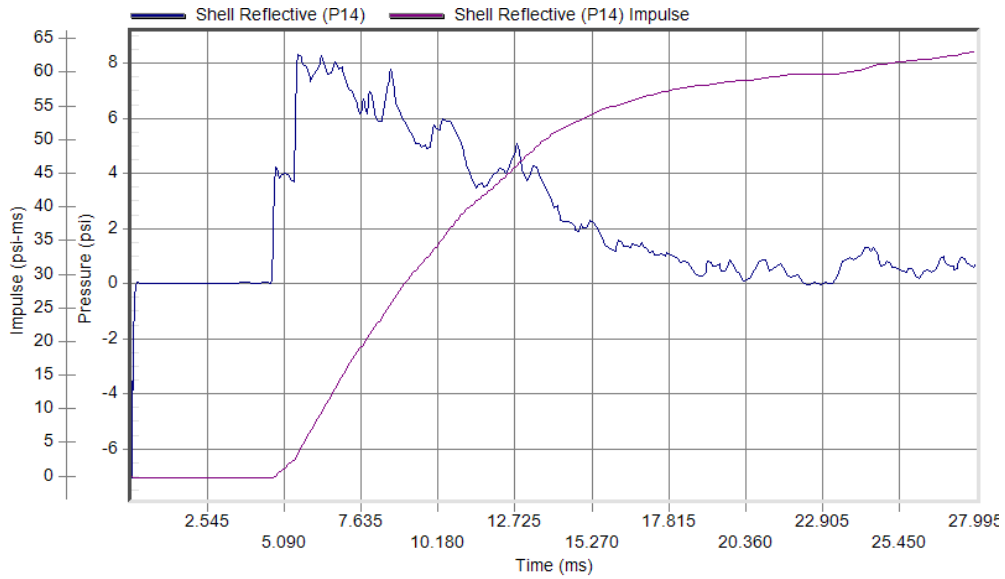
Specimen #1

Peak Pressure: 8.42 psi at 5.60 ms
Duration: 16.63 ms

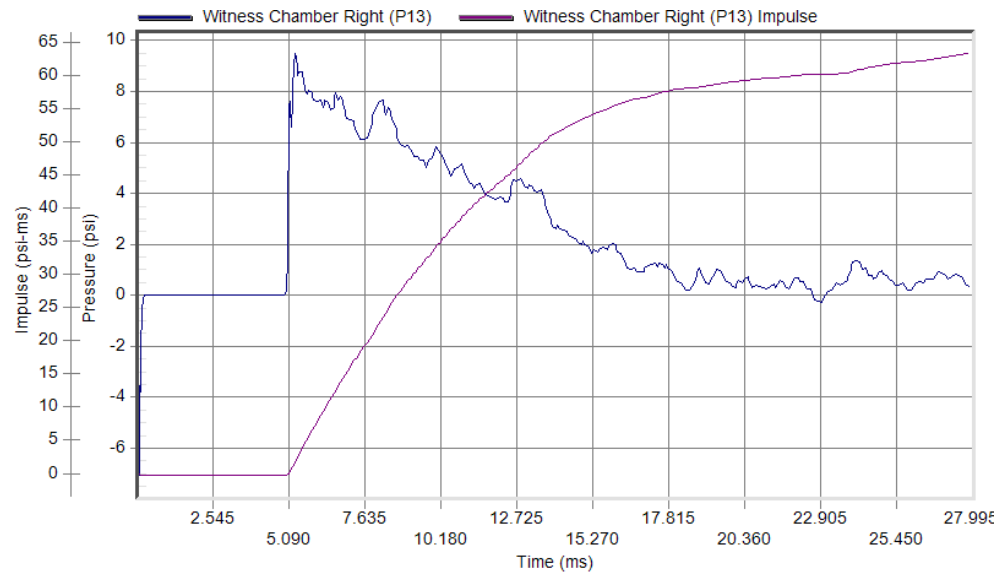
Peak Pressure: 9.50 psi at 5.30 ms
Duration: 17.34 ms

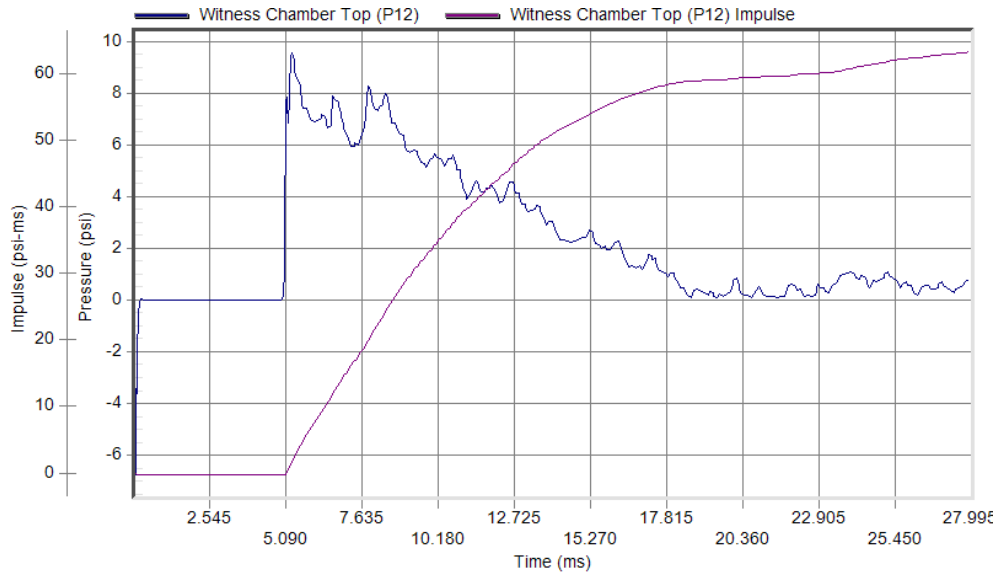
Specimen #1: (Continued)

Peak Pressure: 9.61 psi at 5.30 ms
Duration: 13.24 ms

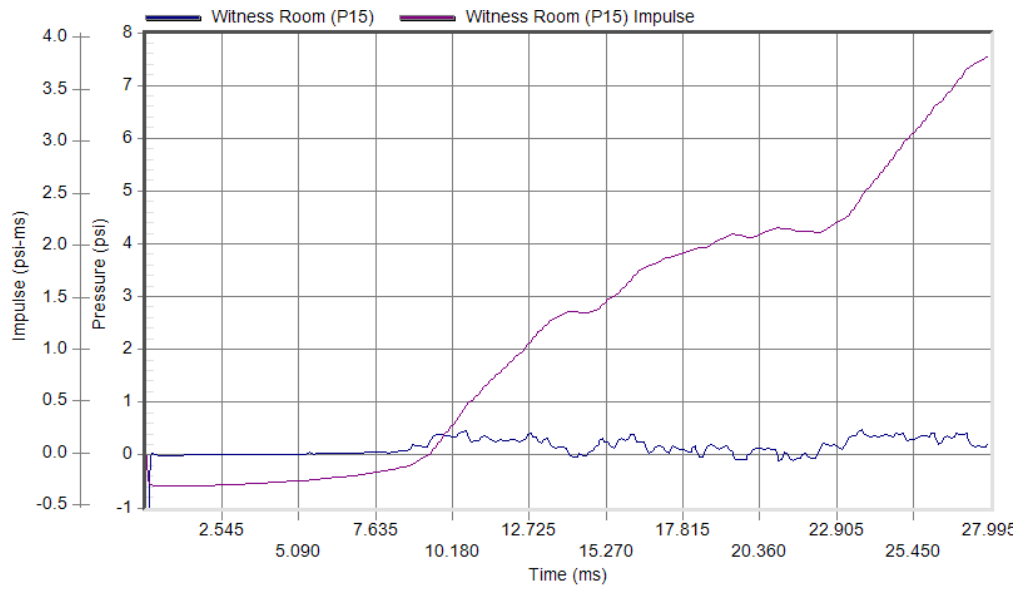
Peak Pressure: 0.49 psi at 23.72 ms
Duration: 1.35 ms

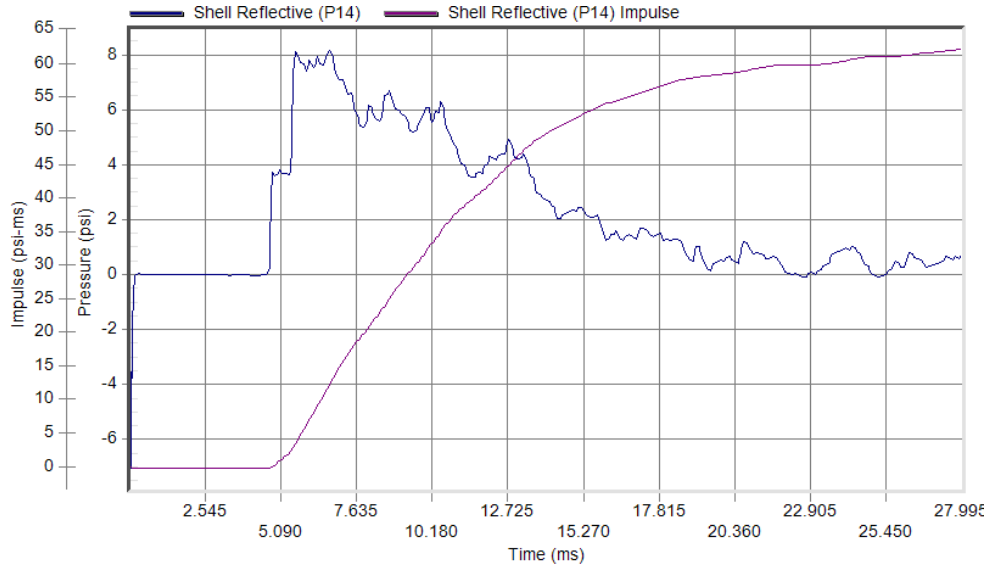
Specimen #2

Peak Pressure: 8.21 psi at 6.77 ms
Duration: 15.32 ms

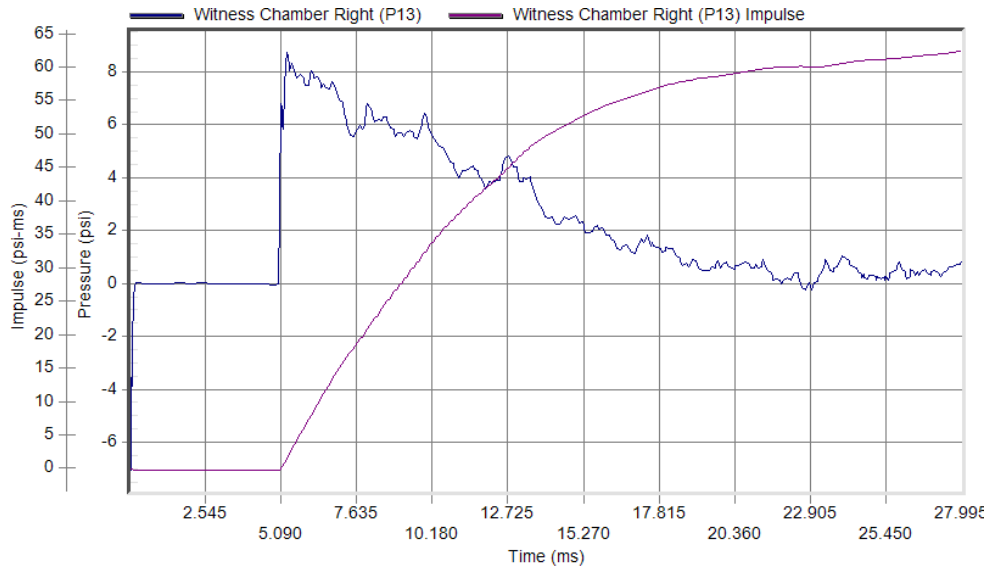
Peak Pressure: 8.80 psi at 5.32 ms
Duration: 16.56 ms

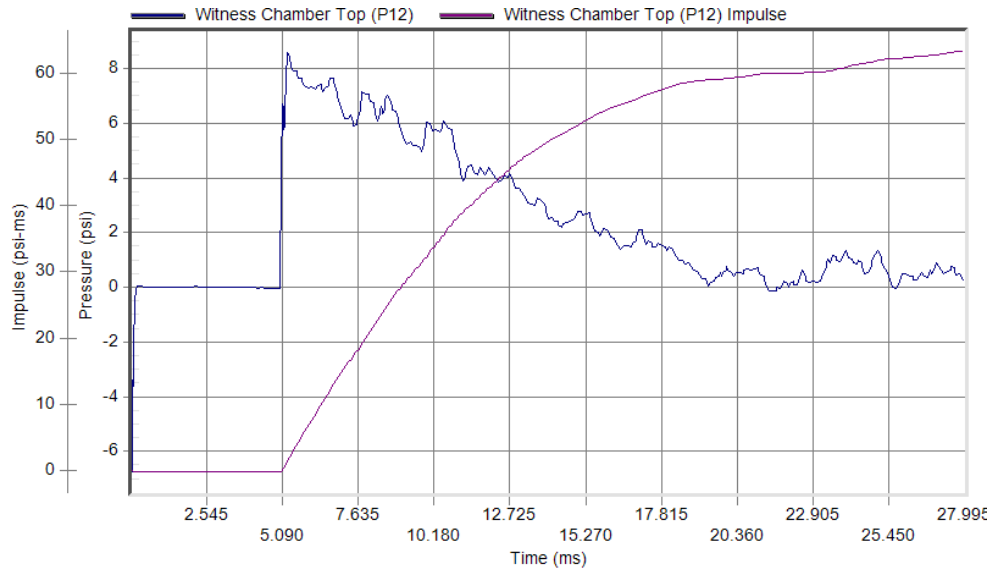
Specimen #2: (Continued)

Peak Pressure: 8.64 psi at 5.31 ms
Duration: 14.08 ms

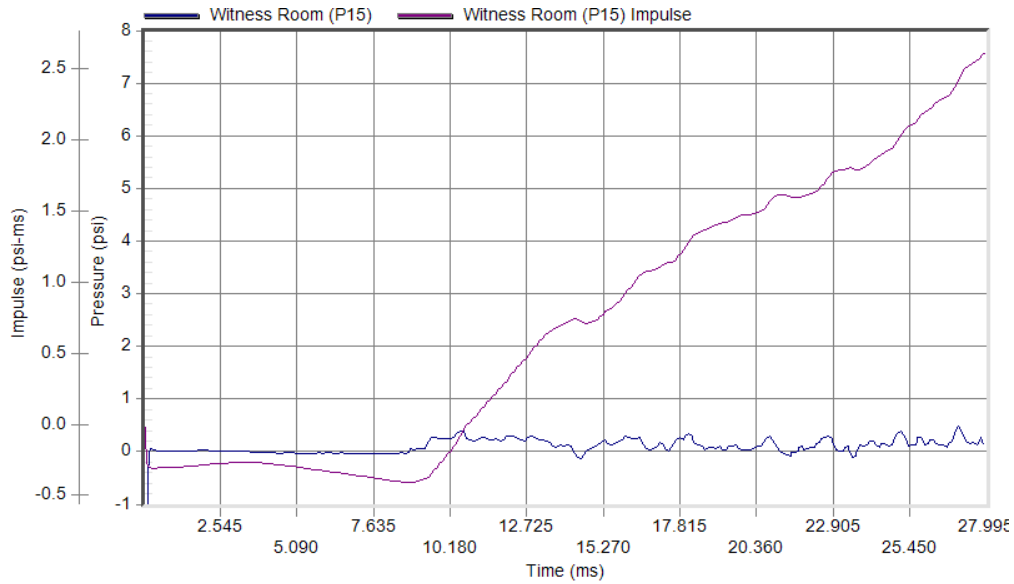
Peak Pressure: 0.48 psi at 27.09 ms
Duration: 0.00 ms

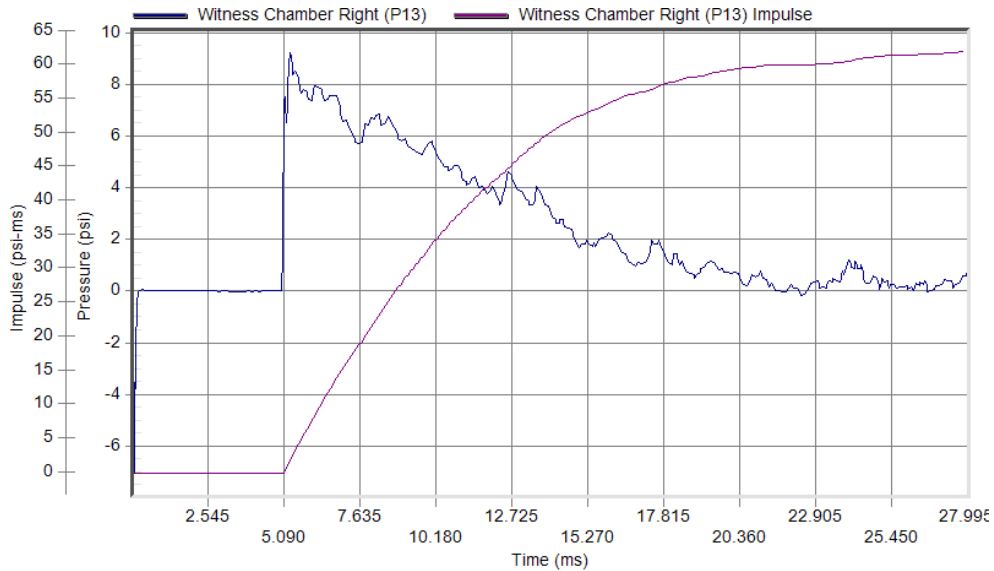
Peak Pressure: 9.29 psi at 5.30 ms
Duration: 16.24 ms

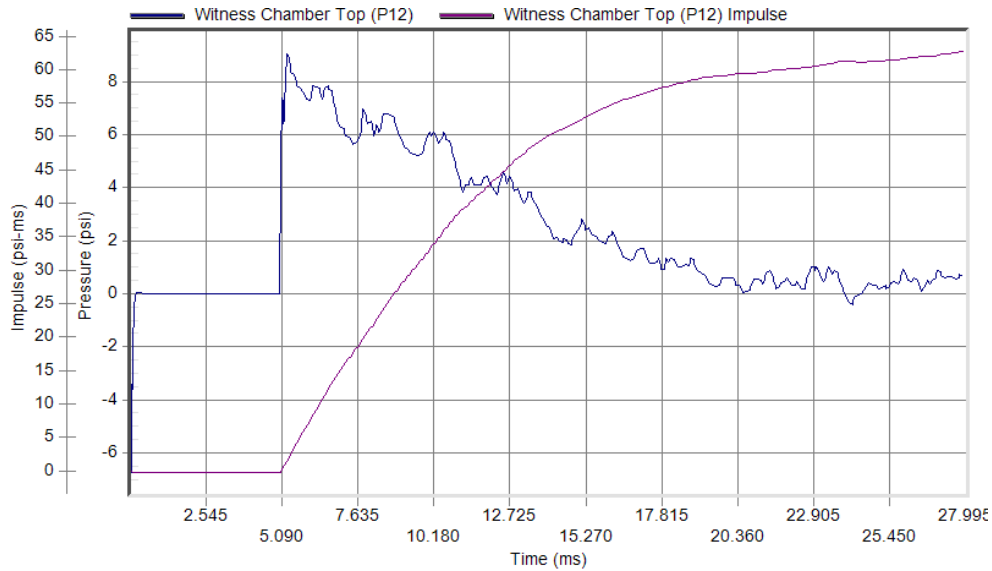
Specimen #3: (Continued)

Peak Pressure: 9.15 psi at 5.31 ms
Duration: 15.21 ms

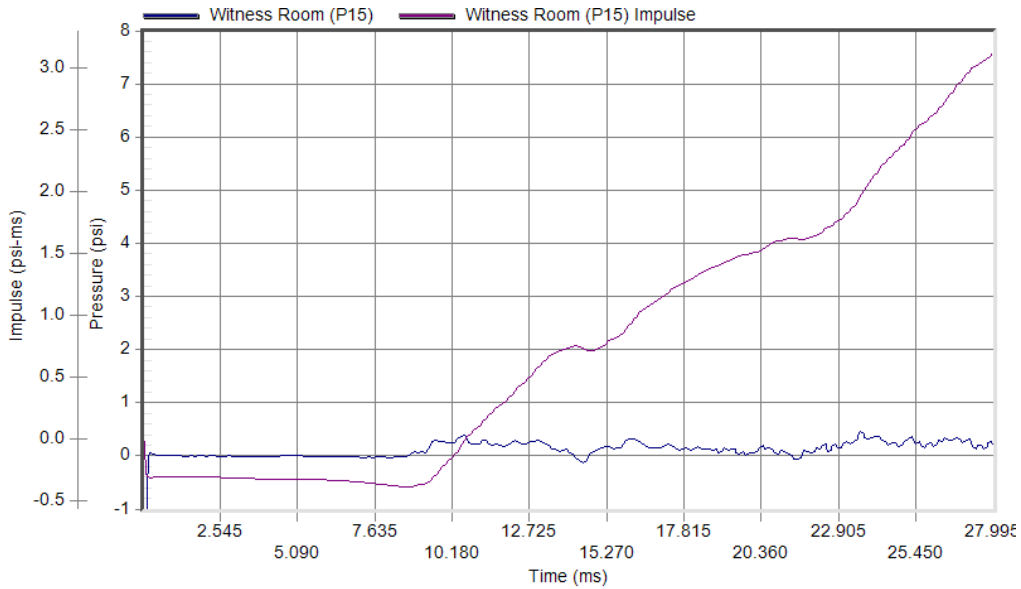
Peak Pressure: 0.49 psi at 23.65 ms
Duration: 4.06 ms

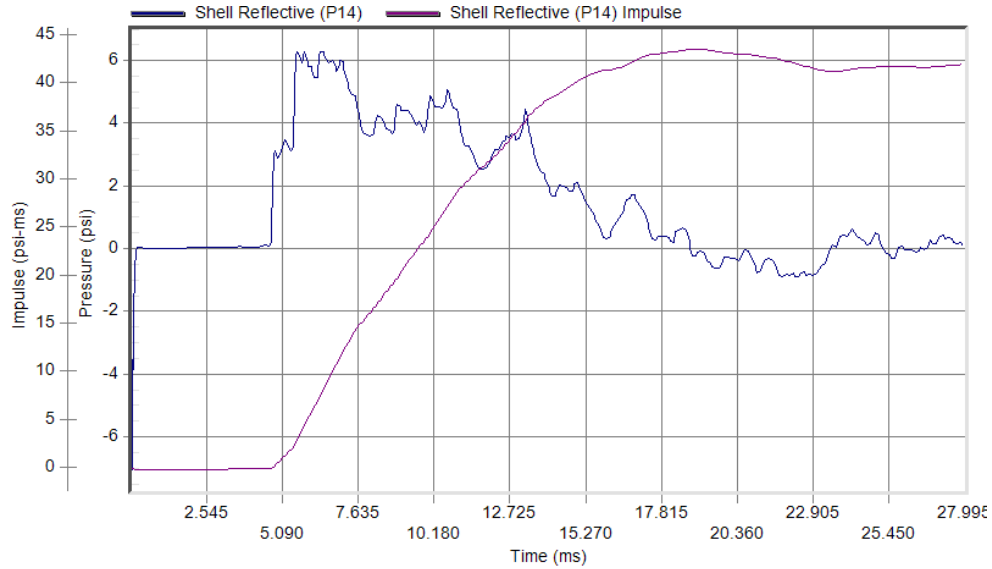
Specimen #4

Peak Pressure: 6.37 psi at 6.43 ms
Duration: 12.35 ms

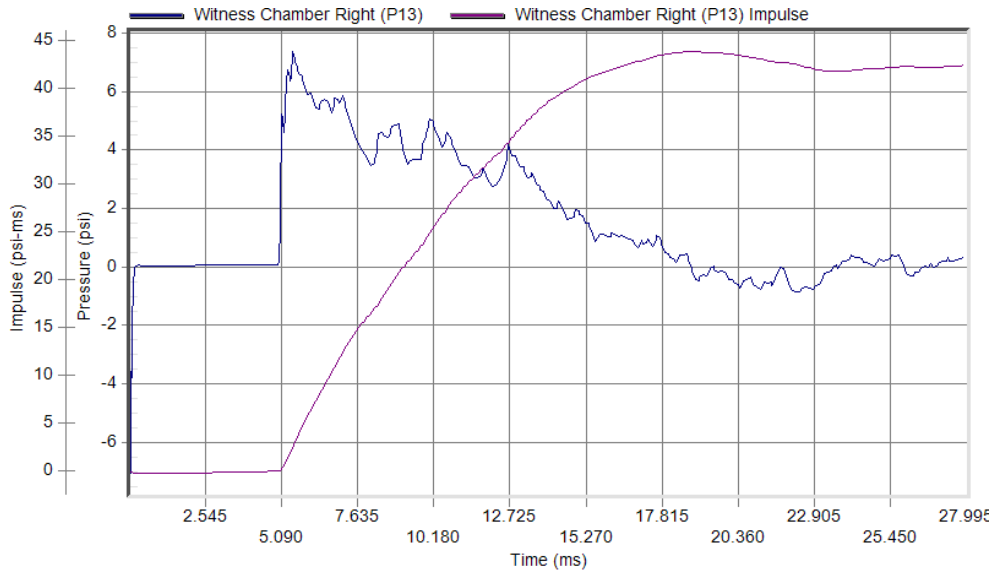
Peak Pressure: 7.38 psi at 5.50 ms
Duration: 13.28 ms

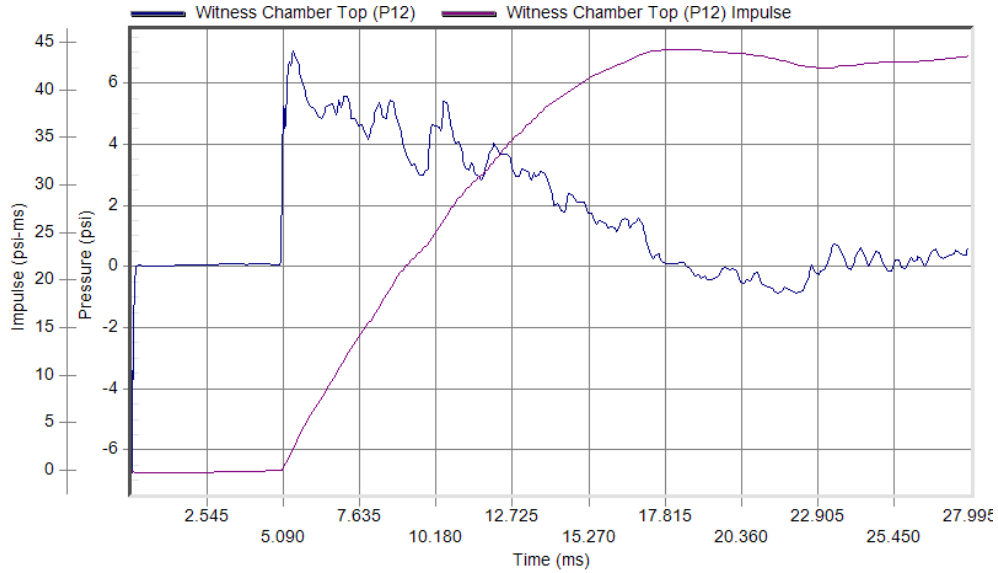
Specimen #4: (Continued)

Peak Pressure: 7.10 psi at 5.43 ms
 Duration: 12.41 ms

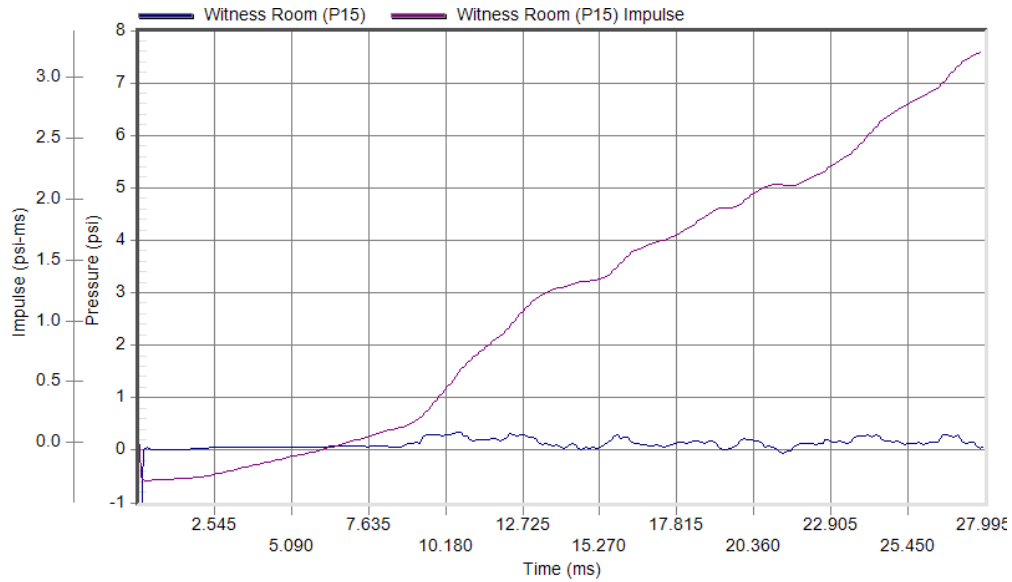
Peak Pressure: 0.35 psi at 10.64 ms
 Duration: 4.02 ms

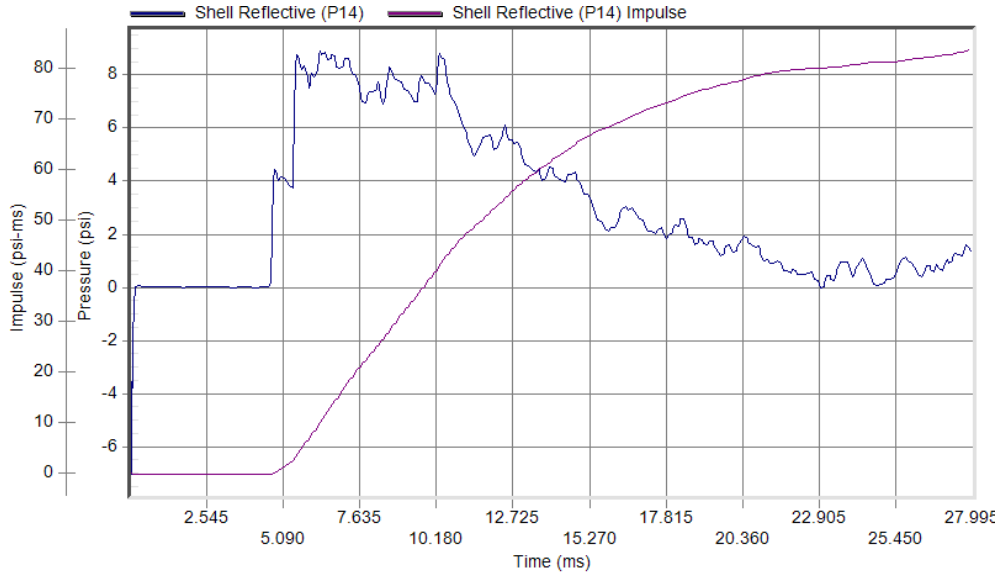
Specimen #5

Peak Pressure: 8.97 psi at 6.33 ms
Duration: 16.60 ms

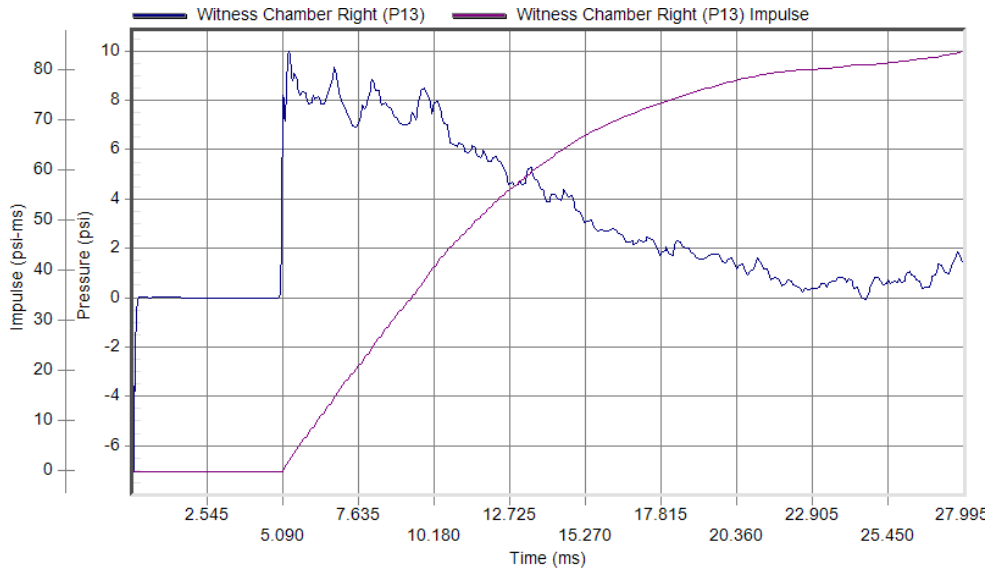
Peak Pressure: 10.00 psi at 5.29 ms
Duration: 19.27 ms

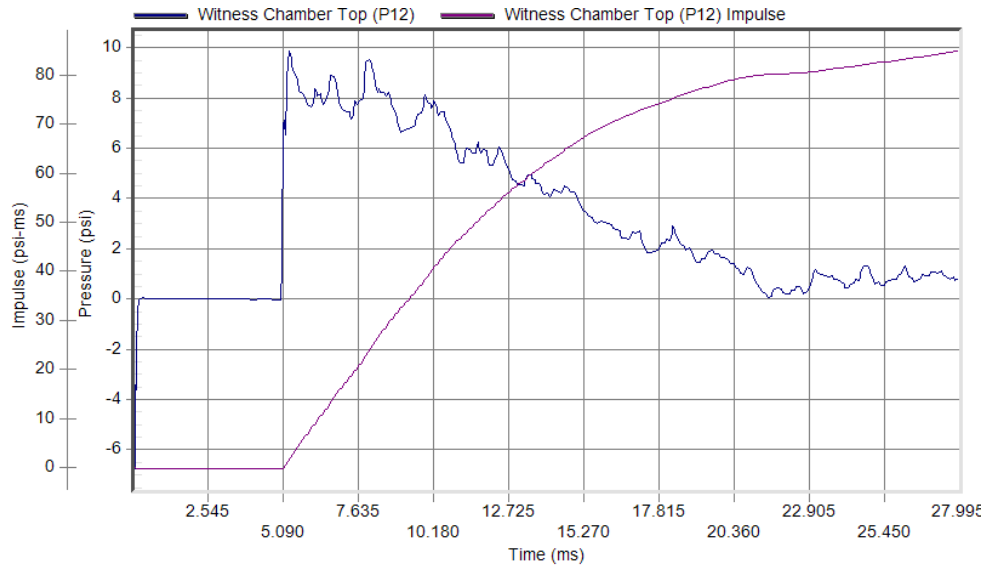
Specimen #5: (Continued)

Peak Pressure: 9.88 psi at 5.31 ms
Duration: 16.21 ms

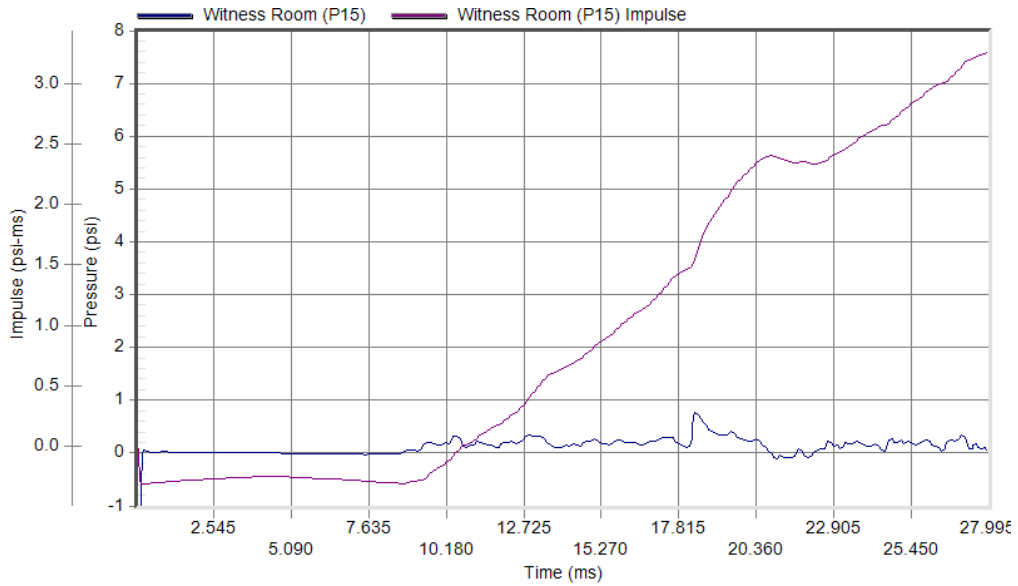
Peak Pressure: 0.78 psi at 18.35 ms
Duration: 2.49 ms

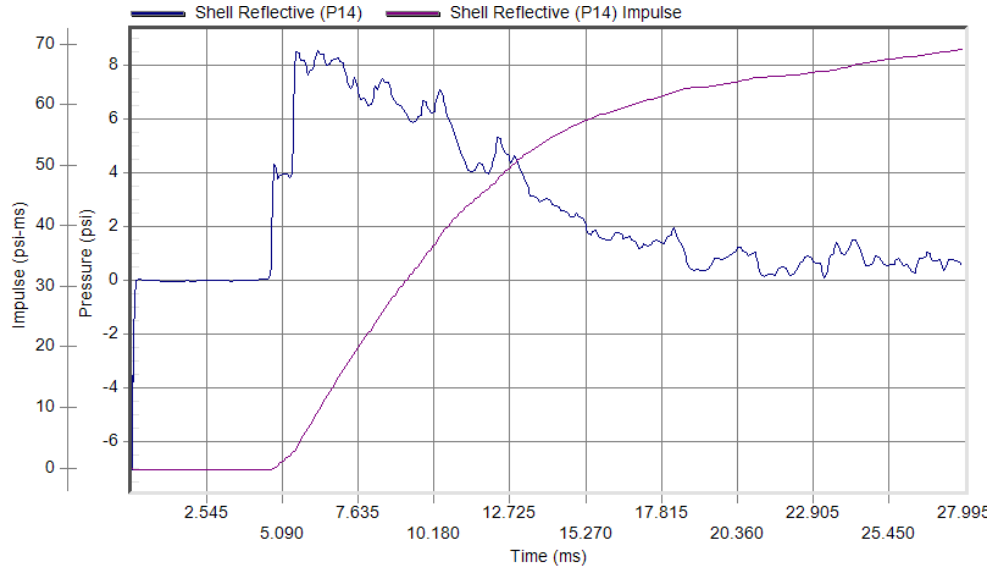
Specimen #6

Peak Pressure: 8.62 psi at 5.60 ms
Duration: 17.66 ms

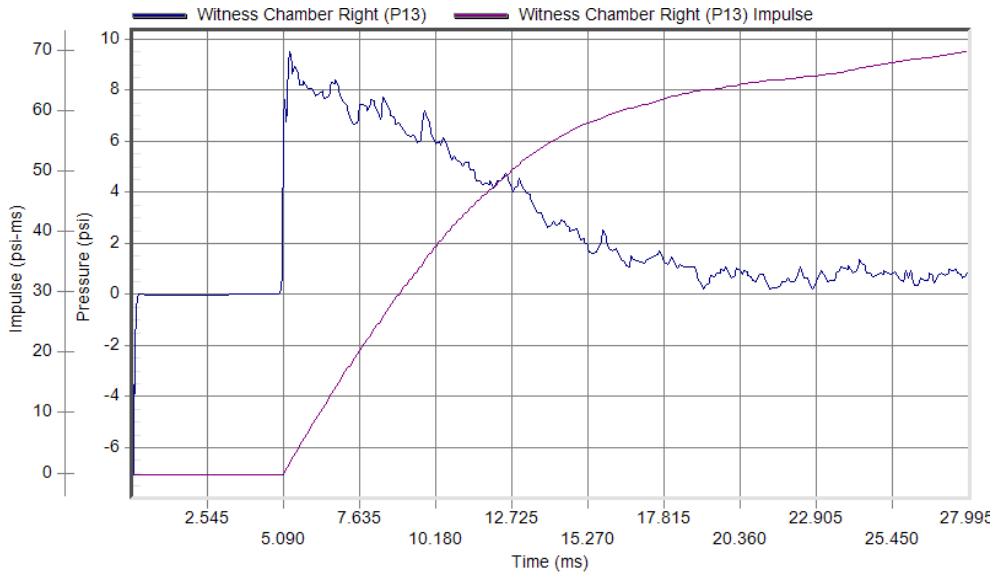
Peak Pressure: 9.53 psi at 5.31 ms
Duration: 16.14 ms

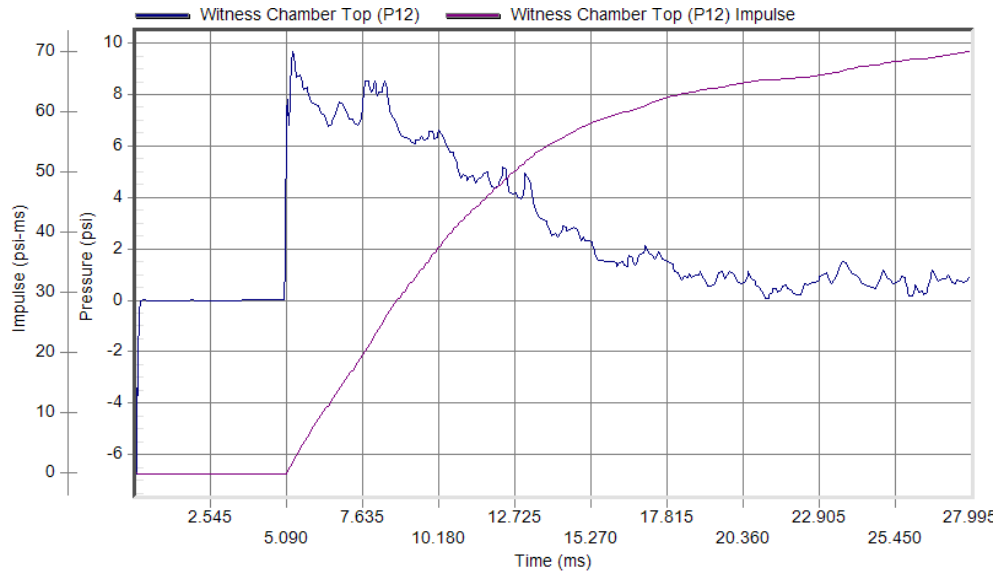
Specimen #6: (Continued)

Peak Pressure: 9.68 psi at 5.30 ms
Duration: 15.82 ms

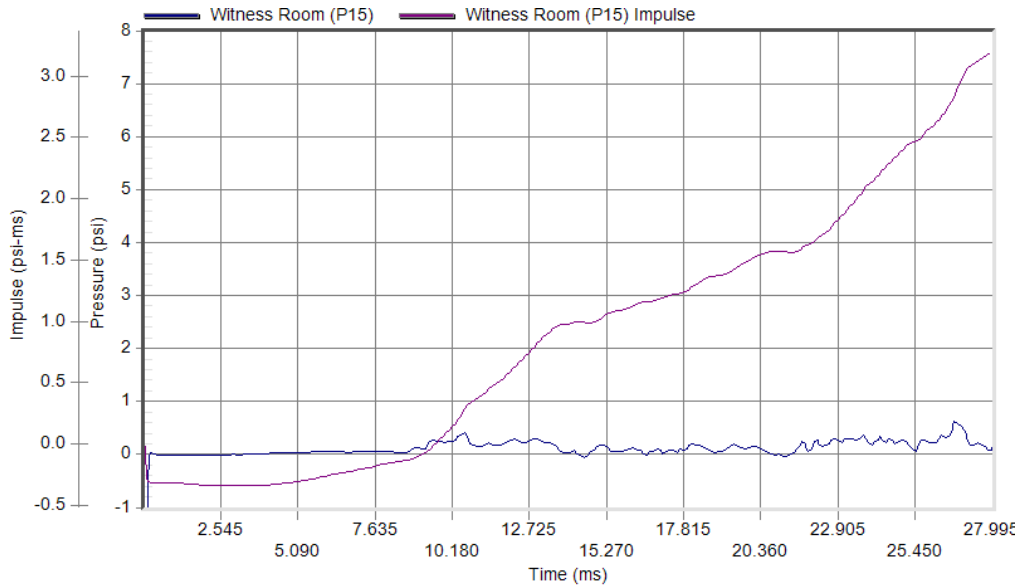
Peak Pressure: 0.64 psi at 26.77 ms
Duration: 0.00 ms

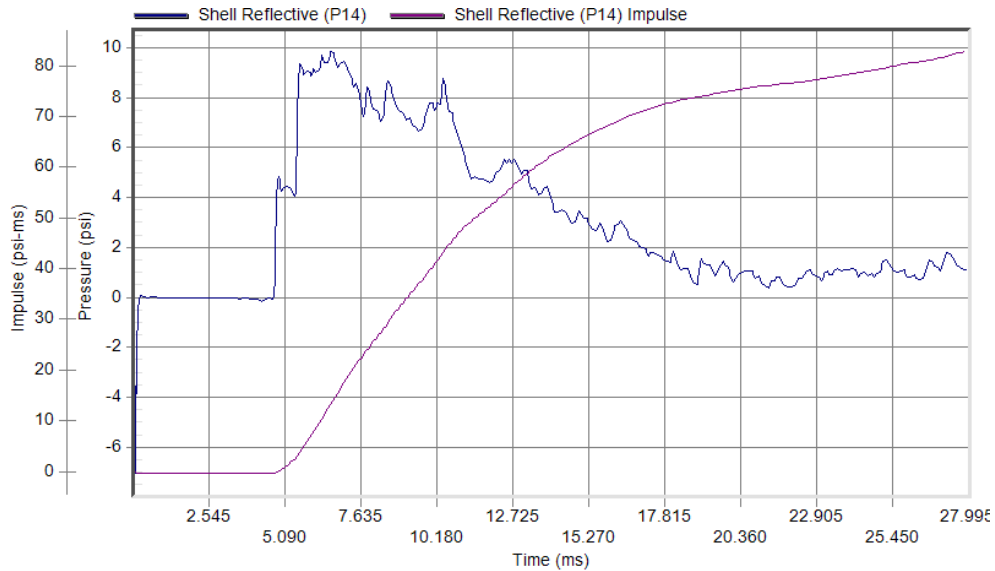
Specimen #7

Peak Pressure: 9.86 psi at 6.64 ms
Duration: 0.00 ms

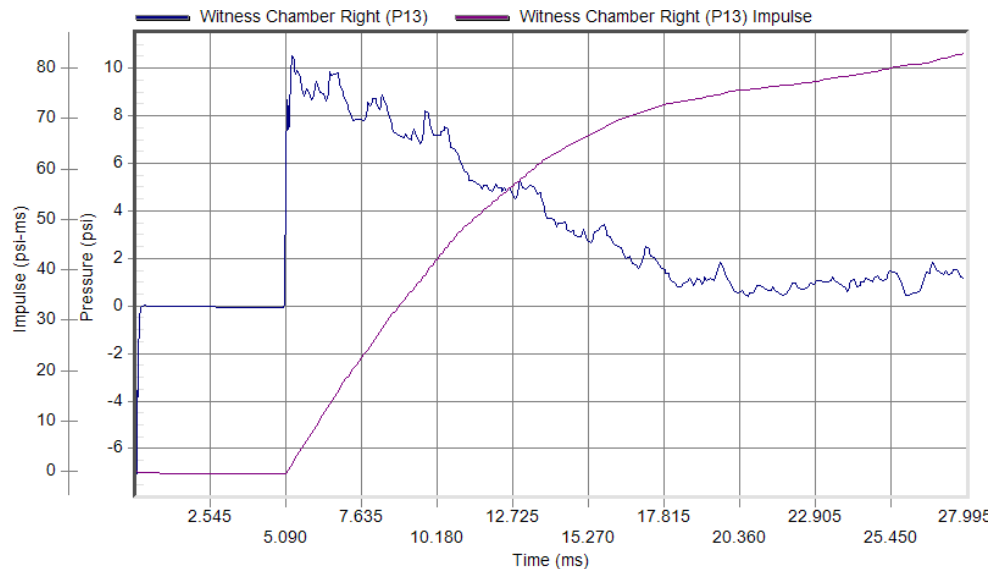
Peak Pressure: 10.64 psi at 5.32 ms
Duration: 0.00 ms

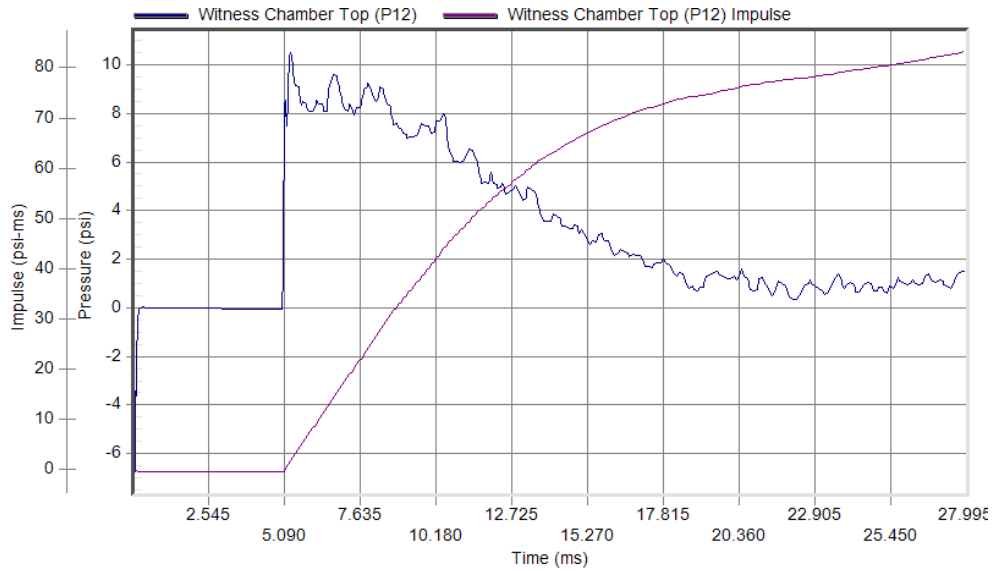
Specimen #7: (Continued)

Peak Pressure: 10.57 psi at 5.30 ms
Duration: 0.00 ms

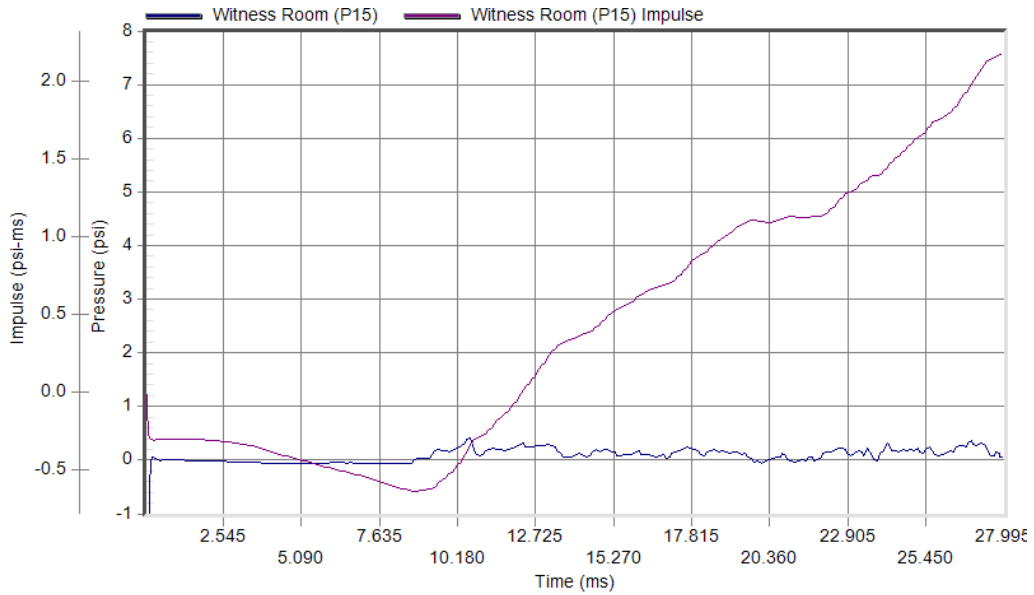
Peak Pressure: 0.42 psi at 10.57 ms
Duration: 9.24 ms

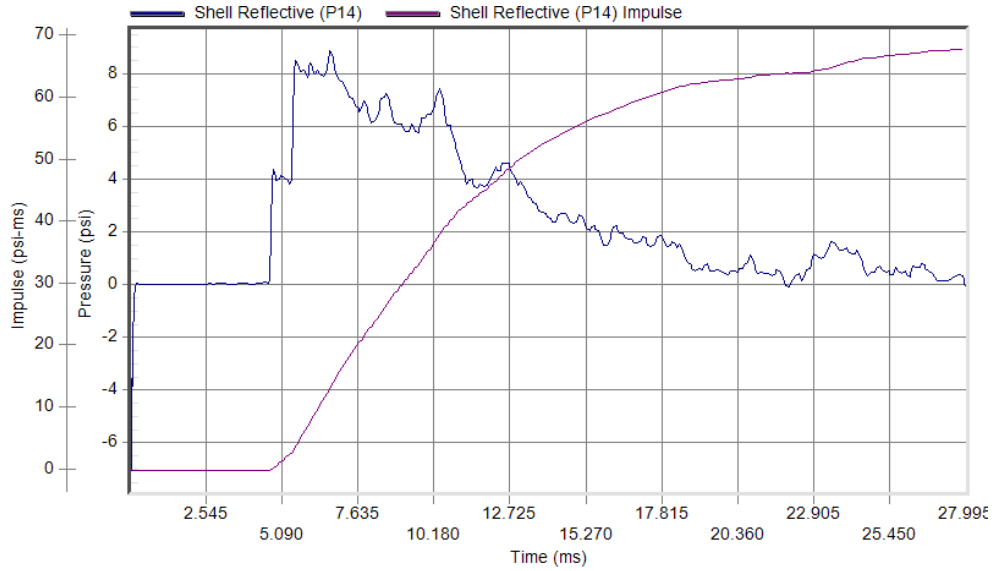
Specimen #8

Peak Pressure: 8.94 psi at 6.73 ms
Duration: 15.20 ms

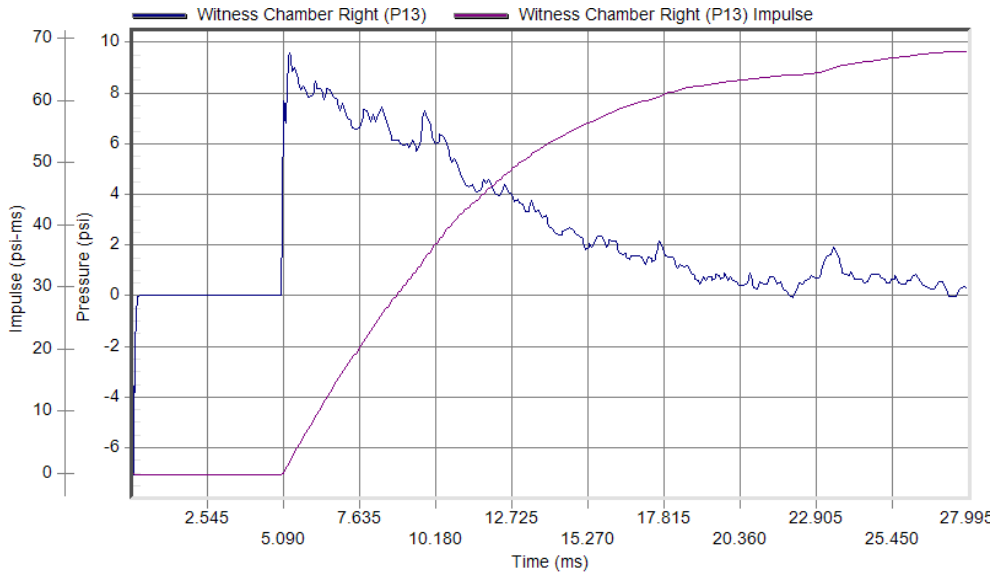
Peak Pressure: 9.64 psi at 5.29 ms
Duration: 16.72 ms

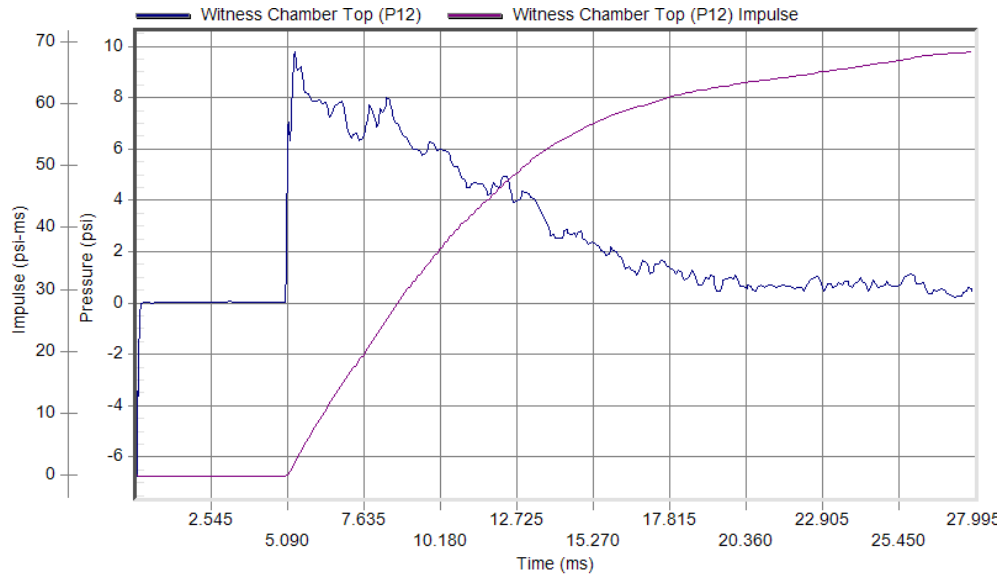
Specimen #8: (Continued)

Peak Pressure: 9.80 psi at 5.32 ms
Duration: 0.00 ms

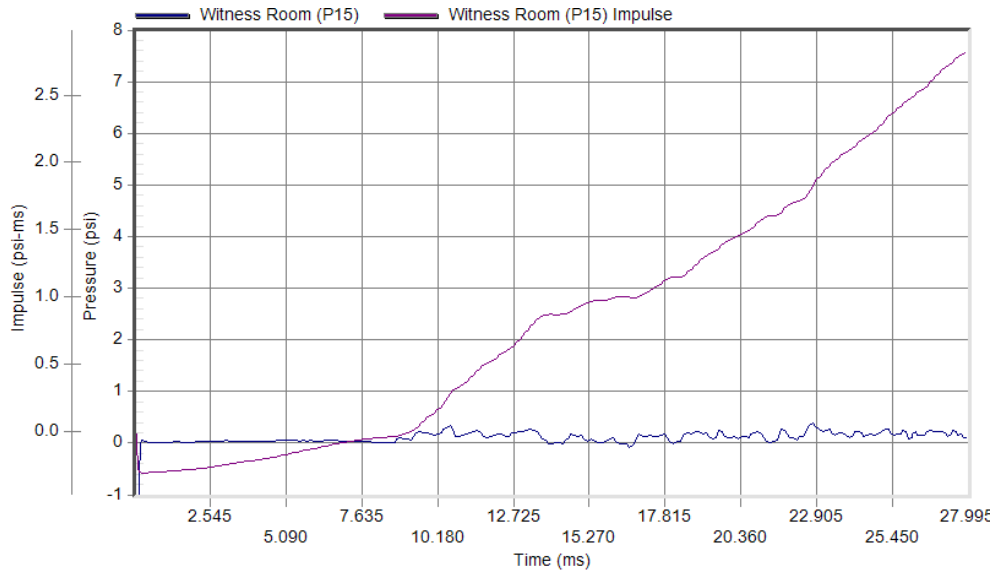
Peak Pressure: 0.39 psi at 22.76 ms
Duration: 0.00 ms

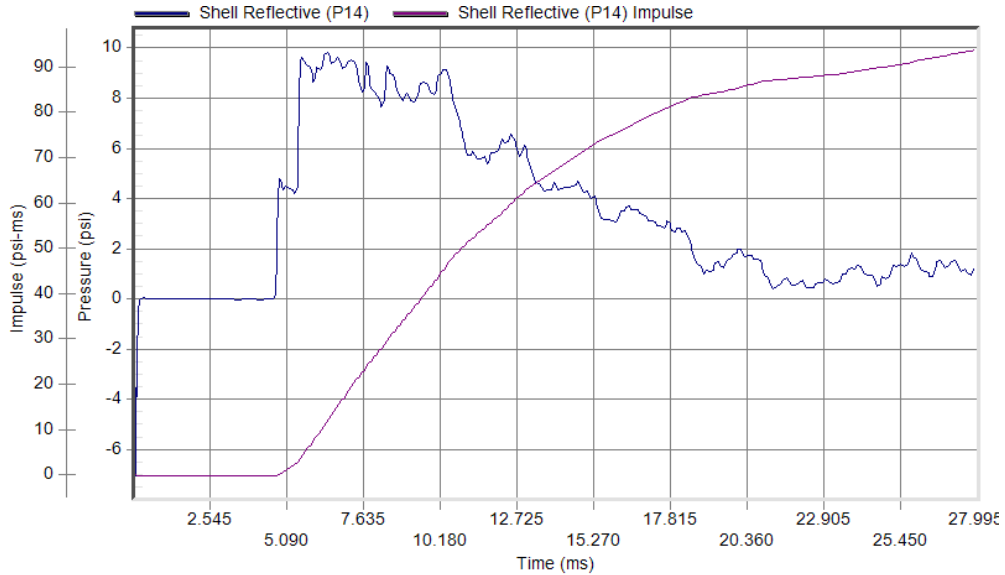
Specimen #9

Peak Pressure: 9.94 psi at 6.45 ms
Duration: 0.00 ms

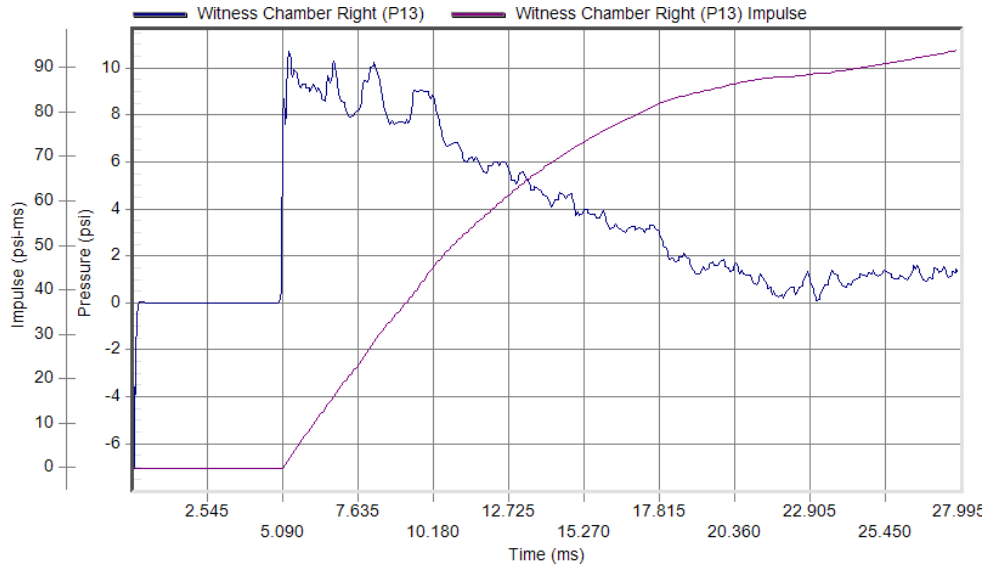
Peak Pressure: 10.78 psi at 5.31 ms
Duration: 16.56 ms

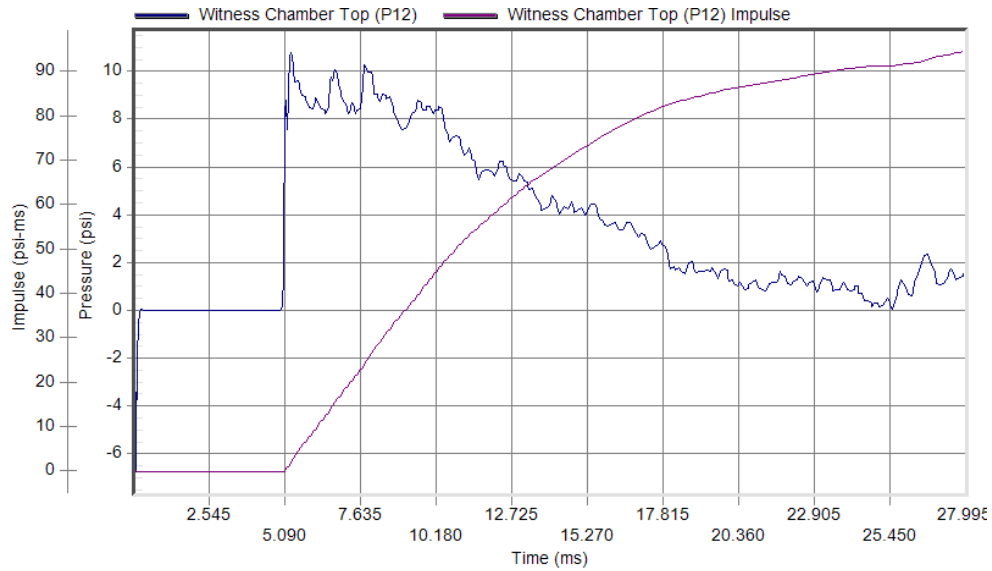
Specimen #9: (Continued)

Peak Pressure: 10.85 psi at 5.30 ms
Duration: 19.83 ms

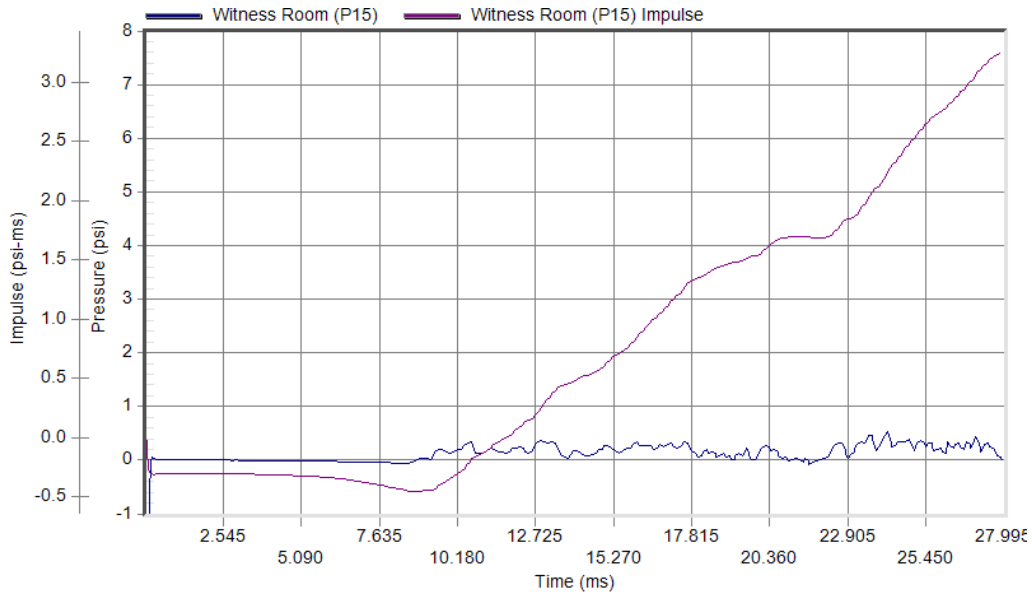
Peak Pressure: 0.52 psi at 24.21 ms
Duration: 3.71 ms

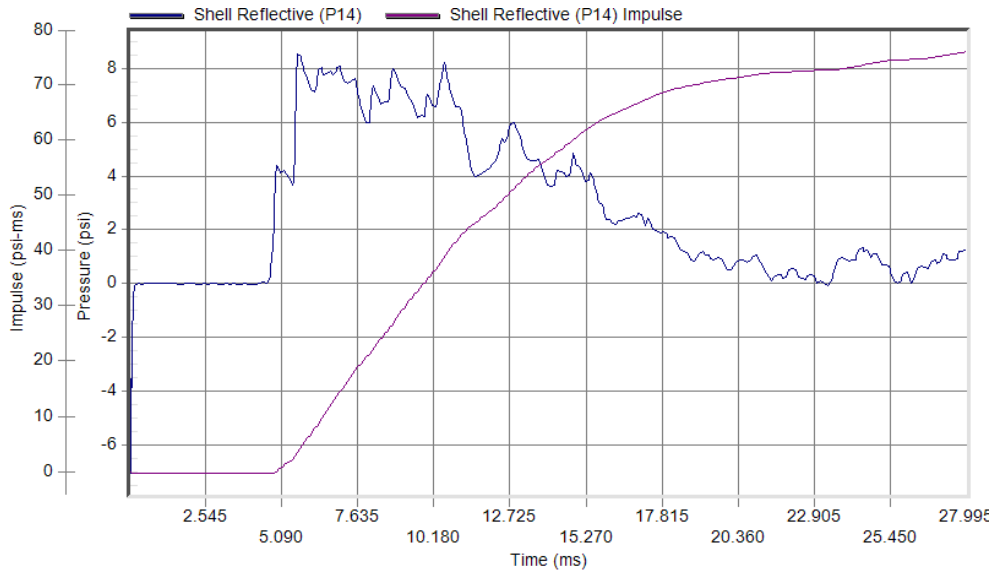
Specimen #10

Peak Pressure: 8.64 psi at 5.67 ms
Duration: 17.31 ms
