ASTM F1642-04 / GSA TS01 TEST REPORT

Report No.: D8934.01-119-12

3M COMPANY
St. Paul, Minnesota

Fragment Retention Film on 1" Double Pane Glass with Film Attachment Systems

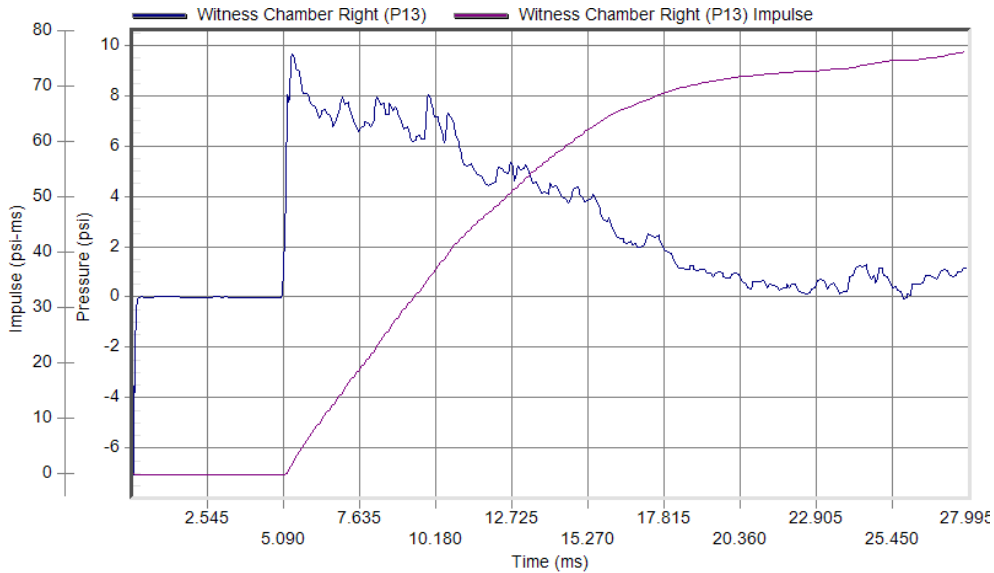
Peak Pressure: 9.76 psi at 5.41 ms
Duration: 17.19 ms

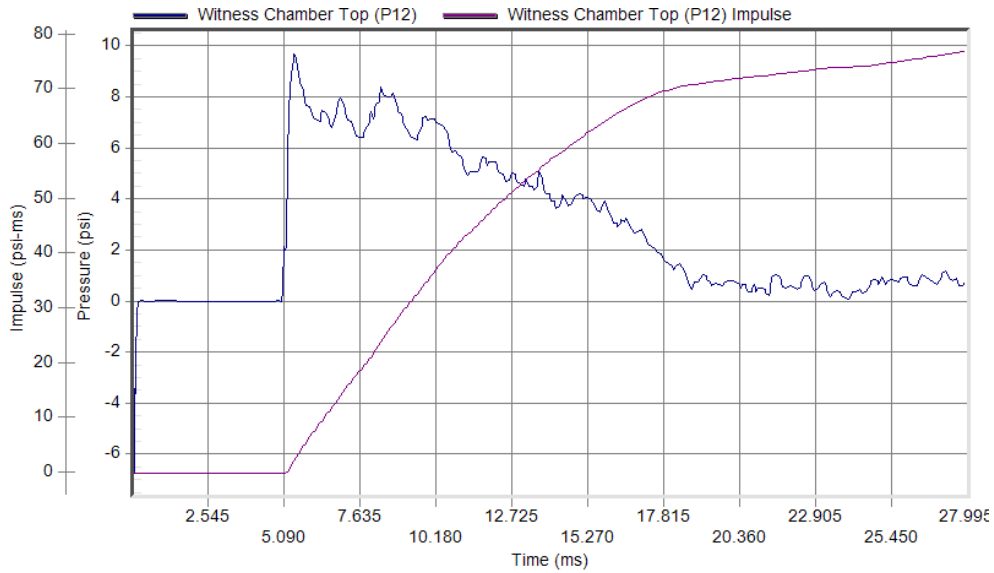
Specimen #10: (Continued)

Peak Pressure: 9.79 psi at 5.44 ms
Duration: 18.46 ms

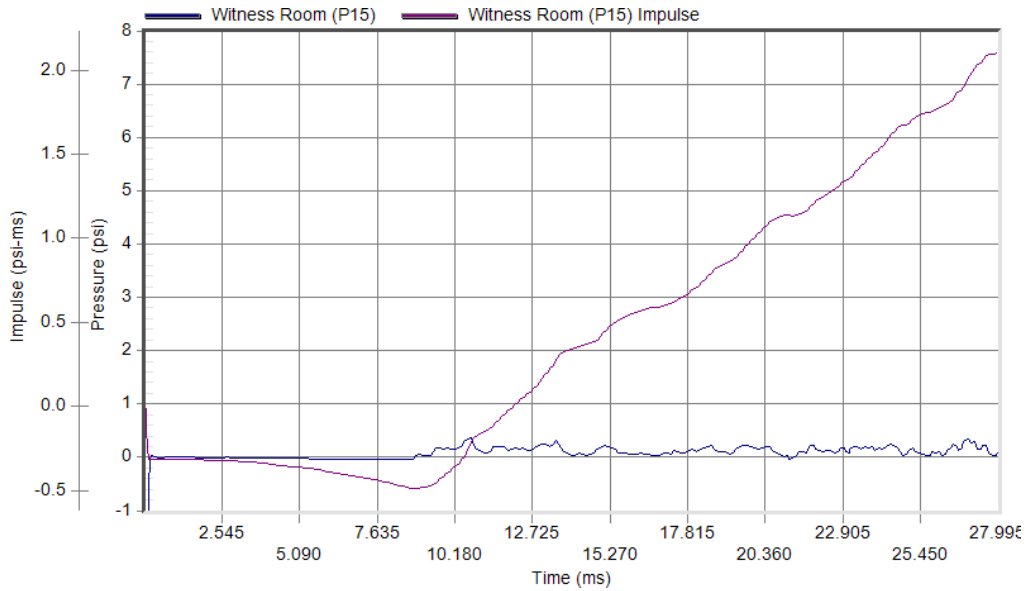
Peak Pressure: 0.37 psi at 10.69 ms
Duration: 6.01 ms

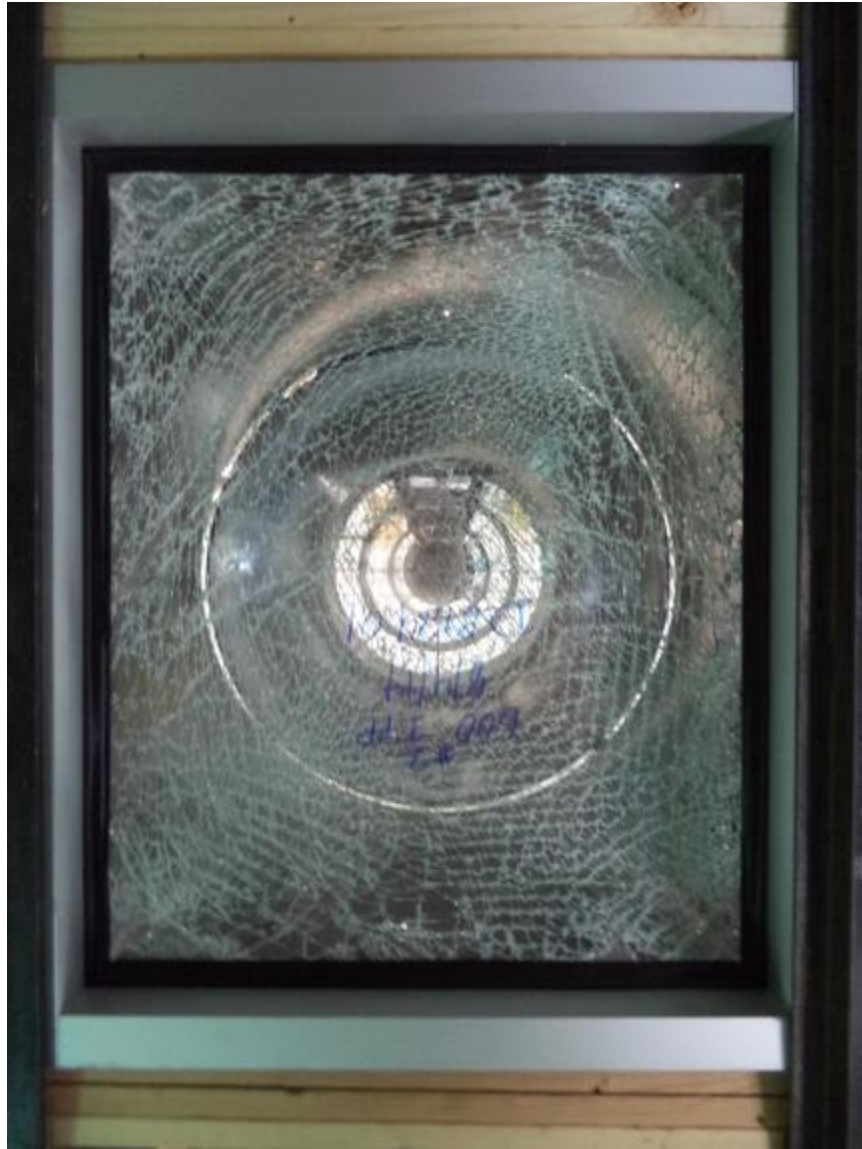
Photo No. 5
Post-test Specimen #2, Interior

Glazing Response	
Exterior Lite	Shattered
Interior Lite	Fractured
Glazing Pullout Length and Location	None
Glazing Tearing	None

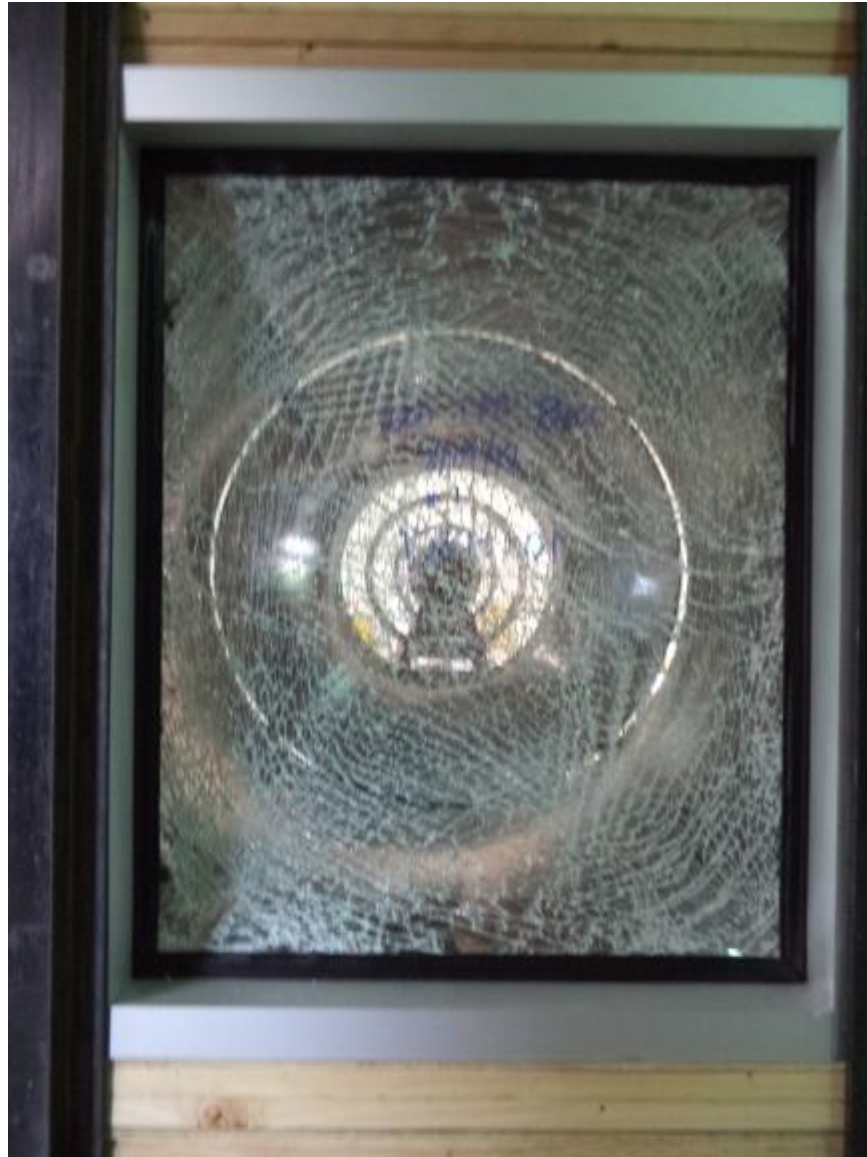
Photo No. 8
Post-test Specimen #3, Interior

Glazing Response	
Exterior Lite	Shattered
Interior Lite	Fractured
Glazing Pullout Length and Location	None
Glazing Tearing	1-1/4" at lower left corner

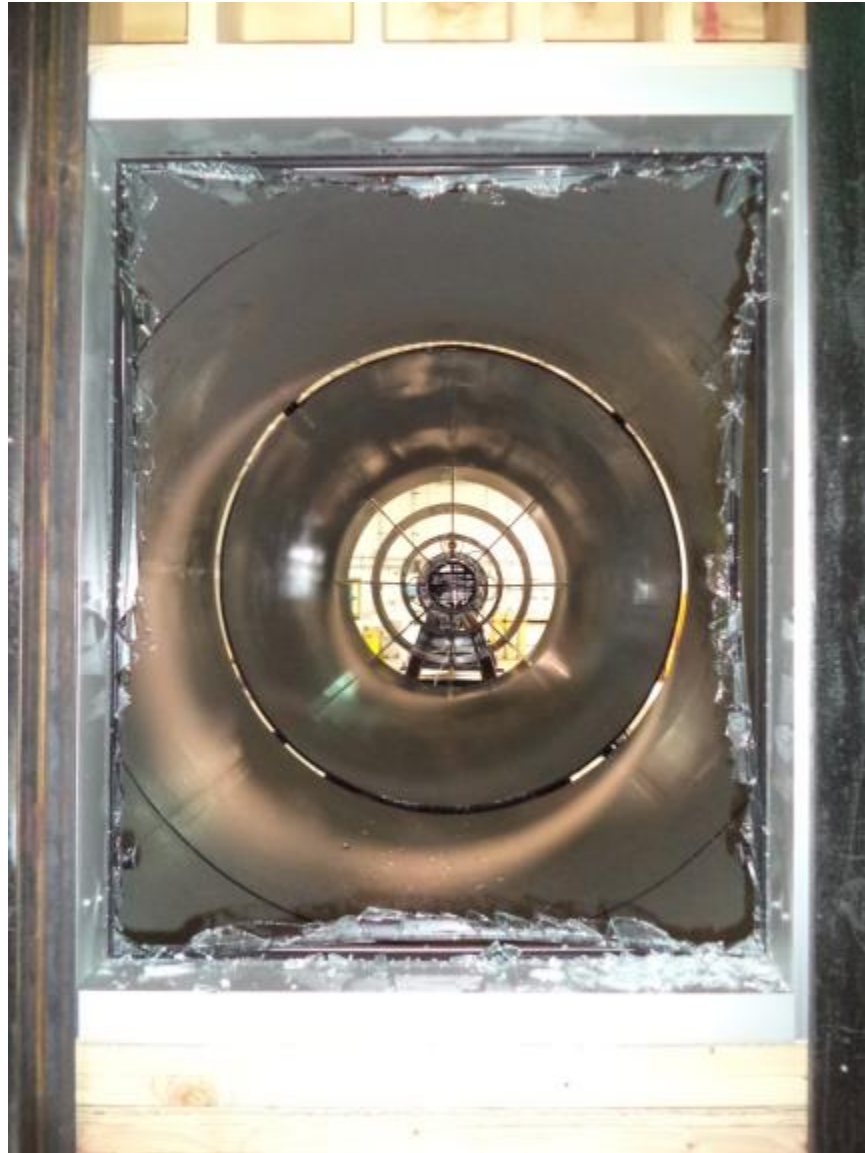
Photo No. 14
Post-test Specimen #5, Interior

Glazing Response	
Exterior Lite	Shattered
Interior Lite	Fractured and blown out
Glazing Pullout Length and Location	Entire interior lite deglazed
Glazing Tearing	N/A

Witness Chamber Results
The interior lite landed on the witness chamber floor, 18" past the 1m mark. Several glazing fragments penetrated into the second layer of witness panel.

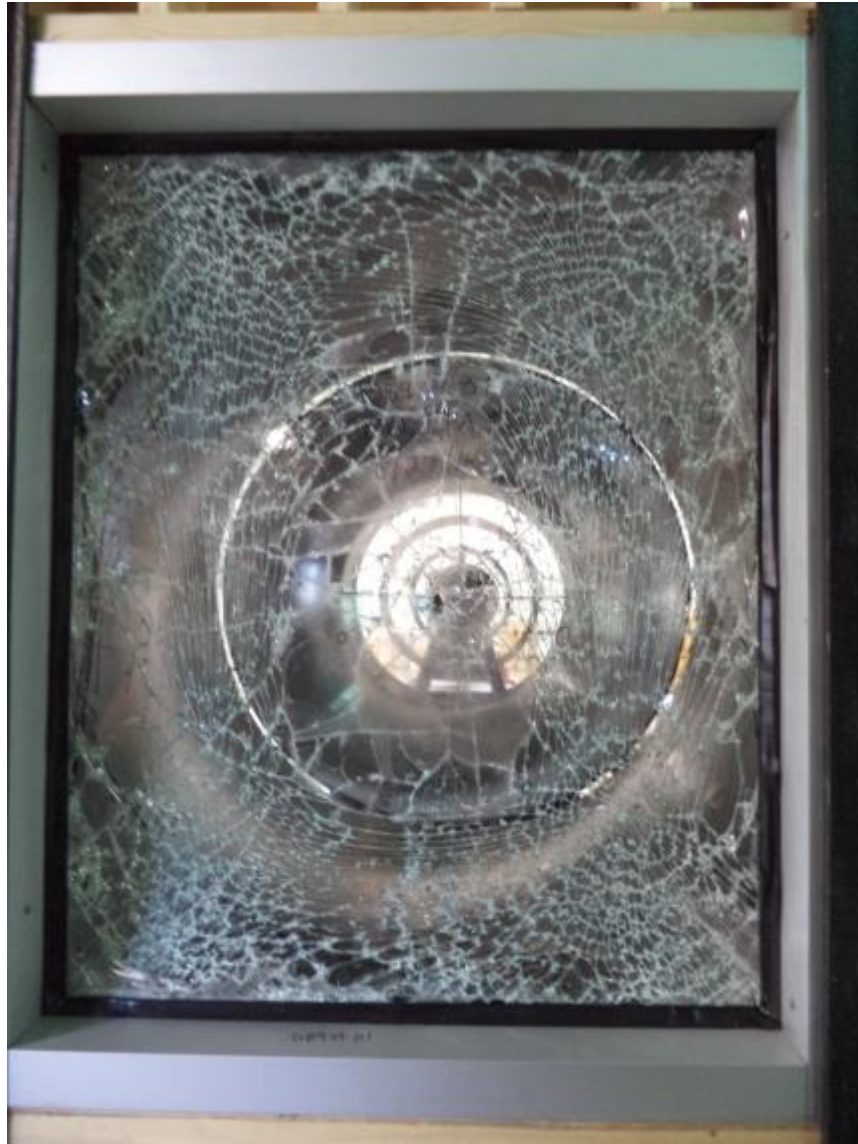
Photo No. 17
Post-test Specimen #6, Interior

Glazing Response	
Exterior Lite	Shattered
Interior Lite	Fractured
Glazing Pullout Length and Location	None
Glazing Tearing	1/2" at each end of sill

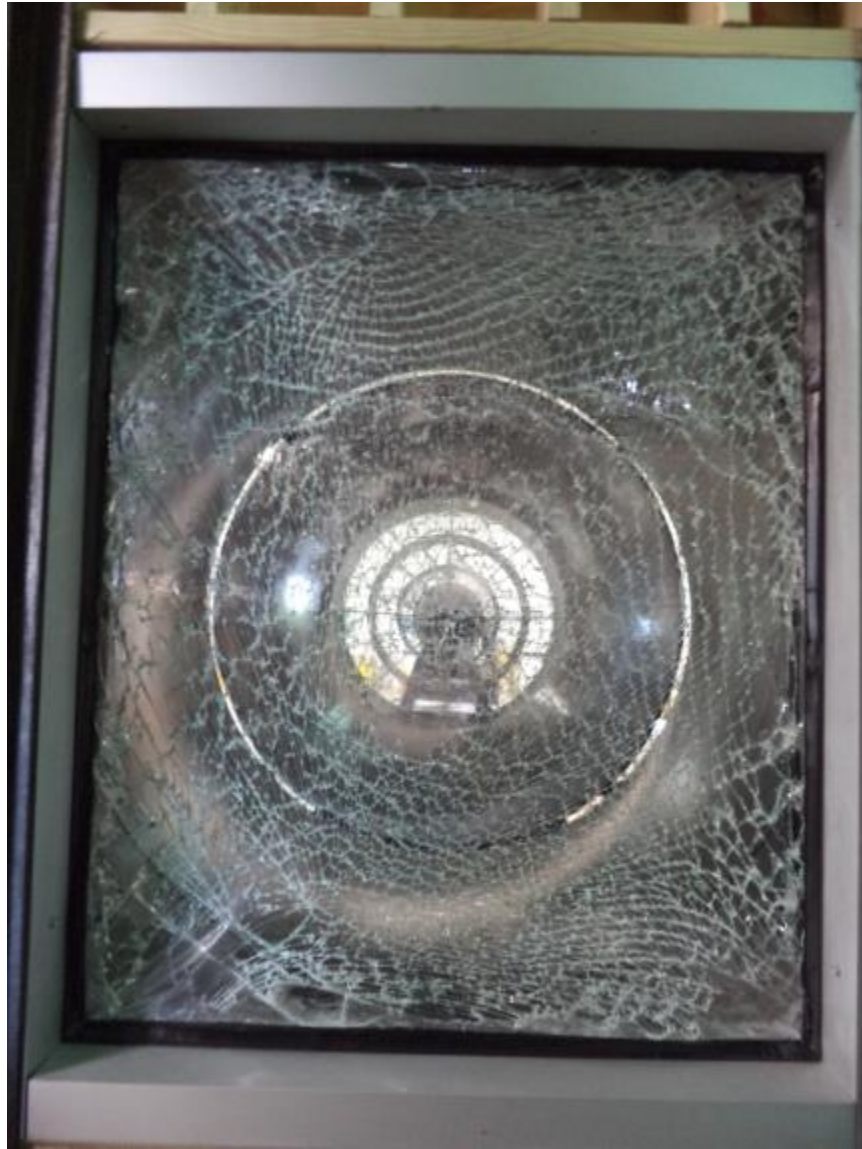
Photo No. 20
Post-test Specimen #7, Interior

Glazing Response	
Exterior Lite	Shattered
Interior Lite	Fractured
Glazing Pullout Length and Location	None
Glazing Tearing	3/4" at upper right corner

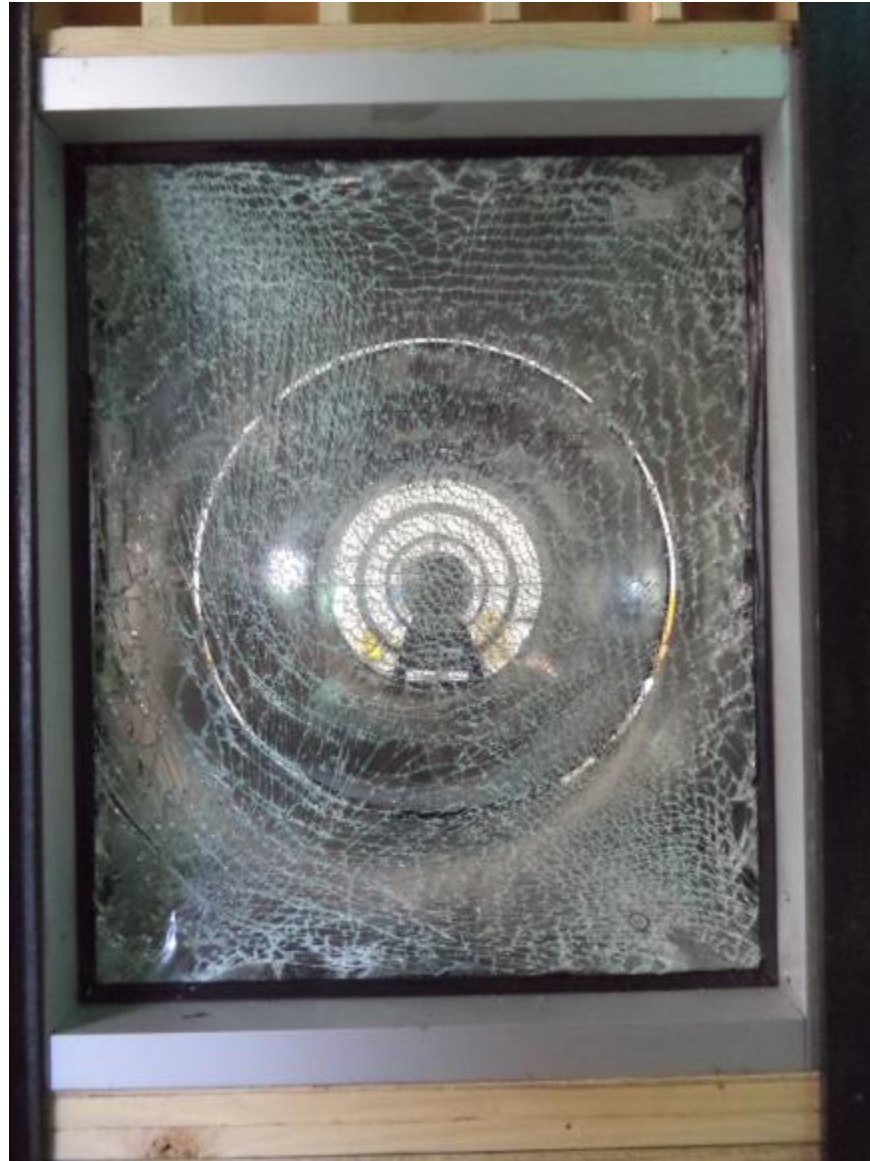
Photo No. 23
Post-test Specimen #8, Interior

Glazing Response	
Exterior Lite	Shattered
Interior Lite	Fractured
Glazing Pullout Length and Location	None
Glazing Tearing	1/4" at lower left corner

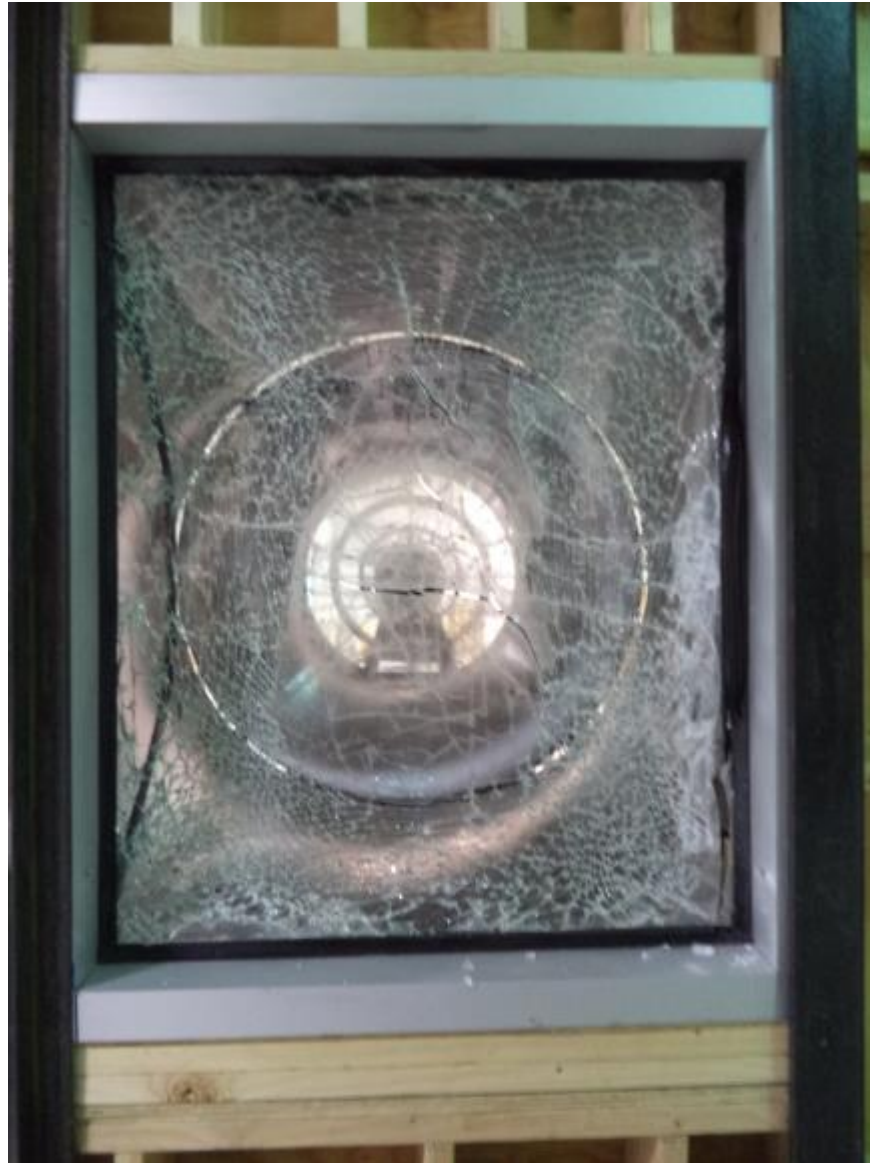
Photo No. 26
Post-test Specimen #9, Interior

Glazing Response	
Exterior Lite	Shattered
Interior Lite	Fractured
Glazing Pullout Length and Location	18" along right jamb
Glazing Tearing	Tore at several locations

Witness Chamber Results
34 Fragment indents were found on witness panel up to a height of 46" from the floor. One sliver perforation was found on the witness panel, 34" from the floor.

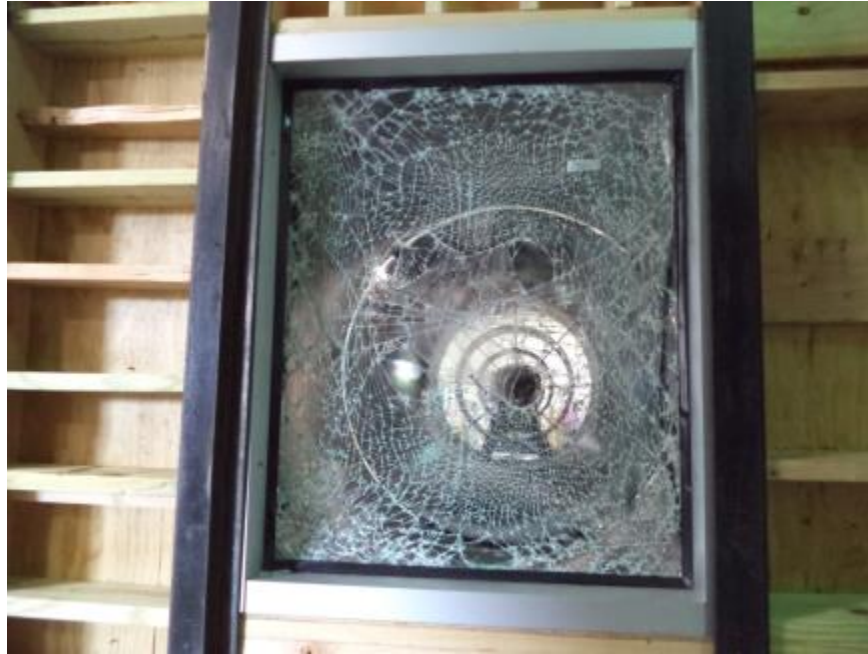
Photo No. 29
Post-test Specimen #10, Interior

Glazing Response	
Exterior Lite	Shattered
Interior Lite	Fractured
Glazing Pullout Length and Location	None
Glazing Tearing	Five tears; 3/4" to 2-1/2" long
