**ASTM F1642-04 / GSA TS01 TEST REPORT**

3M Company - St. Paul, Minnesota

Fragment Retention Film on 1/4" Single Pane Glass

3M™ Scotchshield™ Ultra S600 Safety and Security Window Film with  
3M™ Impact Protection Adhesive Film Attachment System

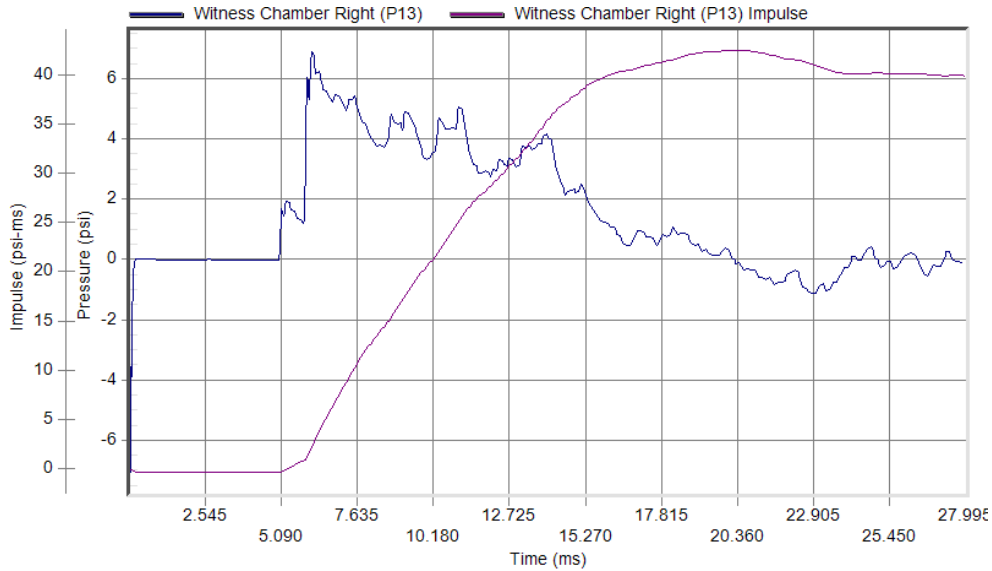
Peak Pressure: 6.94 psi at 6.16 ms  
Duration: 14.01 ms

<b>Peak Positive Pressure</b>	
Top Pressure	6.78 psi
Right Pressure	6.94 psi
Shell Pressure	6.14 psi
<b>Average Pressure</b>	6.62 psi
Witness Chamber Pressure	0.25 psi

<b>Peak Positive Phase Duration</b>	
Top Duration	13.69 msec
Right Duration	14.01 msec
Shell Duration	10.06 msec
<b>Average Duration</b>	12.59 msec

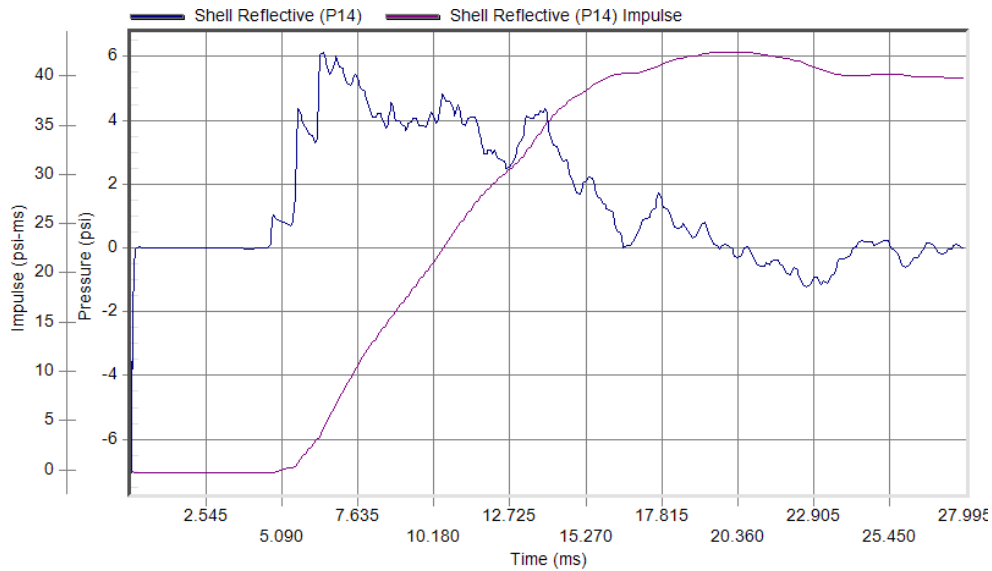
Peak Pressure: 6.14 psi at 6.46 ms  
Duration: 10.06 ms

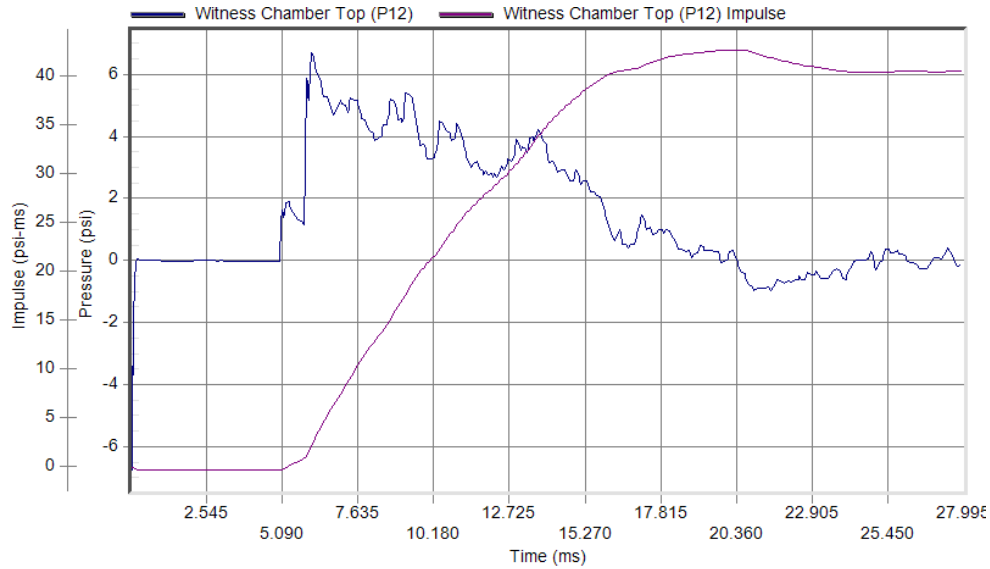
Peak Pressure: 6.78 psi at 6.12 ms  
Duration: 13.69 ms

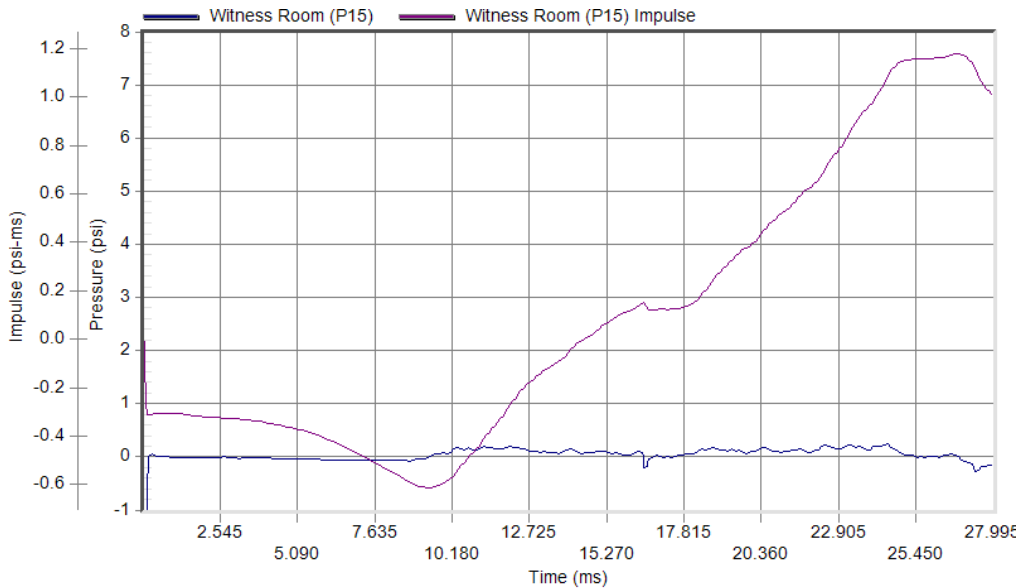
Peak Pressure: 0.25 psi at 24.46 ms  
Duration: 0.97 ms

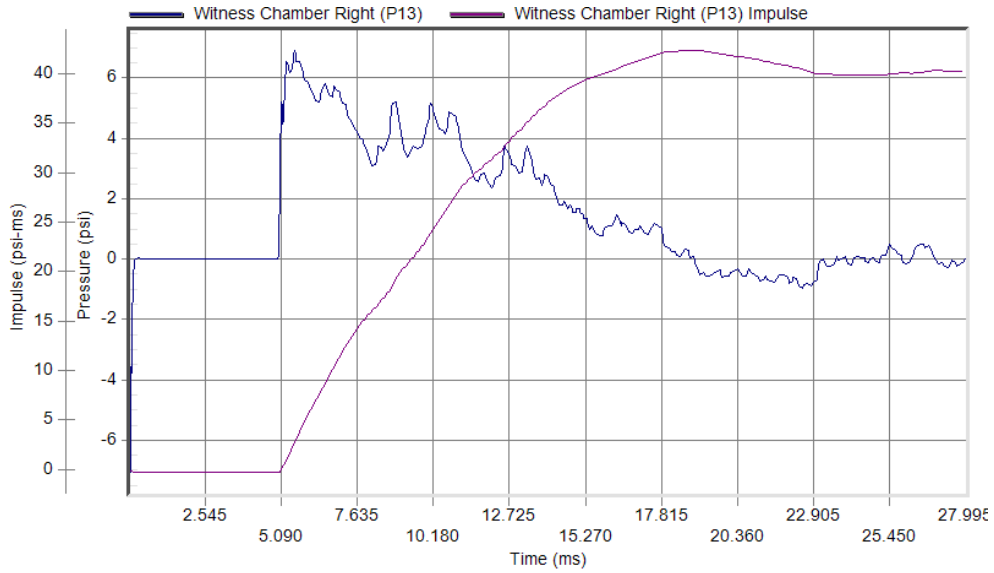
Peak Pressure: 6.92 psi at 5.56 ms  
Duration: 12.80 ms

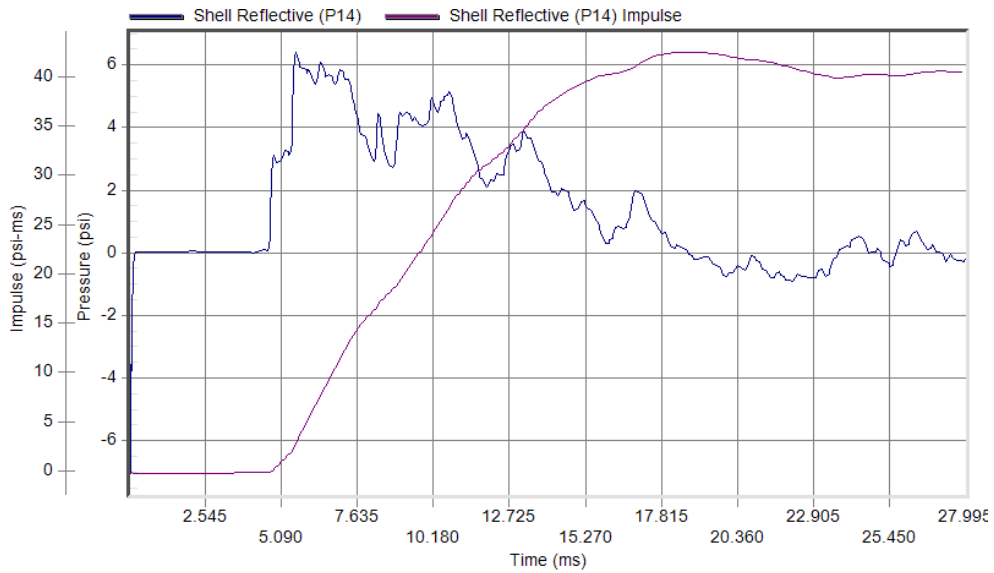
Peak Pressure: 6.41 psi at 5.61 ms  
Duration: 12.99 ms

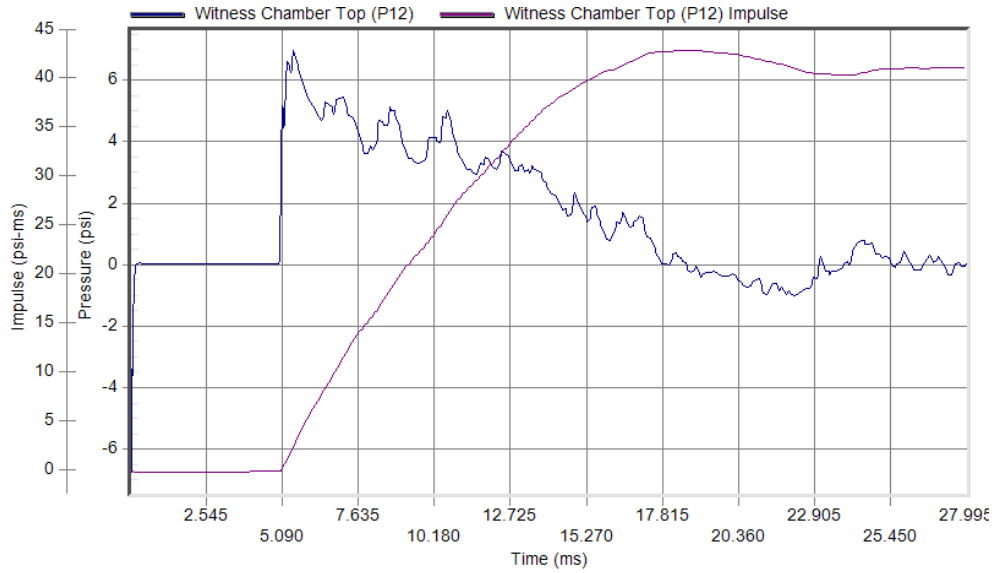
Peak Pressure: 6.98 psi at 5.48 ms  
Duration: 12.29 ms

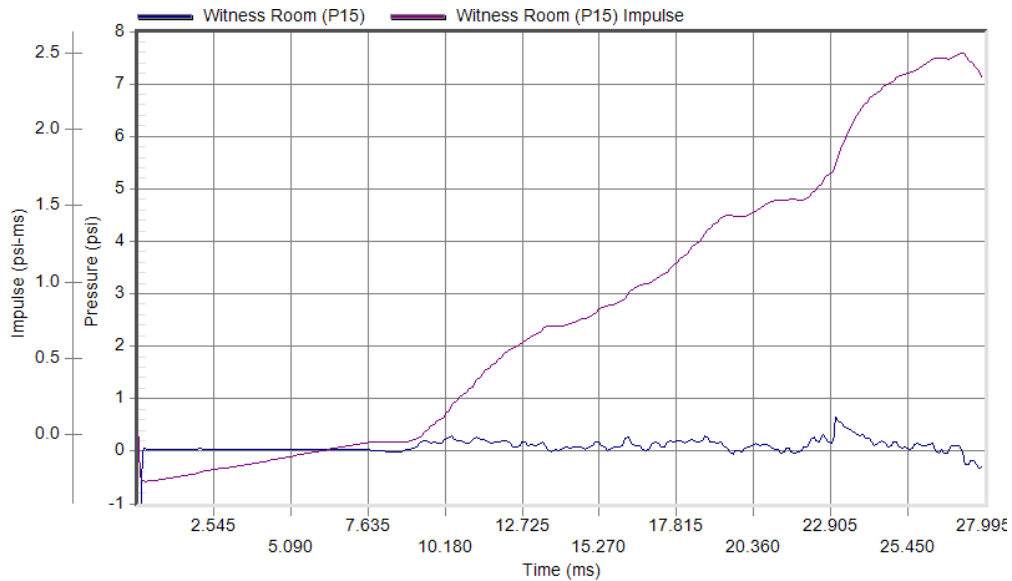
Peak Pressure: 0.65 psi at 23.11 ms  
Duration: 3.28 ms

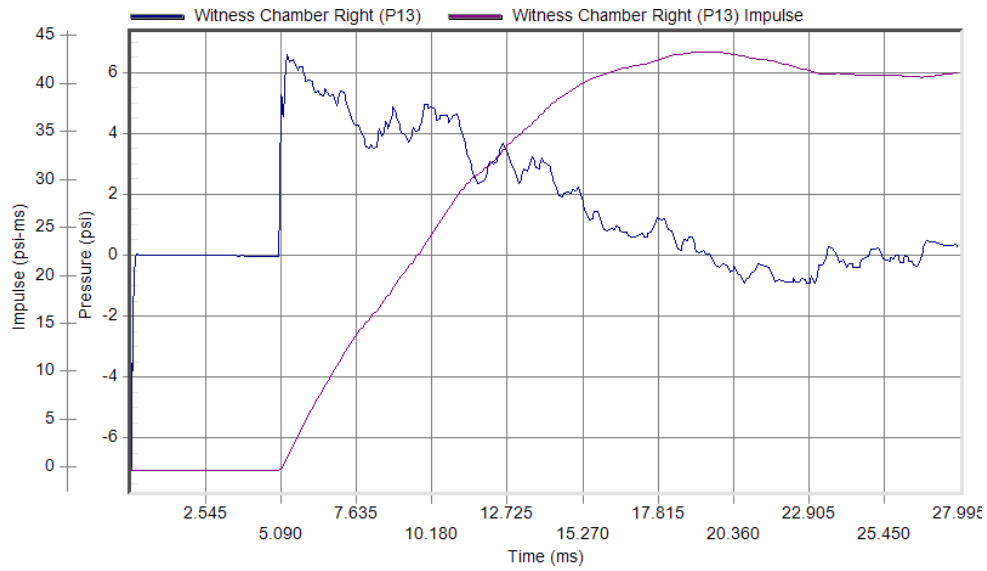
Peak Pressure: 6.68 psi at 5.32 ms  
Duration: 13.78 ms

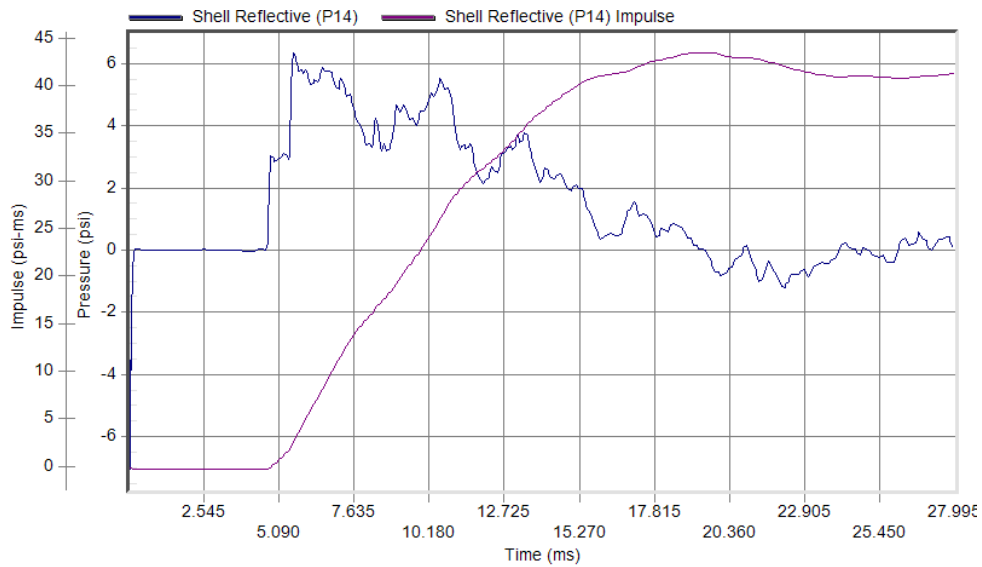
Peak Pressure: 6.35 psi at 5.63 ms  
Duration: 13.66 ms

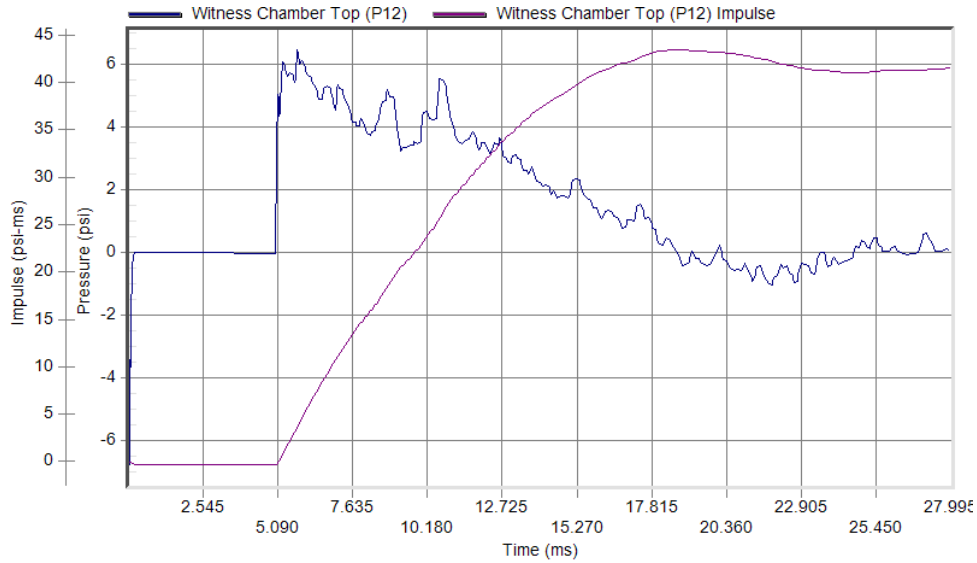
Peak Pressure: 6.46 psi at 5.78 ms  
Duration: 12.87 ms

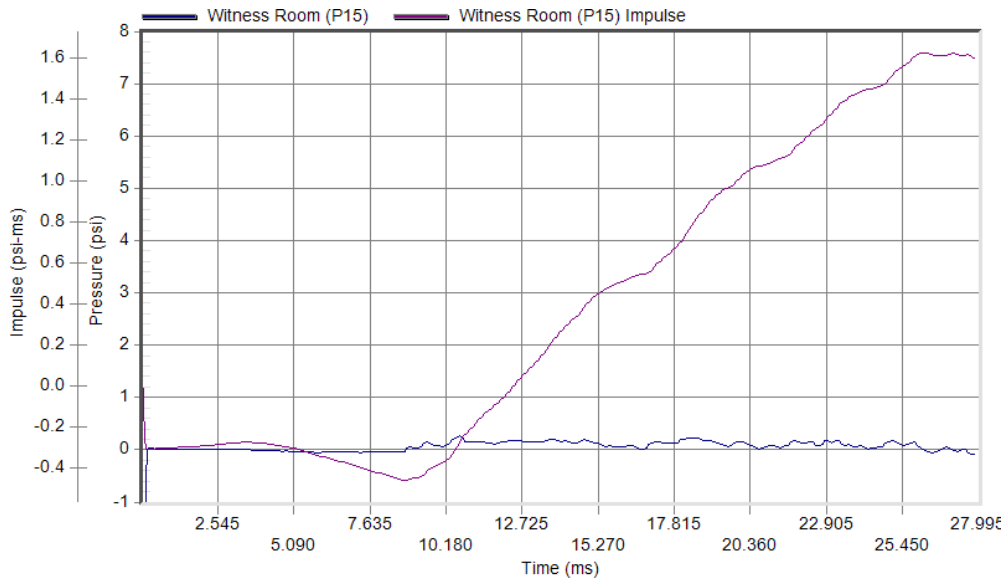
Peak Pressure: 0.28 psi at 10.67 ms  
Duration: 9.95 ms

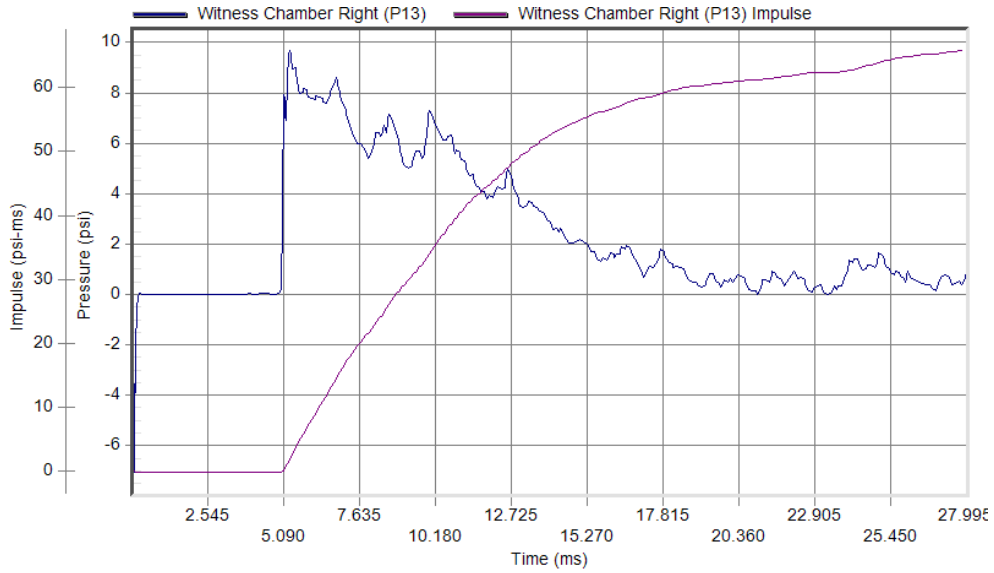
Peak Pressure: 9.69 psi at 5.29 ms  
Duration: 15.53 ms

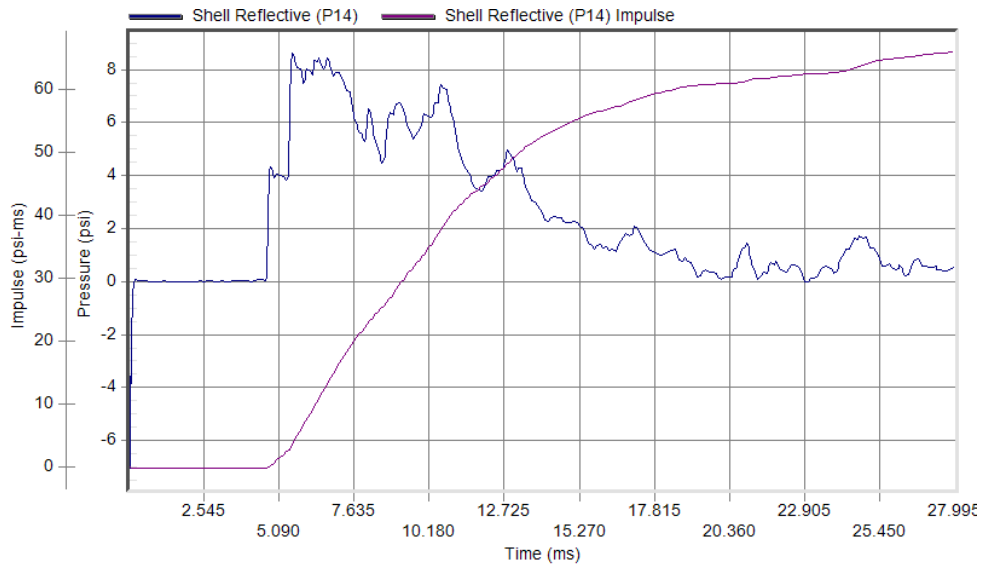
Peak Pressure: 8.68 psi at 5.59 ms  
Duration: 15.74 ms

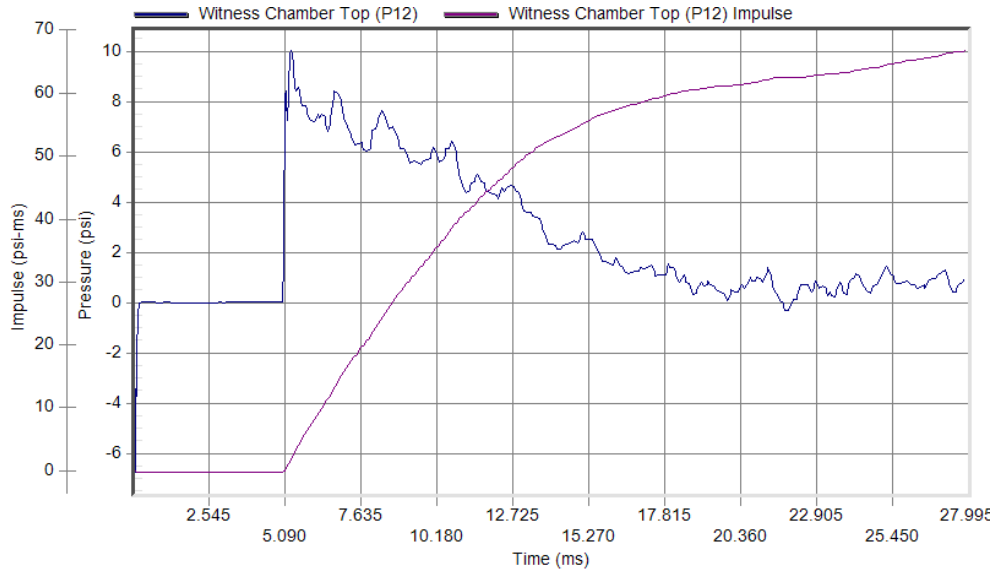
Peak Pressure: 10.04 psi at 5.30 ms  
Duration: 14.64 ms

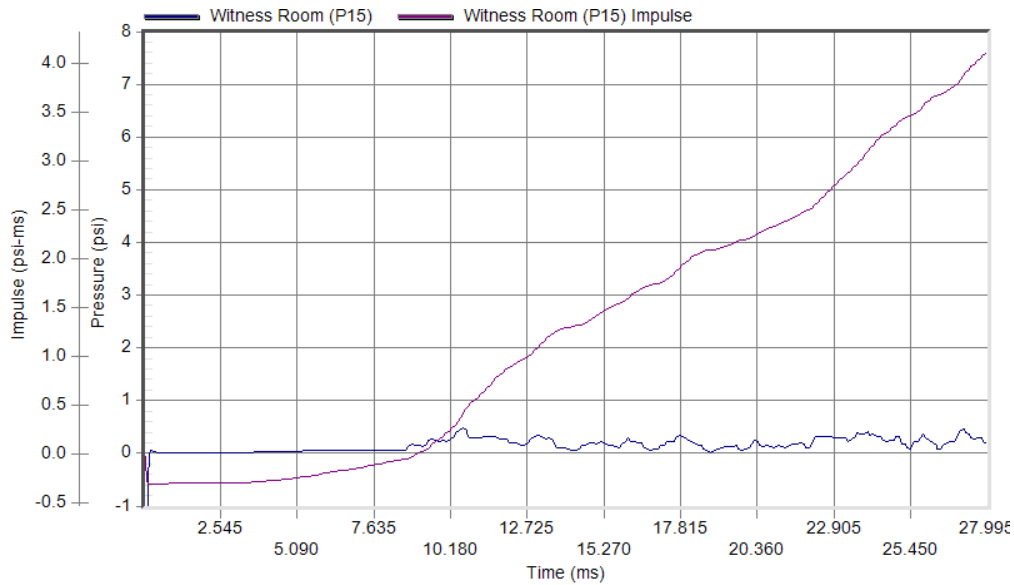
Peak Pressure: 0.53 psi at 10.62 ms  
Duration: 8.15 ms

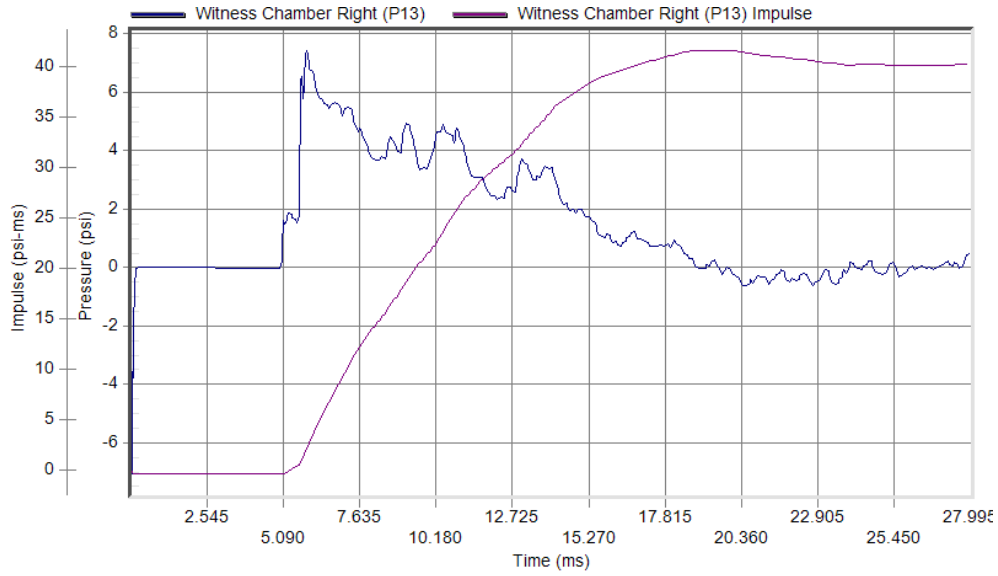
Peak Pressure: 7.44 psi at 5.89 ms  
Duration: 12.91 ms

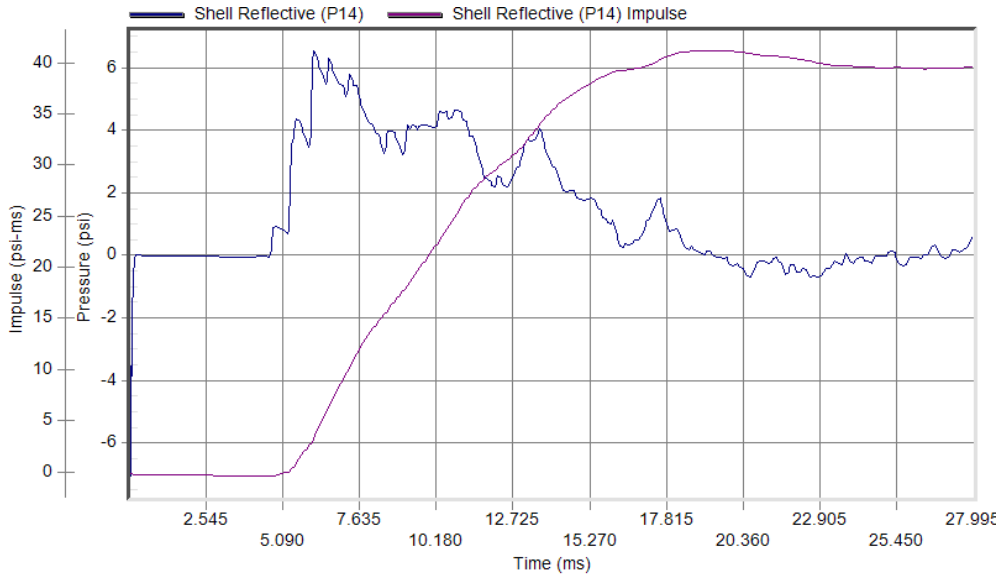
Peak Pressure: 6.55 psi at 6.14 ms  
Duration: 12.80 ms

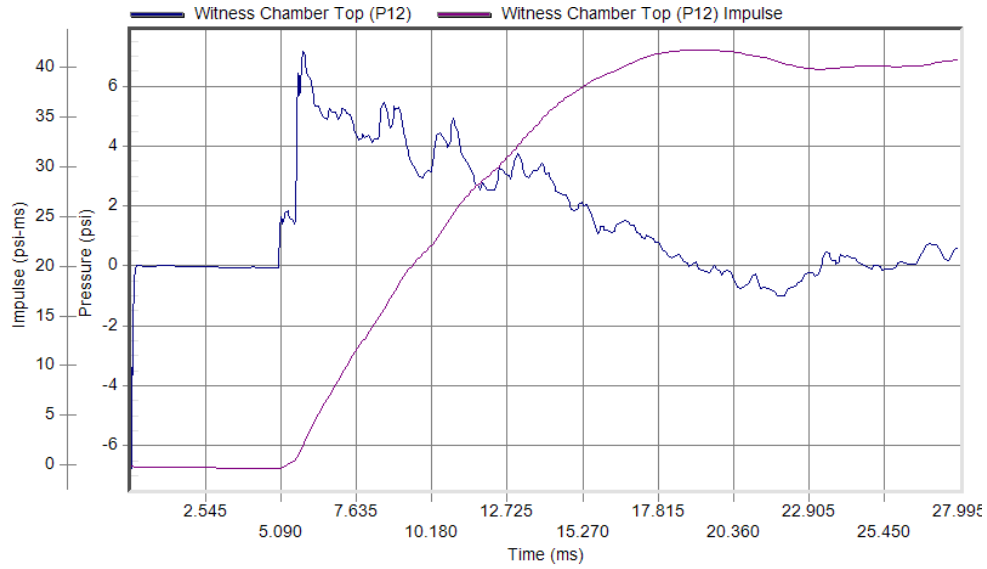
Peak Pressure: 7.21 psi at 5.86 ms  
Duration: 12.94 ms

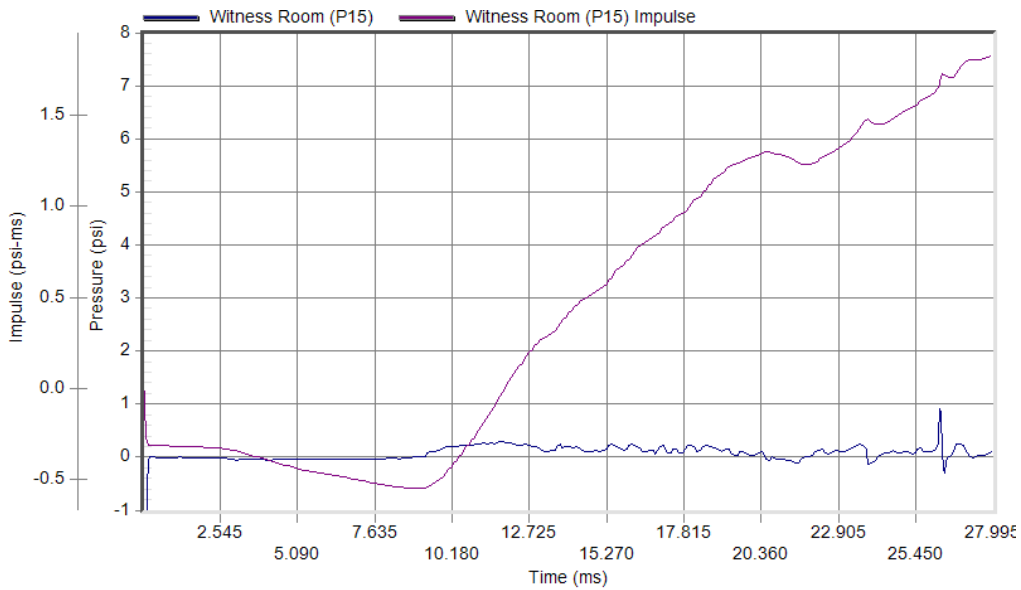
Peak Pressure: 0.91 psi at 26.25 ms  
Duration: 0.09 ms

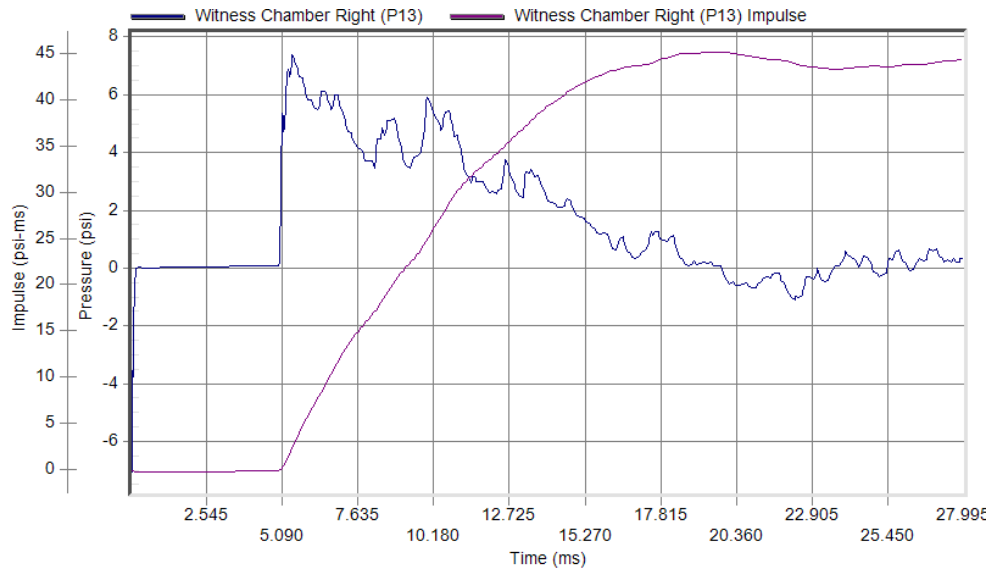
Peak Pressure: 7.48 psi at 5.45 ms  
Duration: 14.14 ms

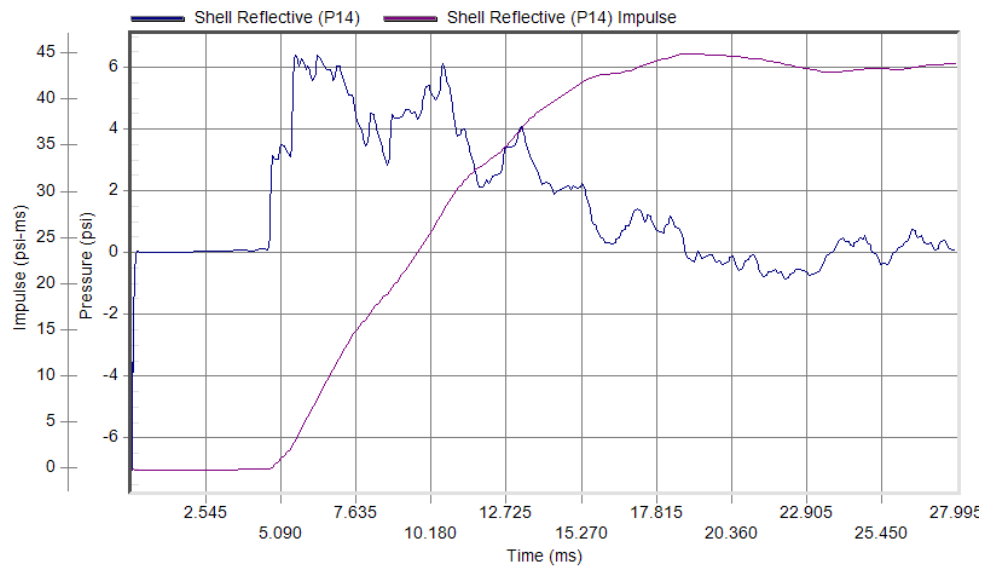
Peak Pressure: 6.45 psi at 5.61 ms  
Duration: 13.18 ms

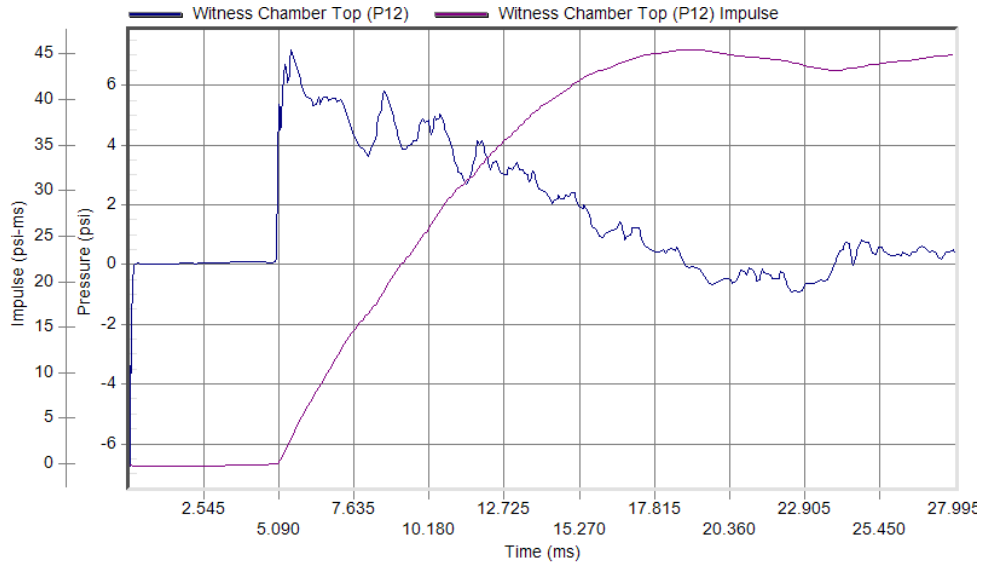
Peak Pressure: 7.19 psi at 5.52 ms  
Duration: 13.30 ms

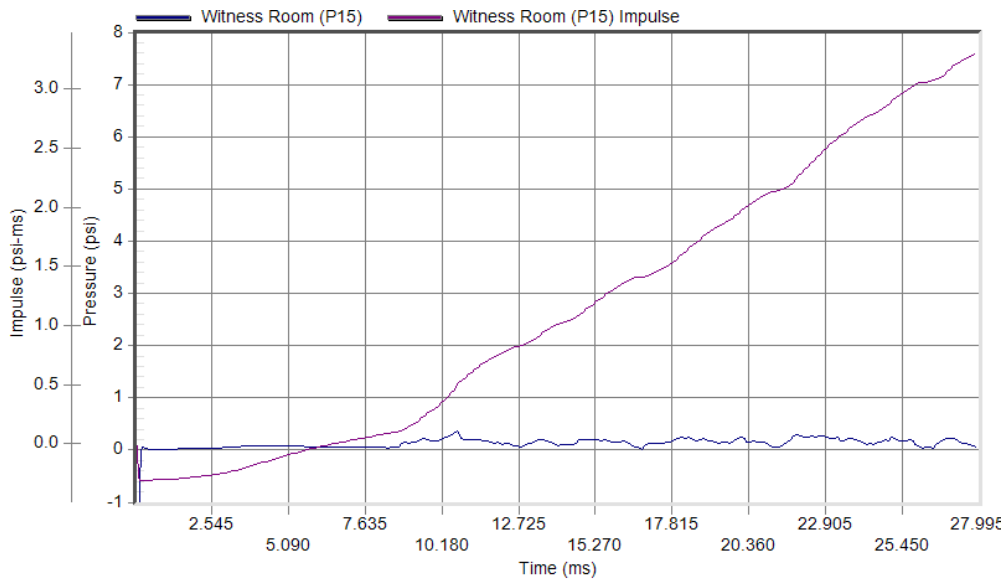
Peak Pressure: 0.37 psi at 10.67 ms  
Duration: 6.10 ms

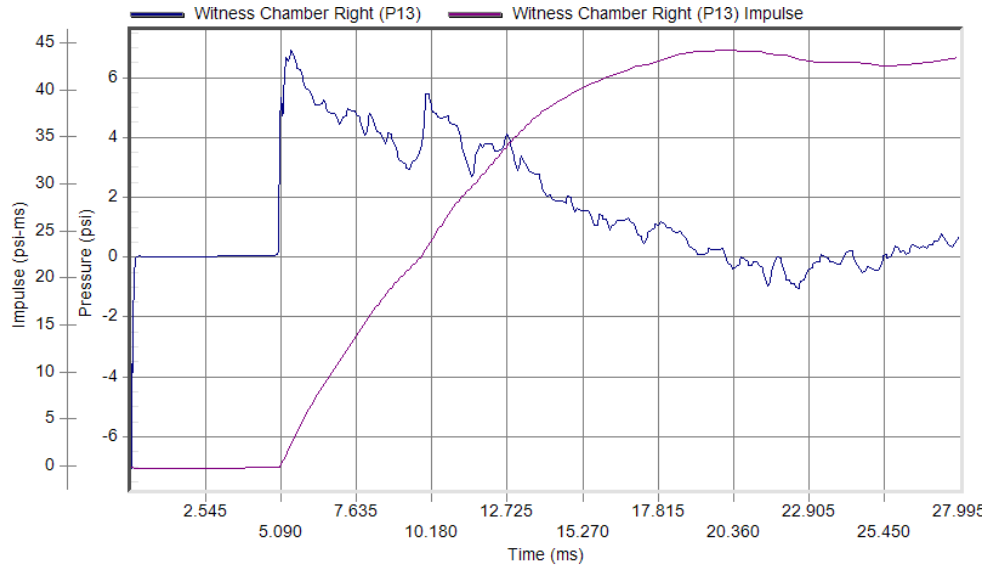
Peak Pressure: 6.93 psi at 5.44 ms  
Duration: 14.65 ms

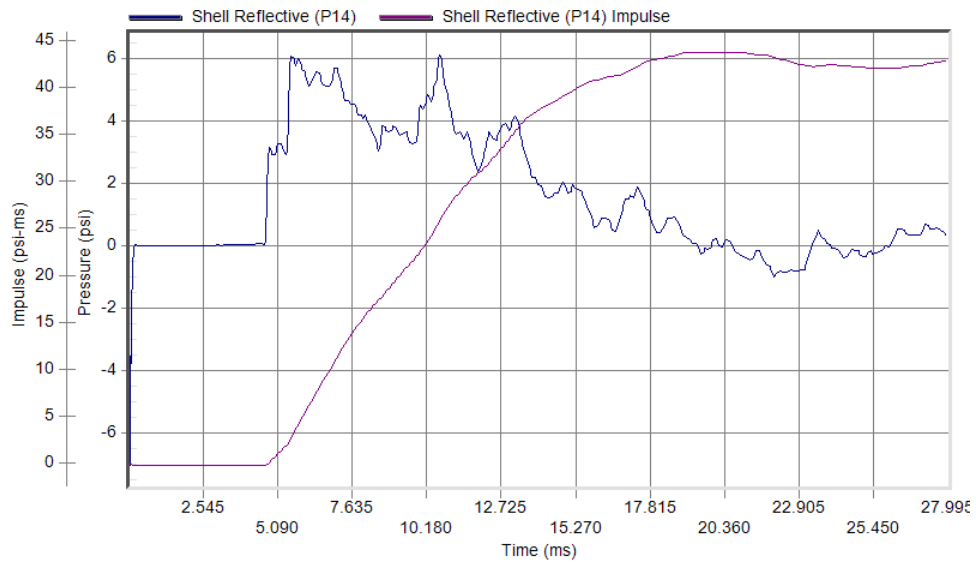
Peak Pressure: 6.21 psi at 10.64 ms  
Duration: 8.65 ms

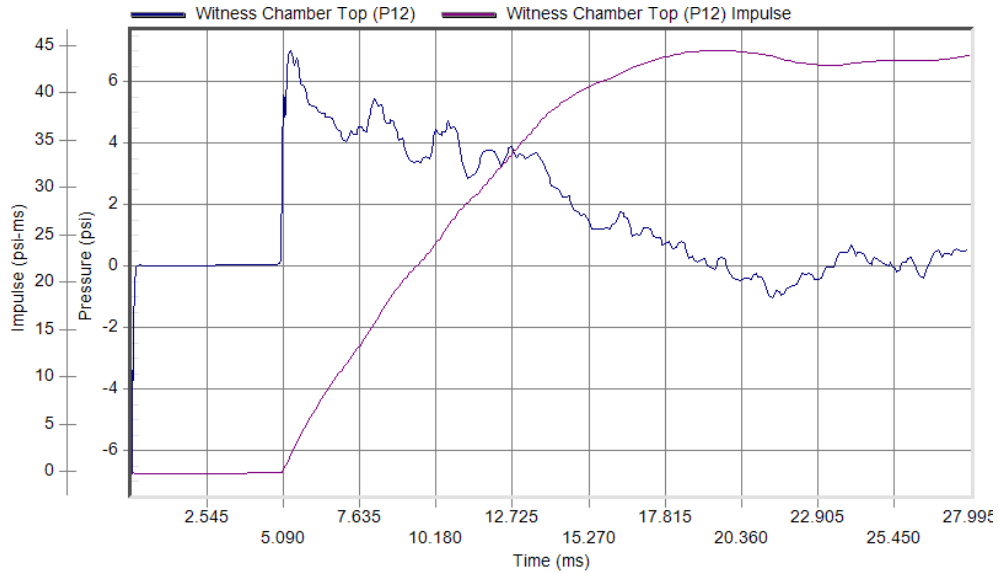
Peak Pressure: 7.02 psi at 5.34 ms  
Duration: 13.86 ms

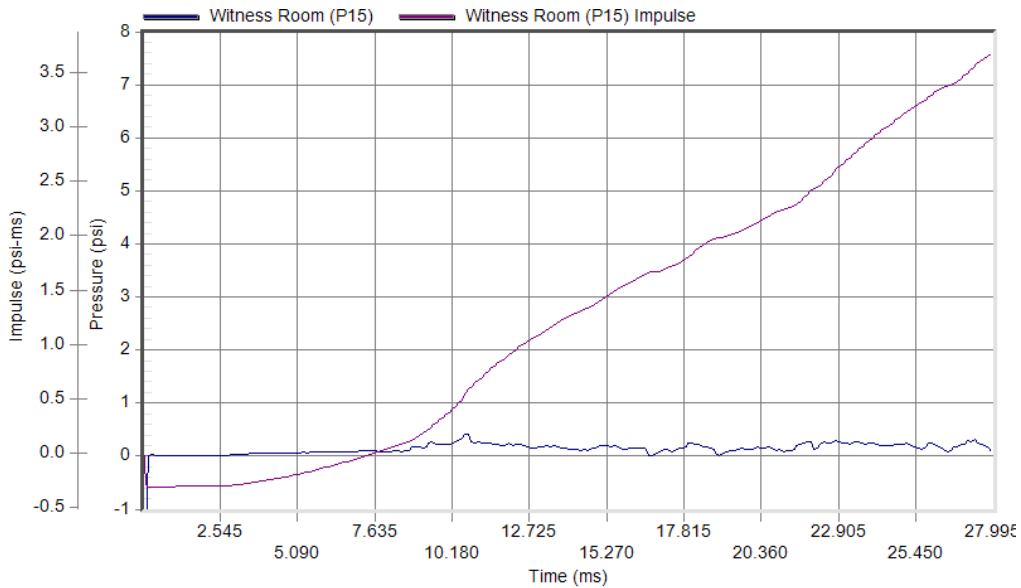
Peak Pressure: 0.42 psi at 10.67 ms  
Duration: 6.02 ms

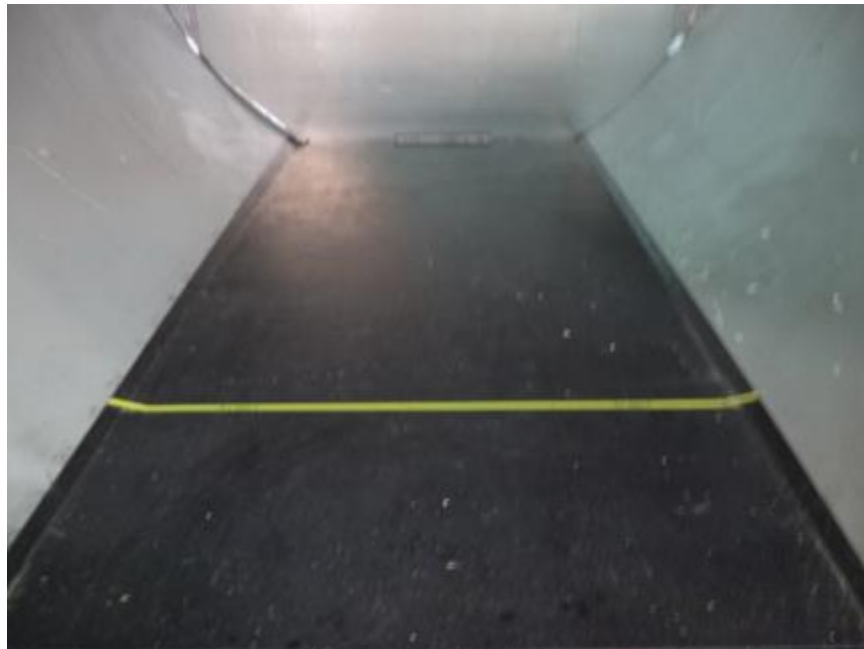
**Photo No. 2**  
**Post-test Specimen #1, Witness Chamber**

<b>Witness Chamber Results</b>
No debris was observed.

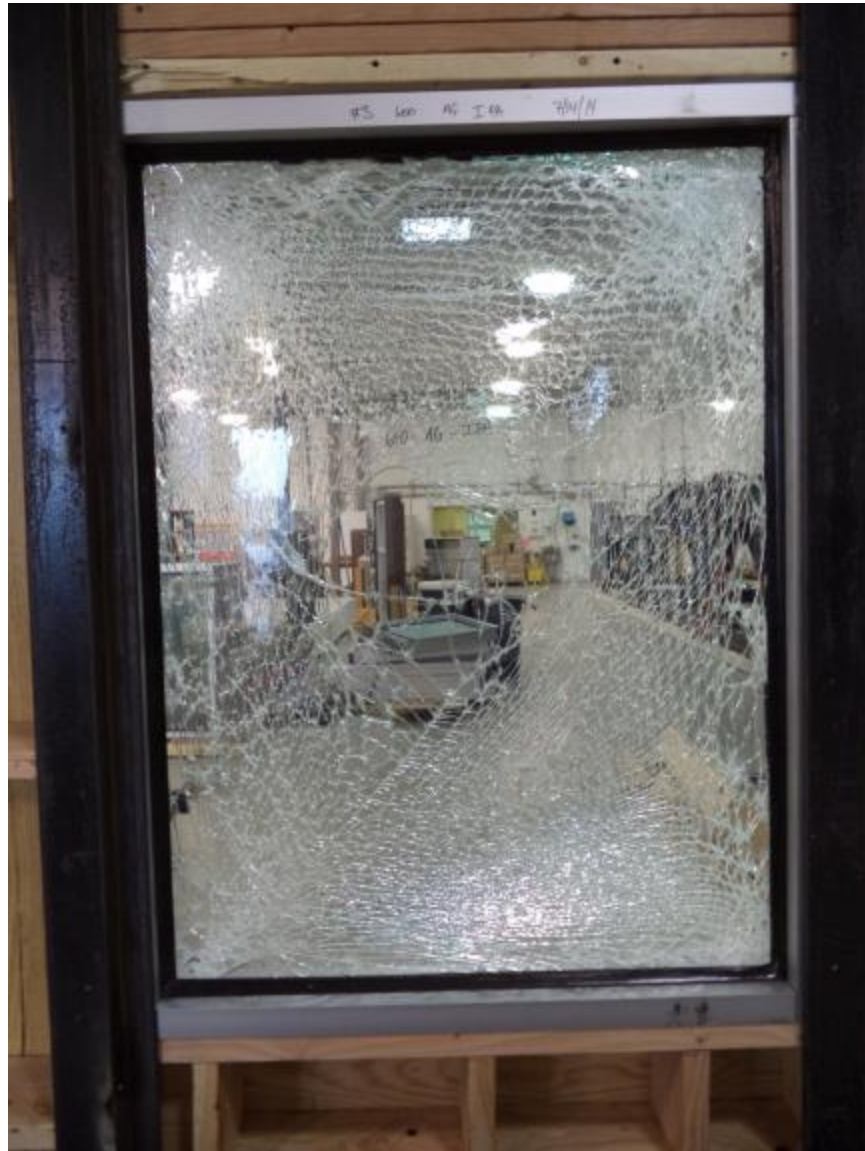
**Photo No. 3**  
**Post-test Specimen #1, Interior**

<b>Glazing Response</b>	
Lite	Fractured
Glazing Pullout Length and Location	None
Glazing Tearing	None

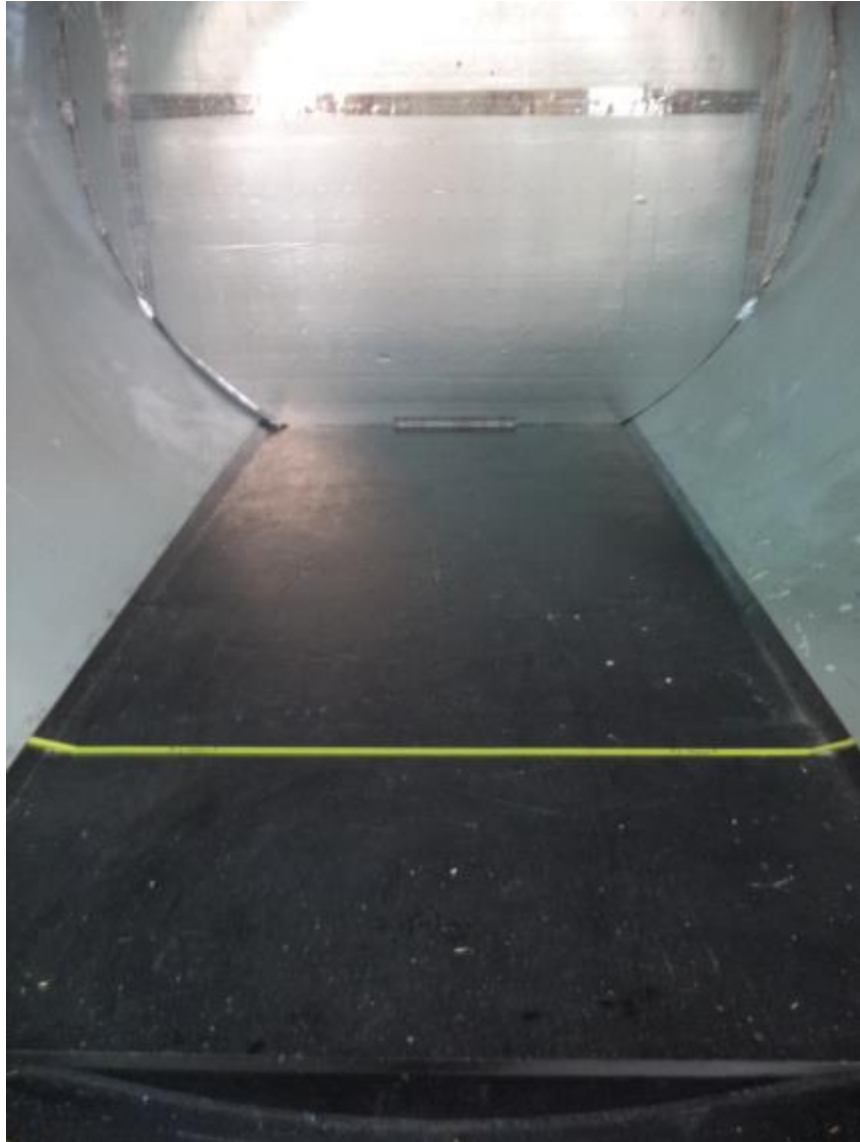
**Photo No. 5**  
**Post-test Specimen #2, Witness Chamber**

<b>Witness Chamber Results</b>
No debris was observed.

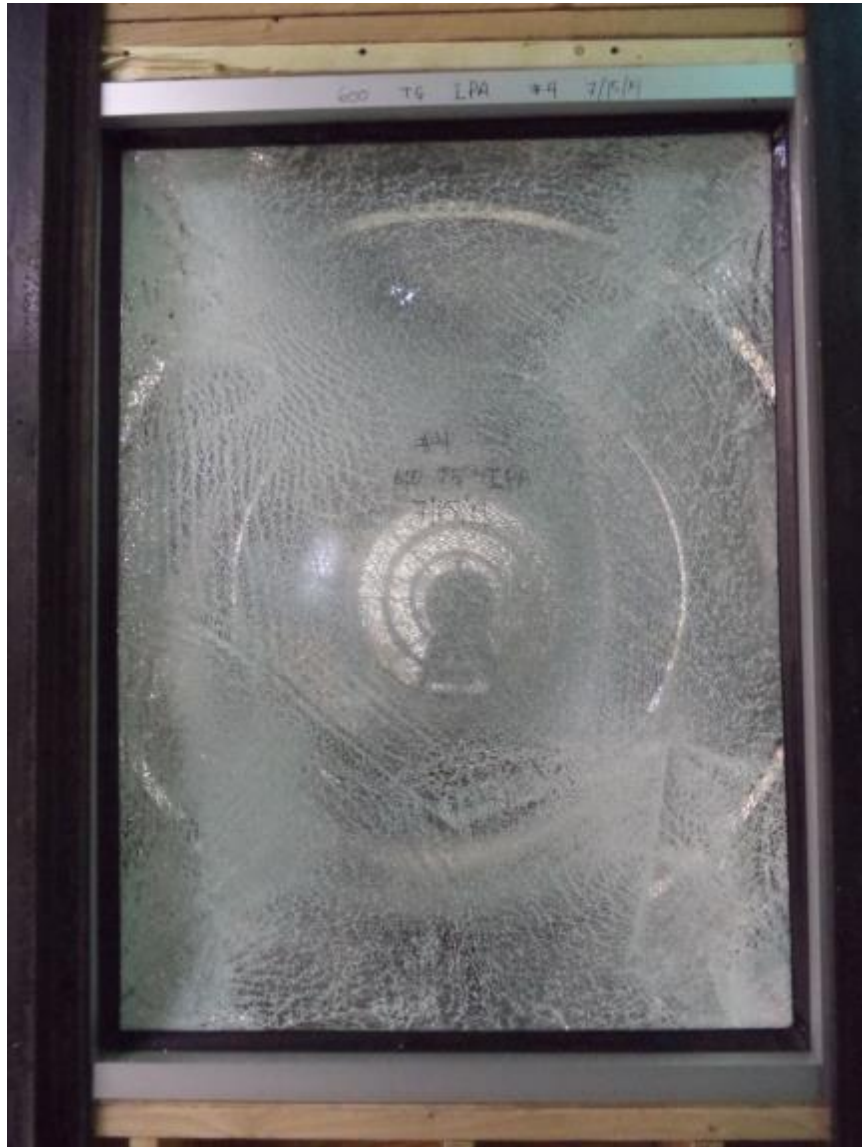
**Photo No. 6**  
**Post-test Specimen #2, Interior**

<b>Glazing Response</b>	
Exterior Lite	Fractured
Glazing Pullout Length and Location	None
Glazing Tearing	None

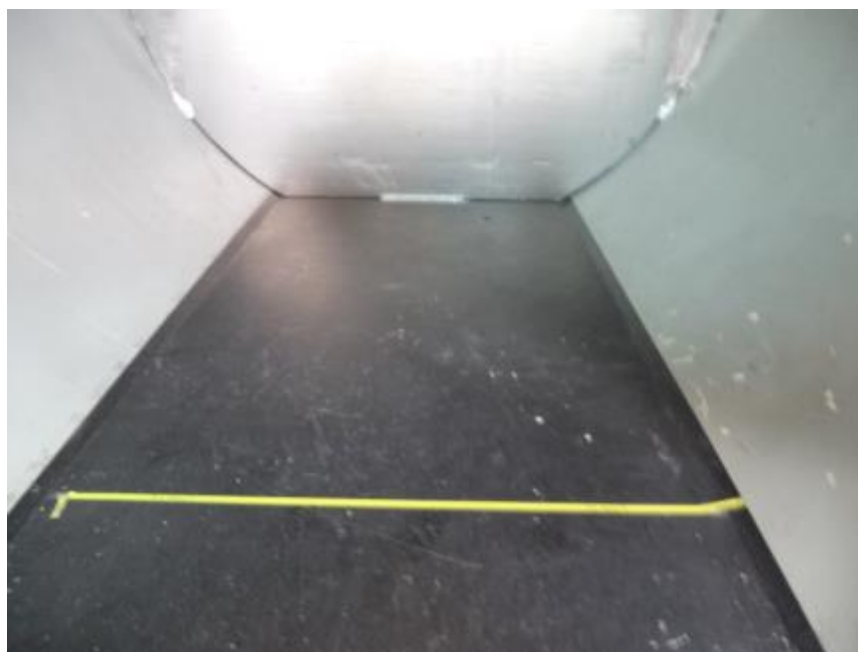
**Photo No. 8**  
**Post-test Specimen #3, Witness Chamber**

<b>Witness Chamber Results</b>	
No debris was observed.

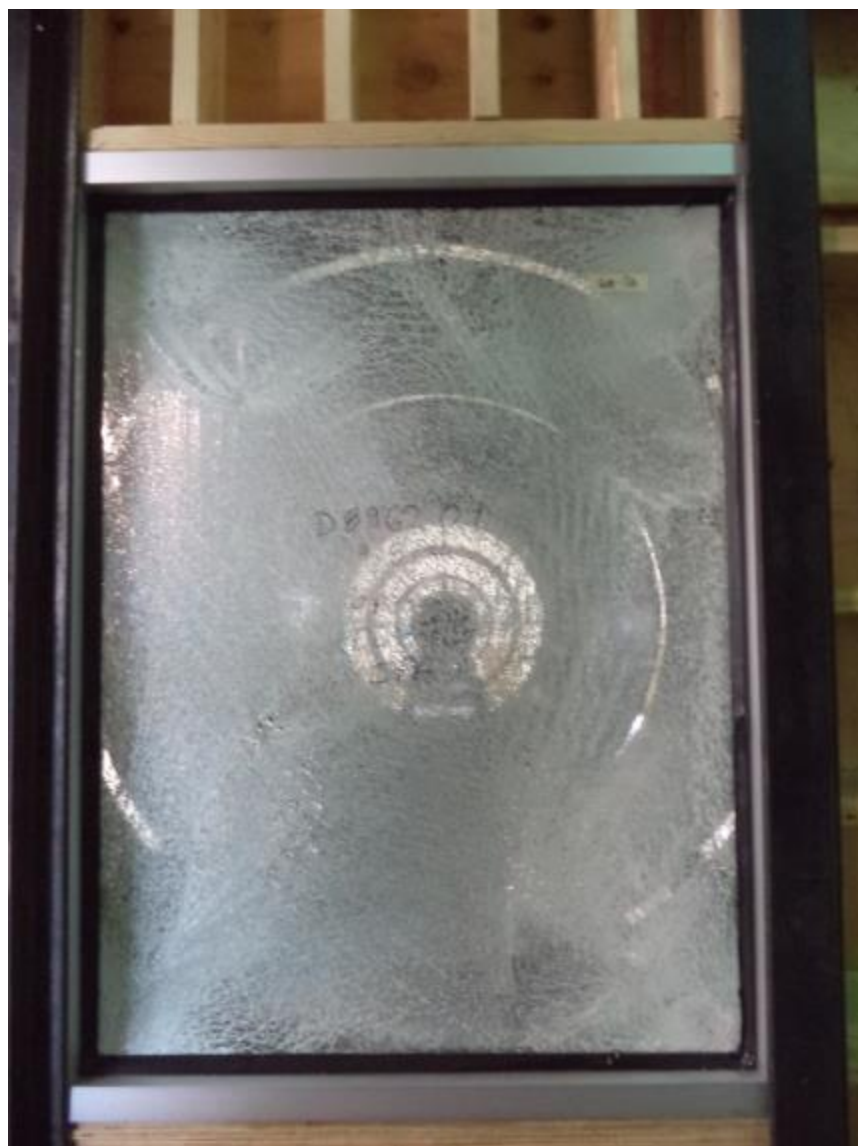
**Photo No. 9**  
**Post-test Specimen #3, Interior**

<b>Glazing Response</b>	
Exterior Lite	Fractured
Glazing Pullout Length and Location	None
Glazing Tearing	None

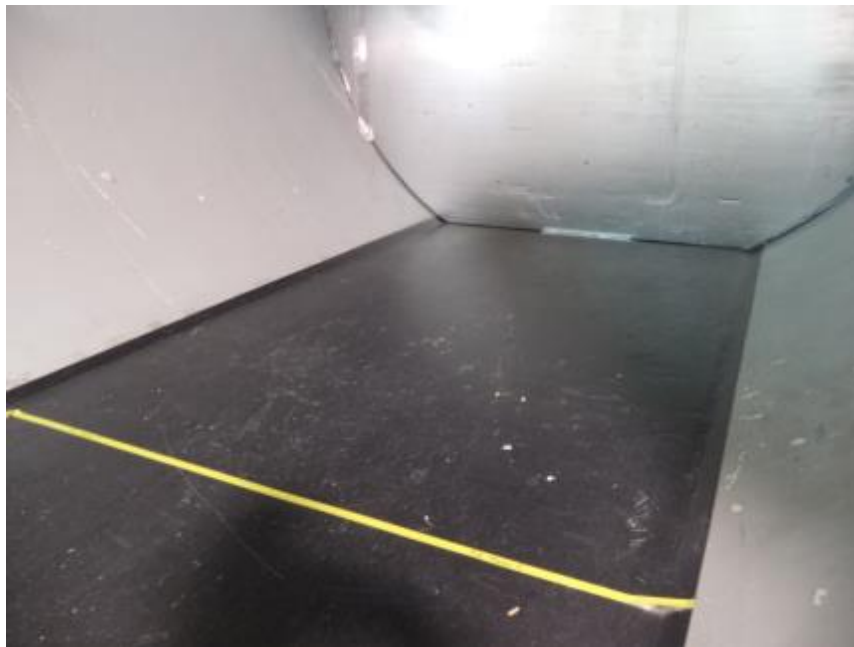
**Photo No. 11**  
**Post-test Specimen #4, Witness Chamber**

Witness Chamber Results
A large quantity of fragments was found on the witness chamber floor past the 1M mark. Several fragment indents were found on the witness panel with 1 perforation at 38" from the floor

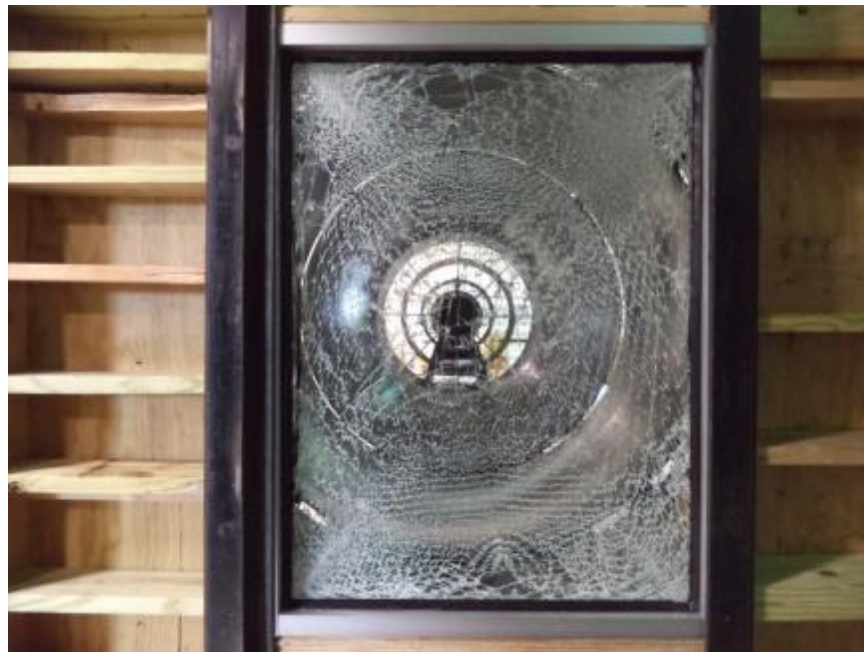
**Photo No. 12**  
**Post-test Specimen #4, Interior**

Glazing Response	
Exterior Lite	Fractured
Glazing Pullout Length and Location	None
Glazing Tearing	None
