**ASTM F1642-04 / GSA TS01 TEST REPORT**

3M Company - St. Paul, Minnesota

Fragment Retention Film on 1/4" Single Pane Glass

3M™ Scotchshield™ Ultra S600 Safety and Security Window Film with  
3M™ Impact Protection Adhesive Film Attachment System

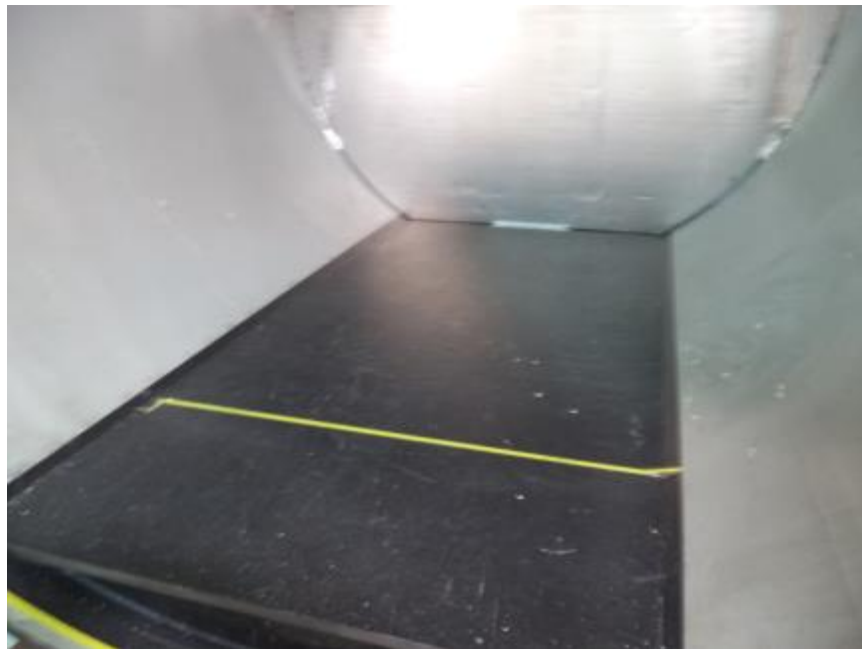
**Photo No. 14**  
**Post-test Specimen #6, Witness Chamber**

<b>Witness Chamber Results</b>
A dusting of glass was deposited on the witness chamber floor back to the 1M mark

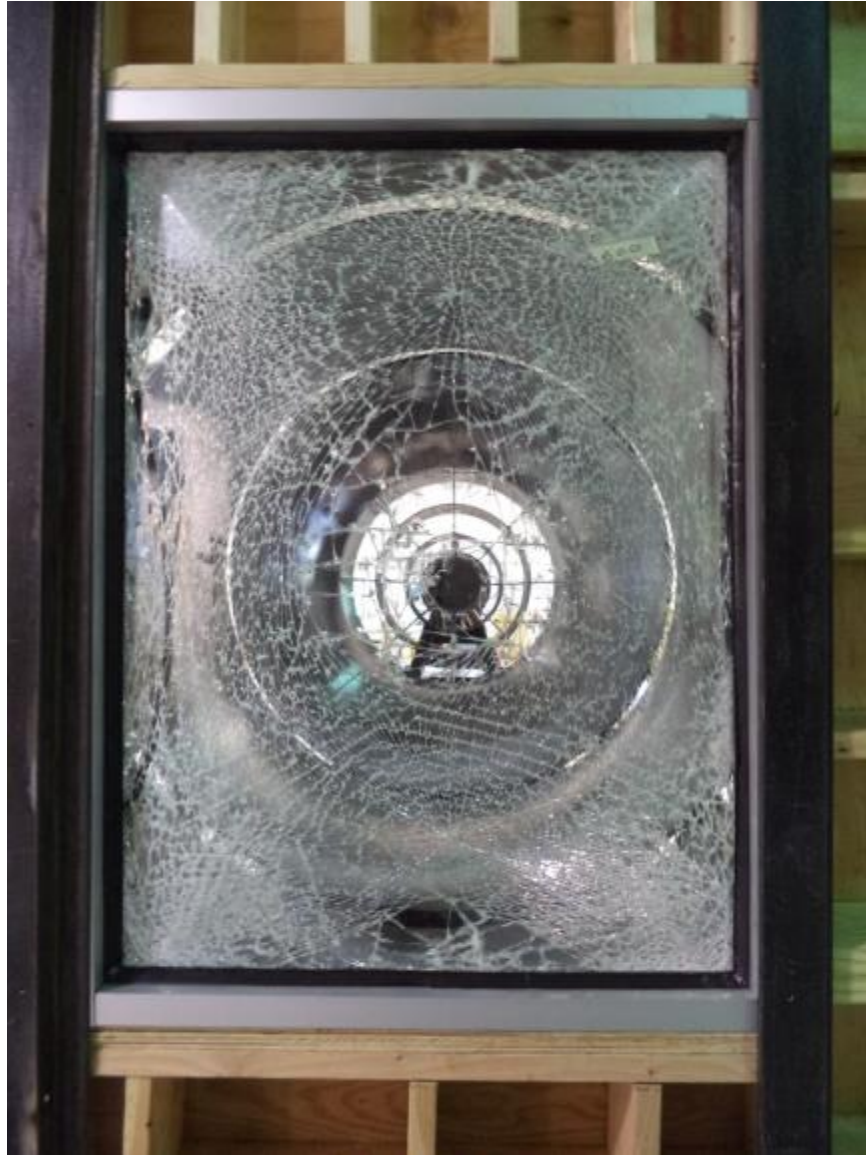
**Photo No. 15**  
**Post-test Specimen #6, Interior**

<b>Glazing Response</b>	
Lite	Fractured
Glazing Pullout Length and Location	None
Glazing Tearing	1" at upper right corner and 3/4" at center

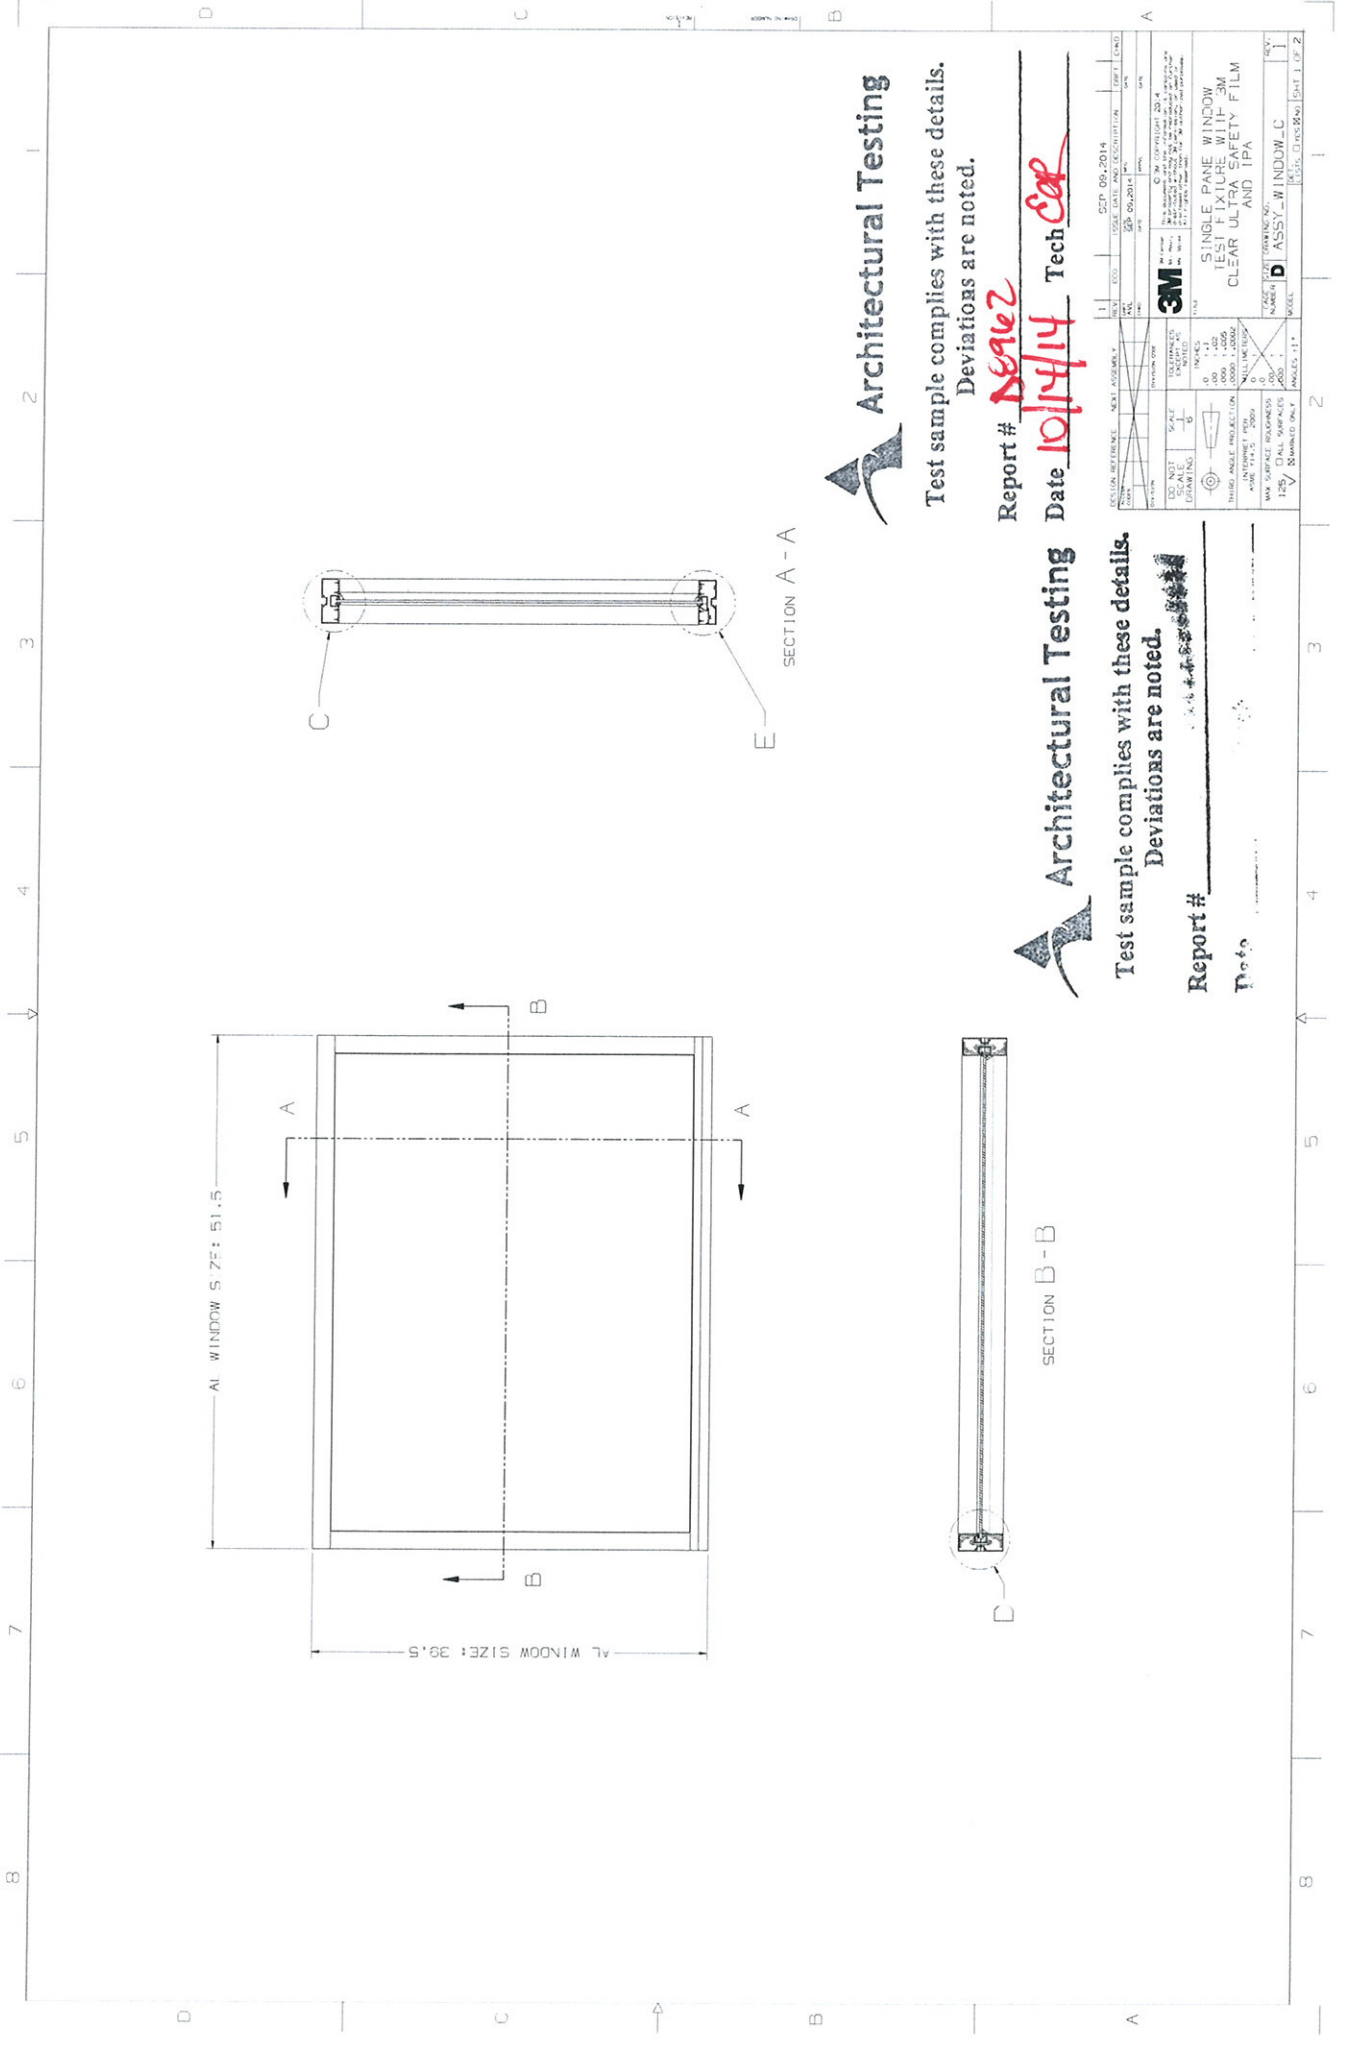
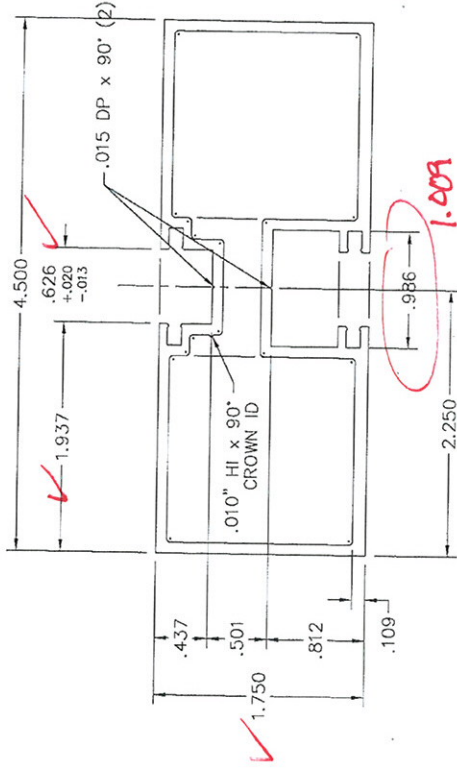
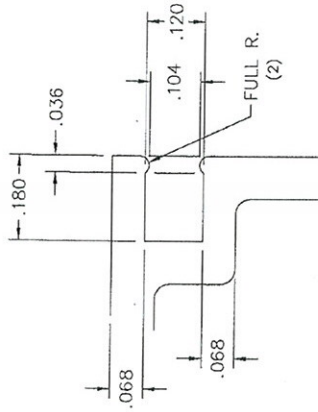
DETAIL "A"  
4 x SIZE

ESTIMATED DIE DATA	
ALLOY/TEMPER:	6063-T5
AREA	1.445 W/FT 1.733
PERIMETER	31.168 SCALE 4 - 5
OUTSIDE PERIMETER	17.197 FACTOR 18
EXPOSED PERIMETER	17.197 HOLLOW
DATE

DIE #	12580
SCALE	FULL & NOTED
DATE	12-11-08
LAST REVISION	03-24-11
DRAWN	TCG
CUSTOMER NUMBER	45-010
<b>Crown Extrusions, Inc.</b> 122 Columbia Court N. Chaska, MN 55318 952-446-3533 Fax: 952-446-3528	
<b>CMI Architectural</b> CMI Architectural Products, Inc. 20621 SD Highway 25 DeSmet, SD 57231-5827 605-854-3226 Fax: 605-854-3220	
PART NAME: MULLION

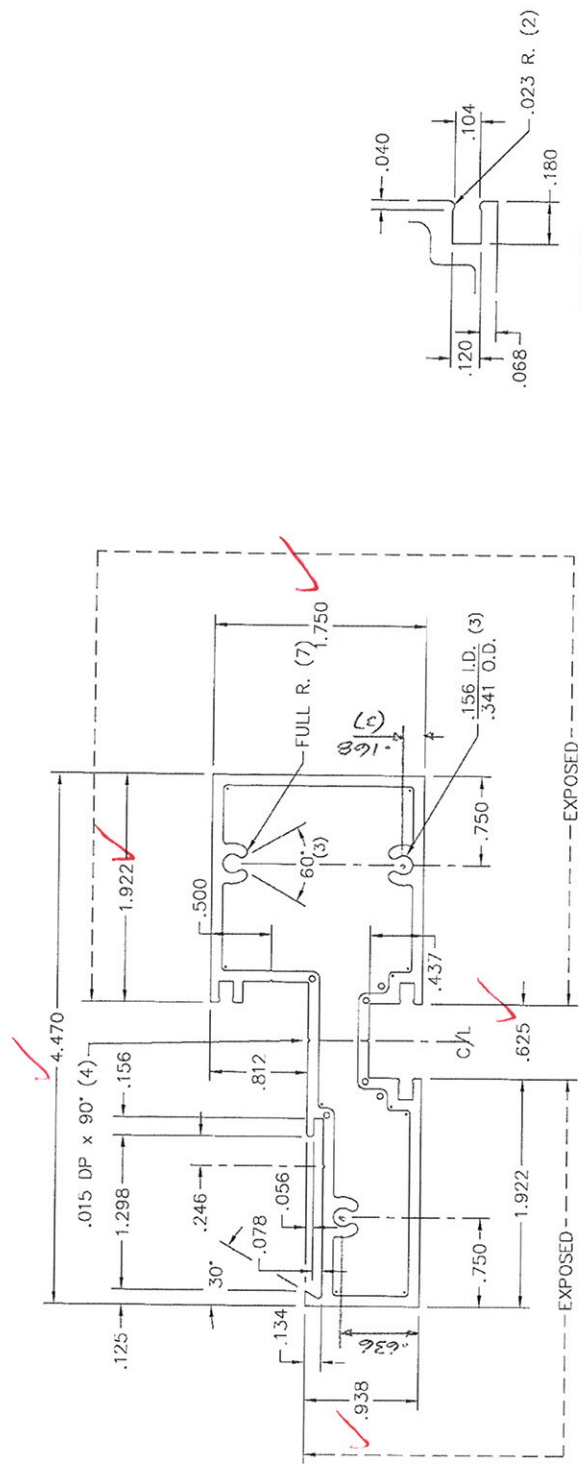
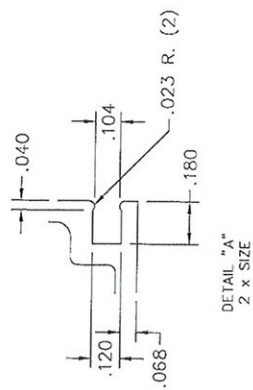
BREAK UNSPECIFIED CORNERS	.010 R	.090	TYPICAL WALL UNLESS SPECIFIED OTHERWISE.
ESTIMATE #	6063-T5	CAD #	CRM-44 350
INTERNAL USE	AREA 1.354	W/FT 1.624	SCALE FULL & NOTED
PERIMETER 29.721	CIRCLE SIZE 4 - 5	FACTOR 18	DATE 7-29-98
NUMBER OF POINTS 15.421	EXPOSED PERIMETER	HOLLOW II	LAST REVISION
CUSTOMER		DRAWN BY	
sapa: Sapa Extrusions, Inc. BEULIA71832		Michael Bryson	
CUSTOMER		JOB	
CMI ARCHITECTURAL PRODUCTS		MINNEAPOLIS, MN 55430	
2800 FREEWAY BOULEVARD		F.C. SILL 1/4"	
SUITE 205		APPLICATION	
MINNEAPOLIS, MN 55430		CUSTOMER NUMBER	
F.C. SILL 1/4"		45-018

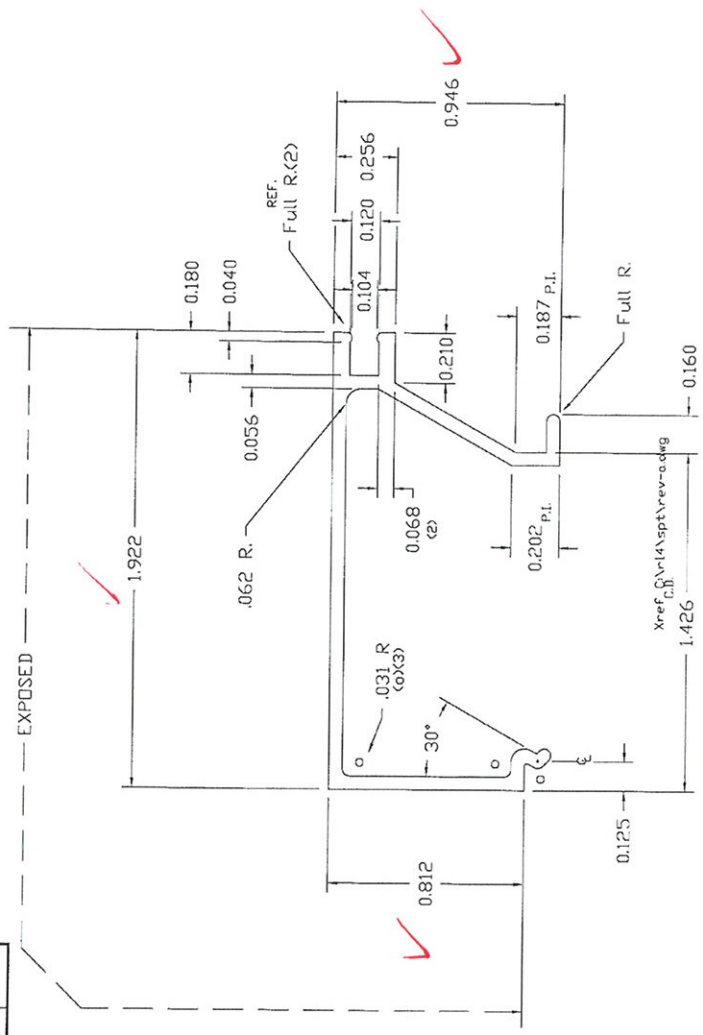
sapa: Sapa Extrusions, Inc. DELU, LA 71232		CARD #
CUSTOMER: CRONSTROMS		SCALE: 2 x & Noted
MINNEAPOLIS, MN		DATE: 10-31-88
APPLICATION: SILL STOP 1/4" TO 1"		LAST REVISION:
DRAWN: J. ALBEREZ		JOB:
CUSTOMER NUMBER: 45-026

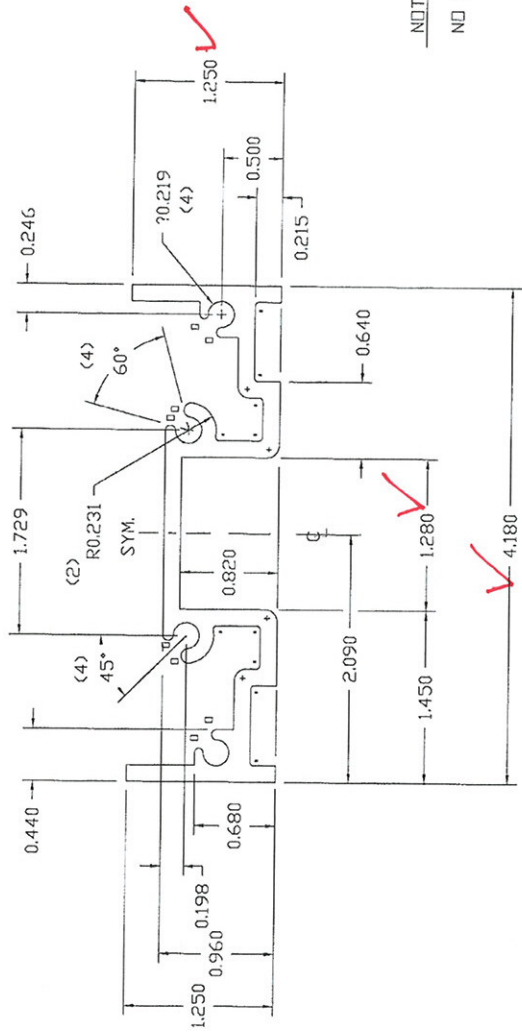
ESTIMATED DIE DATA		SAPA: Sapa Extrusions, Inc.		DAMD # MRC---10 010	
INTERNAL USE	6063-T5	CUSTOMER	CRONSTROMS	SCALE	ACTUAL
AREA	1.389	W/FT	1.667	DATE	12-3-88
PERIMETER	23.555	CIRCLE SIZE	4-5	LAST REVISION	
OUTSIDE LENGTH		FACTOR	12	DRAWN	M. COPEL
EXPOSED PERIMETER				JOB	308
DIE DIMENSIONS		MINNEAPOLIS, MINN.		CUSTOMER NUMBER	
				32-002	
APPLICATION		MULL. CLIP
