ASTM F1642-04 / GSA TS01 TEST REPORT

3M Company - St. Paul, Minnesota

Fragment Retention Film on 1/4" Single Pane Glass

Report No.: D8962.03-119-12

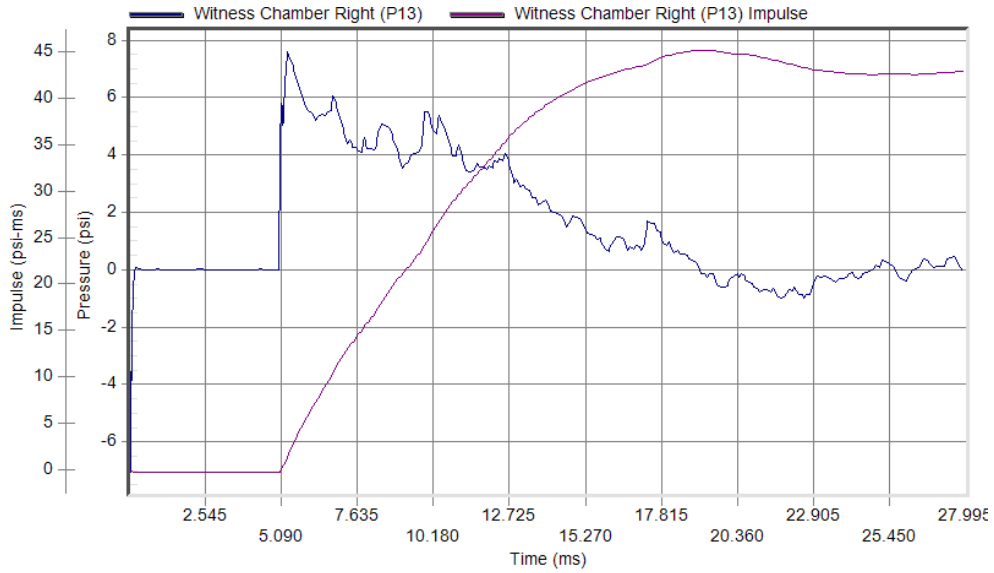
Peak Pressure: 7.65 psi at 5.32 ms
Duration: 13.76 ms

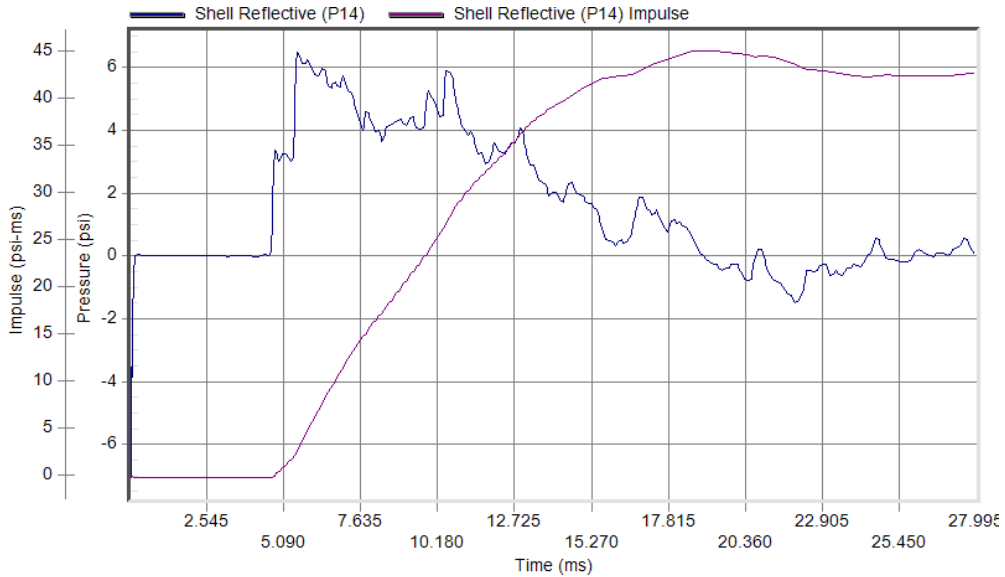
Peak Pressure: 6.53 psi at 5.59 ms
Duration: 13.27 ms

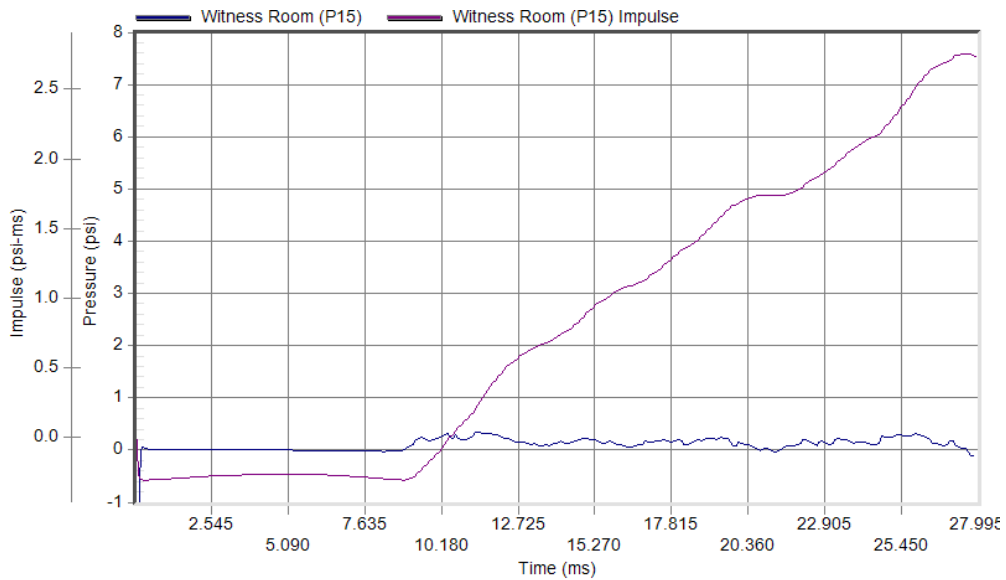
Peak Pressure: 0.34 psi at 11.41 ms
Duration: 9.27 ms

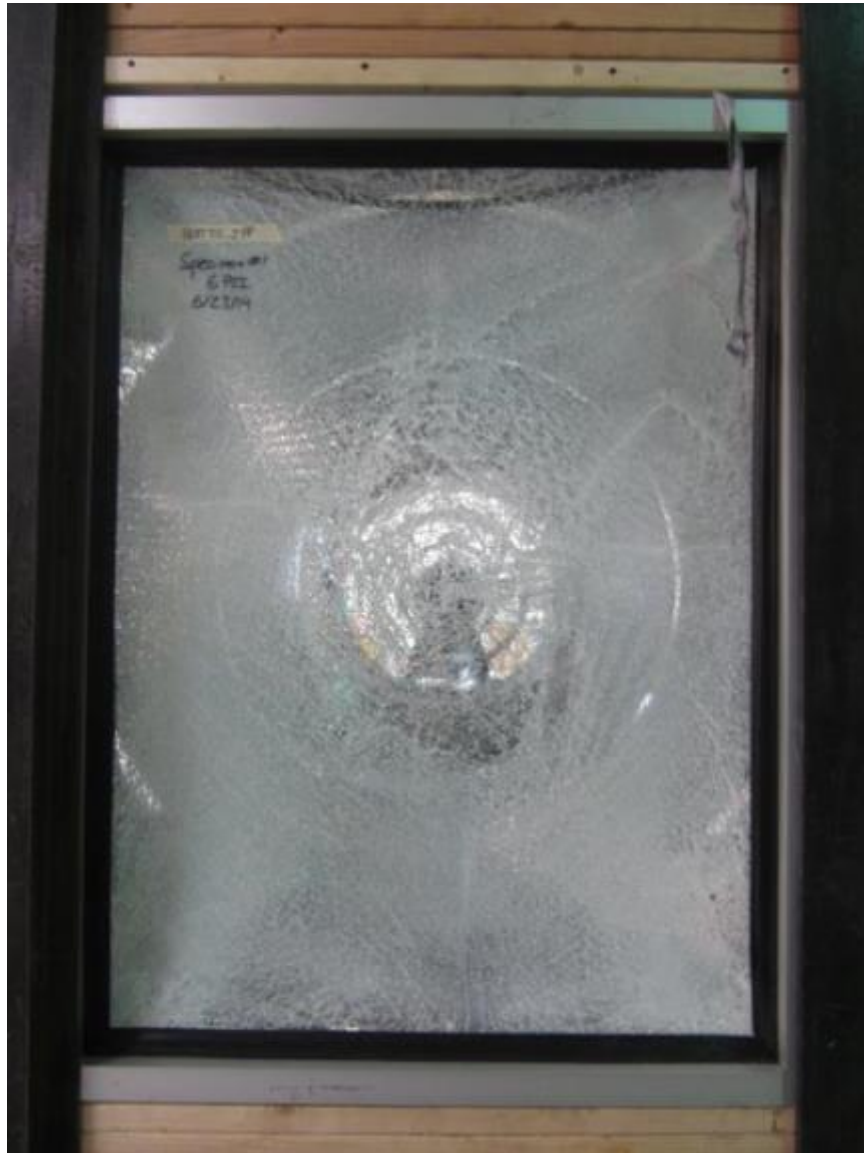
Photo No. 3
Post-test Specimen #1, Interior

Glazing Response	
Lite	Fractured
Glazing Pullout Length and Location	None
Glazing Tearing	None

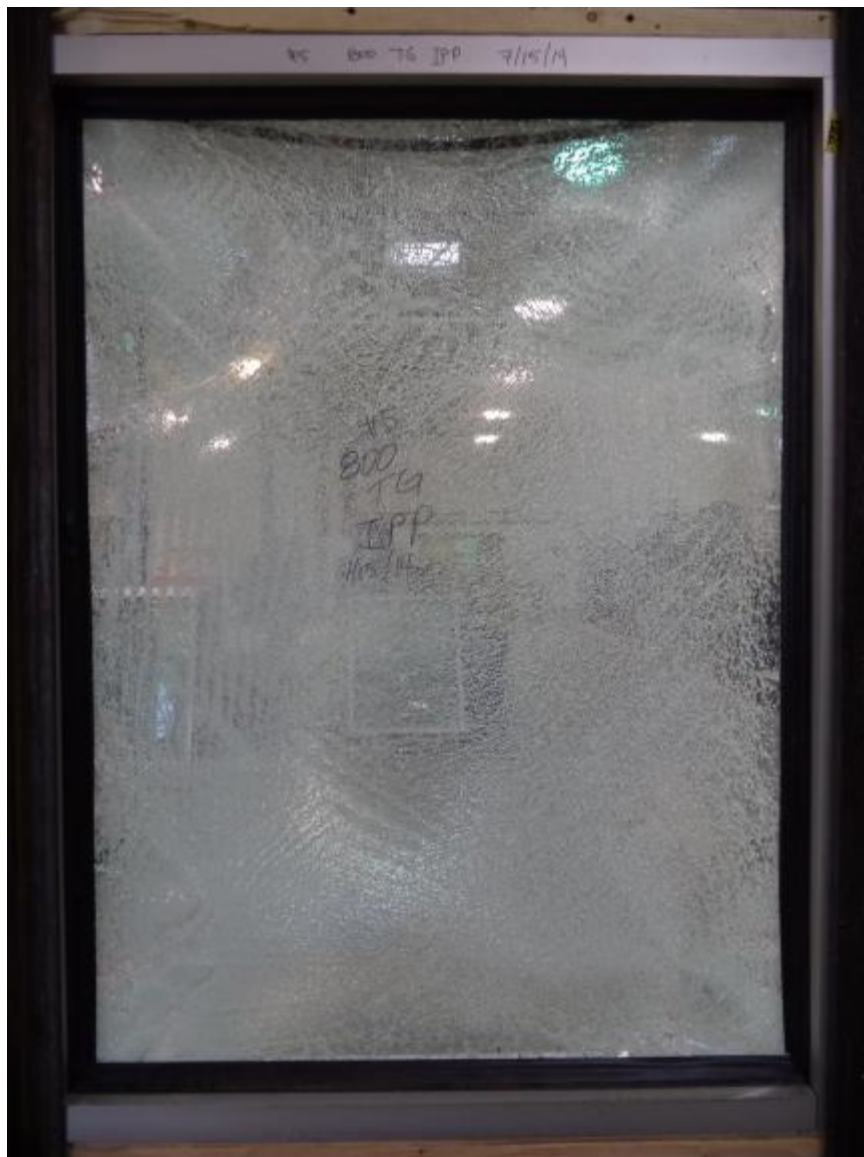
Photo No. 5
Post-test Specimen #2, Interior

Glazing Response	
Exterior Lite	Fractured
Glazing Pullout Length and Location	None
Glazing Tearing	None

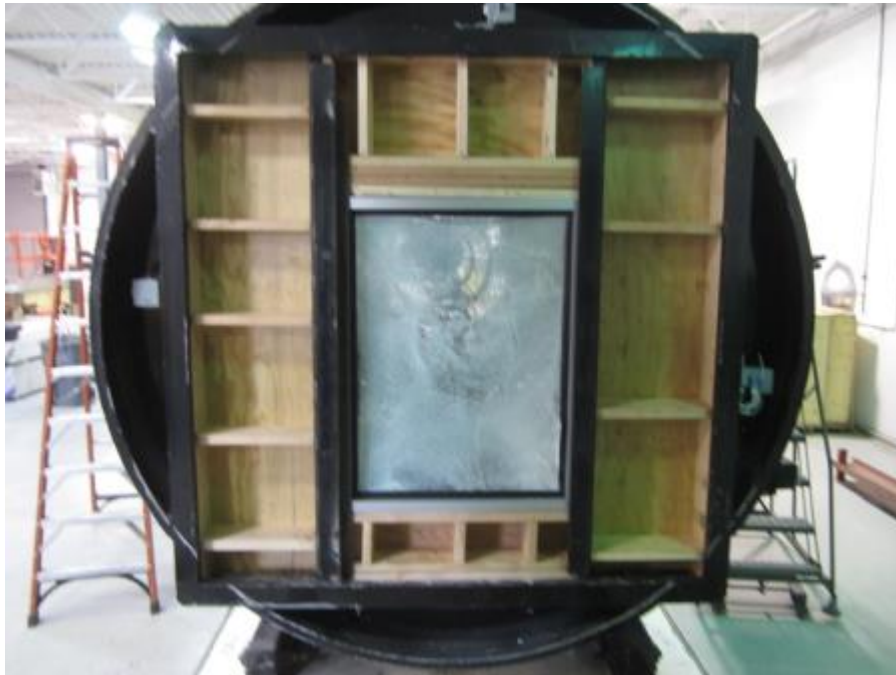
Photo No. 11
Post-test Specimen #4, Interior

Glazing Response	
Exterior Lite	Fractured
Glazing Pullout Length and Location	None
Glazing Tearing	None

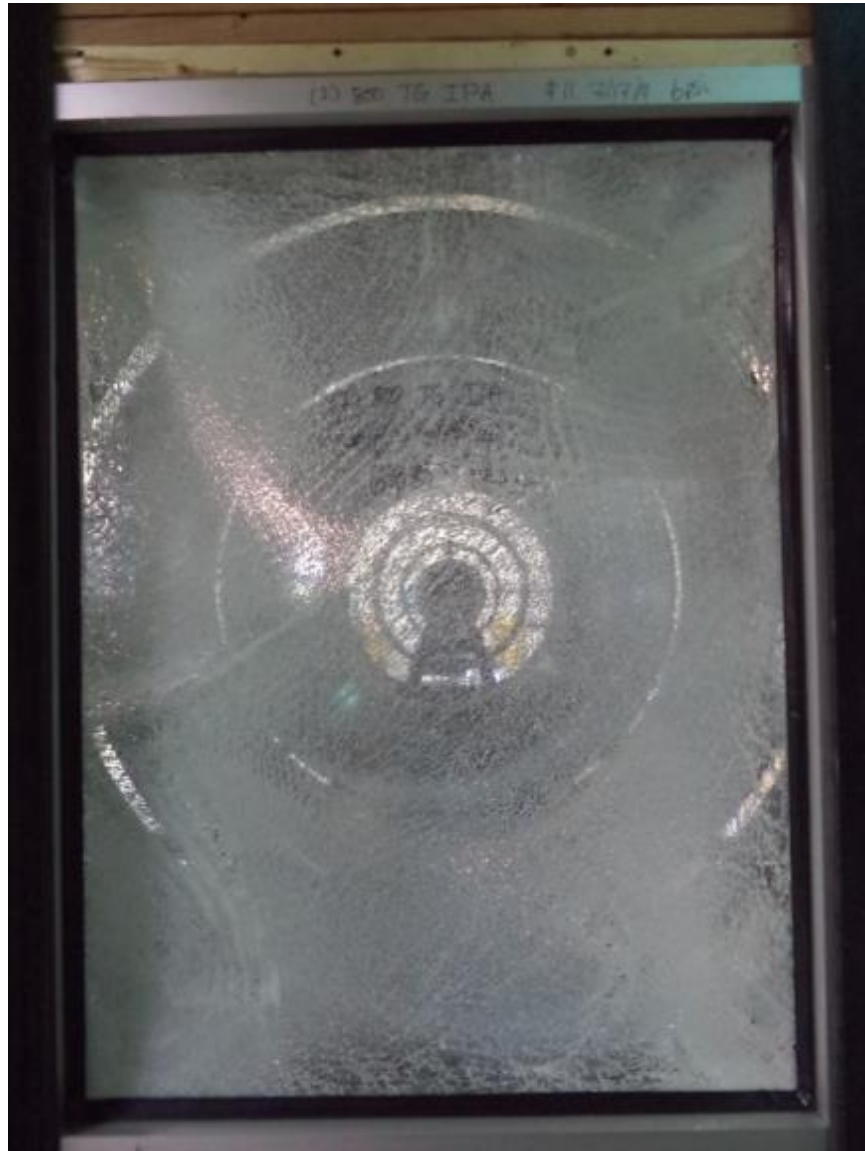
Photo No. 16
Post-test Specimen #6, Interior

Glazing Response	
Lite	Fractured
Glazing Pullout Length and Location	None
Glazing Tearing	None

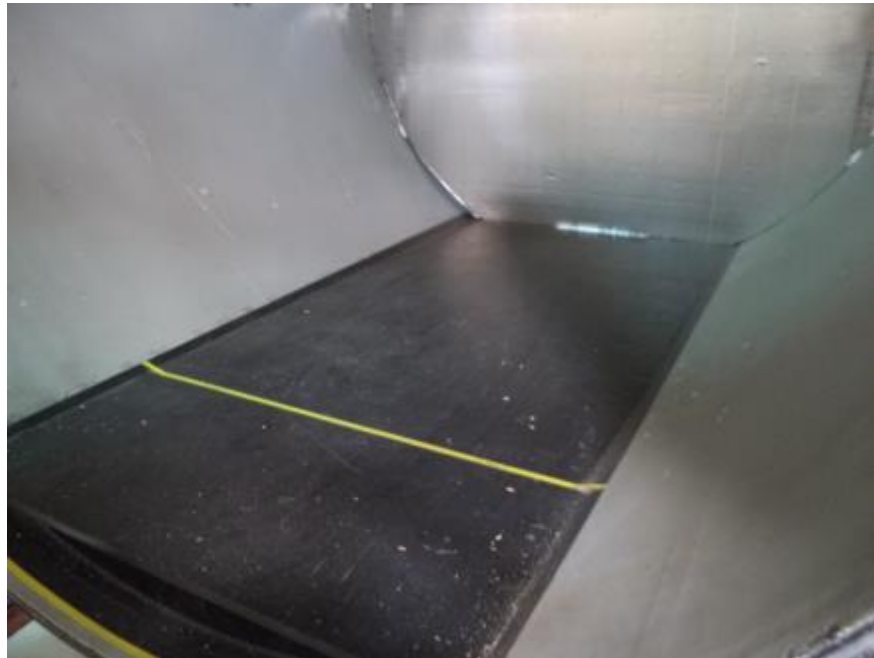
Photo No. 17
Post-test Specimen #6, Witness Chamber

Witness Chamber Results
No debris was observed.

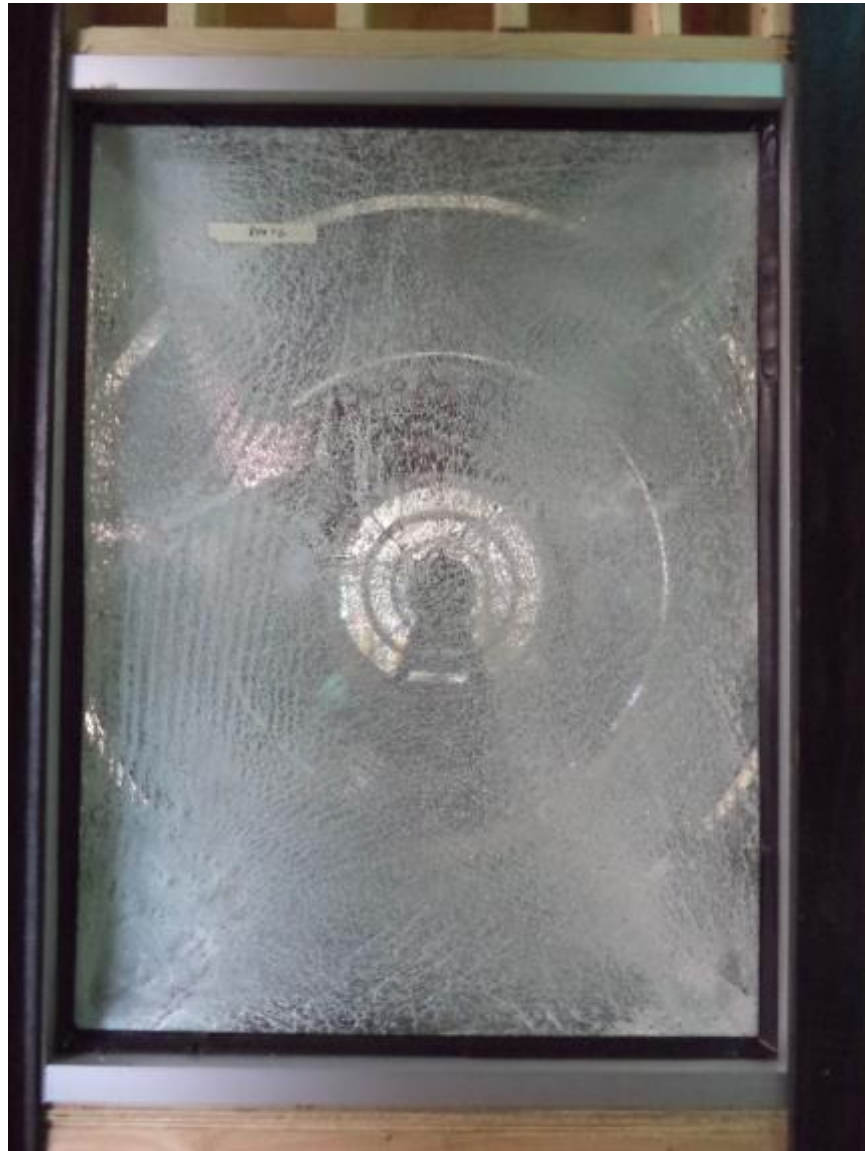
Photo No. 19
Post-test Specimen #7, Interior

Glazing Response	
Exterior Lite	Fractured
Glazing Pullout Length and Location	None
Glazing Tearing	None

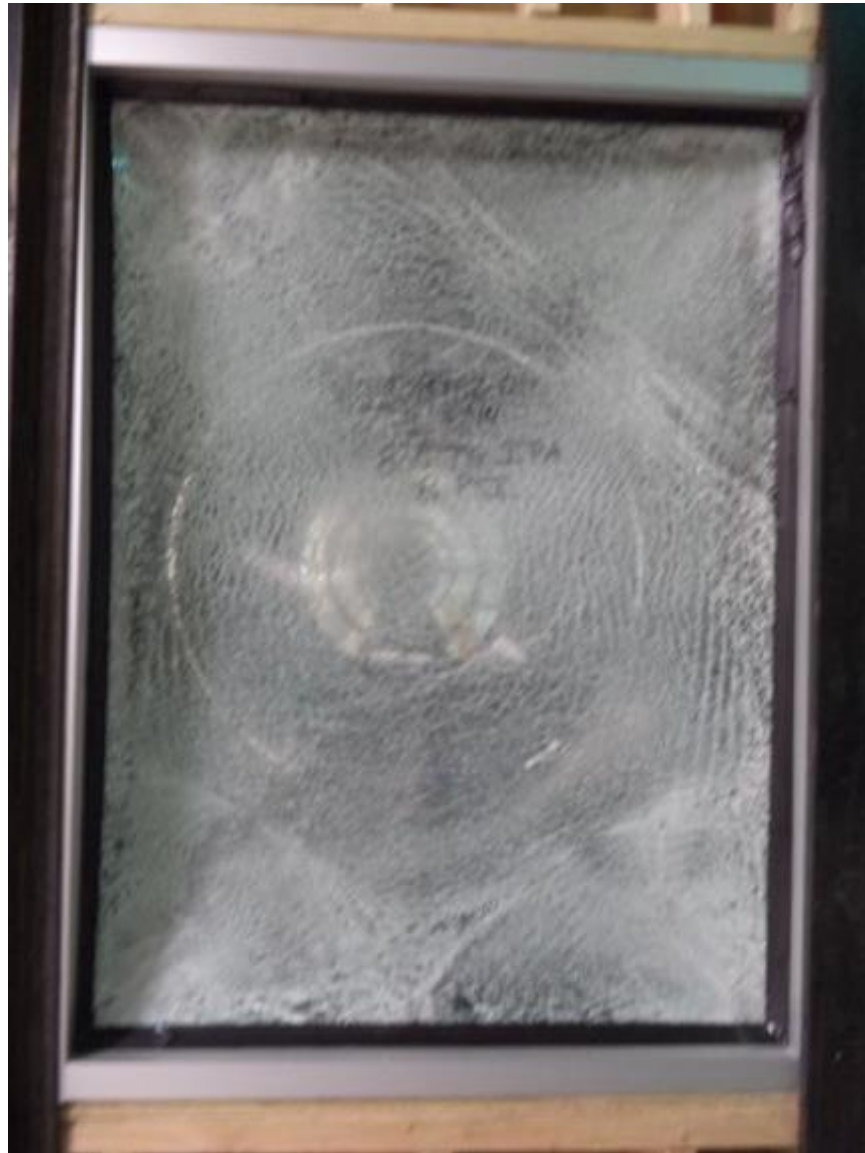
Photo No. 22
Post-test Specimen #8, Interior

Glazing Response	
Lite	Fractured
Glazing Pullout Length and Location	None
Glazing Tearing	None
