ARA-TR-03-16095.1

Explosive Tests for the Evaluation of 3M Corporation Window Systems

**Applied Research Associates, Inc.
Security Engineering Group
119 Monument Place
Vicksburg, MS 39180**

November 2003

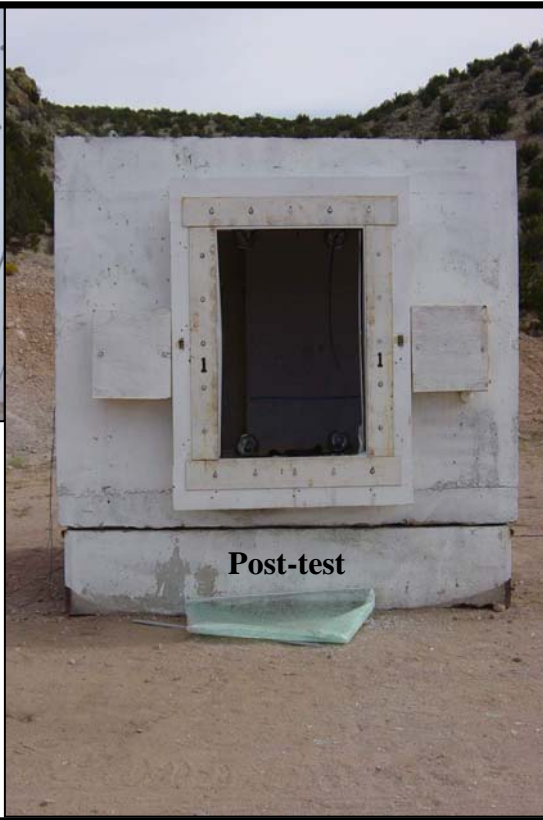
Test 2, Window 1
4.15 psi – 29.08 psi-msec

- 1/4" monolithic AG, mechanically attached 8-mil security film (2-sided batten bar attachment)
- Glazing landed outside of structure. Glass fragments landed inside of structure. One glass fragment impacted the witness panel in Region 5.

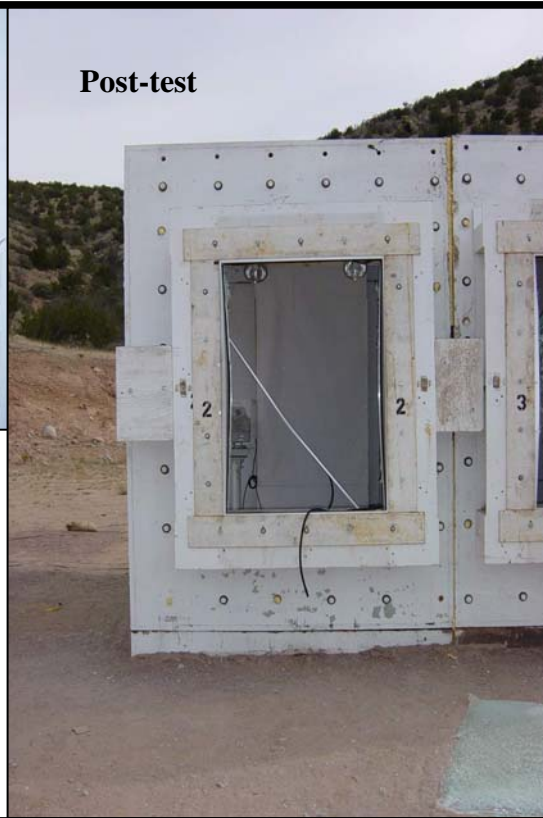
Test 2, Window 2
4.15 psi – 29.08 psi-msec

- 1/4" monolithic AG, mechanically attached 4-mil security film (2-sided batten bar attachment)
- Glazing landed outside of structure. Glass fragments landed inside of structure. Two glass fragments impacted the witness panel in Region 4.

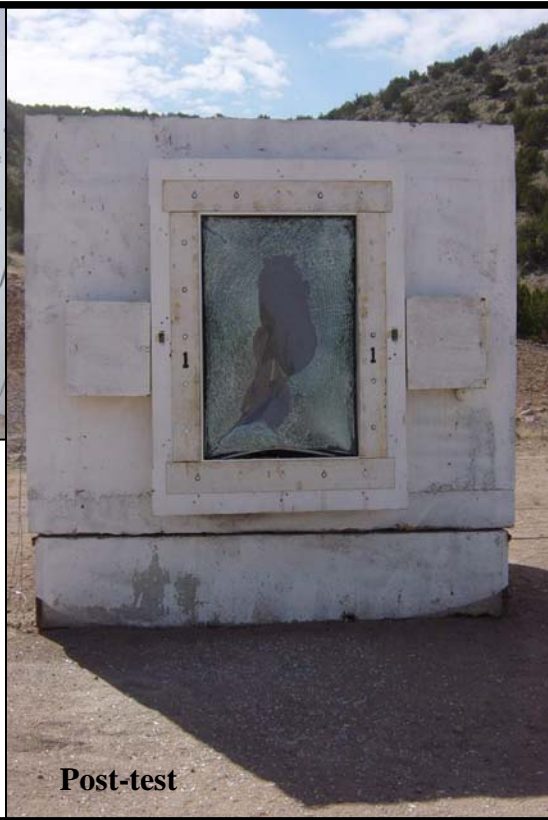
Test 3, Window 1

- 1/4" monolithic AG, mechanically attached 8-mil security film (4-sided batten bar attachment)
- Film remained attached to frame, but some glass was stripped from the film and landed to the exterior of the structure. Fragments landed in 3b region inside of structure. No impacts evident on witness panel.

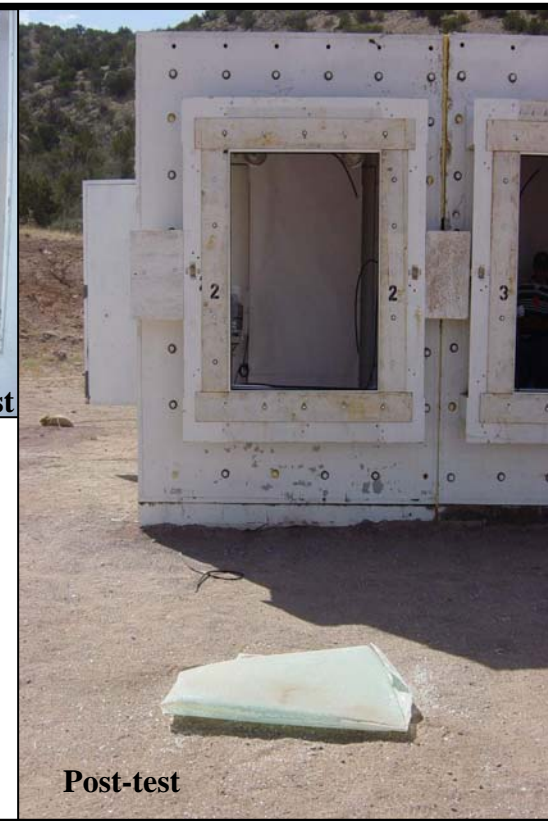
Test 3, Window 2

- 1/4" monolithic TTG, daylight applied 8-mil security film
- Glazing landed outside of structure. Fragments landed in 3b region inside of structure. No impacts evident on witness panel.

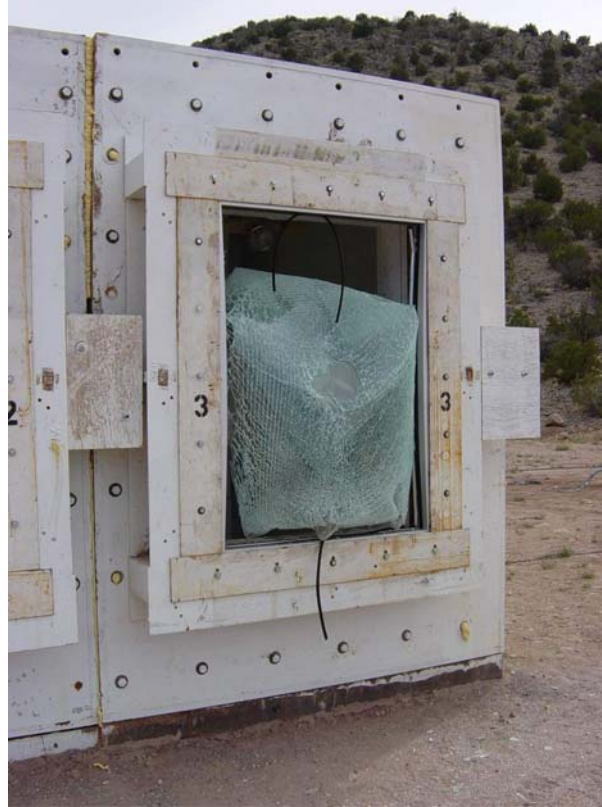
Figure 3-22 Exterior post-test view of window 3. (DSC04162.jpg)

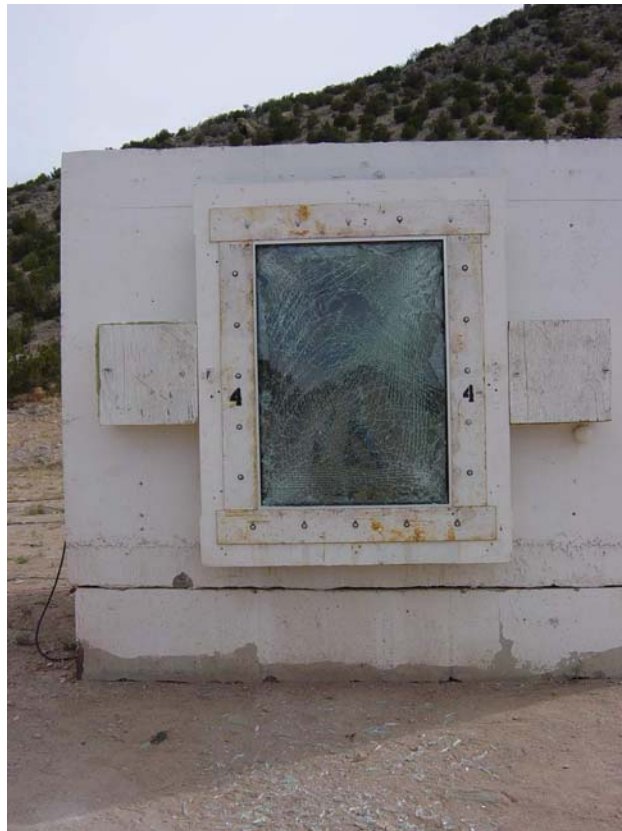
Figure 3-25 Exterior post-test view of window 4. (DSC04214.jpg)

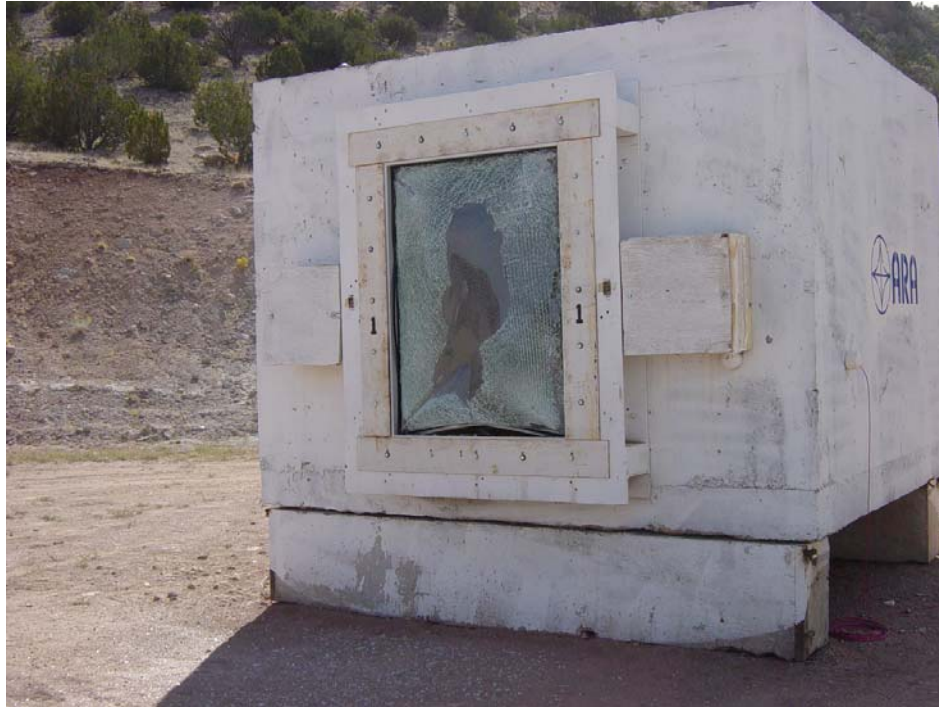
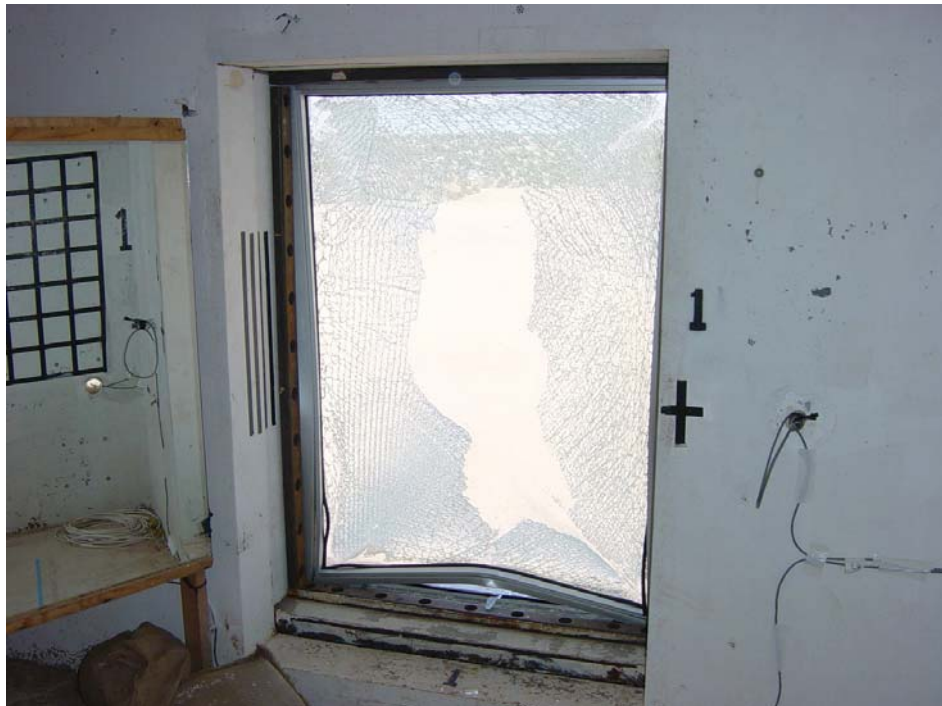
Rating: GSA Condition 3b

Figure 3-29 Exterior post-test view of window 1. (DSC4280.jpg)

Figure 3-30 Interior post-test view of window 1. (DSC04288.jpg)

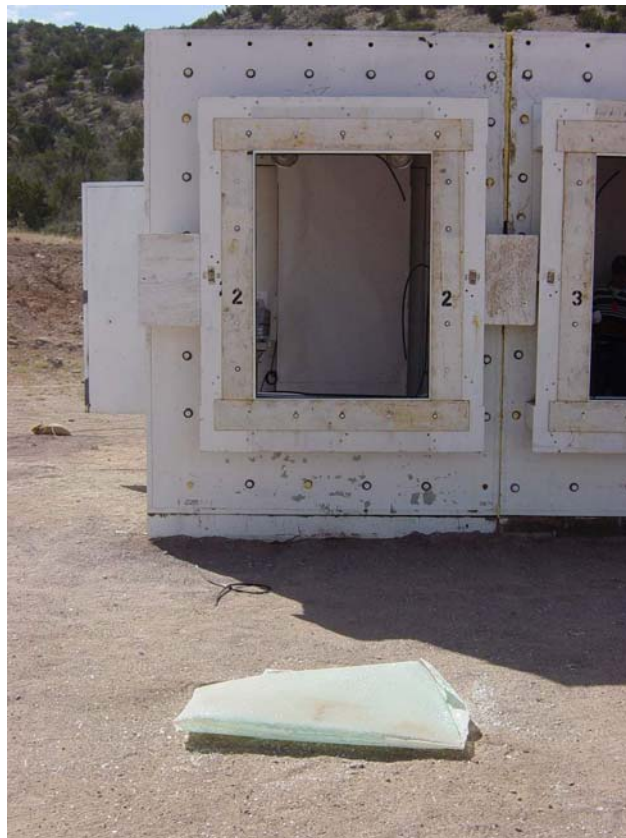
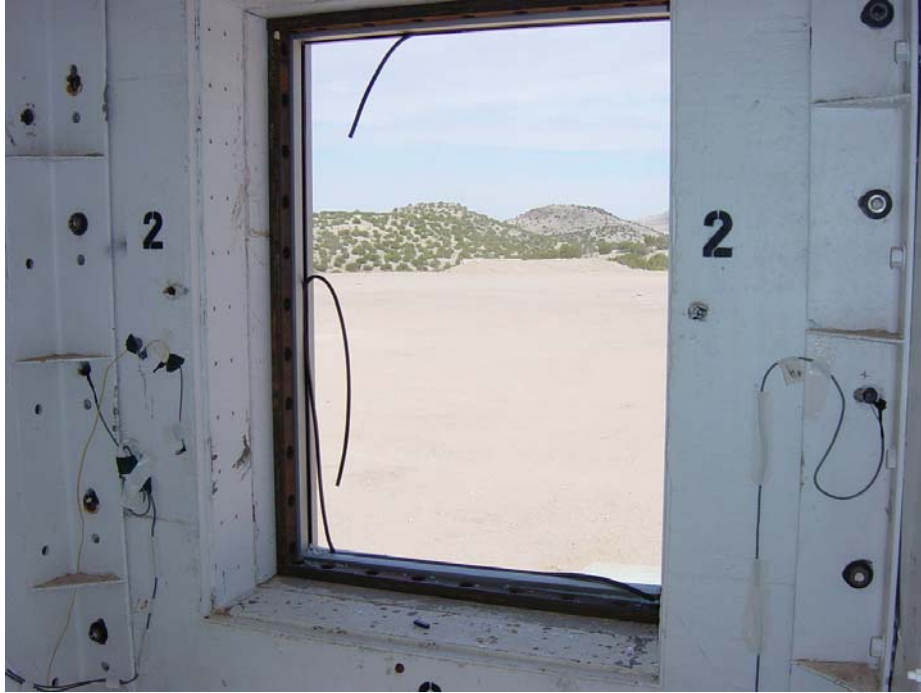
Rating: GSA Condition 3b

Figure 3-32 Exterior post-test view of window 2. (DSC04292.jpg)

Figure 3-33 Interior post-test view of window 2. (DSC04304.jpg)

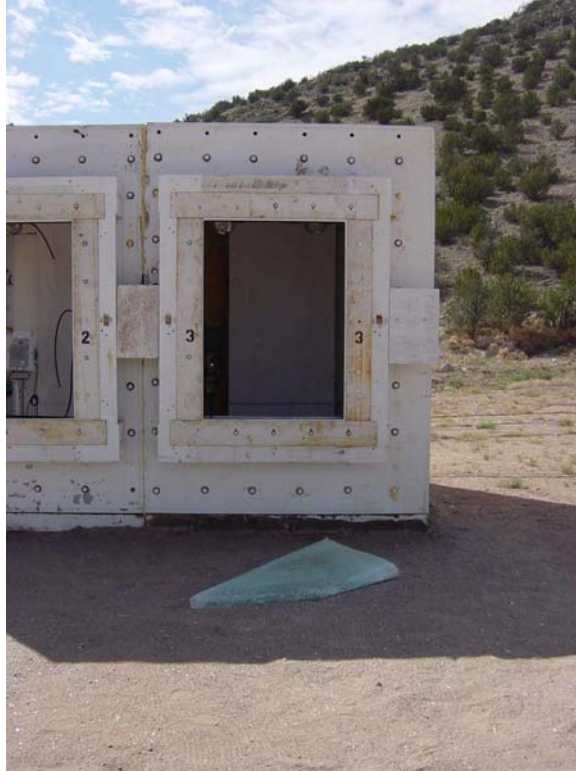
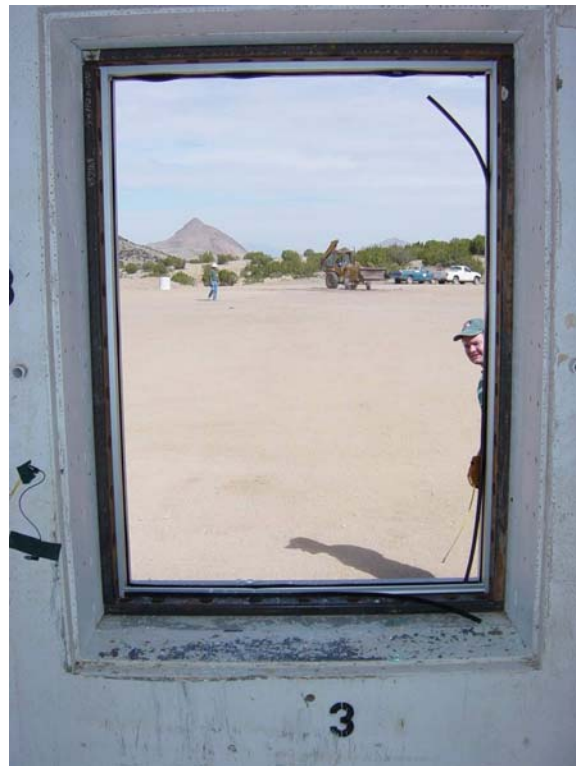
Rating: GSA Condition 2

Outer pane failed with fragments landing outside of structure. No visible frame deformation. Inner pane cracked but remained attached to frame. No fragments visible inside structure. No impacts evident on witness panel.

Figure 3-35 Exterior post-test view of window 3. (DSC04297.jpg)

Figure 3-36 Interior post-test view of window 3. (DSC04318.jpg)

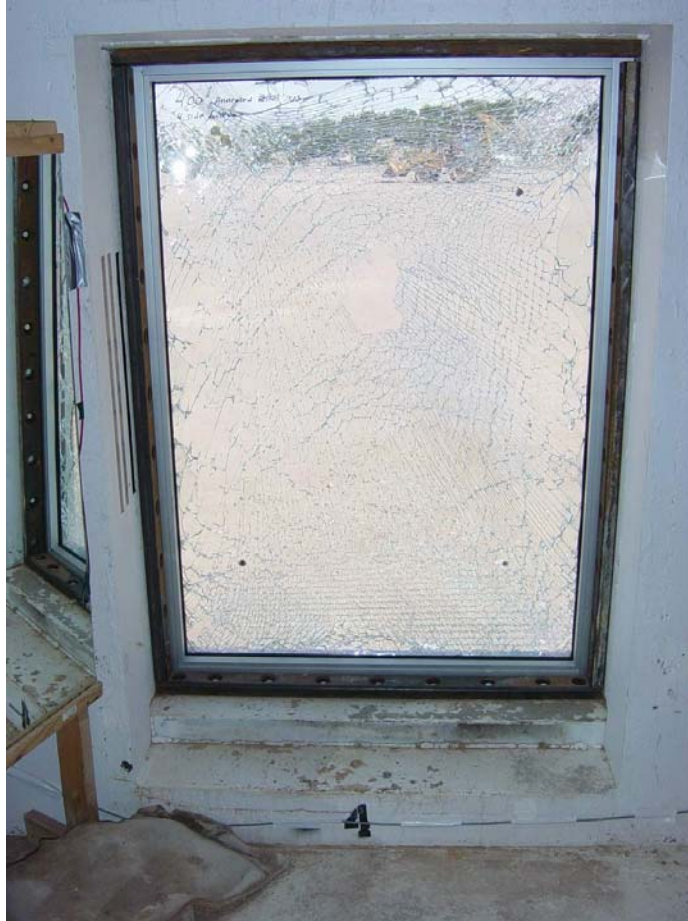
Figure 3-39 Interior post-test view of window 4. (DSC04341.jpg)

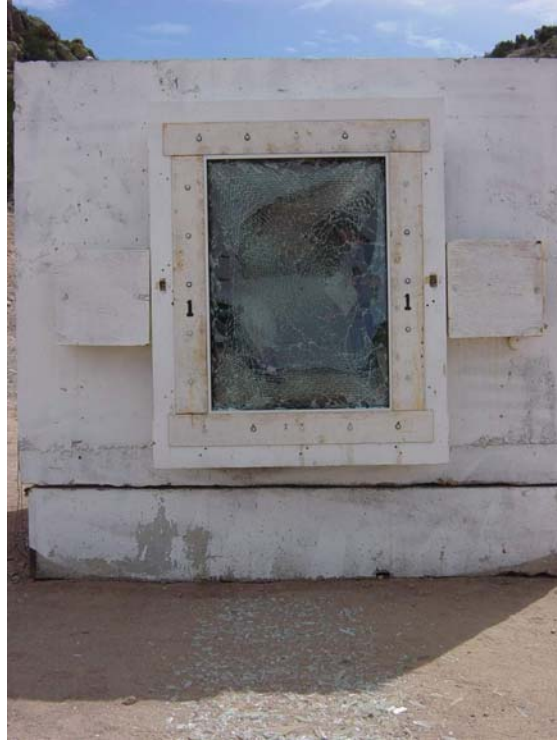
Rating: GSA Condition 2

Outer pane failed with fragments landing outside of structure. No visible frame deformation. Inner pane cracked but remained in frame. Light dusting of glass on sill. No impacts evident on witness panel.

Figure 3-42 Exterior post-test view of window 1. (DSC04350.jpg)

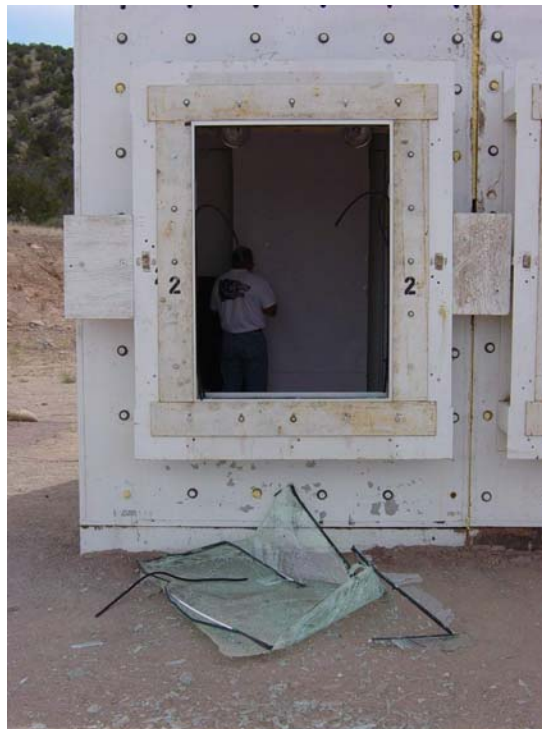
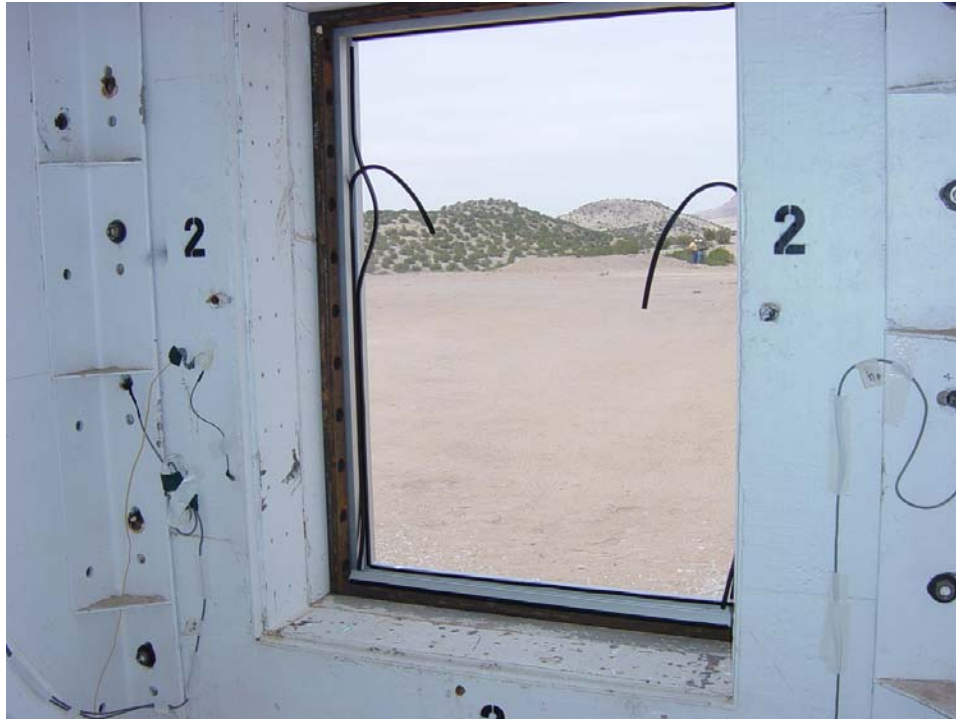
Rating: GSA Condition 3b

Outer pane failed with fragments landing outside of structure. Inner pane left the frame and fell just outside of structure. Minor deformation at bottom of frame. No other visible frame deformation. Fragments landed in 3b region inside of structure. No impacts evident on witness panel.

Figure 3-45 Exterior post-test view of window 2. (DSC04364.jpg)

Figure 3-46 Interior post-test view of window 2. (DSC04383.jpg)

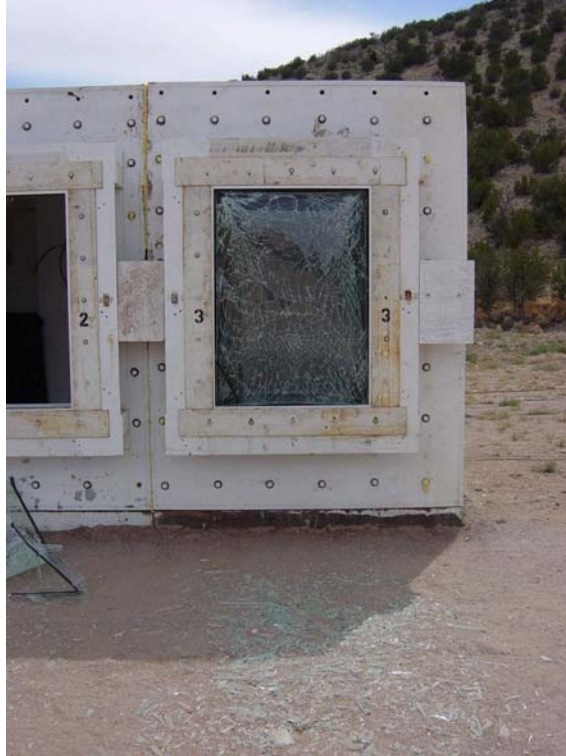
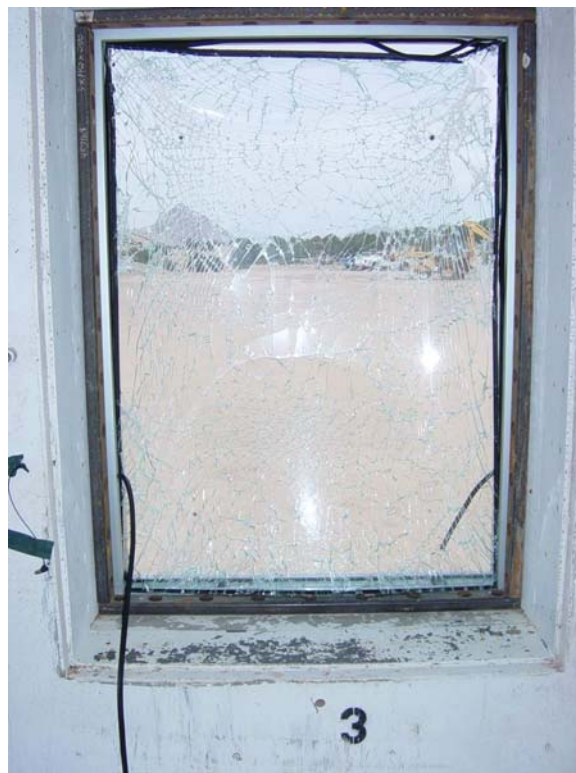
Rating: GSA Condition 5

Outer pane failed with fragments landing outside of structure. Top and bottom of inner pane pulled out of frame while the sides remained attached. Deformation occurred at bottom of frame. No other visible frame deformation. One glass fragment impacted the witness panel in Region 4. Two glass fragments impacted the witness panel in Region 5.

Figure 3-48 Exterior post-test view of window 3. (DSC04367.jpg)

Figure 3-49 Interior post-test view of window 3. (DSC04395.jpg)

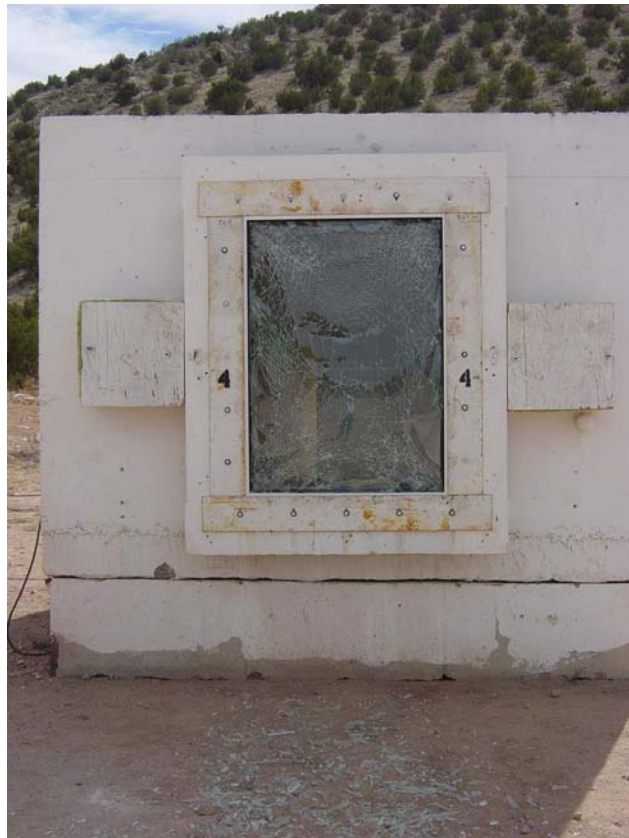
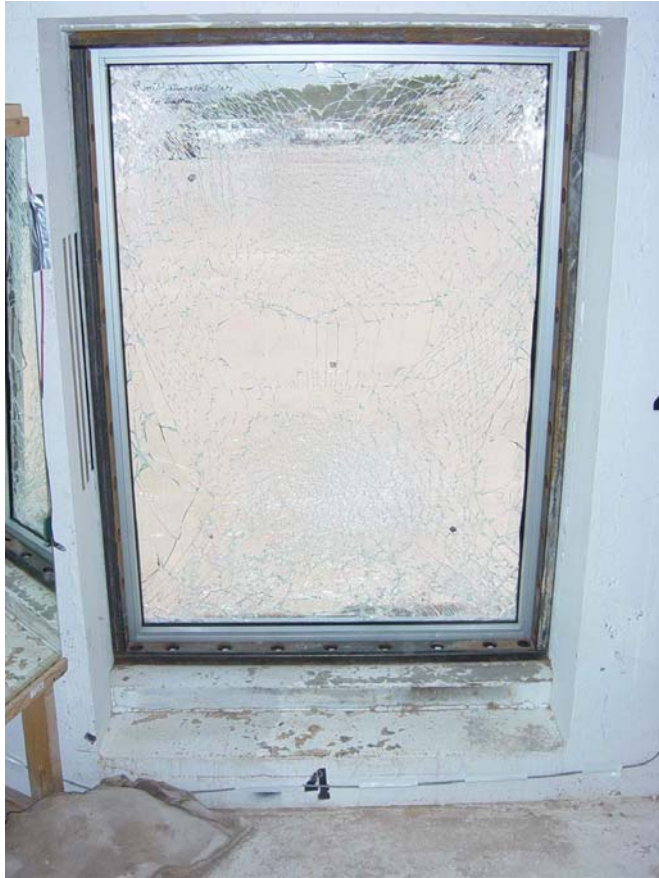
Rating: GSA Condition 3a

Outer pane failed with fragments landing outside of structure. Inner pane did not leave frame, but small tears (approximately 8 to 11 inches in length) occurred in film at bottom corners. No visible frame deformation. Inner pane cracked but remained in frame. Fragments landed in 3a region inside of structure. No impacts evident on witness panel.

Figure 3-51 Exterior post-test view of window 4. (DSC04413.jpg)

Figure 3-52 Interior post-test view of window 4. (DSC04432.jpg)

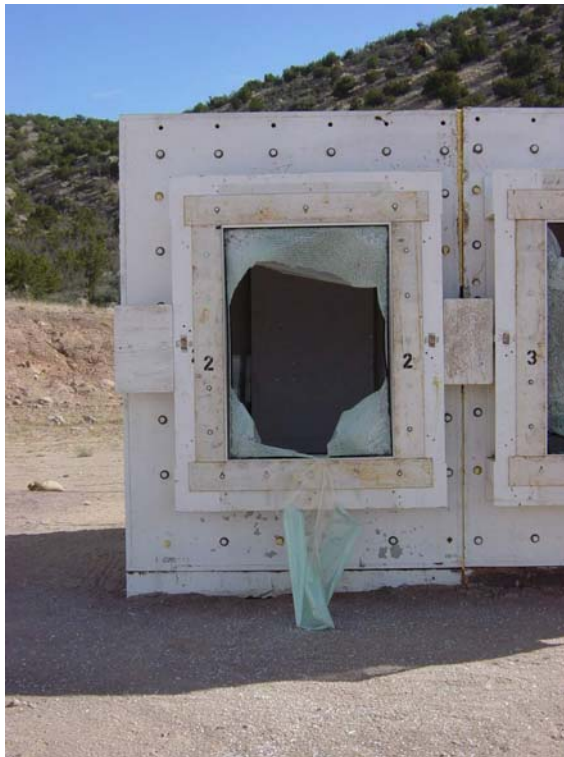
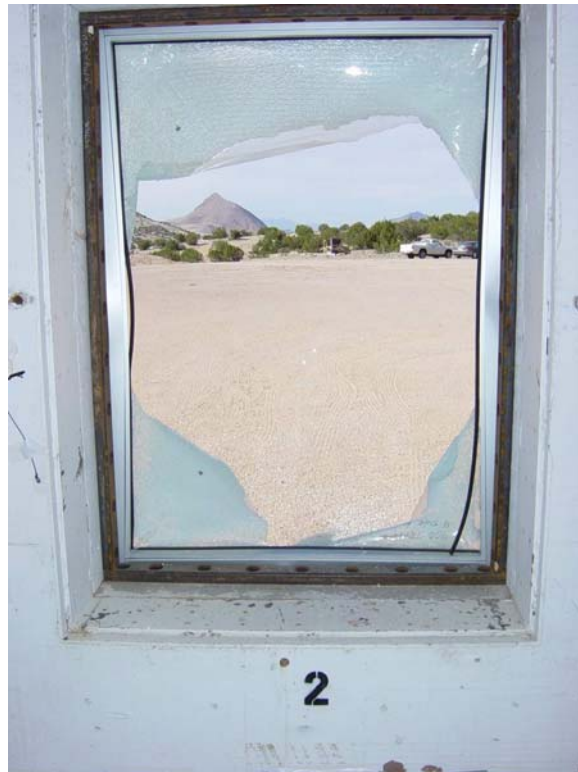
Rating: GSA Condition 3b

Figure 3-58 Exterior post-test view of window 2. (DSC04497.jpg)

Figure 3-59 Interior post-test view of window 2. (DSC04533.jpg)

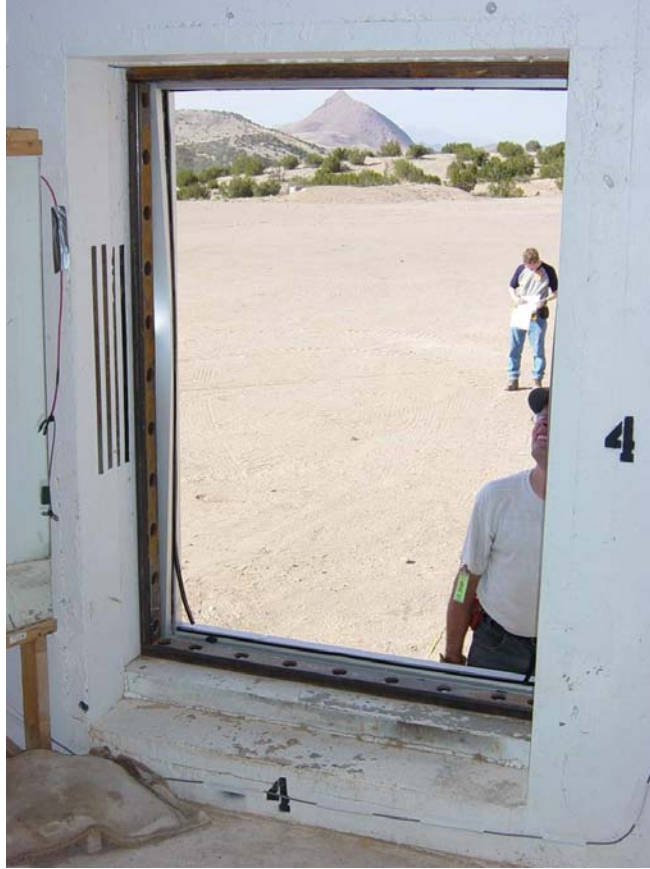
Rating: GSA Condition 4

Glazing left frame and landed approximately 48 inches to the exterior of the structure. Sides of frame deformed into window opening up to 1 inches. One glass fragment impacted the witness panel in Region 4.

Figure 3-65 Interior post-test view of window 4. (DSC04567.jpg)
