FULL SCALE ARENA  
GSA TEST REPORT

**MODEL DESIGNATION:** Solar Gard® Armorcoat® Safety & Security Films

<b>Test Report No.:</b>	B7294.02-801-12
<b>Test Date:</b>	10/13/10
<b>Report Date:</b>	03/02/11
<b>Test Report Retention End Date:</b>	03/02/15

- 2.1 Introduction  
Solar Gard retained Architectural Testing, Inc. (ATI) to conduct a full scale arena blast test on their Solar Gard Armorcoat window film per the requirements of GSA-TS01-2003.

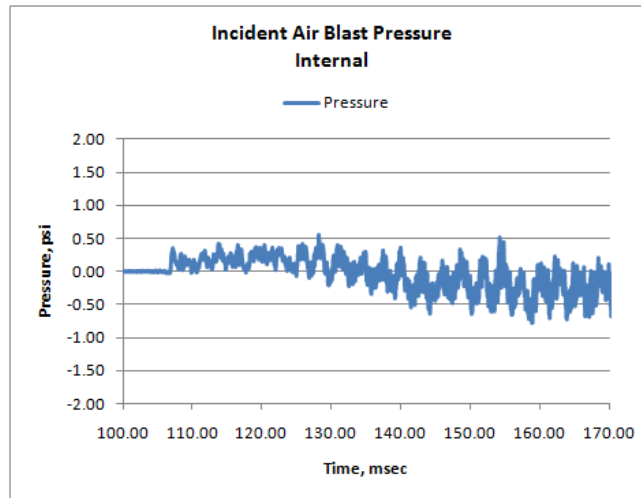
Figure 7: Internal Incident Air Blast Pressure Time History

ATI measured a maximum internal air blast pressure of approximately 0.56 psi inside the air blast reaction chamber during air blast pressure loading. Figure 7 provides a graph of the internal incident air blast pressure time history.

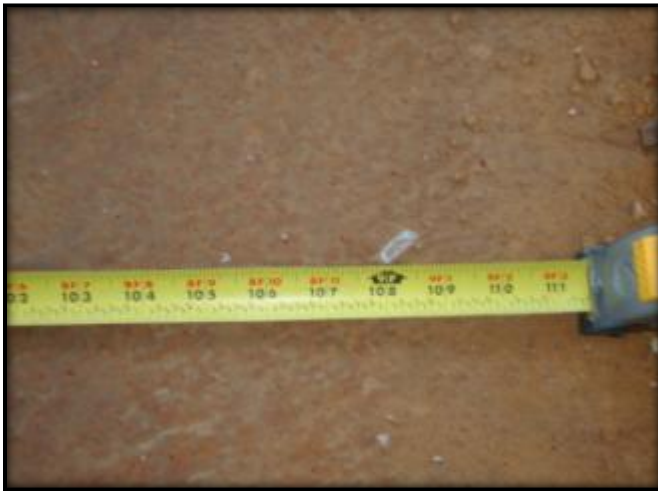
Figure C.7: L2 Fragment

All four (4) of the specimens' inboard and outboard lites fractured during air blast pressure loading. Specimen 2's inboard film tore producing one (1) qualifying fragment between the 3.3 foot and 10 foot mark. Zero (0) perforations or fragment indents were observed in the vertical witness panel. Table 8 provides a summary of the glazing response during air blast pressure loading.

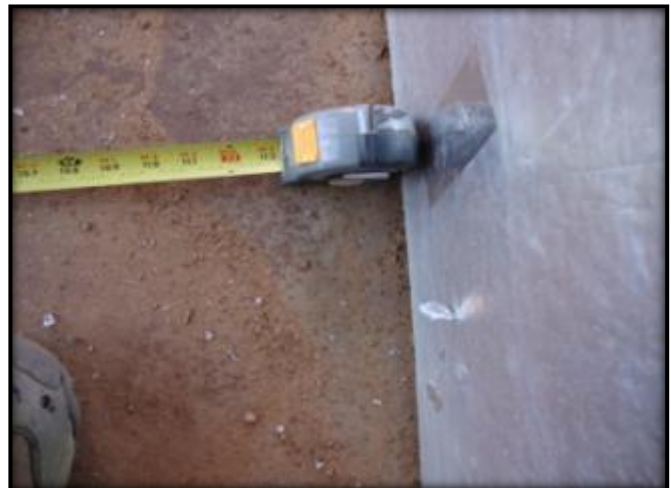
Figure C.20: L5 Fragment  
In Vertical Witness Panel

All four (4) of the specimens' lites fractured during air blast pressure loading. Specimen 5's film tore allowing a fragment to impact the vertical witness panel at 9" above the chamber floor. Specimen 6 and 8's film tore and allowed fragments to enter the occupied space between the 3.3 foot and 10 foot mark. Specimen 7's film showed no signs of tearing and fully retained the glazing within the frame. Zero (0) perforations or fragment indents were observed anywhere in the vertical witness panel behind Specimens 6, 7 and 8. Table 9 provides a summary of the glazing response during air blast pressure loading.
