ARA-TR-98-4589.1-1

## **Explosive Tests For Evaluation of the Glass Fragment Mitigation Characteristics of 3M Security Window Films**

**by: Joseph L. Smith, Director of Security Engineering  
Steven C. Lofton, Blast/Security Engineer  
Scott R. Swatzell, Blast/Security Engineer**

**Prepared for: 3M  
Specified Construction Products Division  
3M Center Bldg. 225-4S-08  
St. Paul, MN 55144**

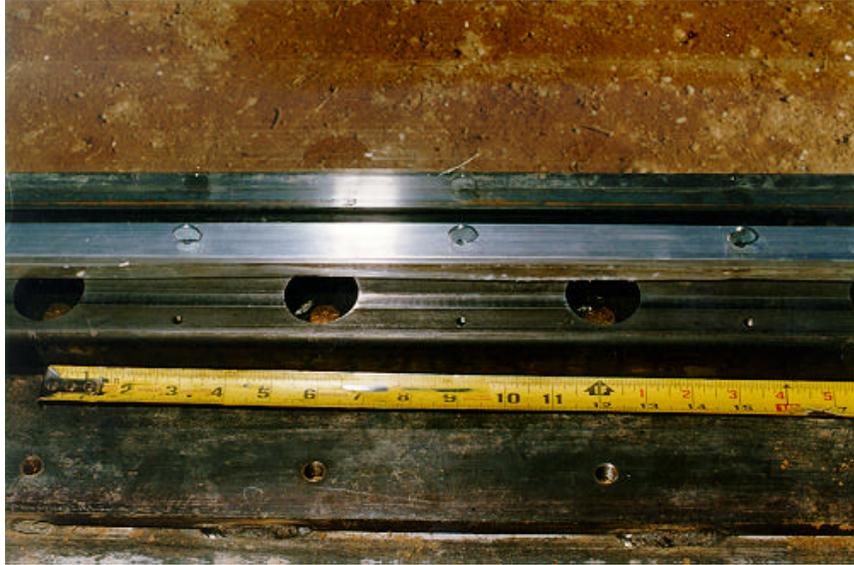
Test 1 was detonated on January 12 at 14:00. The charge was located at a standoff of 190 ft for a target pressure of 4.1 psi. A typical airblast waveform is shown in Figure 3.1, and the average airblast values from the exterior gages are given in Table 3.1. For this test two of the windows used batten attachments. The battens for these windows were held to the steel window frame with quarter-inch thumb screws as shown in Figure 3.2. This was the only test where these type screws were used. For all following days hex-head quarter-inch screws were used to secure the battens to the frames.

Figure 3.2. Thumb-screw attachment of batten for test 1, windows 2 and 3 (3M T1 pre 01.tif).

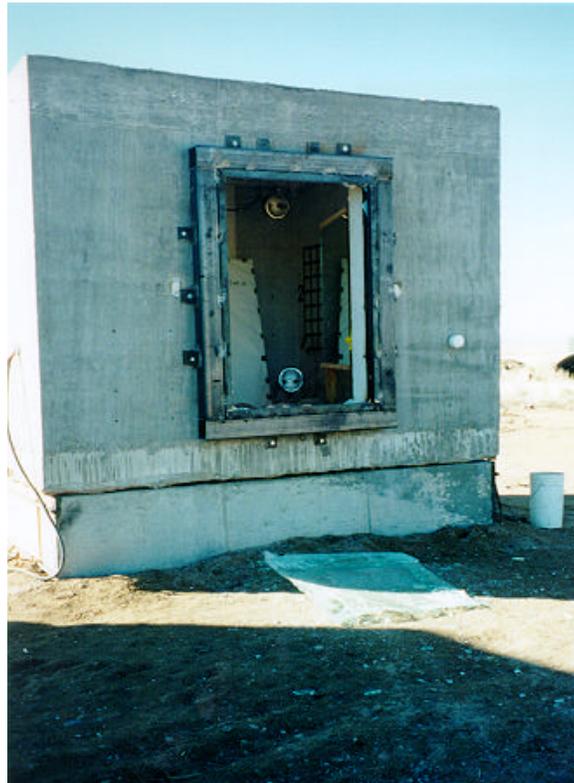
**Rating:** GSA Condition 3 (significant hazard reduction)

Figure 3.3. Exterior posttest view of window 1, test 1 (3M SD T1 post 05.tif).

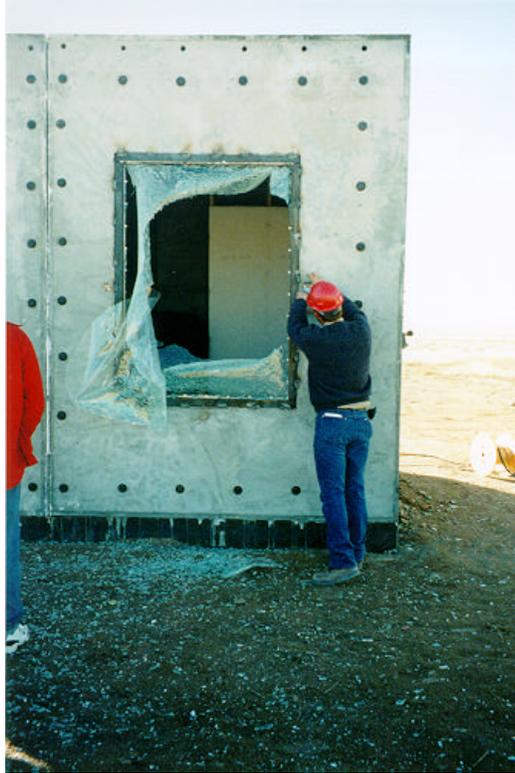
Figure 3.4. Exterior posttest view of window 2, test 1(3M SD T1 post 20.tif).

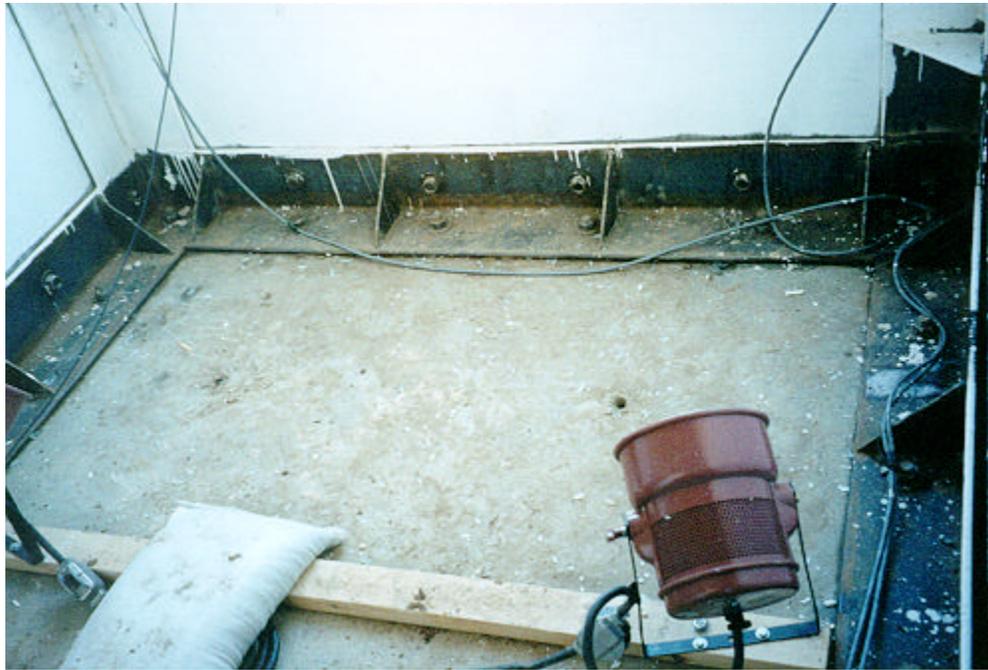
Figure 3.5. Interior view of glass fragmentation from window 2, test 1 (3M SD T1 post 18.tif).

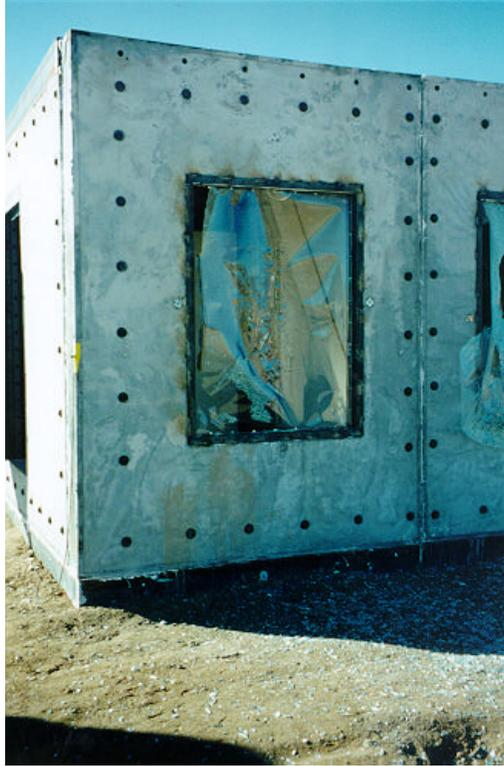
Figure 3.6. Exterior posttest view of window 3, test 1 (3M SD T1 post 36.tif).

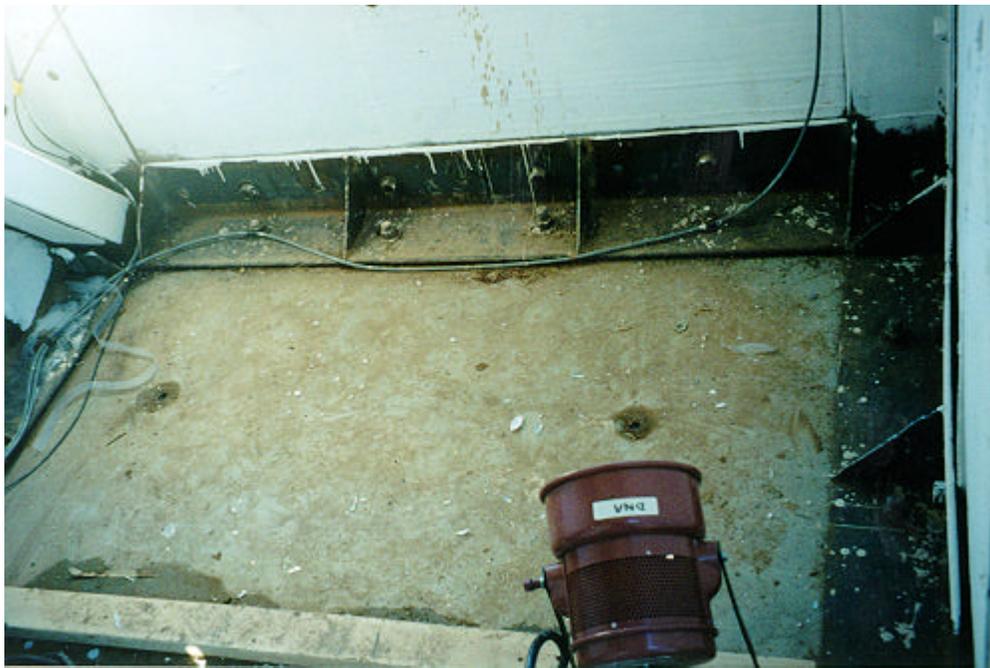
Figure 3.7. Interior view of glass fragmentation from window 3, test 1 (3M SD T1 post 31.tif).

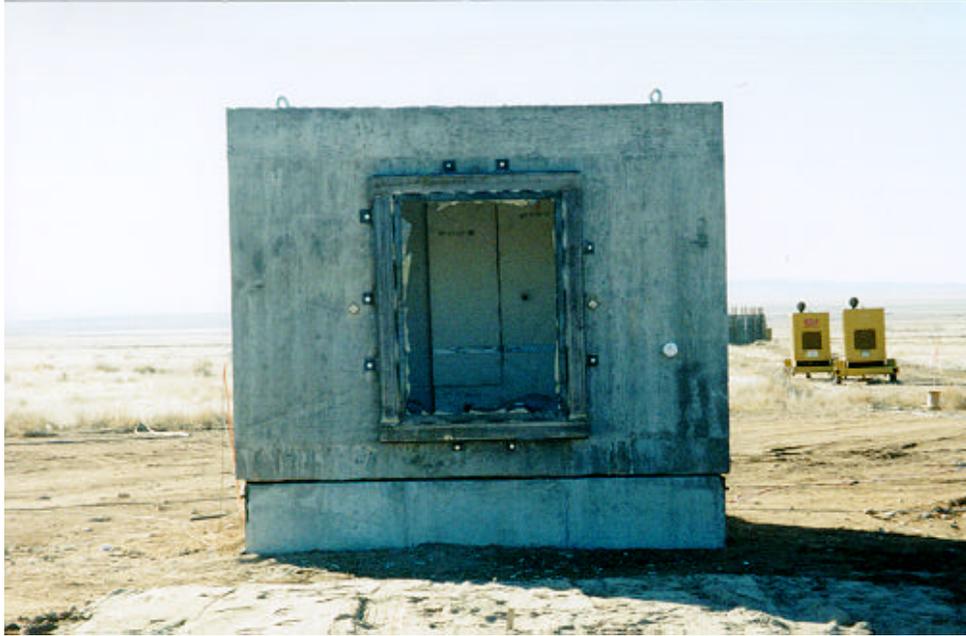
The glazing of window 4 failed. About 95% of the fragments entered the structure at high velocities. The glass fragments were strewn across the floor of the reaction structure and many glass fragments impacted the witness panel. Ninety-eight total glass fragment impacts were surveyed on the witness panel with 82 below a 2-ft height (i.e., transition from GSA Condition 4 to GSA Condition 5) and 16 impact above a 2-ft height.

Figure 3.8. Exterior posttest view of window 4, test 1 (3M SD T1 post 48.tif).

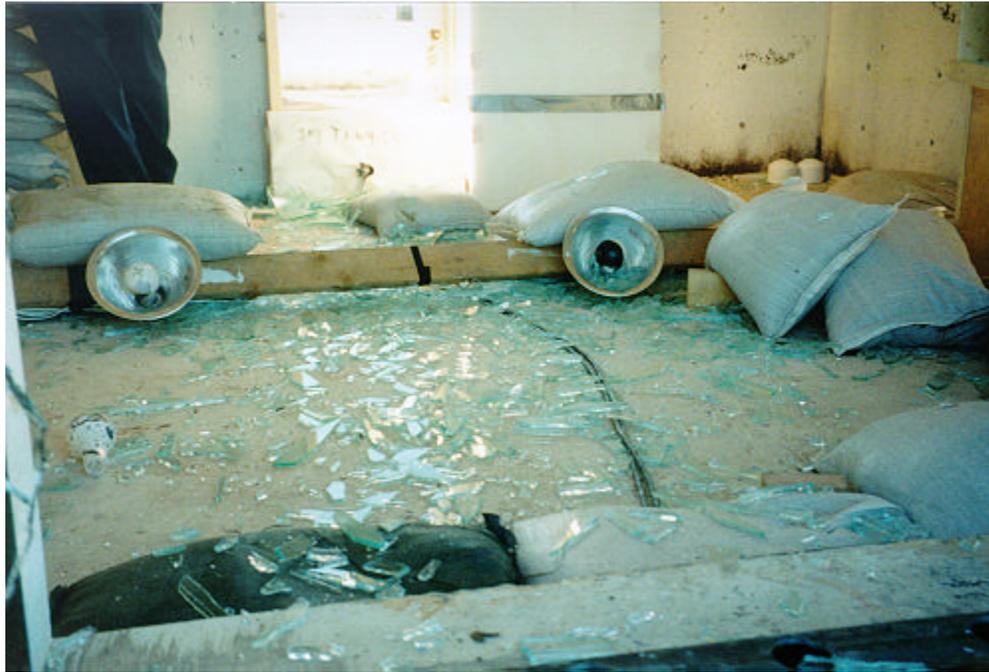
Figure 3.9. Interior view of glass fragmentation from window 4, test 1 (3M SD T1 post 16.tif).

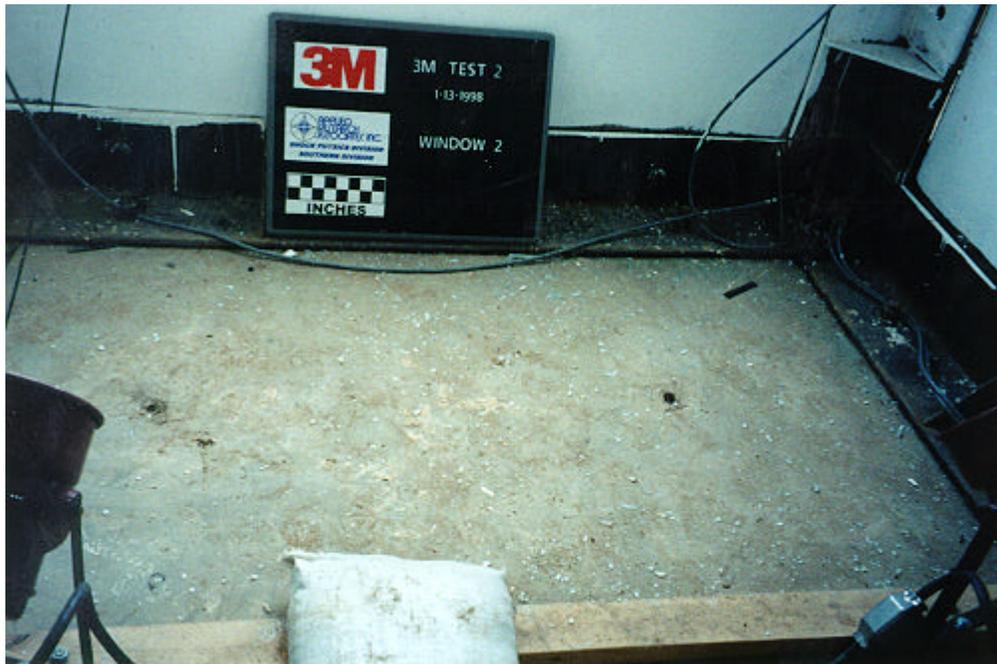
Figure 4.4. Exterior posttest view of window 2, test 2 (3M SD T2 post 31.tif).

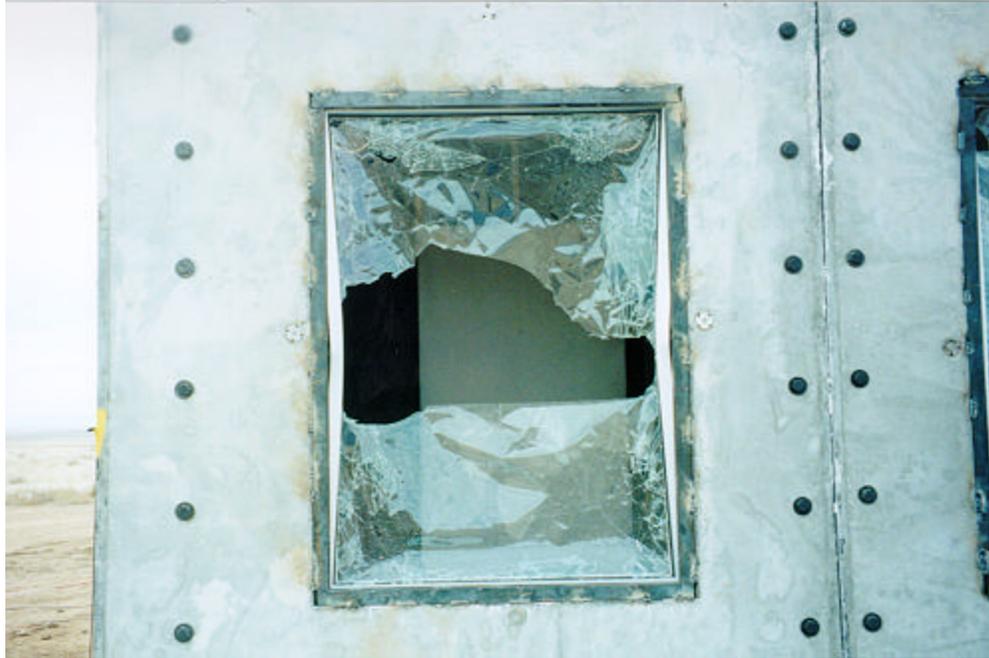
Figure 4.5. Interior view of glass fragmentation from window 2, test 2 (3M SD T2 post 12.tif).

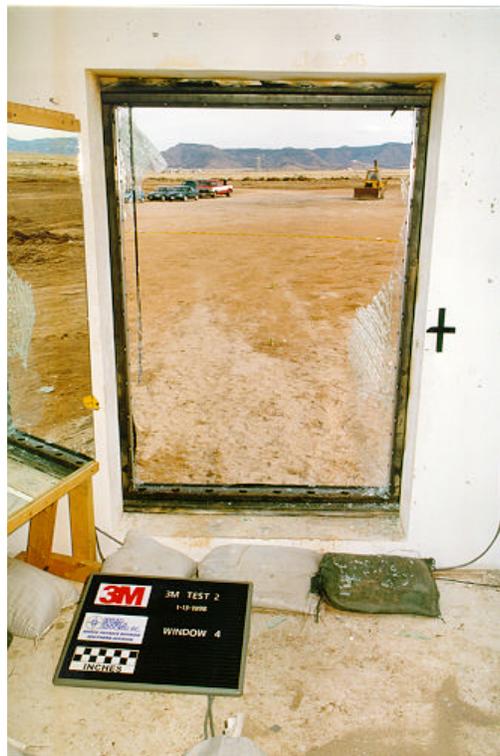
Figure 4.8. Exterior posttest view of window 4, test 2 (3M SD T2 post 43.tif).

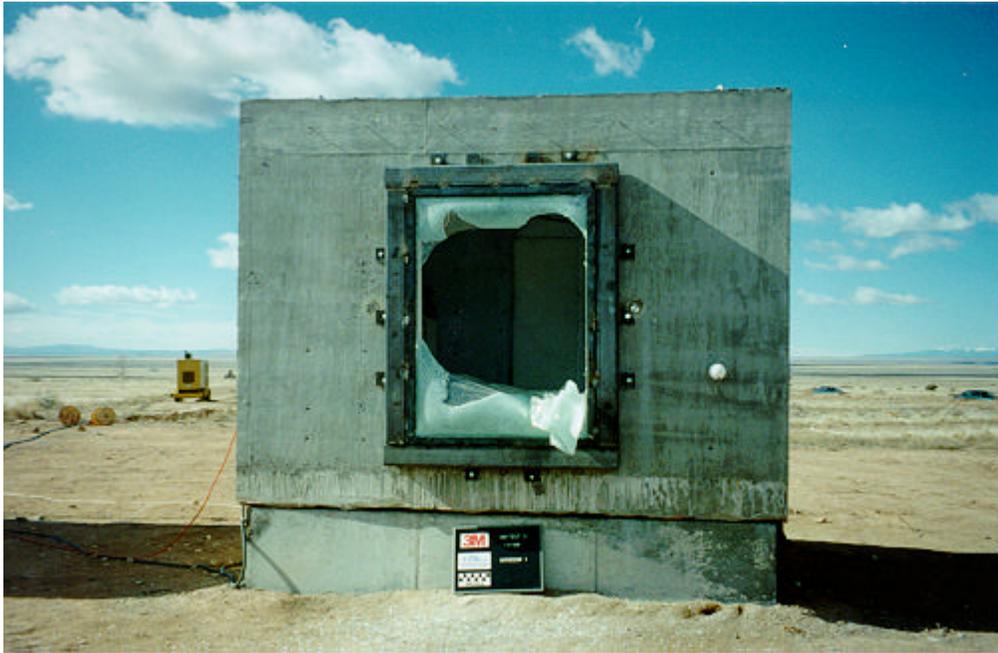
Figure 5.2. Exterior posttest view of window 1, test 3 (3M SD T3 post 24.tif).

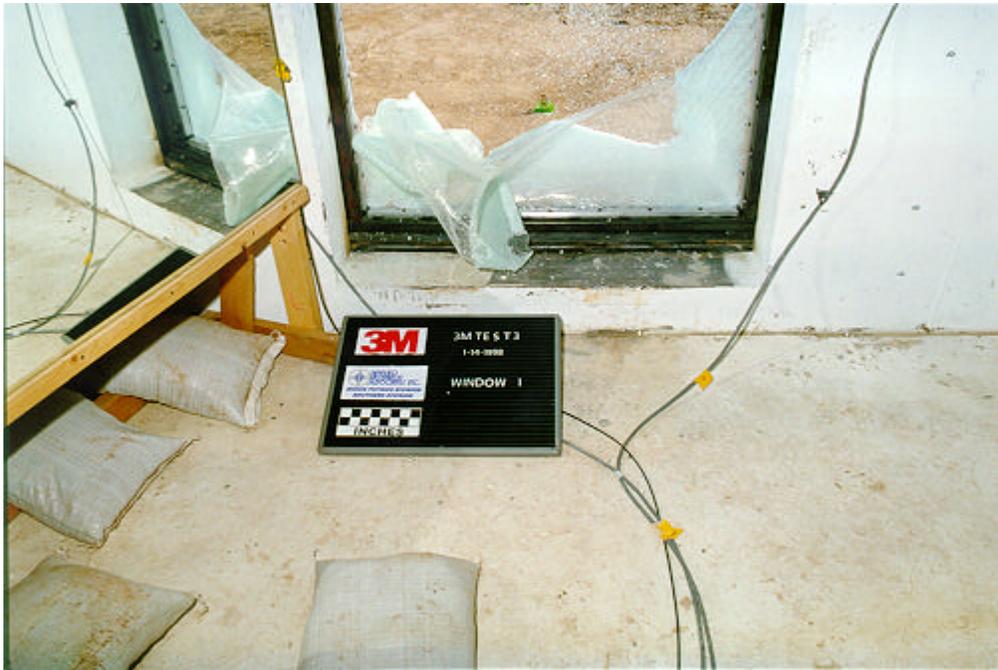
Figure 5.3. Interior view of window 1 and fragmentation, test 3 (3M T3 post 23.tif).

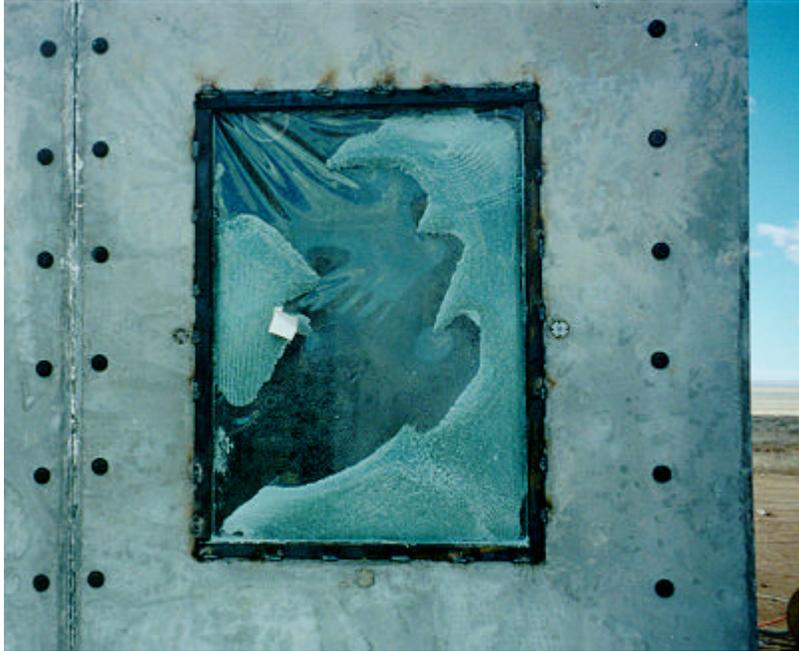
**Rating:** GSA Condition 2

The glazing of window 2 failed. The film pulled out slightly from the batten on the right vertical edge of the window over about 10 inches. There was also a small tear in the film in the top left corner of the window. About half the glass was retained on the window film. Fragments that rebounded off the film landed within about 43 ft from the structure. Only some slight dusting of glass fragments was noticed inside near the sill.

Figure 5.4. Exterior posttest view of window 2, test 3 (3M SD T3 post 19.tif).

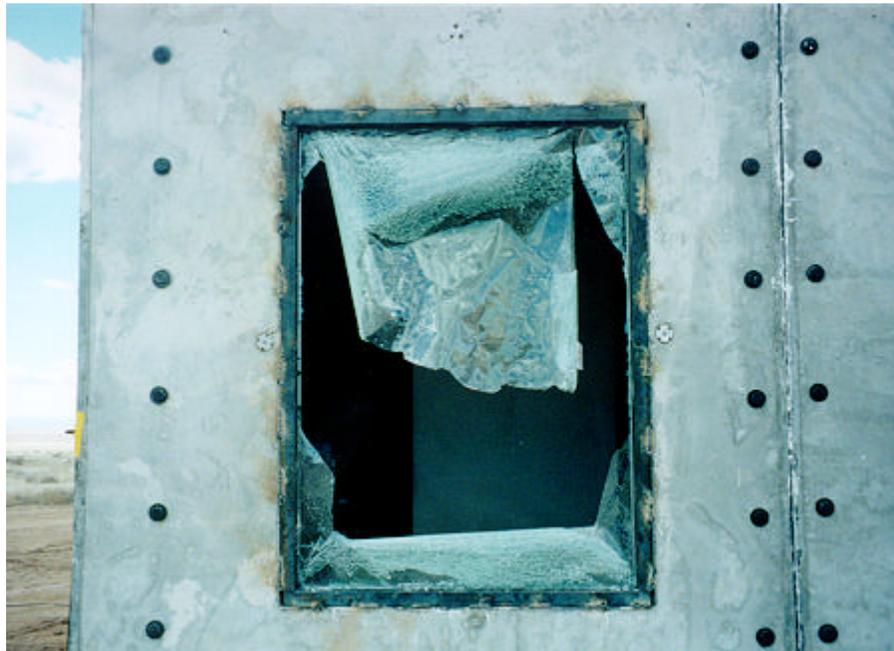
**Rating:** GSA Condition 3 (significant hazard reduction)

The glazing of window 3 failed and the film tore at the vertical edges. All film was retained in the frame. Most glass left the film on the rebound of the window system and landed in front of the structure. Many large chunks of glass were located far from the structure with the farthest at 89 ft from the structure. A few fragments entered the structure with a few located to the back of the structure on the floor. There were no glass fragment impact marks on the witness panel.

Figure 5.5. Exterior posttest view of window 3, test 3 (3M SD T3 post 17.tif).

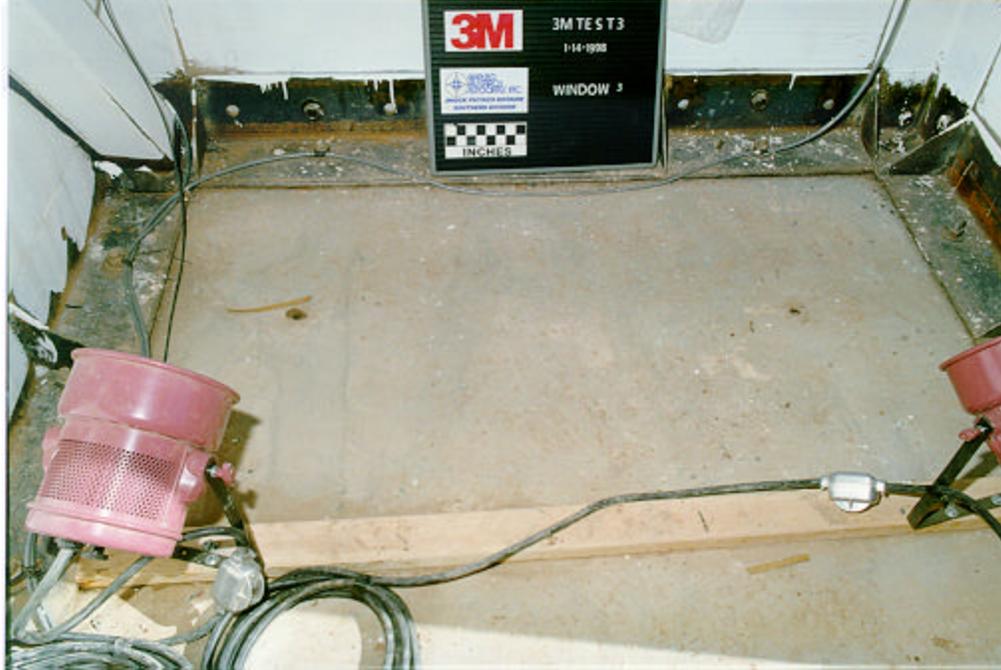
Figure 5.6. Interior view of window 3 and fragmentation, test 3 (3M T3 post 30.tif).

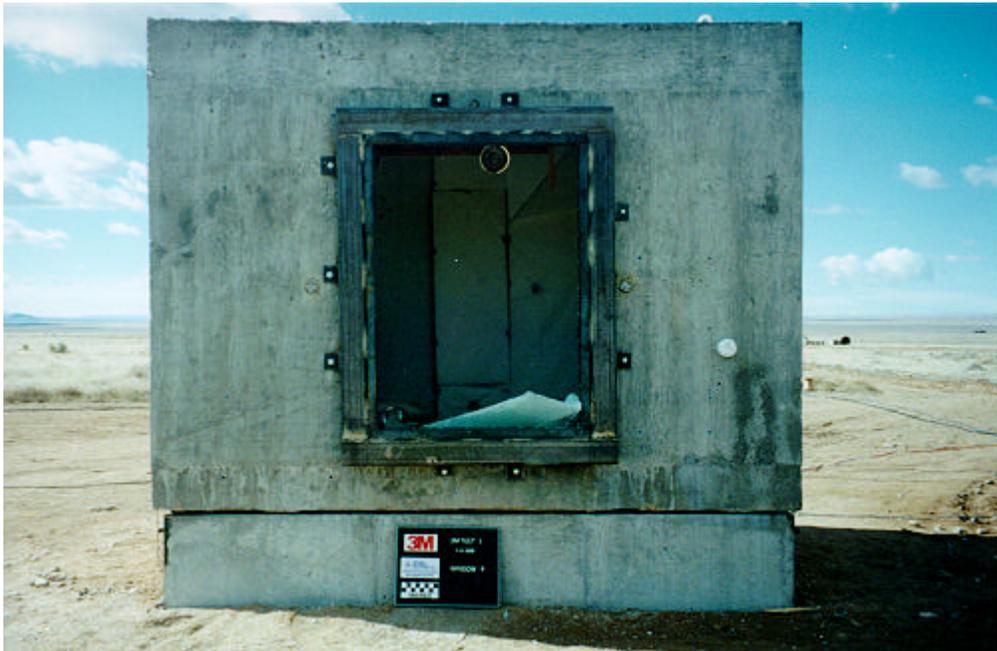
**Rating:** GSA Condition 3

The glazing of window 4 failed. The film, with most glass attached, left the window frame and landed inside the structure resting on the sill with one corner of the window protruding to the outside. About 90-95% of the glass was retained on the film. Exterior glass fragments were surveyed out to about 33 ft from the front of the structure. A few fragments entered the structure with a few located to the back of the structure on the floor. There were no glass fragment impact marks on the witness panel.

Figure 5.7. Exterior posttest view of window 4, test 3 (3M SD T3 post 14.tif).

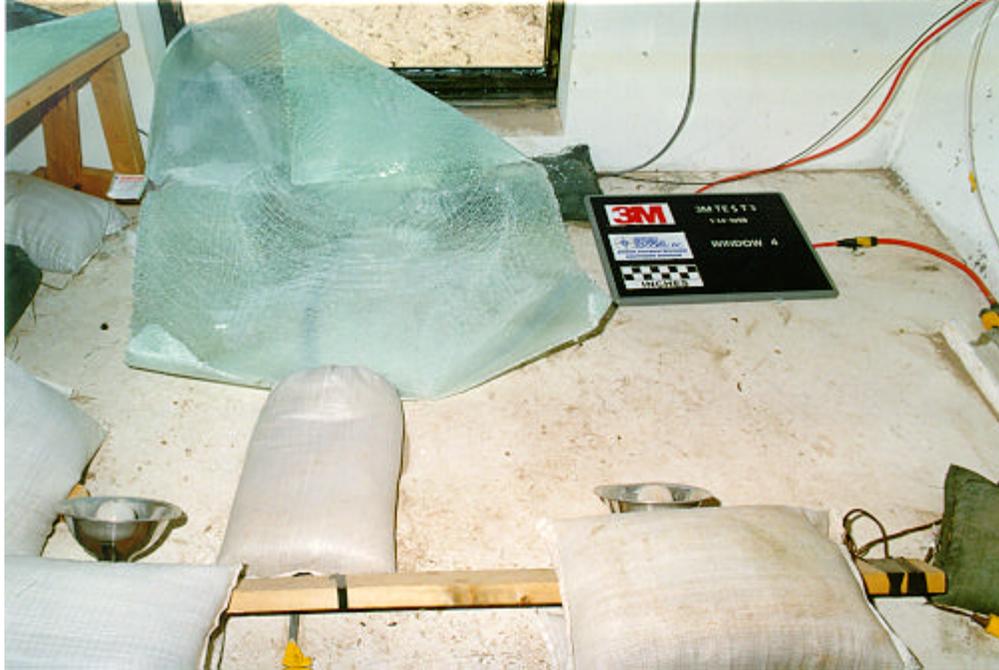
Figure 5.8. Interior view of window 4 and fragmentation, test 3 (3M T3 post 01.tif).

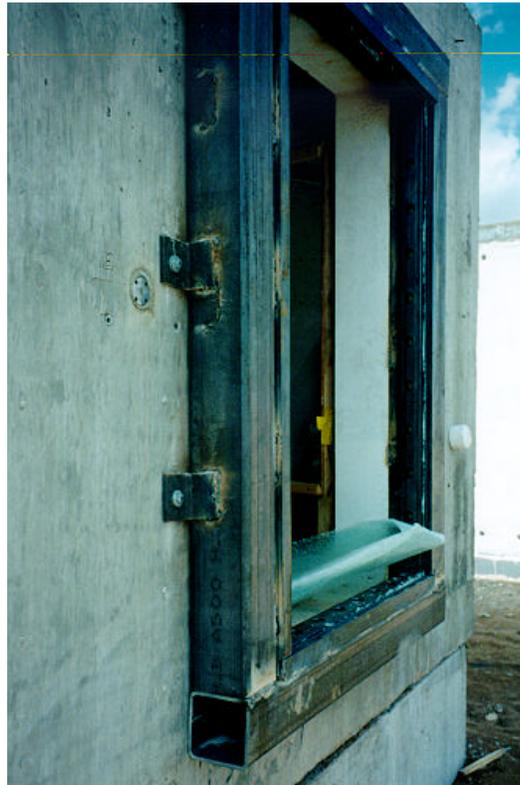
Figure 5.9. Exterior posttest view of window 4, test 3 (3M SD T3 post 12.tif).

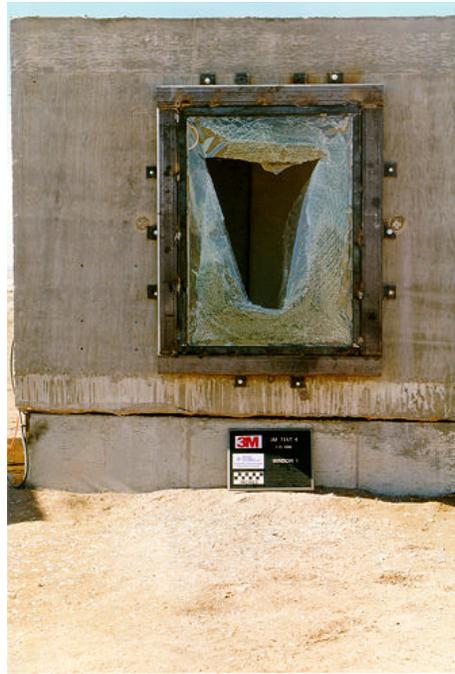
**Rating:** GSA Condition 3

Figure 6.1. Exterior posttest view of window 1, test 4 (3M T4 post 06.tif).

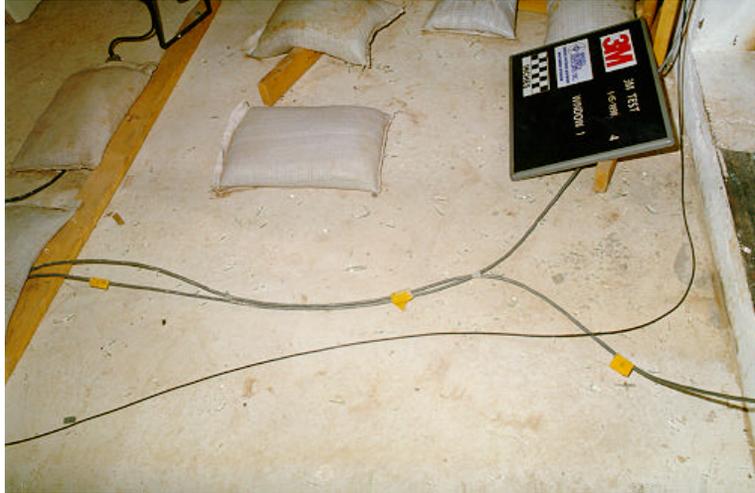
Figure 6.2. Interior view of fragmentation from window 1, test 4 (3M T4 post 20.tif).

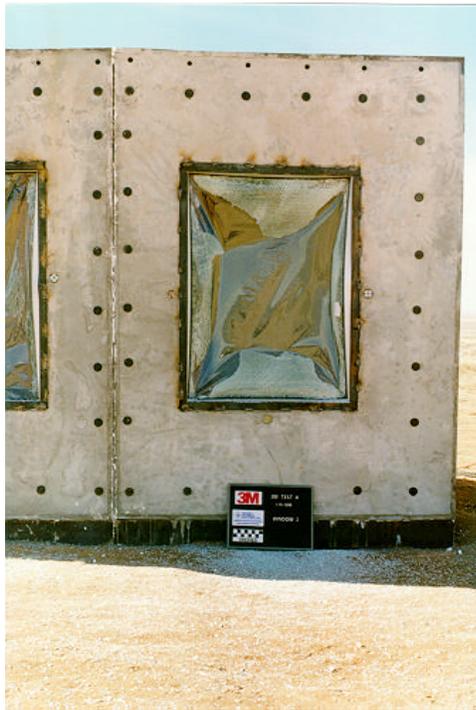
**Rating:** GSA Condition 2

The glazing of window 2 failed and the film remained intact in the window frame with no openings. About 30% of the glass was retained on the window film. Fragments that rebounded off the film landed within about 47 ft from the structure. No glass fragments entered the structure.

Figure 6.3. Exterior posttest view of window 2, test 4 (3M T4 post 10.tif).

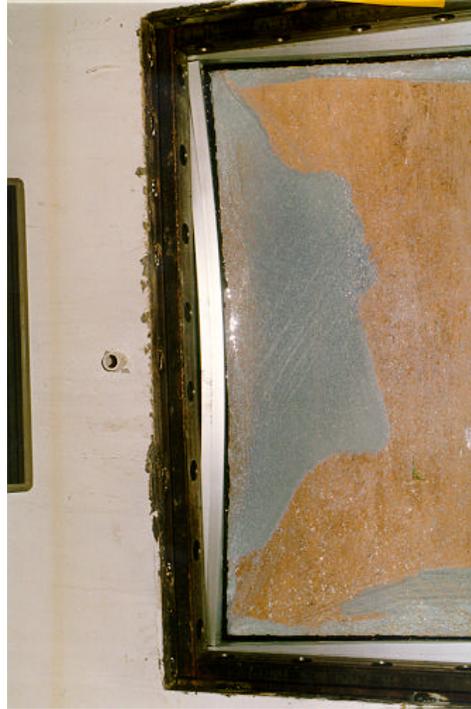
Figure 6.4. Interior view of window 2 frame deformation, test 4 (3M T4 post 14.tif).

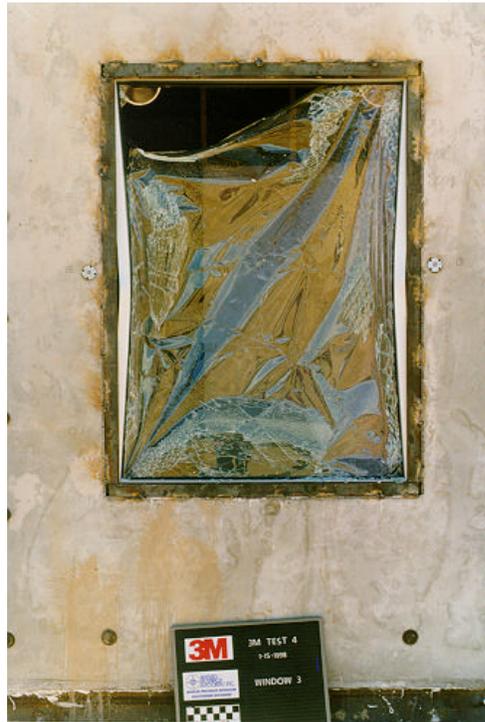
**Rating:** GSA Condition 3 (significant hazard reduction)

The glazing of window 3 failed and the film was pulled from the window frame on the top left corner. All film was retained in the frame. About 85-90% of the total window glass left the film on the rebound of the window system and landed in front of the structure out to a distance of 74 ft from the front of the structure. A few fragments entered the structure and all landed within the first two-thirds of the distance to the rear of the structure. There were no glass fragment impact marks on the witness panel.

Figure 6.5. Exterior posttest view of window 3, test 4 (3M T4 post 12.tif).

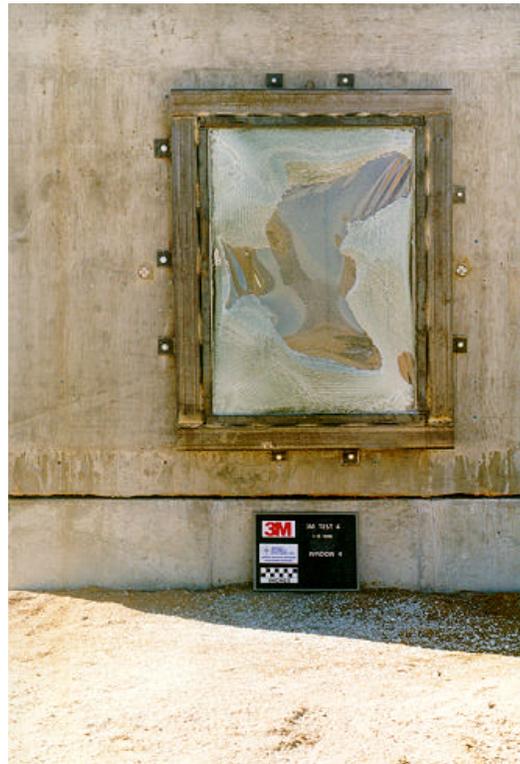
**Rating:** GSA Condition 3 (significant hazard reduction)

The glazing of window 4 failed and the film remained in the frame. The film was pulled out of the batten on both vertical edges near the vertical center of the window. These pulled out sections measured 21 inches on the right edge and 23 inches on the left edge. About 60% of the glass was retained on the film. Exterior glass fragments were surveyed out to about 37 ft from the

front of the structure. Only a few small fragments entered the structure. There were no glass fragment impact marks on the witness panel. The windows performance was a borderline GSA Condition 2 because the fragments inside were very small. However, these fine fragments were located to the rear the structure and, hence, the window was rated a Condition 3.

Figure 6.7. Exterior posttest view of window 4, test 4 (3M T4 post 44.tif).

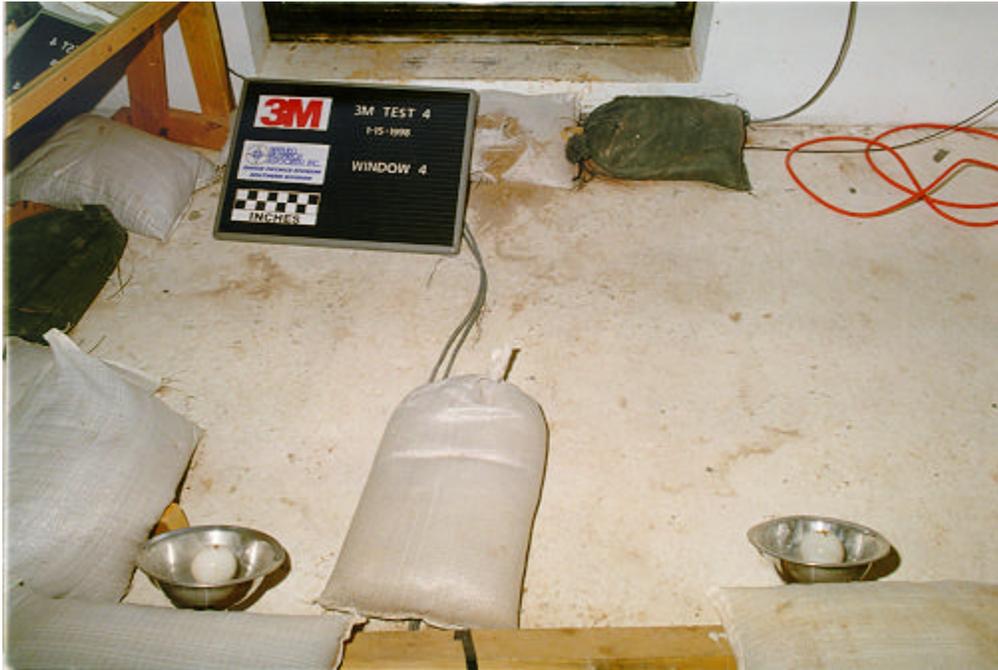
Figure 6.8. Interior view of window 4 fragmentation, test 4 (3M T4 post 45.tif).

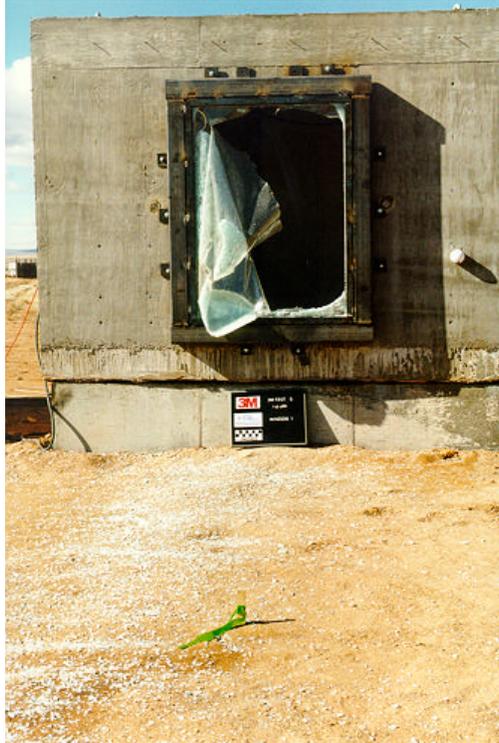
**Rating:** GSA Condition 3

Figure 7.2. Exterior posttest view of window 1, test 5 (3M T5 post 25.tif).

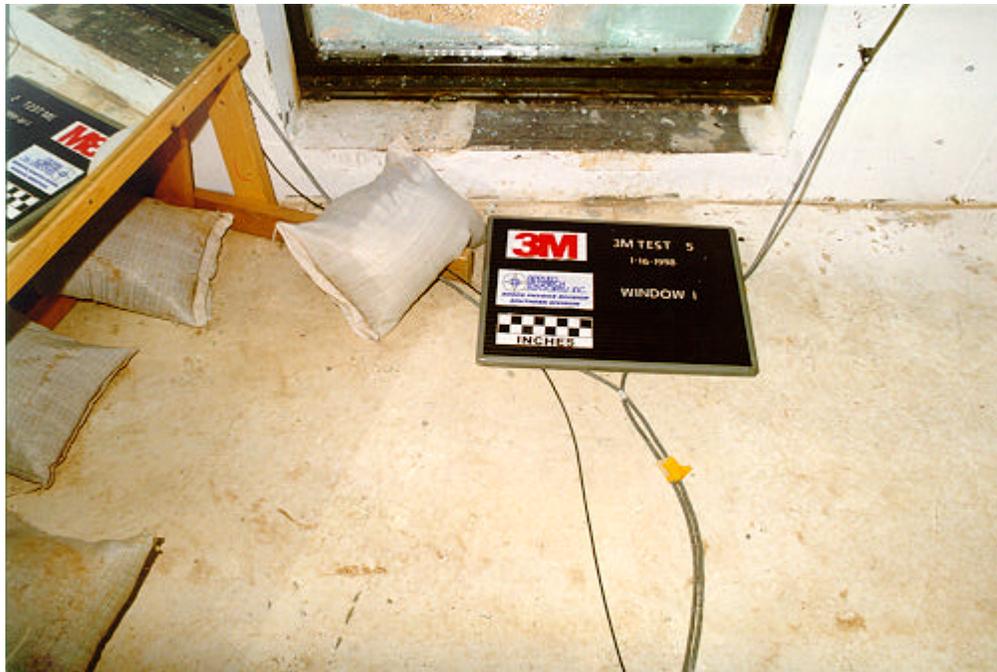
Figure 7.3. Interior view of fragmentation from window 1, test 5 (3M T5 post 07.tif).

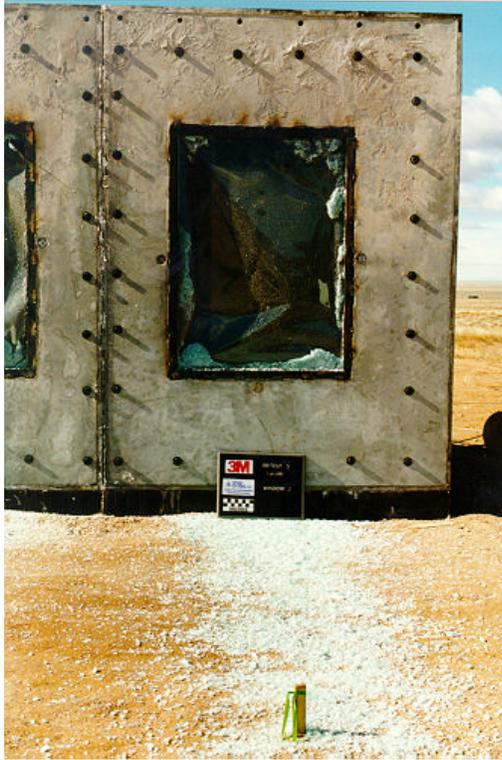
**Rating:** GSA Condition 2

The glazing of window 2 failed and the film remained intact in the window frame with no openings. Only about 5-10% the total window glass was retained on the window film. Fragments that rebounded off the film landed within about 34 ft from the structure. No glass fragments entered the structure.

Figure 7.4. Exterior posttest view of window 2, test 5 (3M T5 post 28.tif).

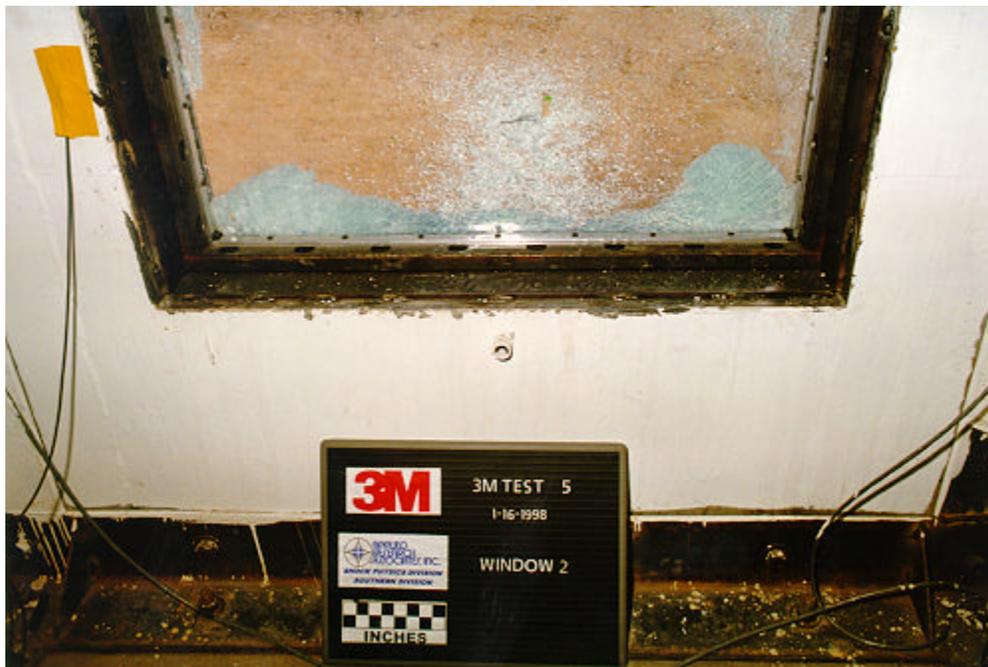
Figure 7.5. Interior view of window 2 frame deformation, test 5 (3M T5 post 06.tif).

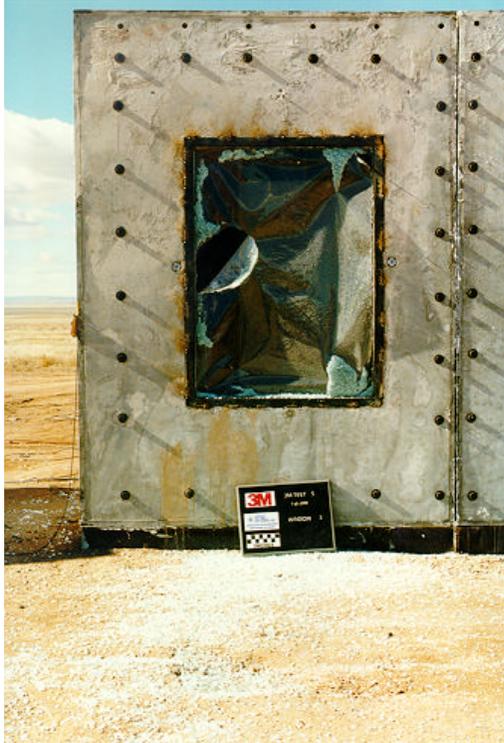
**Rating:** GSA Condition 5 (significant hazard reduction)

The glazing of window 3 failed. The film was pulled from the batten along the right edge and a large tear also developed at the left edge. All film was retained in the frame. About 95% of the total window glass left the film on the rebound of the window system and landed in front of the structure out to a distance of 43 ft from the front of the structure. Several fragments entered

Figure 7.6. Exterior posttest view of window 3, test 5 (3M T5 post 32.tif).

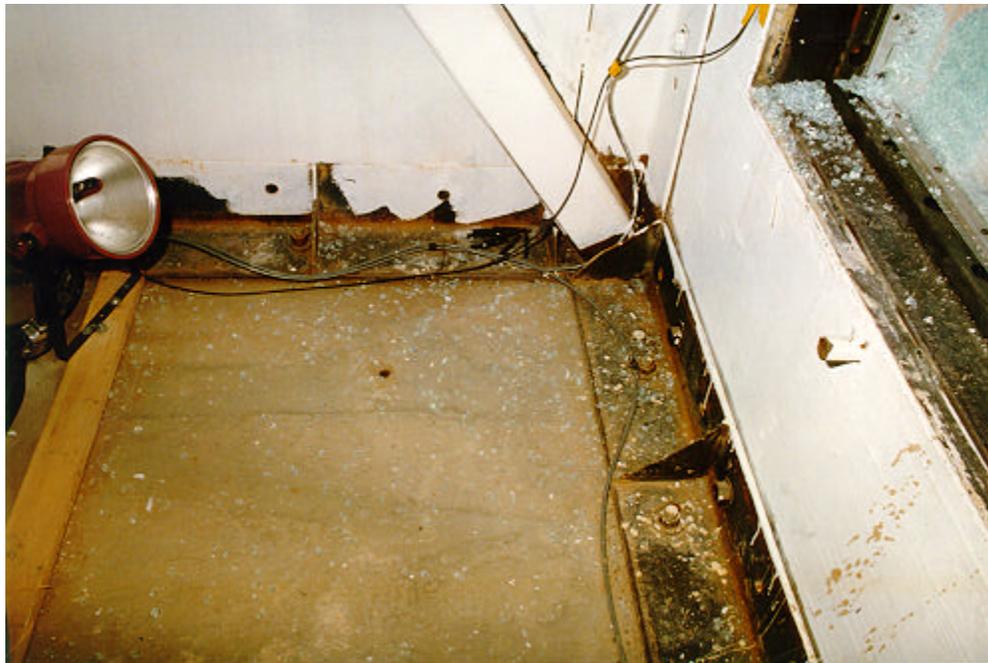
Figure 7.7. Interior view of fragmentation from window 3, test 5 (3M T5 post 03.tif).

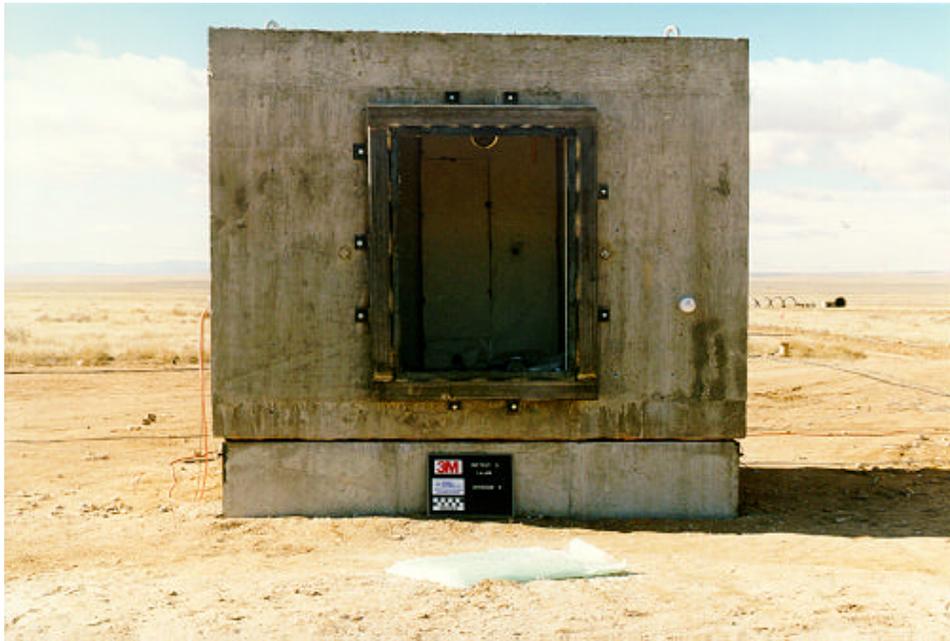
**Rating:** GSA Condition 3 (significant hazard reduction)

The glazing of window 4 failed and the film with most glass attached left the window frame and landed 46 inches from the front of the structure. About 60% of the glass was retained on the film. Exterior glass fragments landed out to a distance of about 23 ft from the front of the structure. A few fragments entered the structure and these were contained within the first half of the structure. There were no glass fragment impact marks on the witness panel.

Figure 7.8. Exterior posttest view of window 4, test 5 (3M T5 post 37.tif).

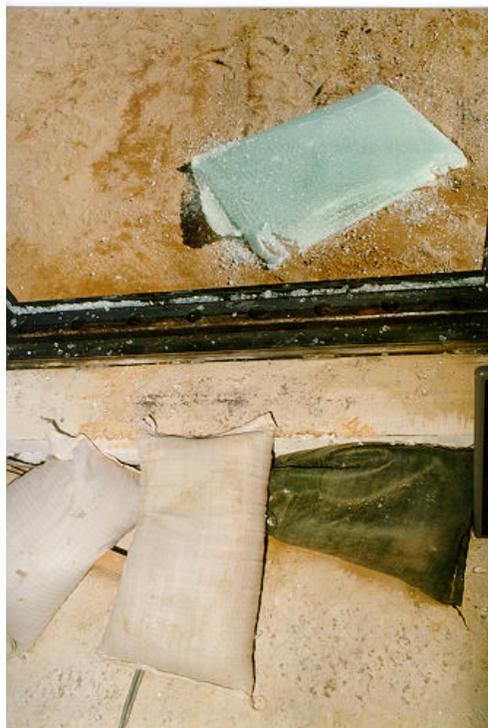
Figure 7.9. Interior view of window 4 fragmentation, test 5 (3M T5 post 47.tif).

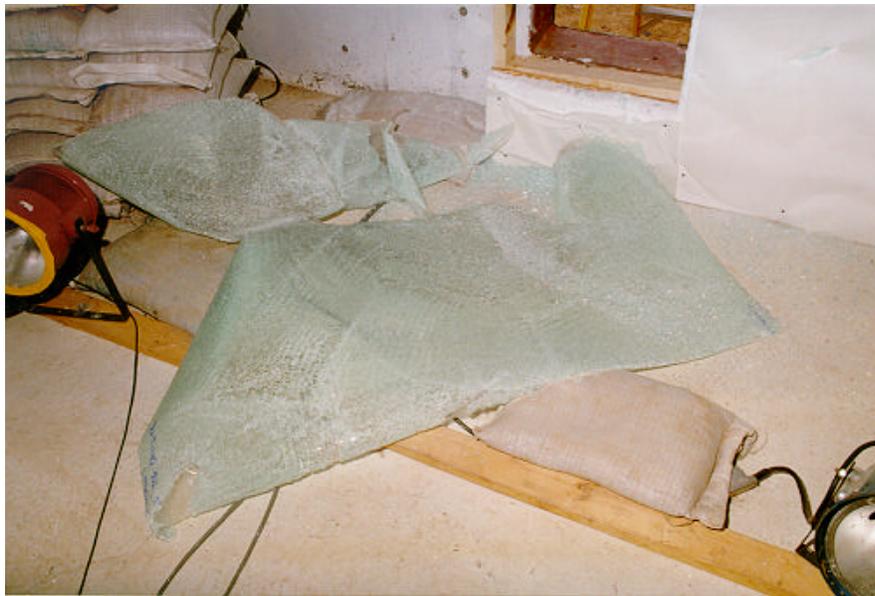
**Rating:** GSA Condition 5

The glazing of window 1 broke. The film left the frame in one piece with most glass attached. The film/glass entered the structure and impacted the witness panel. Where the film/glass impacted the witness panel, most of the impact mark was below the 2-ft height on the witness panel and the mark reached above the 2-ft height for only a few inches. Many other glass fragment impact marks were noted on the witness panel. Only a few glass fragments left the front of the structure and landed within about 12 ft from the structure.

Figure 8.3. Interior posttest view of window 1 fragmentation near the rear of the structure, test 6 (3M T6 post 21.tif).

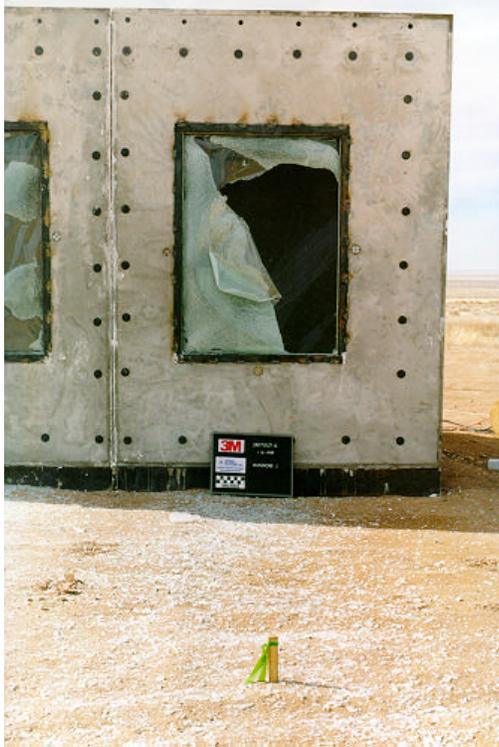
**Rating:** GSA Condition 3 (significant hazard reduction)

Both lites of window 2 failed and the film tore along the right edge and across the bottom edge and all film was retained in the frame. About 80% of the glass from the inner lite was retained on the film. The glass fragment scatter in front of the modular structure for windows 2 and 3 fell within 61 ft from the structure. Which window created which fragments was difficult to determine as both windows used the same glass type and thickness. Only a few glass fragments entered the structure and no glass fragments impacted the witness panel.

Figure 8.4. Exterior posttest view of window 2, test 6 (3M T6 post 01.tif).

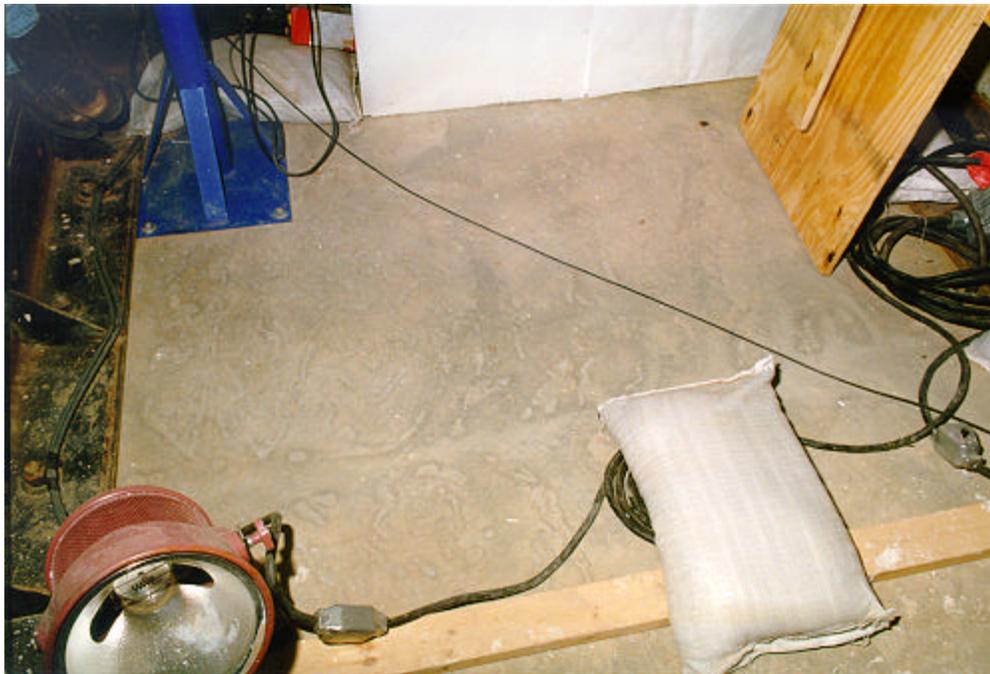
Figure 8.5. Interior view of window 2 glass fragmentation, test 6 (3M T6 post 33.tif).

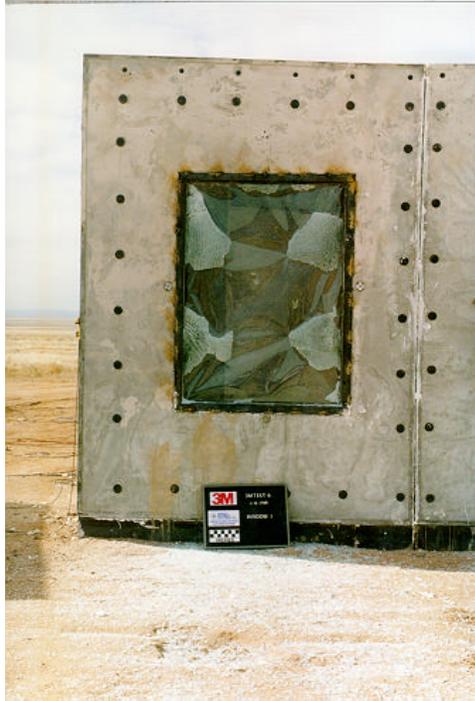
**Rating:** GSA Condition 2

Both lites from window 3 failed and the film was completely retained in the frame with no openings. No glass entered the structure. Only about 20% of the glass from the inner lite was retained on the film. The glass fragment scatter in front of the modular structure for windows 2 and 3 fell within 61 ft from the structure.

Figure 8.6. Exterior posttest view of window 3, test 6 (3M T6 post 04.tif).

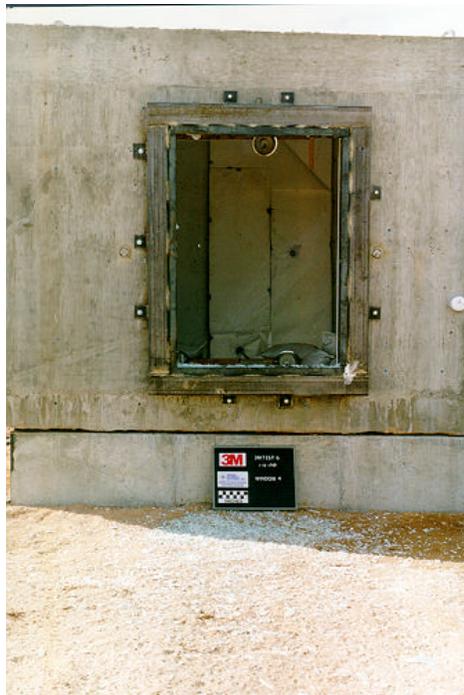
**Rating:** GSA Condition 5

The glazing of window 4 failed and most glass entered the structure at high velocities. Less than 20% of the glass left the front of the structure and this glass was contained within 22 ft from the front of the structure. Glass was scattered throughout the inside of the structure and much of the glass impacted the rear witness panel. About 130 impact marks were surveyed on the witness panel; 72 impacts were surveyed above a 2-ft height on the witness panel and 58 impact marks were surveyed below the 2-ft height.

Figure 8.7. Exterior posttest view of window 4, test 6 (3M T6 post 07.tif).
