ARA-TR-98-4589.1-1

## **Explosive Tests For Evaluation of the Glass Fragment Mitigation Characteristics of 3M Security Window Films**

**by: Joseph L. Smith, Director of Security Engineering  
Steven C. Lofton, Blast/Security Engineer  
Scott R. Swatzell, Blast/Security Engineer**

**Prepared for: 3M  
Specified Construction Products Division  
3M Center Bldg. 225-4S-08  
St. Paul, MN 55144**

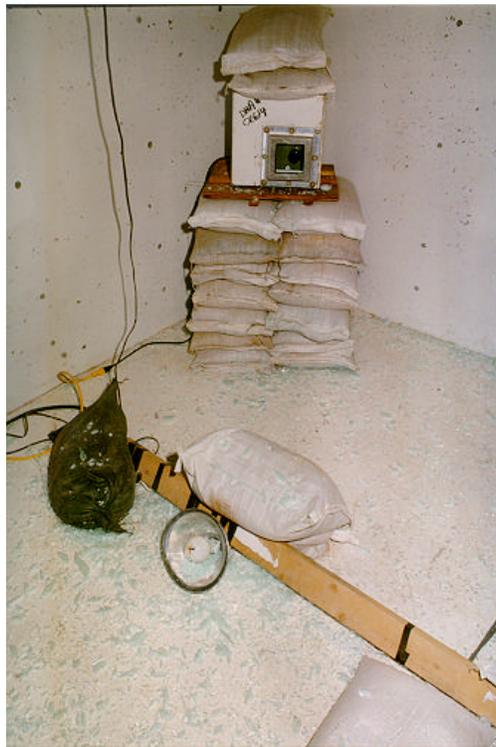
Figure 8.8. Interior view of window 4 glass fragmentation, test 6 (3M T6 post 27.tif).

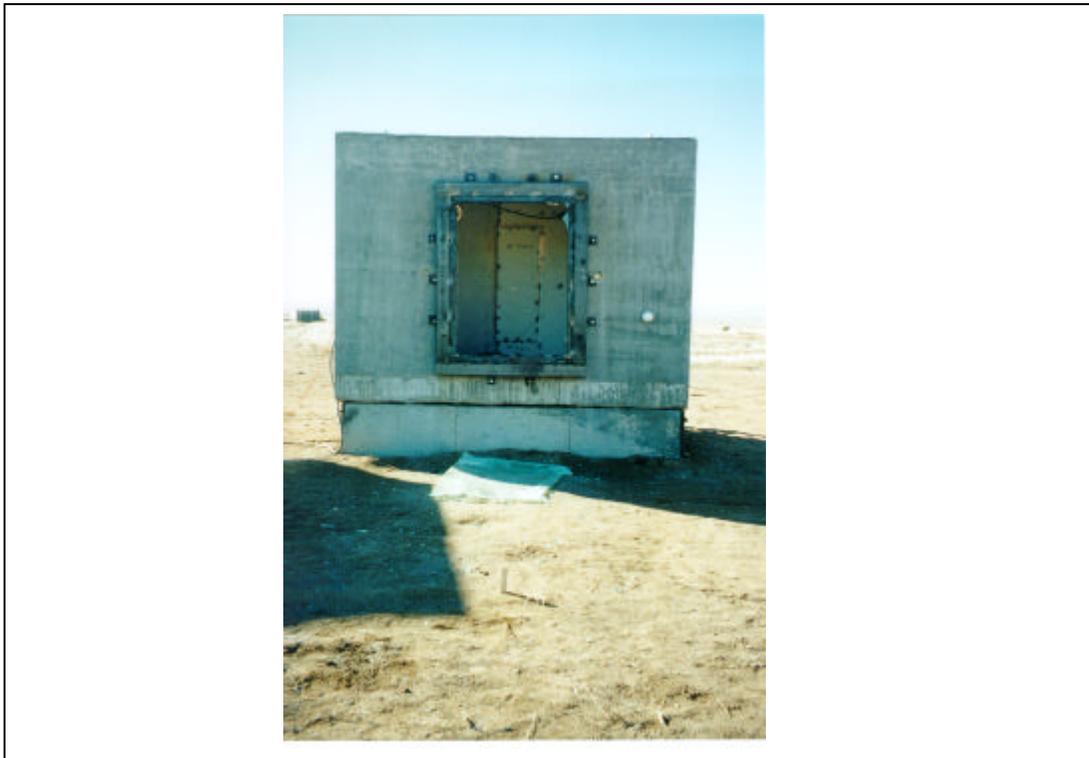
Figure A.17. Test 1. Posttest, exterior view of window 1 (3m sd T1 post37.tif).

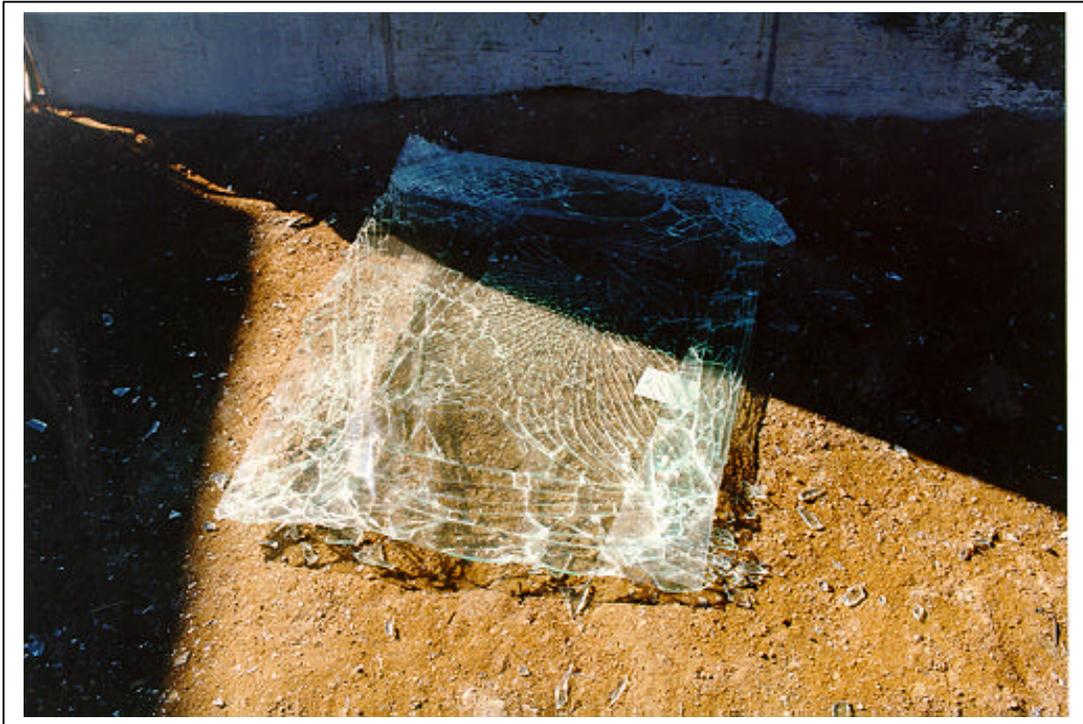
Figure A.19. Test 1. Posttest view of the security film and attached glazing from window 1 (3M T1 POST 05.tif).

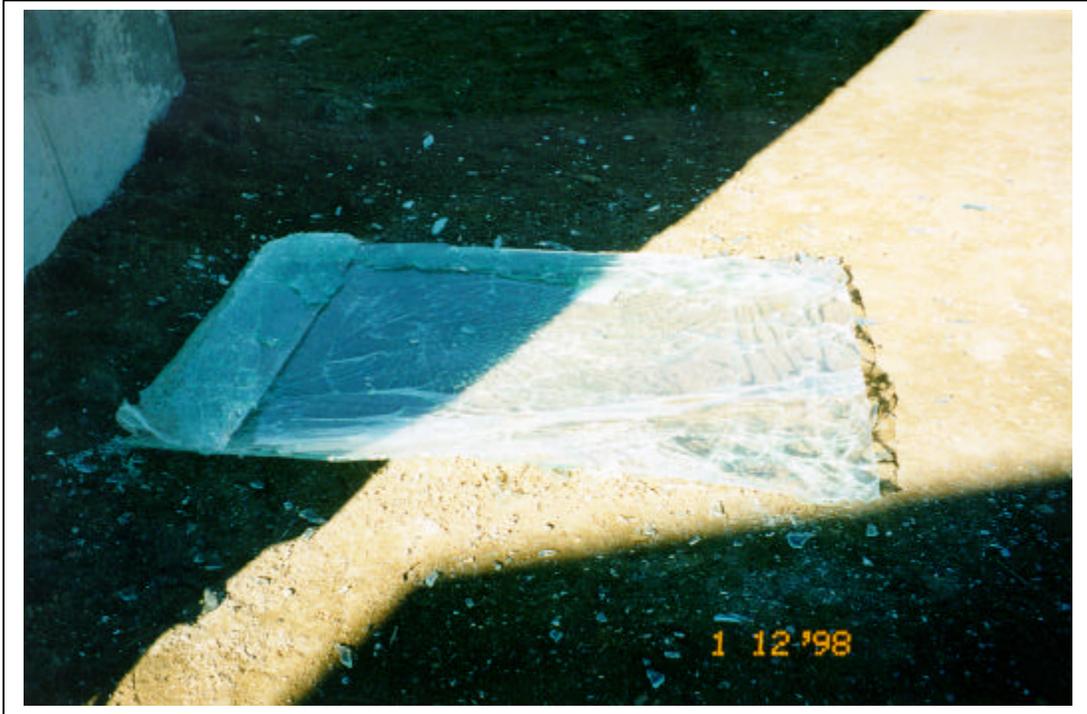
Figure A.20. Test 1. Posttest view of the security film and attached glazing from window 1 (3M T1 F51.tif).

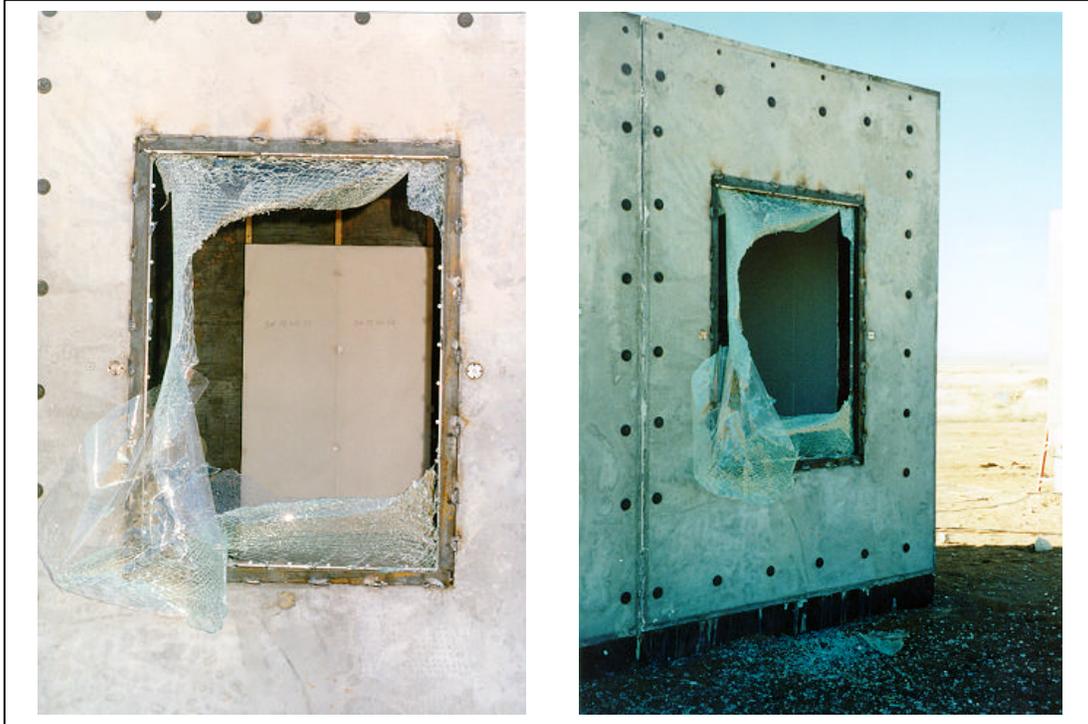
**Rating:** GSA Condition 3 (significant hazard reduction)

Both lites of window 2 failed and the film tore along the right edge and across the bottom edge and all film was retained in the frame. About 80% of the glass from the inner lite was retained on the film. The glass fragment scatter in front of the modular structure for windows 2 and 3 fell within 61 ft from the structure. Which window created which fragments was difficult to determine as both windows used the same glass type and thickness. Only a few glass fragments entered the structure and no glass fragments impacted the witness panel.

Figure A.28. Test 1. Posttest, exterior views of window 2 (3M T1 POST 07.tif, 3m sd t1 post25.tif).

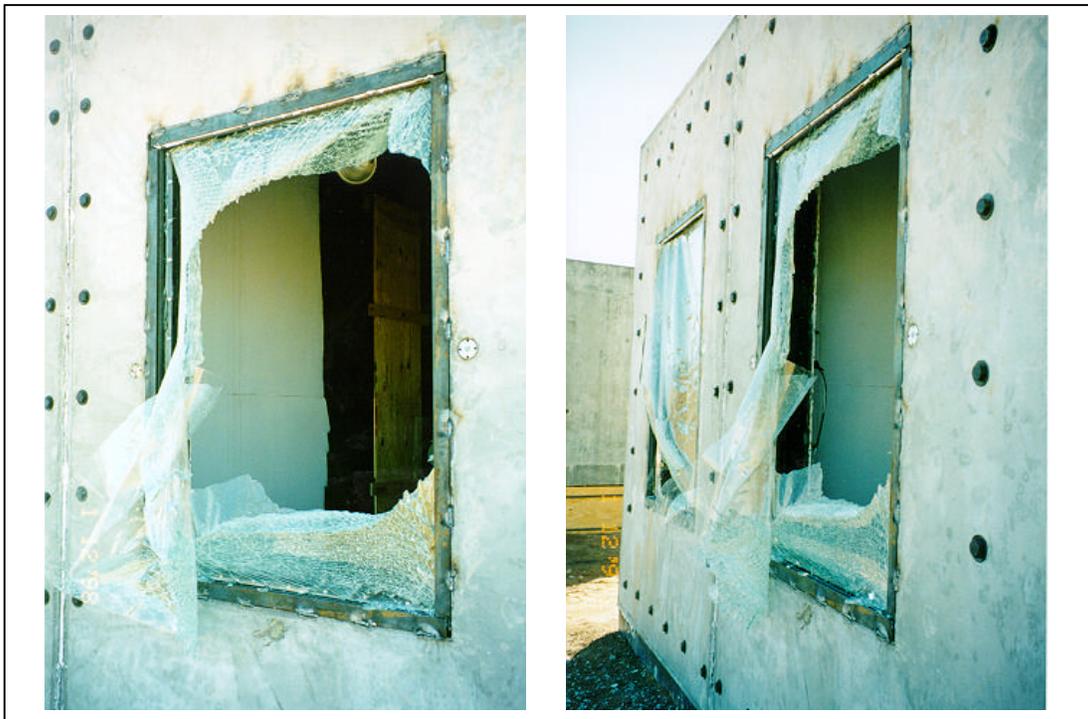
Figure A.29. Test 1. Posttest, exterior views of window 2 (3M T1 F17.tif, 3M T1 F18.tif ).

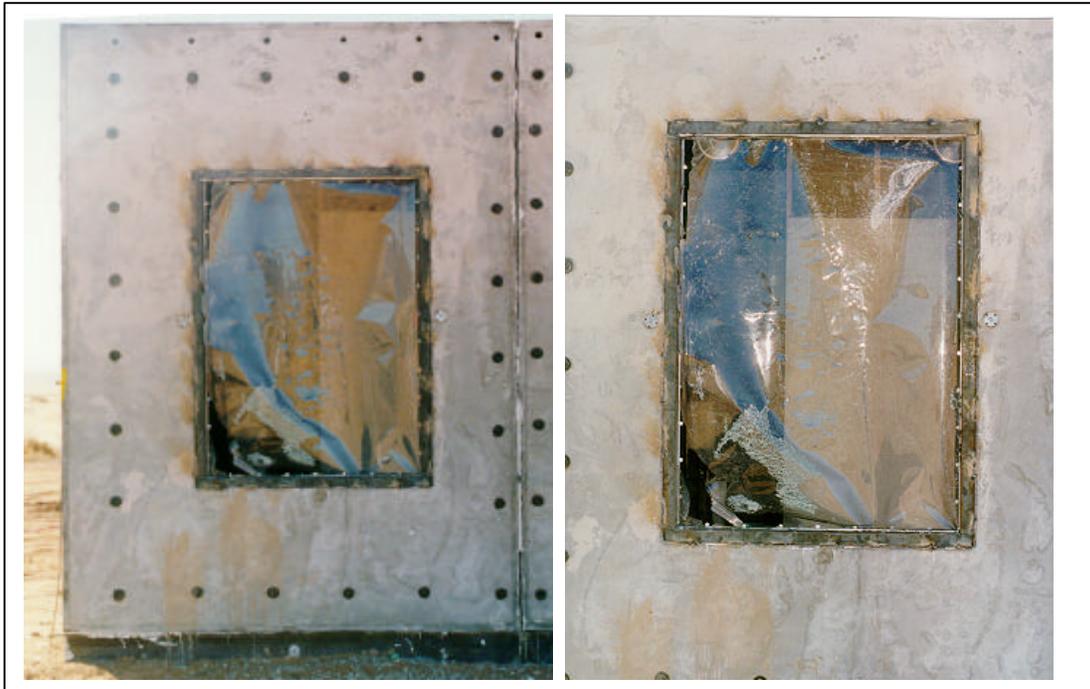
**Rating:** GSA Condition 2

Both lites from window 3 failed and the film was completely retained in the frame with no openings. No glass entered the structure. Only about 20% of the glass from the inner lite was retained on the film. The glass fragment scatter in front of the modular structure for windows 2 and 3 fell within 61 ft from the structure.

Figure A.34. Test 1. Posttest, exterior views of window 3 (3M T1 POST 10a.tif, 3M T1 POST 08.tif).

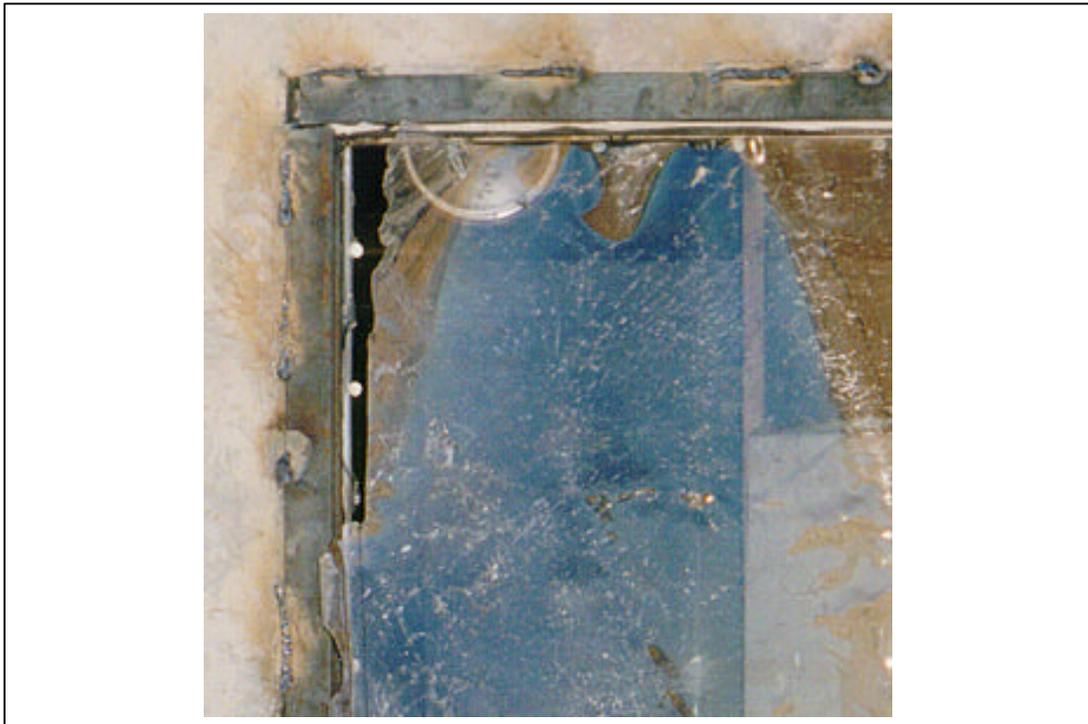
Figure A.35. Test 1. Posttest, exterior view of Window 3. View of top left corner (3M T1 POST 08a.tif).

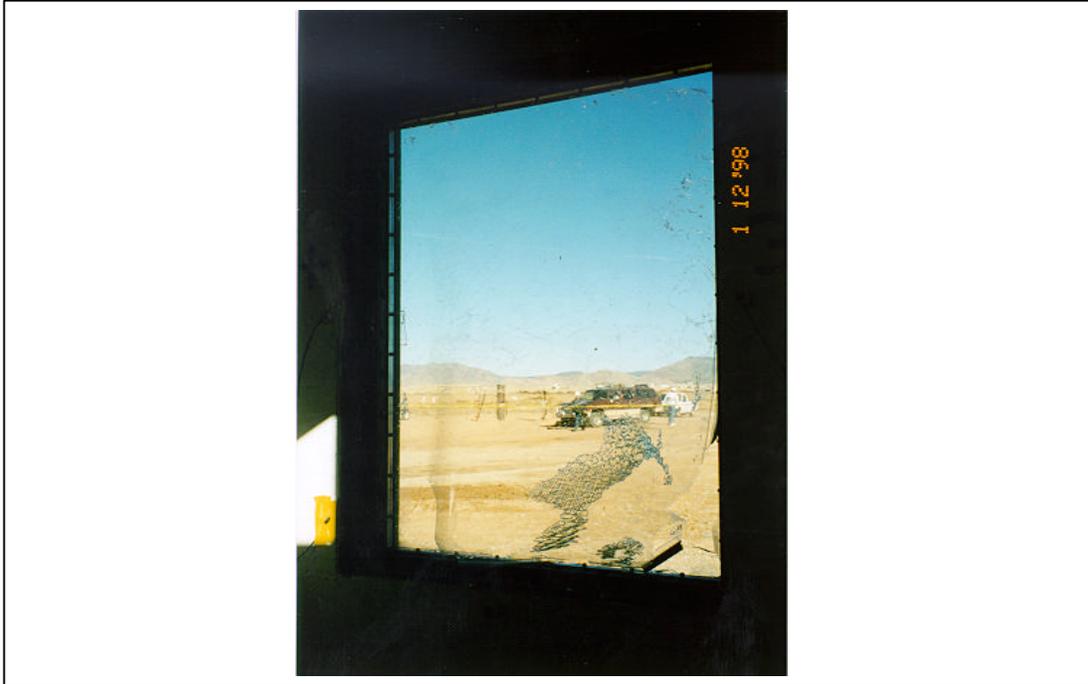
Figure A.37. Test 1. Posttest, interior view of window 2 (3M T1 F55.tif).

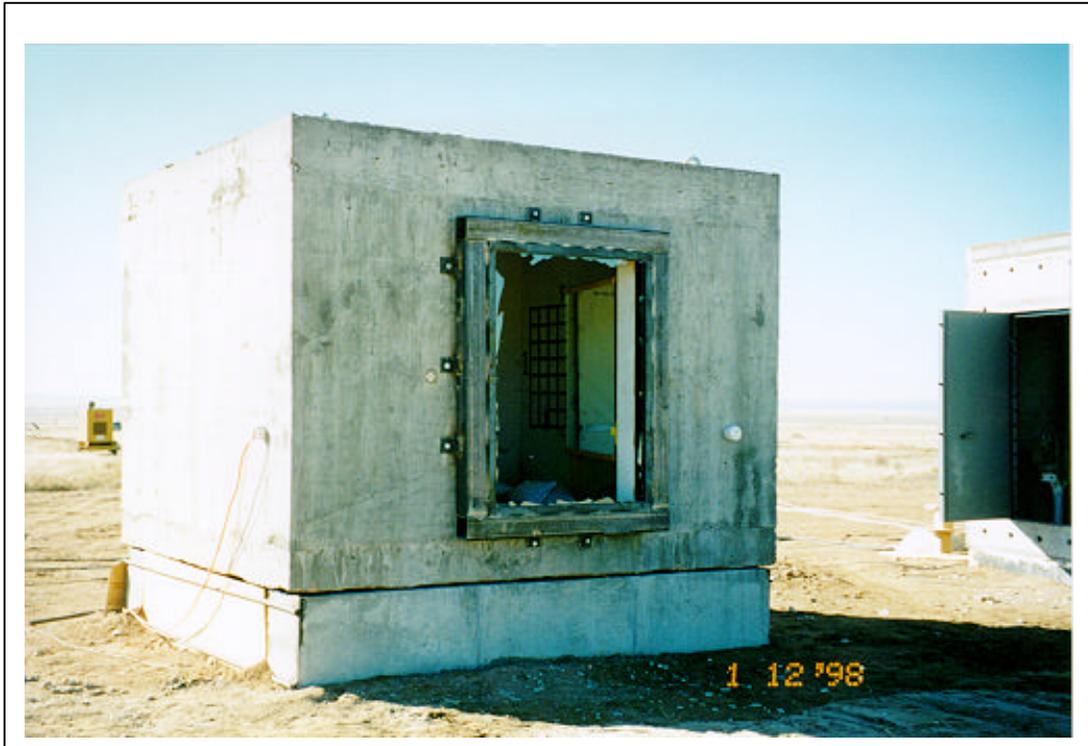
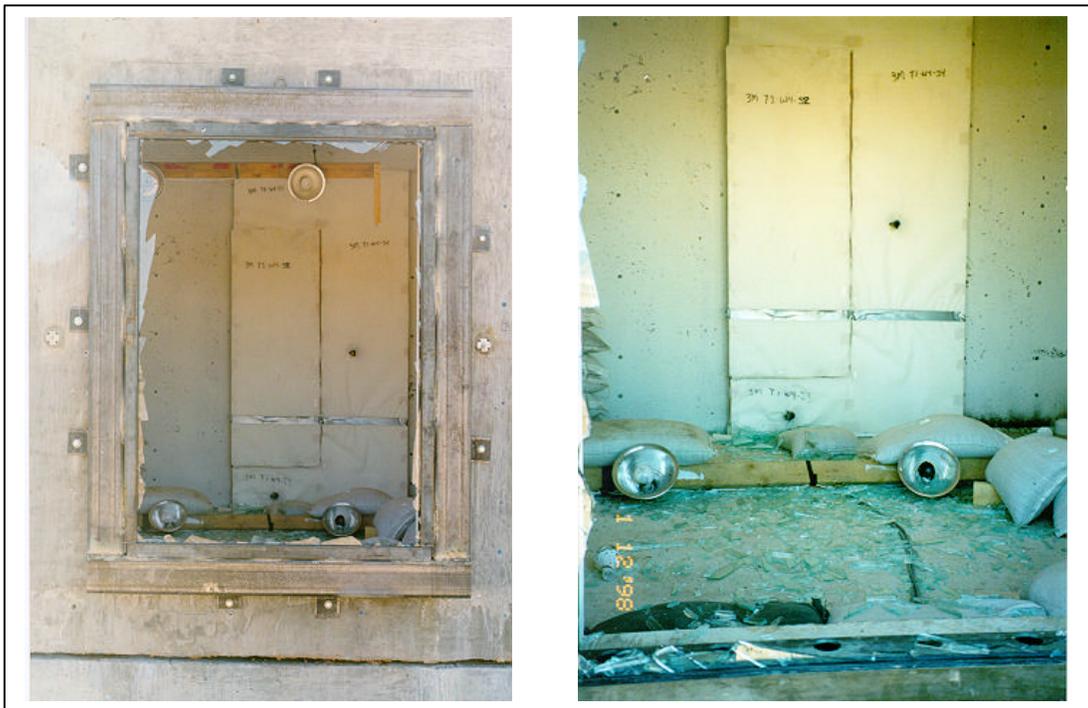
**Rating:** GSA Condition 5

The glazing of window 4 failed and most glass entered the structure at high velocities. Less than 20% of the glass left the front of the structure and this glass was contained within 22 ft from the front of the structure. Glass was scattered throughout the inside of the structure and much of the glass impacted the rear witness panel. About 130 impact marks were surveyed on the witness panel; 72 impacts were surveyed above a 2-ft height on the witness panel and 58 impact marks were surveyed below the 2-ft height.

Figure A.42. Test 1. Posttest, exterior view of window 4 (3M T1 F61.tif).

Figure A.43. Test 1. Posttest, exterior views of window 4 (3M T1 POST 11.tif, 3M T1 F58.tif).

Figure A.44. Test 1. Posttest, interior view of window 4 (test1\_41.jpg).

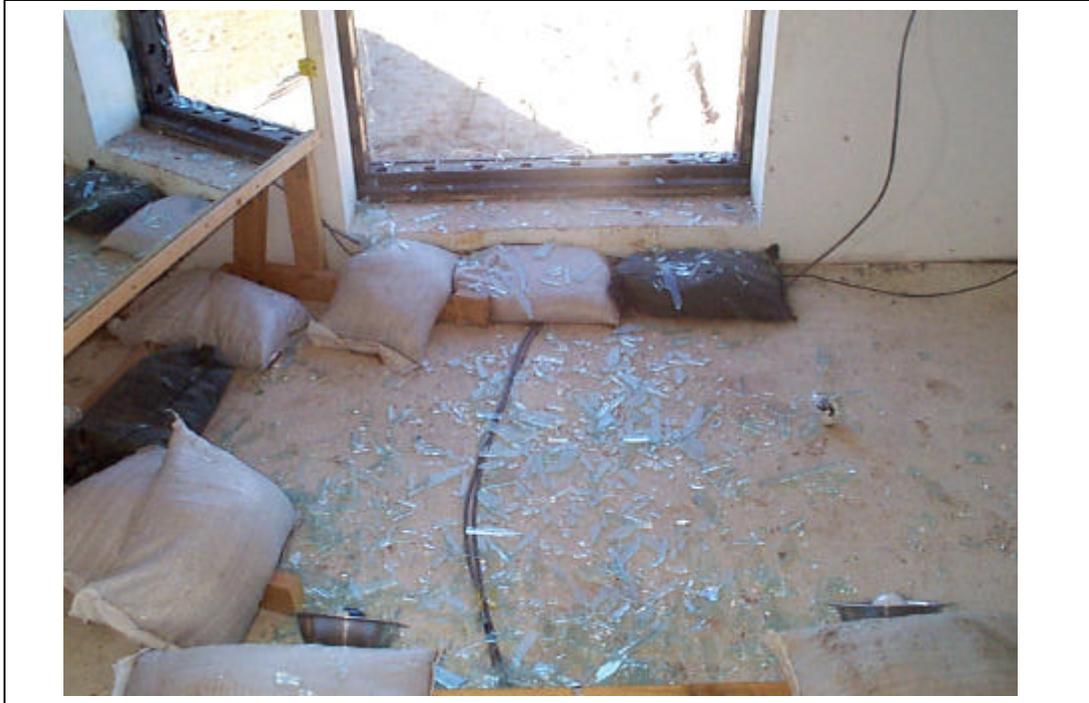
Figure A.45. Test 1. Posttest view of glass debris on the South Structure floor (test1\_42.jpg).

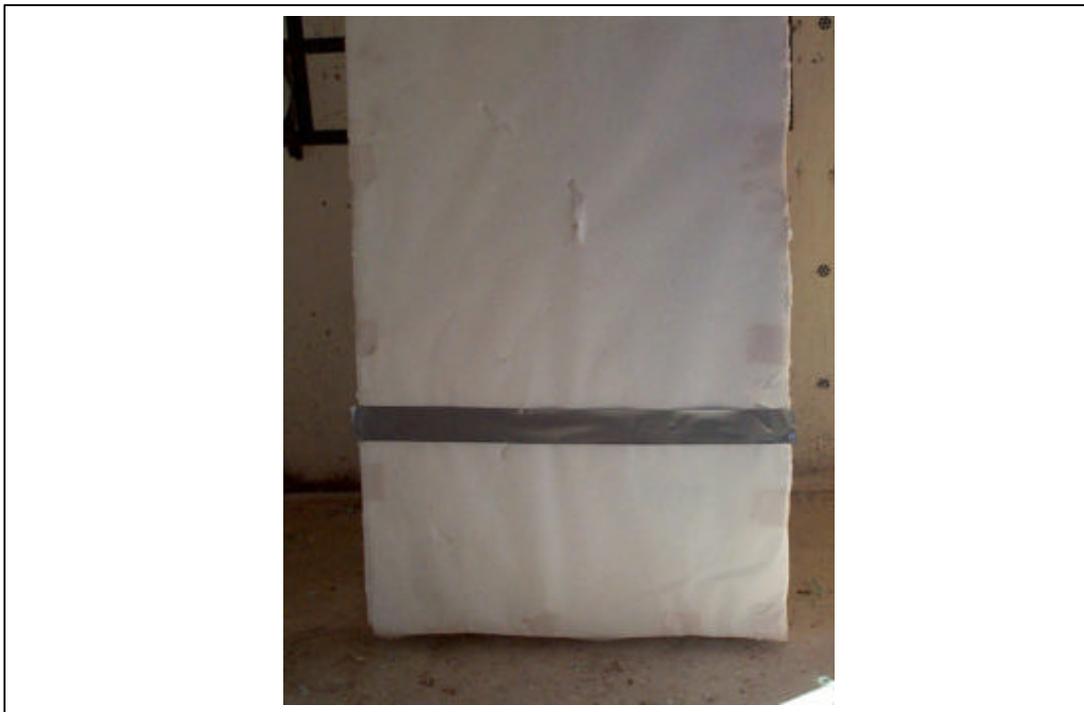
Figure A.47. Test 1. Posttest view of the witness panel located behind window 4 (test1\_45.jpg).

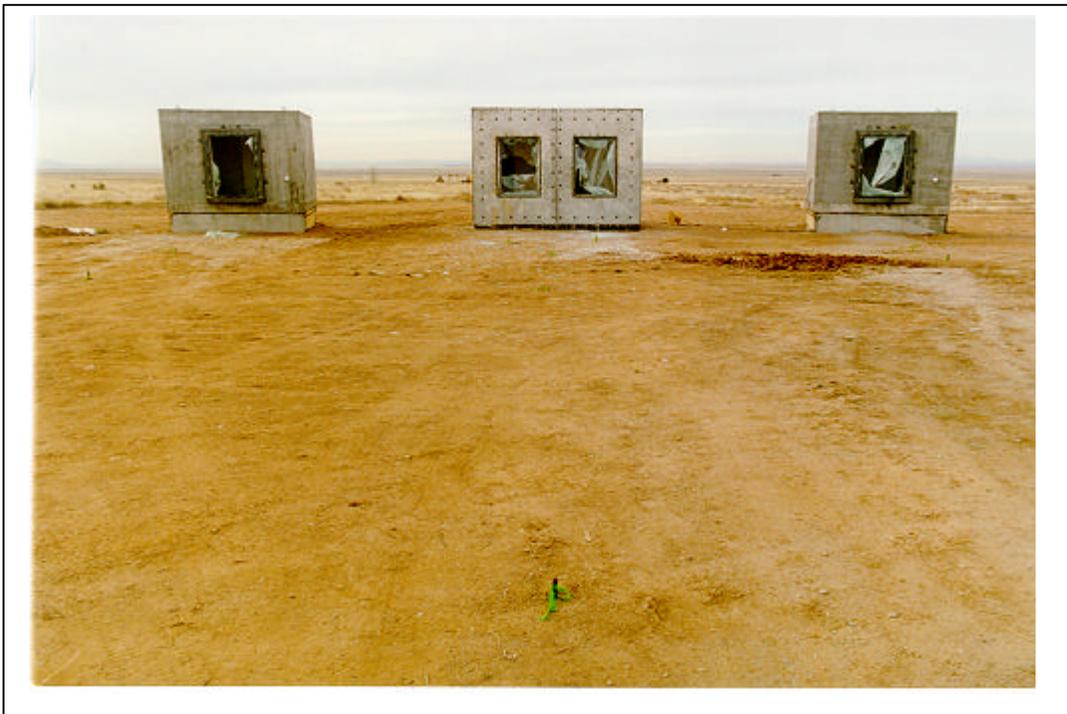
Figure A.49. Test 2. Posttest view of the test bed (3M T2 PRE 23.tif).

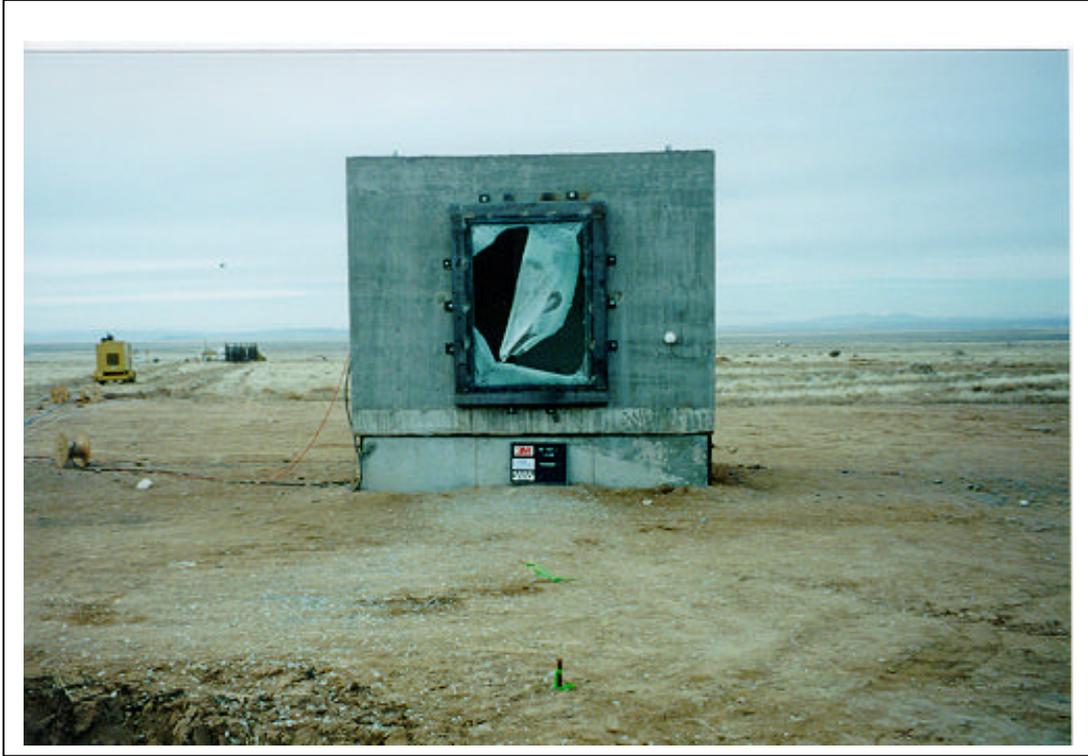
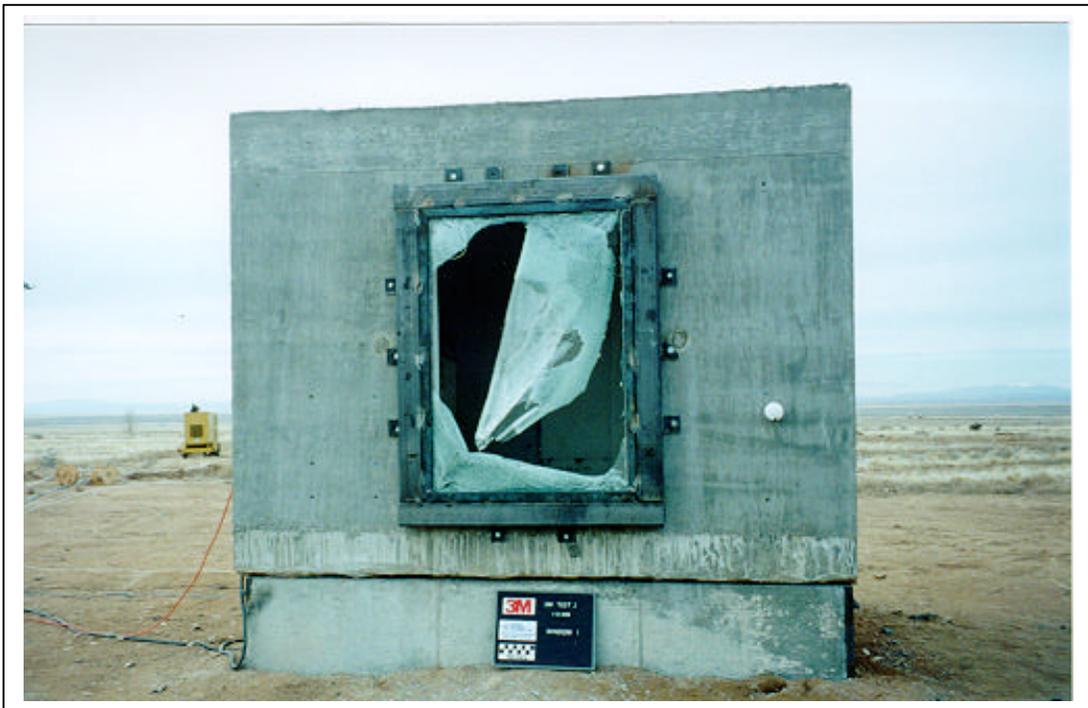
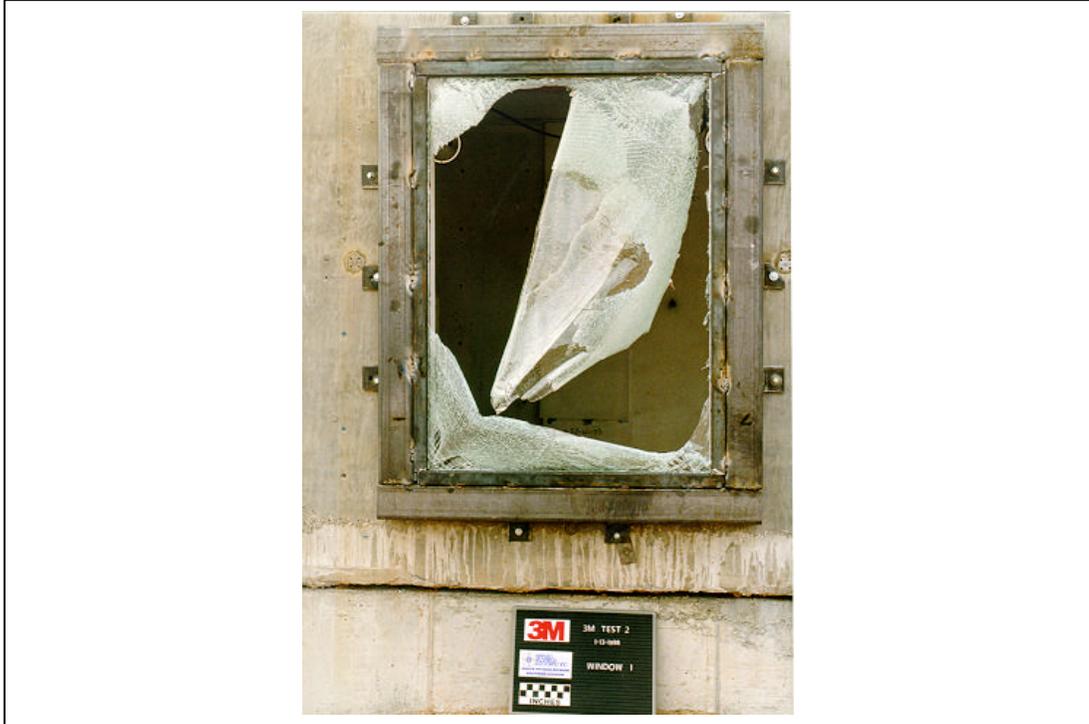
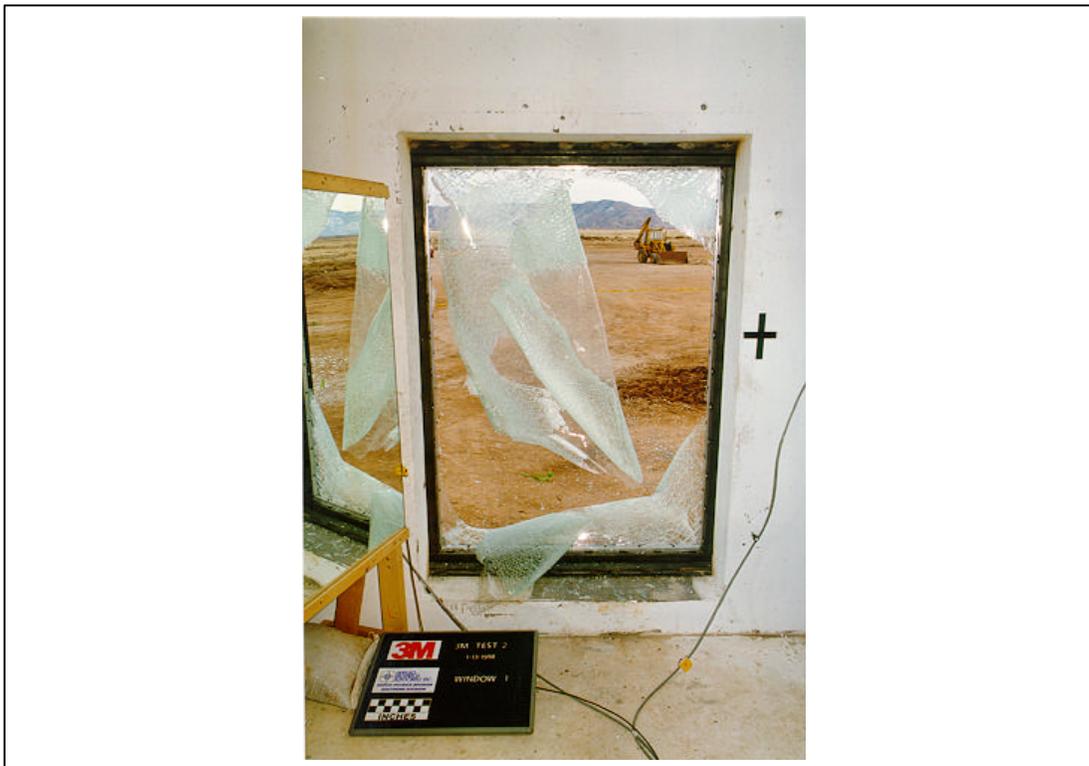
Figure A.54. Test 2. Posttest, exterior view of window 1 (3m sd T2 post28.tif).

Figure A.55. Test 2. Posttest, exterior view of window 1 (3m sd T2 post27).

Figure A.56. Test 2. Posttest, exterior view of window 1 (3M T2 POST 10.tif).

Figure A.57. Test 2. Posttest interior view of window 1 (3M T2 POST 12 .tif).

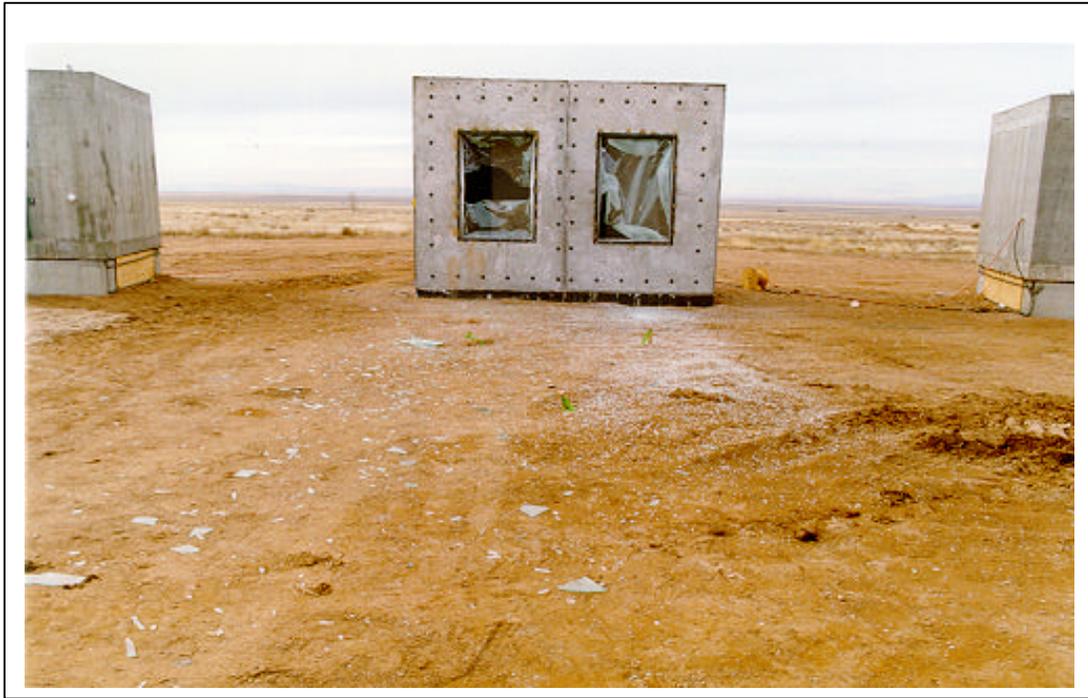
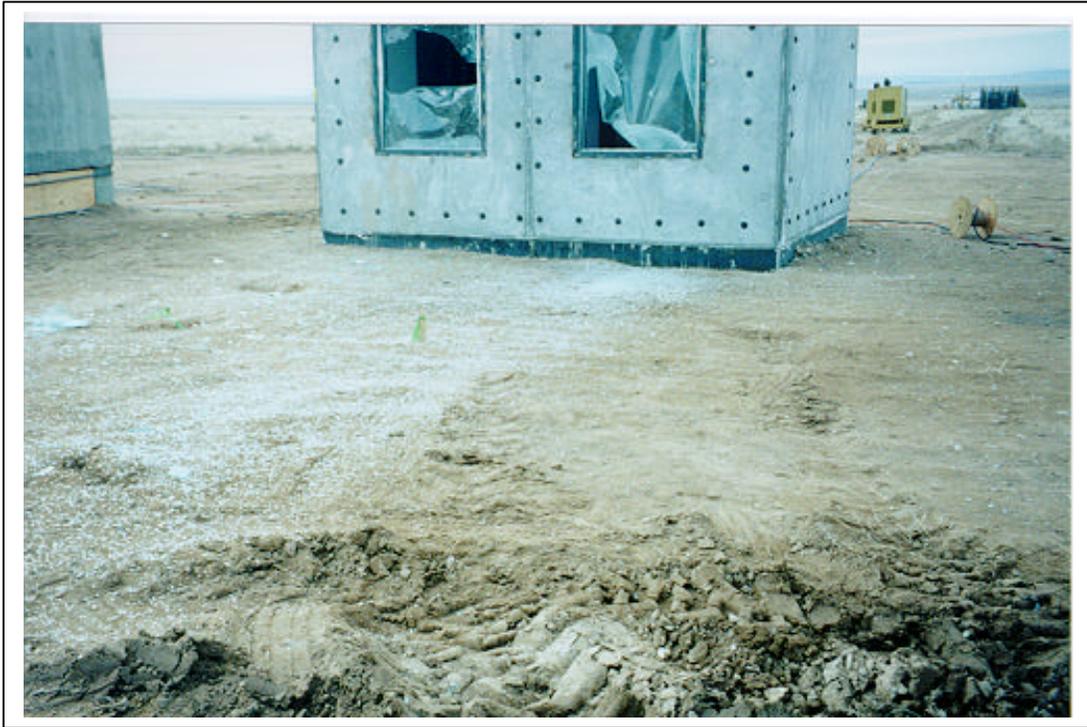
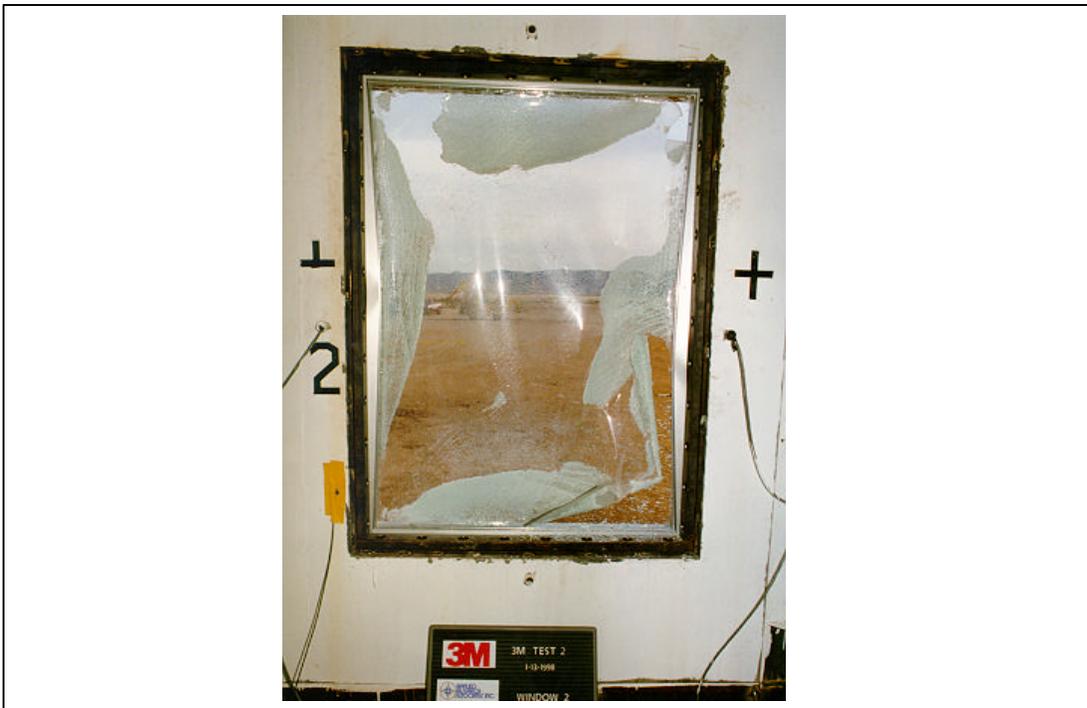
Figure A.62. Test 2. Posttest, exterior view of windows 2 and 3 (3M T2 POST 01.tif).

Figure A.63. Test 2. Posttest, exterior view of window 2 (3M T2 POST 17.tif).

Figure A.64. Test 2. Posttest, exterior view of windows 2 and 3 (3m sd T2 post30 .jpg).

Figure A.65. Test 2. Posttest, interior view of window 2 (3M T2 POST 23.tif).

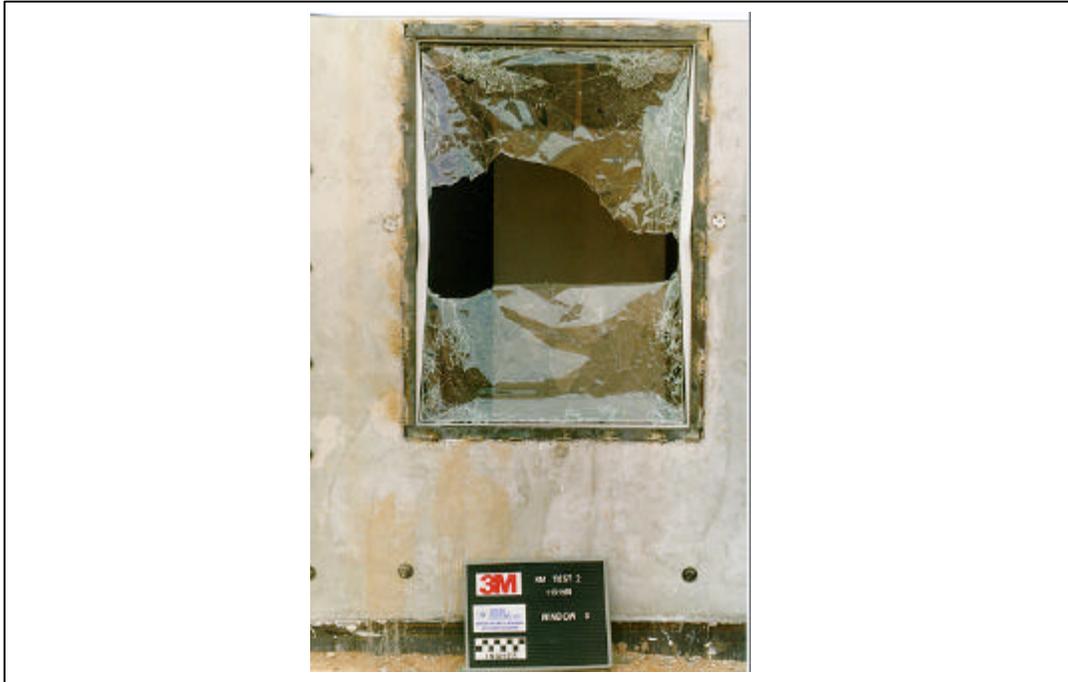
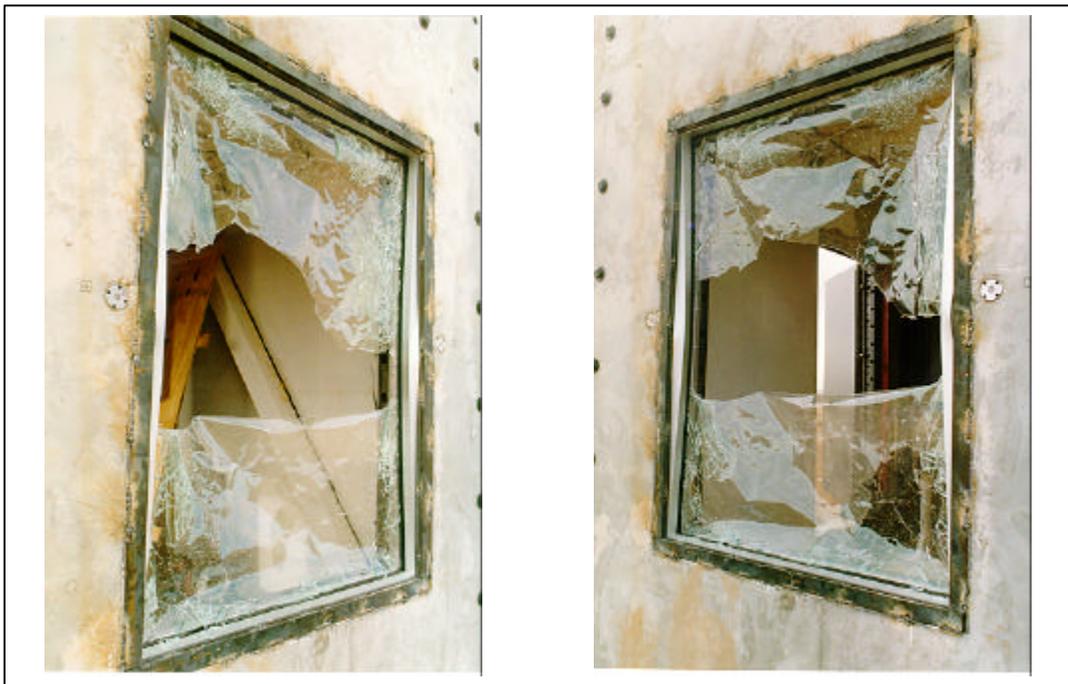
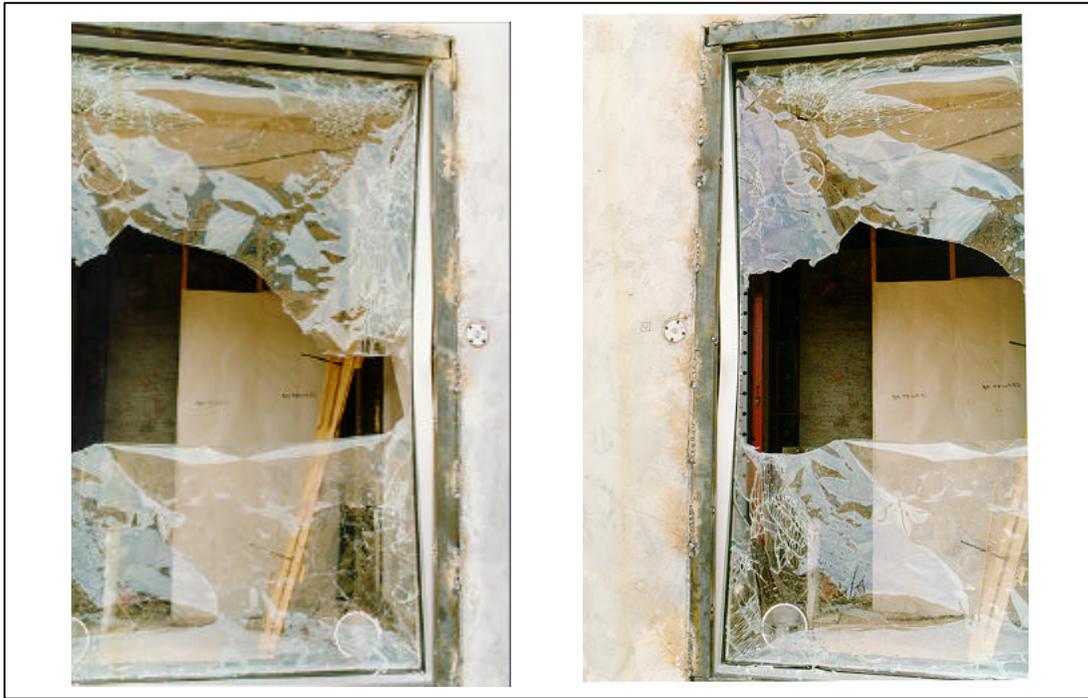
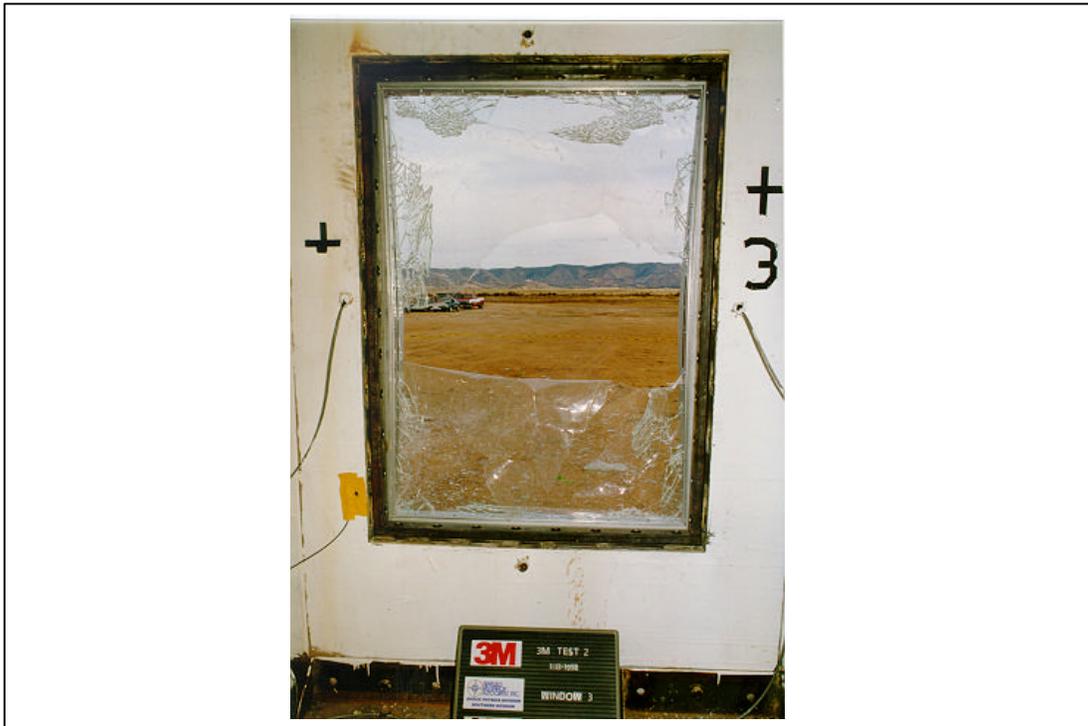
Figure A.68. Test 2. Posttest, exterior view of window 3 (3M T2 POST 15.tif).

Figure A.69. Test 2. Posttest, exterior views of window 3 (3M T2 POST 34.tif, 3M T2 POST 35.tif).

Figure A.70. Test 2. Posttest, exterior views of window 3 (3M T2 POST 37.tif, 3M T2 POST 38.tif).

Figure A.71. Test 2. Posttest, interior view of window 3 (3M T2 POST 26.tif).

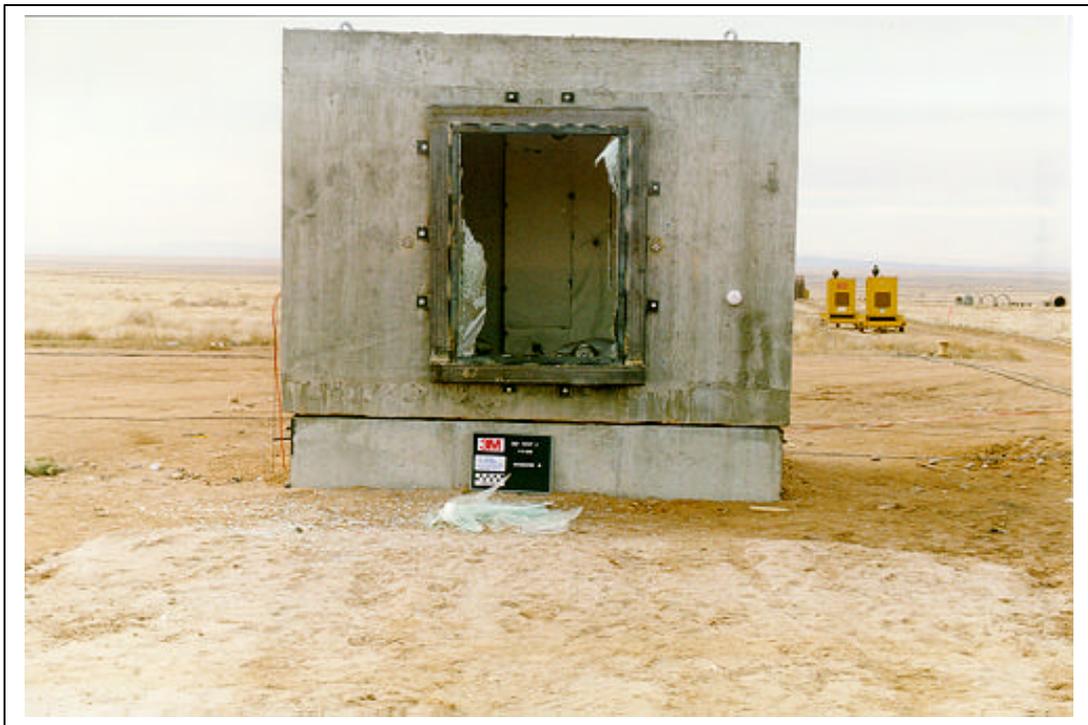
Figure A.77. Test 2. Posttest, exterior view of window 4 (3M T2 POST 02.tif).

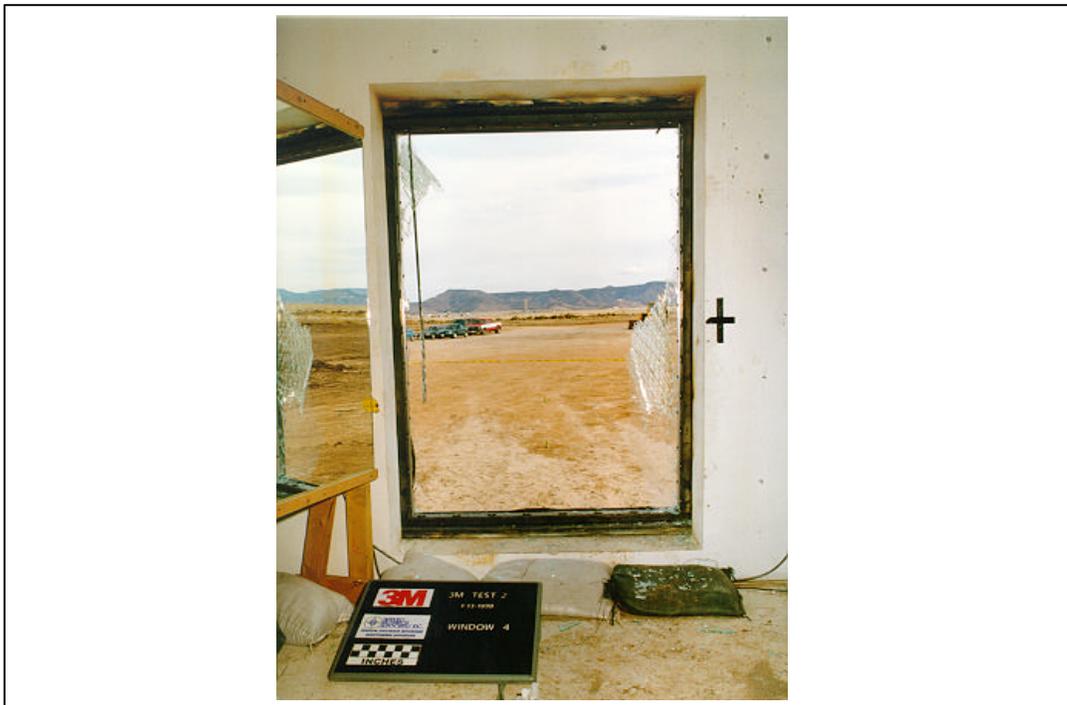
Figure A.79. Test 2. Posttest, interior view of window 4 (3M T2 POST 21.tif).

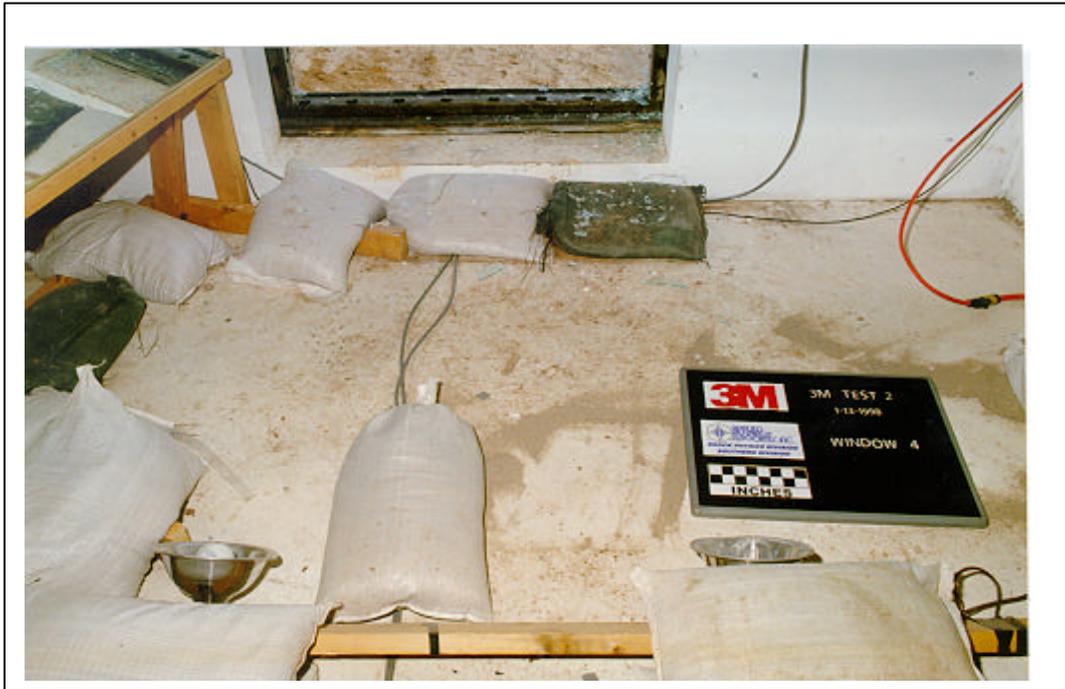
Figure A.80. Test 2. Posttest view of the glass debris on the South Structure floor (3M T2 POST 22.tif).
