ARA-TR-98-4589.1-1

## **Explosive Tests For Evaluation of the Glass Fragment Mitigation Characteristics of 3M Security Window Films**

**by: Joseph L. Smith, Director of Security Engineering  
Steven C. Lofton, Blast/Security Engineer  
Scott R. Swatzell, Blast/Security Engineer**

**Prepared for: 3M  
Specified Construction Products Division  
3M Center Bldg. 225-4S-08  
St. Paul, MN 55144**

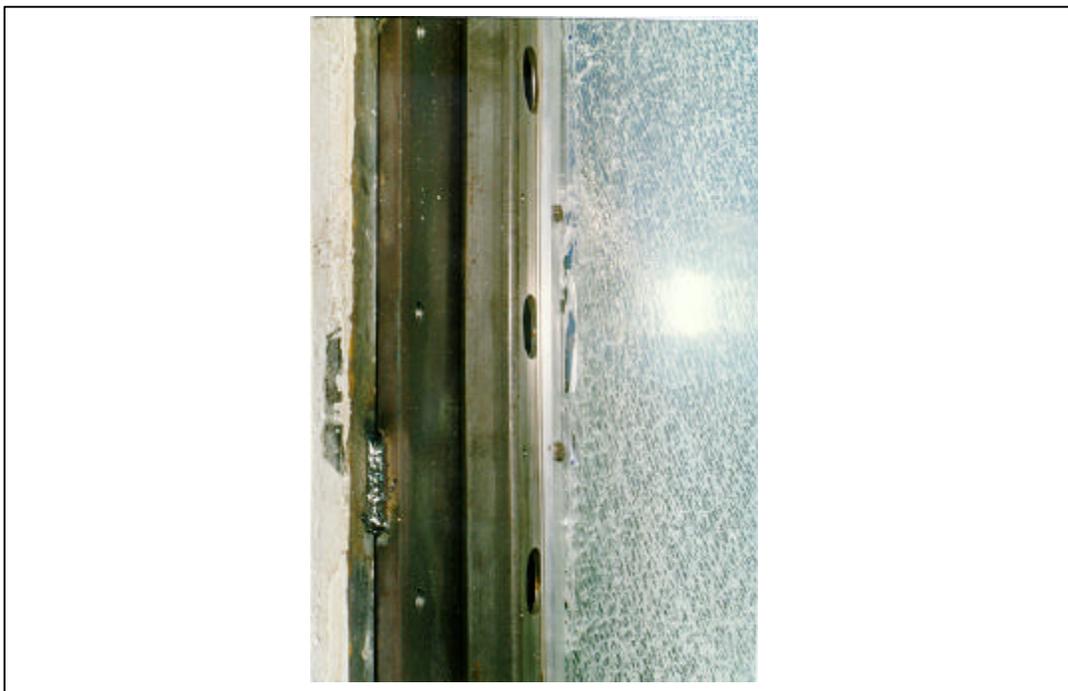
Figure A.96. Test 3. Posttest, interior view of window 2. Close-up view of a tear in the security film along the vertical edge (3M T3 POST 27.tif).

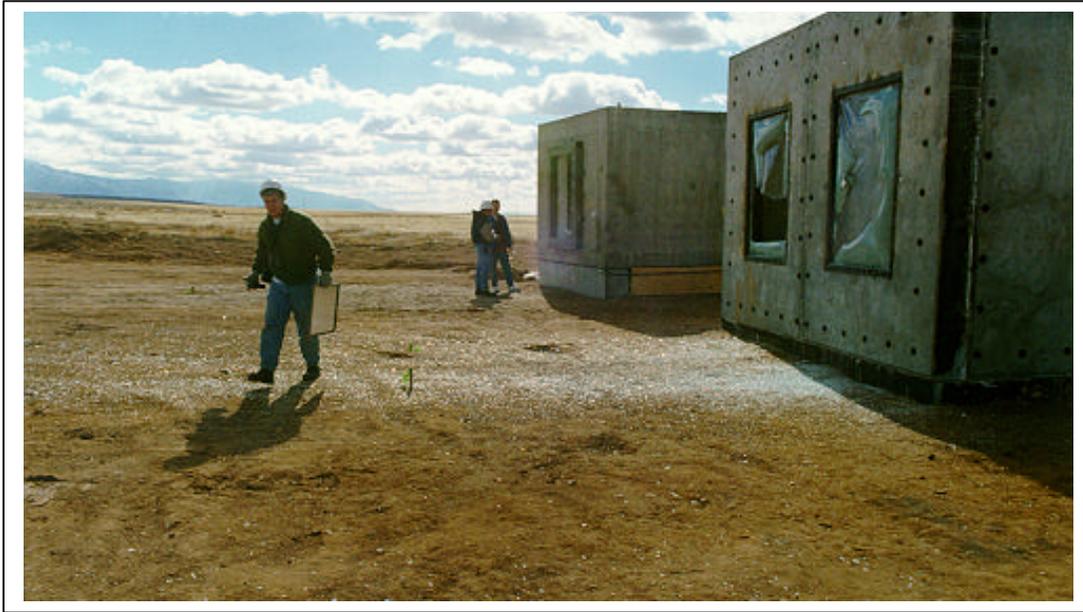
Figure A.103. Test 3. Posttest, exterior view of windows 2 and 3. Picture depicting the glass fragment spray in front of the reaction structures (3M T3 POST 20.tif).

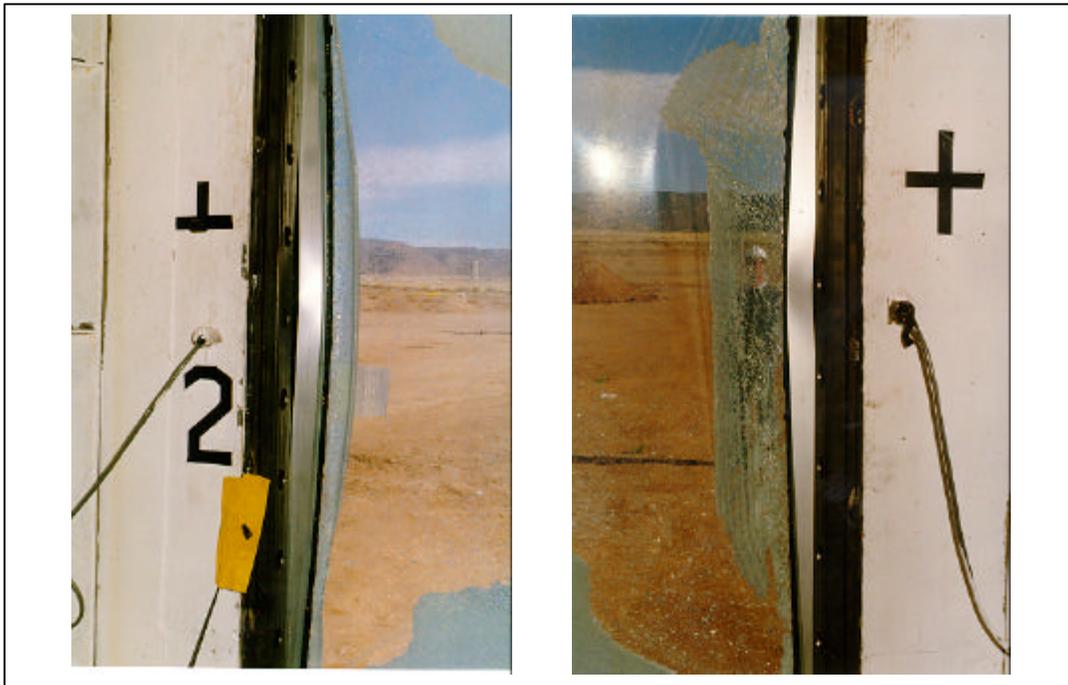
Figure A.130. Test 4. Posttest, interior views of window 2. Pictures of the aluminum frame displacement along the vertical edges (3M T4 POST 16.tif).

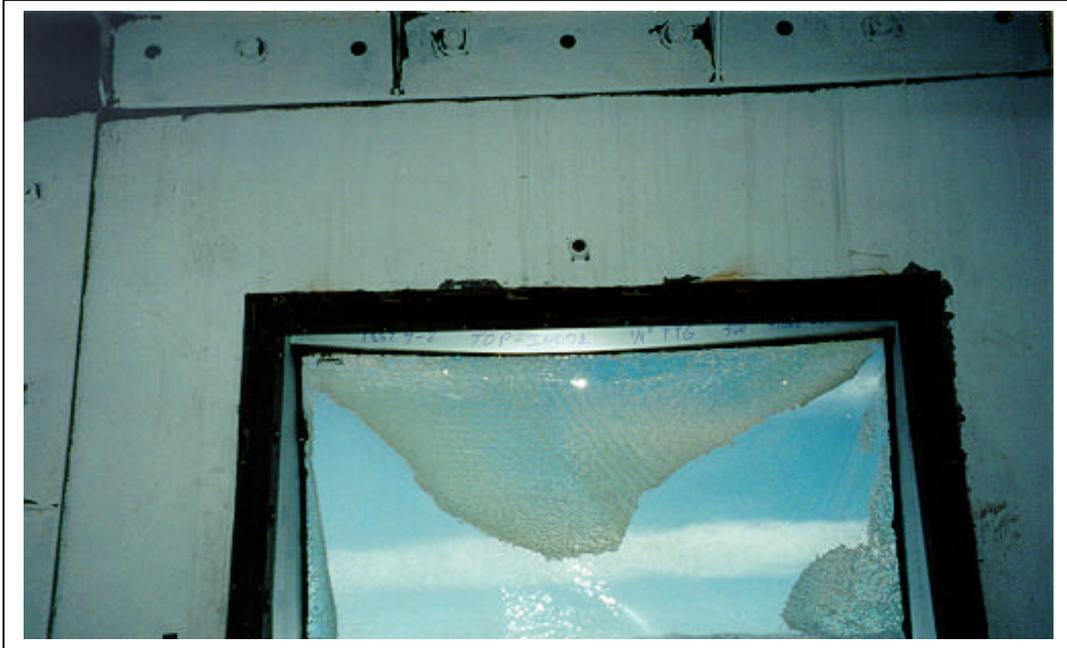
Figure A.131. Test 4. Posttest, interior view of window 2. Picture of the aluminum frame displacement along the top edge (3m sd T4 post02.tif).

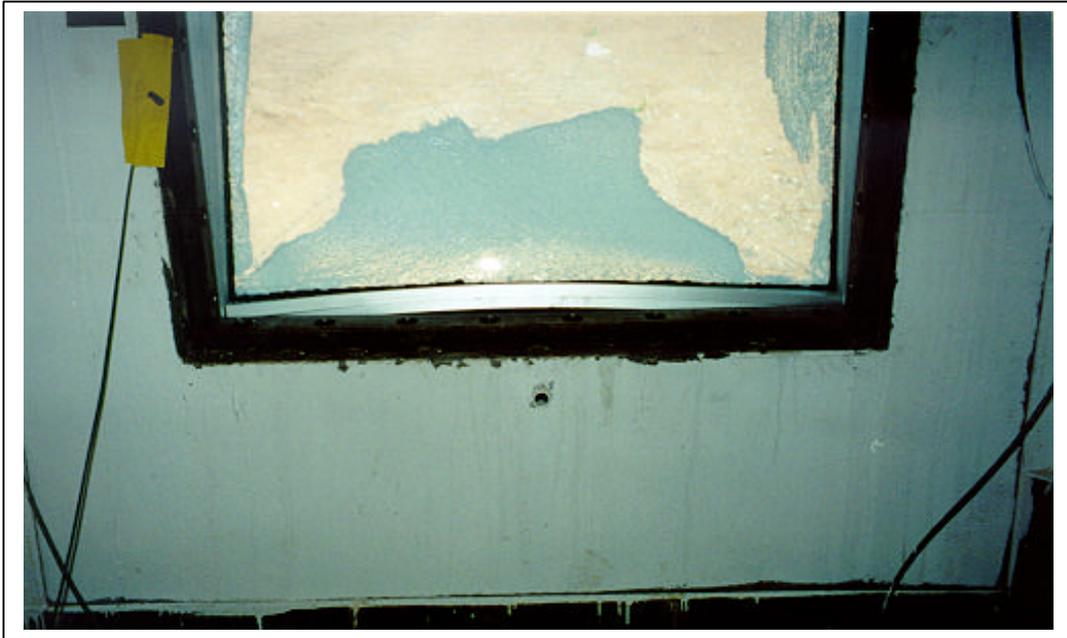
Figure A.132. Test 4. Posttest, interior view of window 2. Picture of the aluminum frame displacement along the bottom edge (3m sd T4 post02.tif).

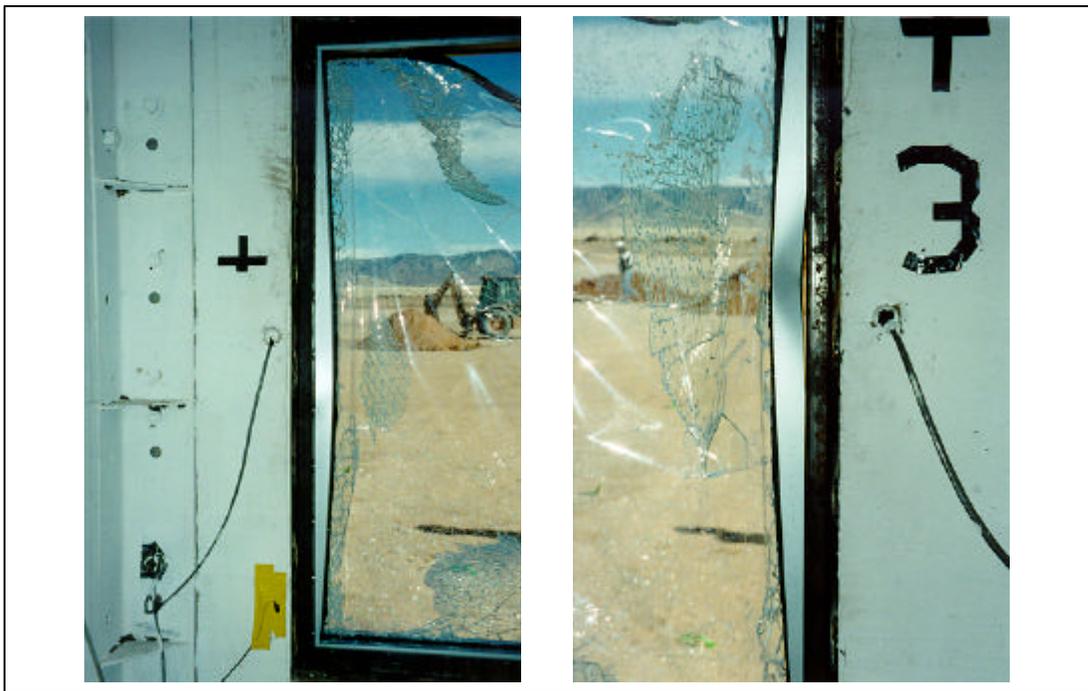
Figure A.138. Test 4. Posttest, interior views of window 3. Pictures of the aluminum frame displacement along the vertical edges (3m sd T4 post04.tif, 3m sd T4 post03.tif).

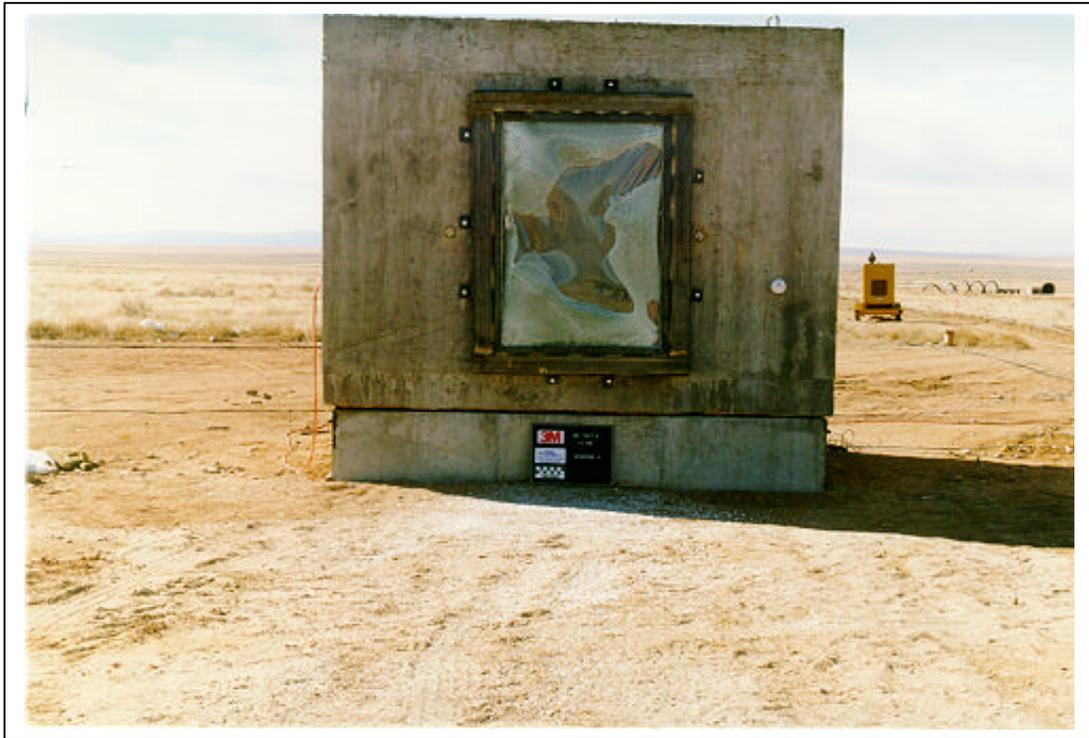
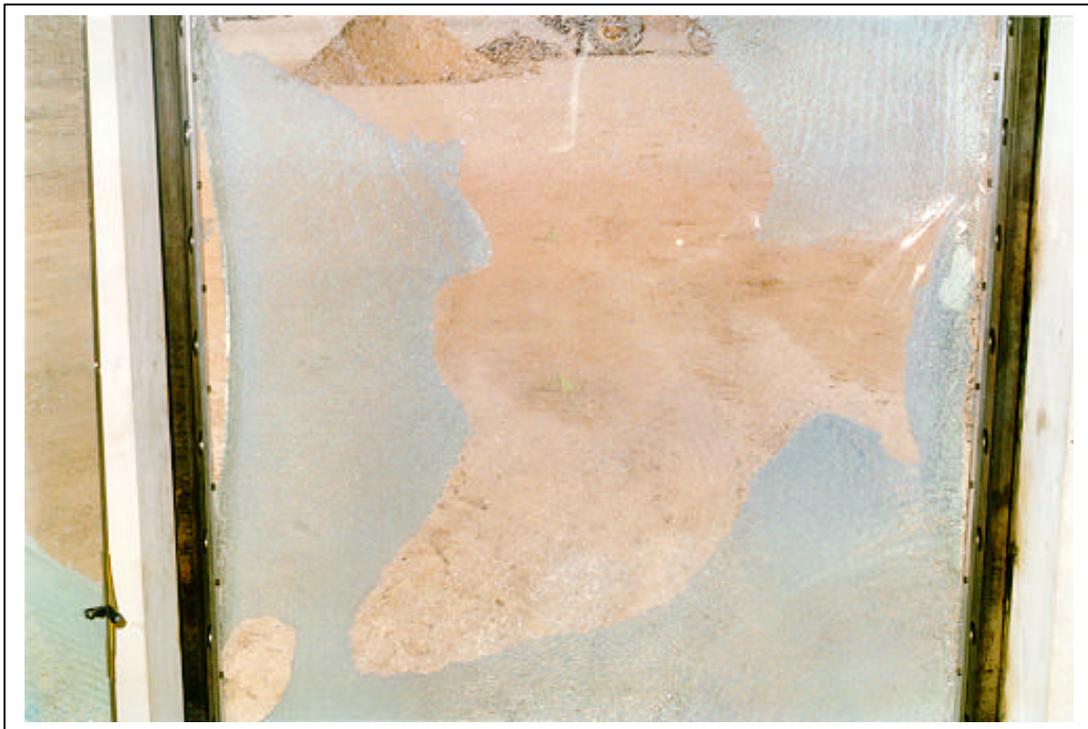
**Rating:** GSA Condition 5

The glazing of window 4 failed and most glass entered the structure at high velocities. Less than 20% of the glass left the front of the structure and this glass was contained within 22 ft from the front of the structure. Glass was scattered throughout the inside of the structure and much of the glass impacted the rear witness panel. About 130 impact marks were surveyed on the witness panel; 72 impacts were surveyed above a 2-ft height on the witness panel and 58 impact marks were surveyed below the 2-ft height.

Figure A.143. Test 4. Posttest, exterior view of window 4 (3M T4 POST 43.tif).

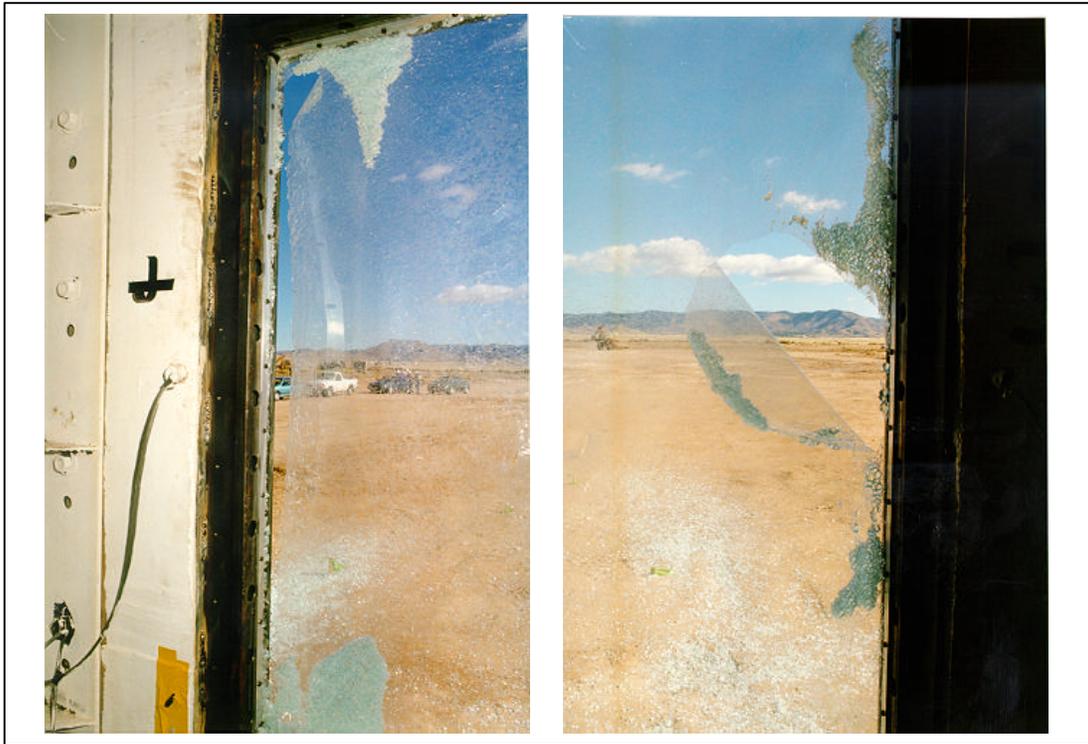
Figure A.168. Test 5. Posttest, exterior view of window 3. Picture of an apparent projectile penetration (3M sd T5 post01.tif).

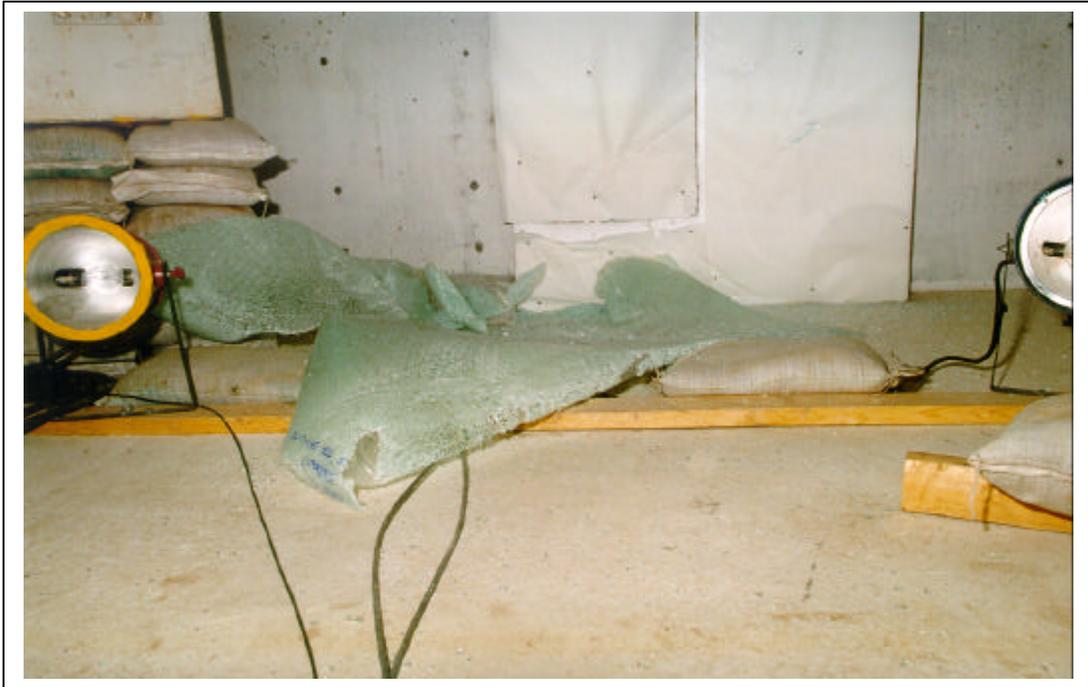
Figure A.186. Test 6. Posttest view of the back wall and floor of the North Structure (3M T6 POST 14.tif).

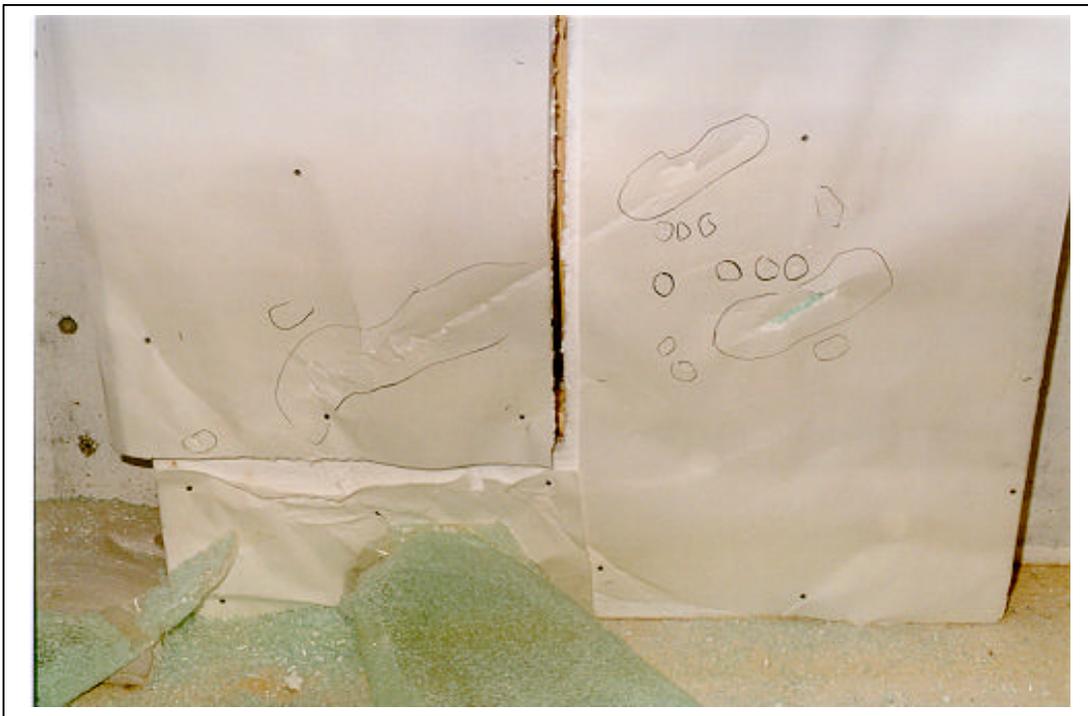
Figure A.187. Test 6. Posttest view of the witness panel located behind window 1 (3M T6 POST 22.tif).

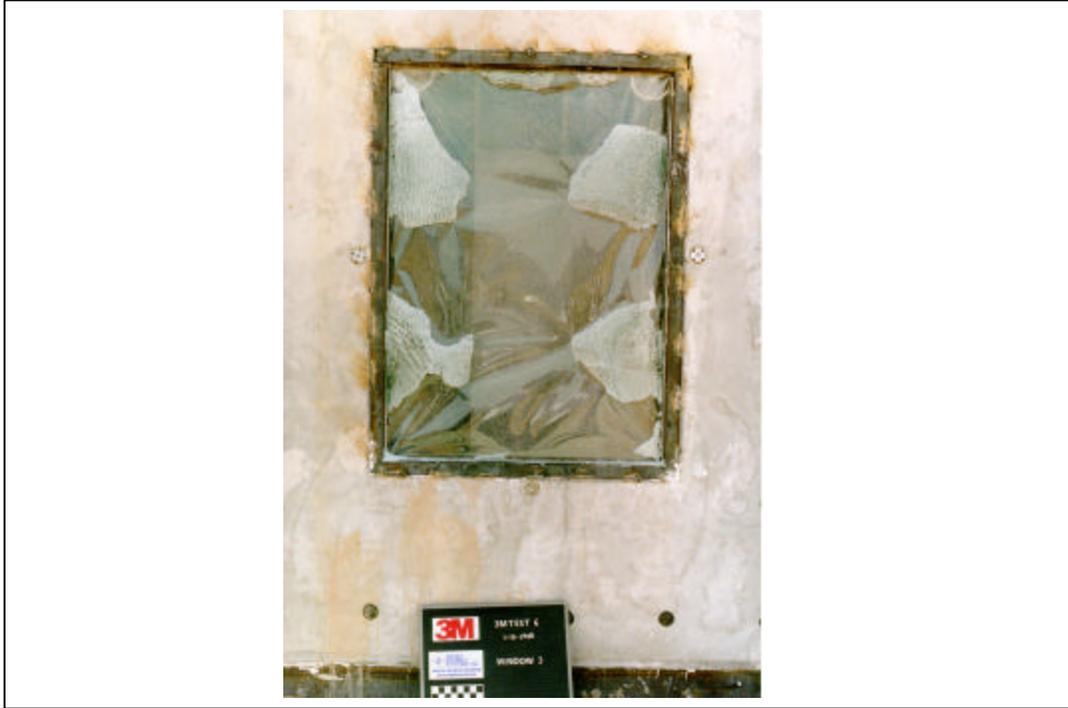
Figure A.198. Test 6. Posttest, exterior view of window 3 (3M T6 POST 03.tif).

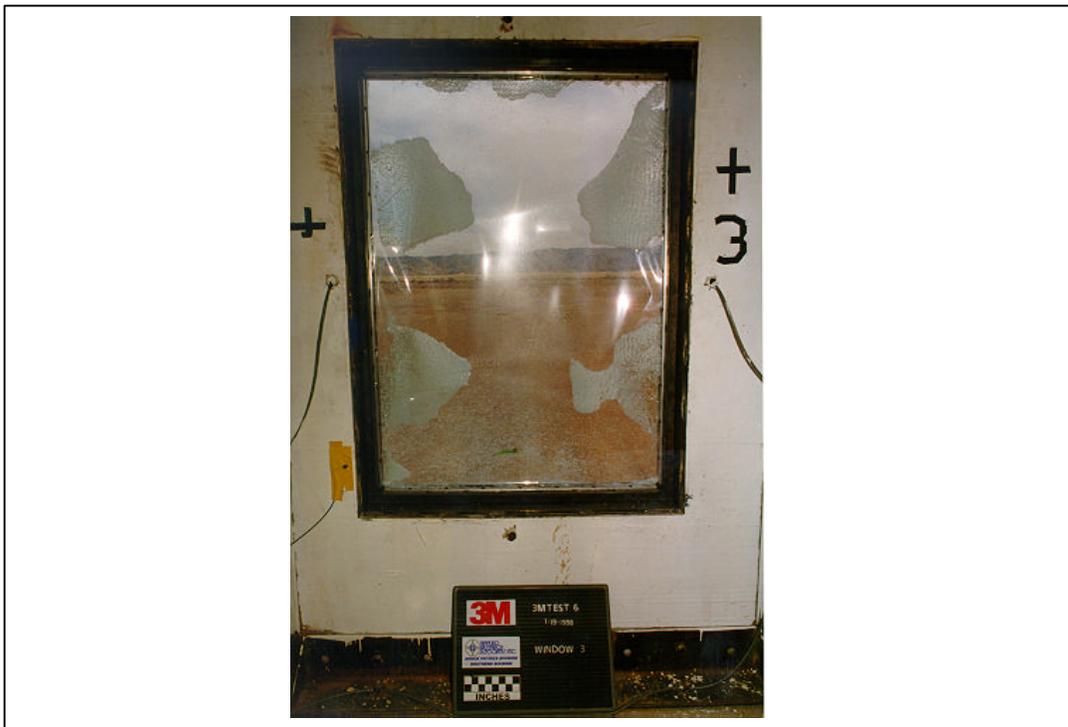
Figure A.199. Test 6. Posttest, interior view of window 3 (3M T6 POST 35.tif).

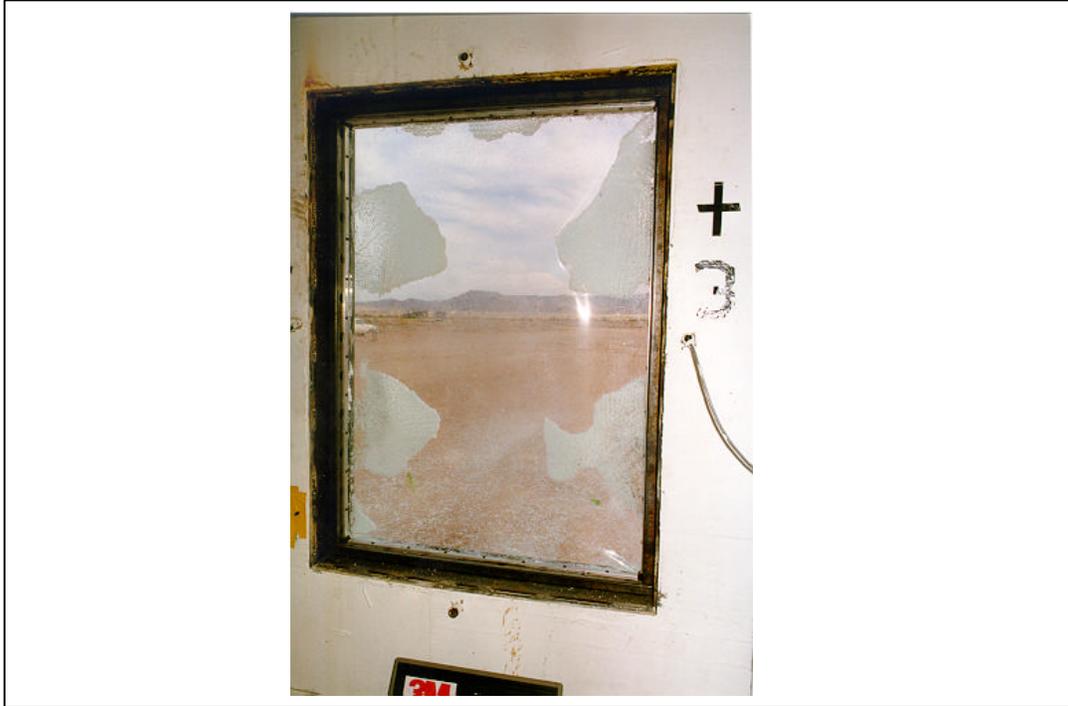
Figure A.200. Test 6. Posttest, interior view of window 3 (3M T6 POST 36.tif).

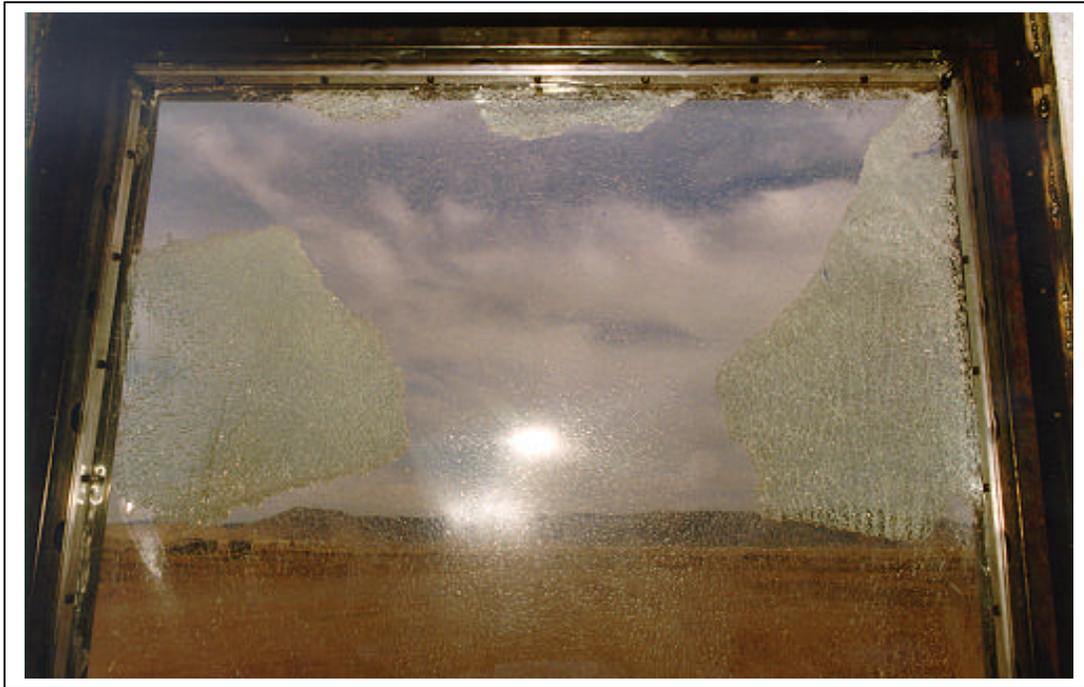
Figure A.201. Test 6. Posttest, interior view of window 3 (view of top half)  
(3M T6 POST 38.tif).

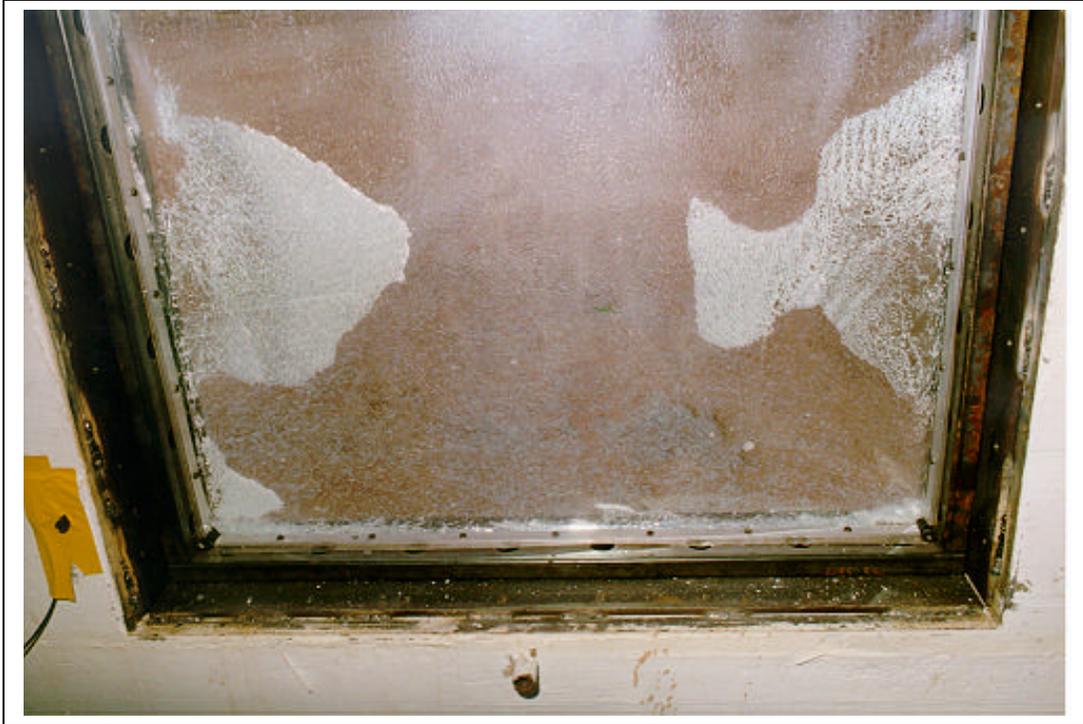
Figure A.202. Test 6. Posttest, interior view of window 3 (view of bottom half) (3M T6 POST 37.tif).

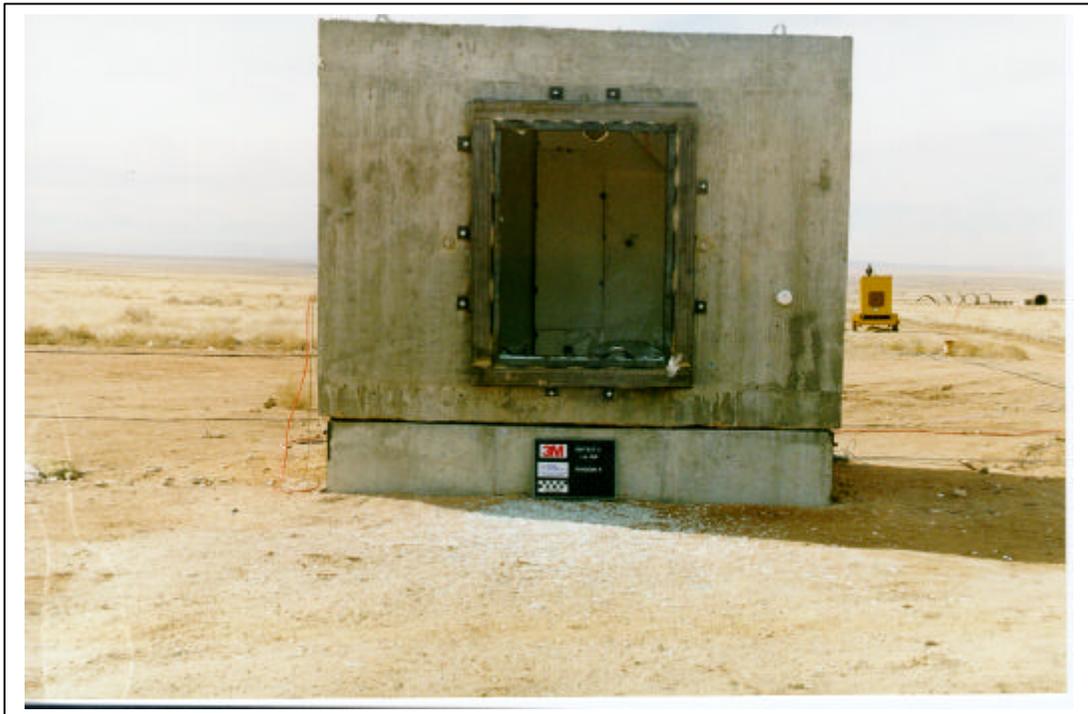
Figure A.207. Test 6. Posttest, exterior view of window 4 (3M T6 POST 06.tif).

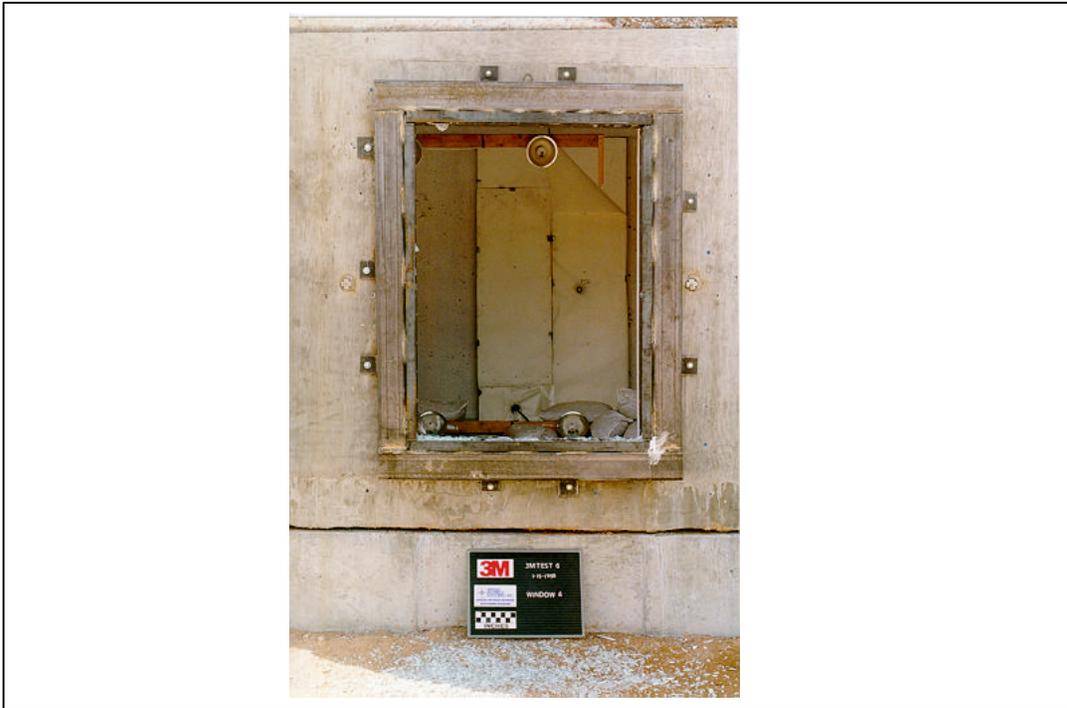
Figure A.208. Test 6. Posttest, exterior view of window 4 (3M T6 POST 16.tif).

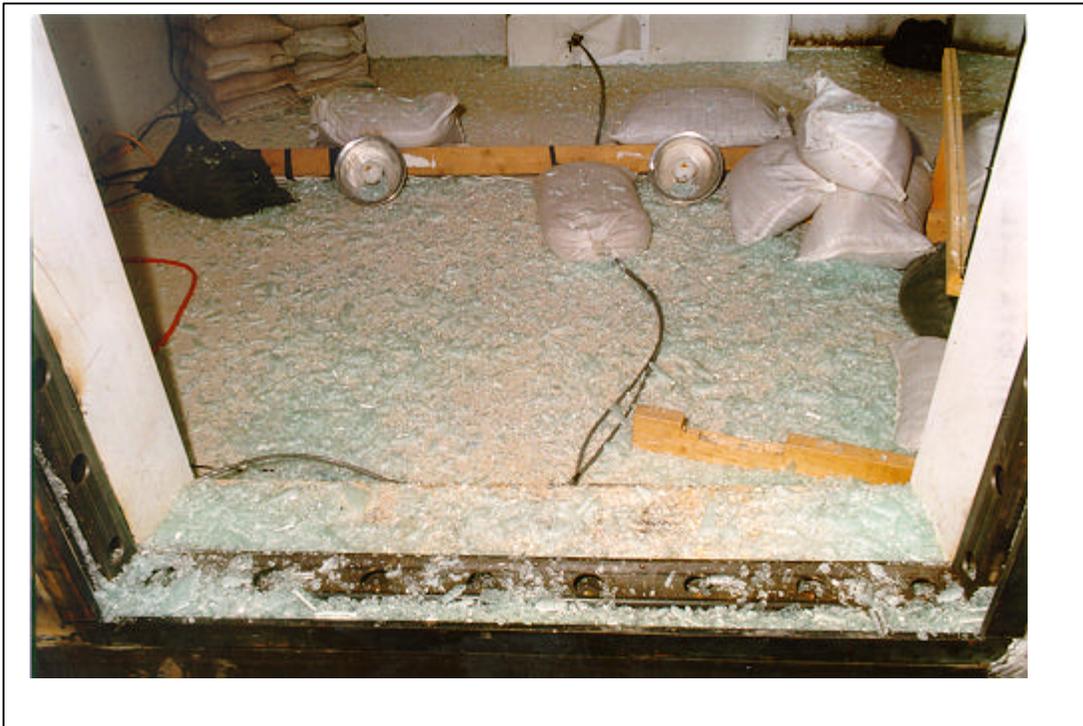
Figure A.209. Test 6. Posttest, exterior view of window 4 (3M T6 POST 17.tif).

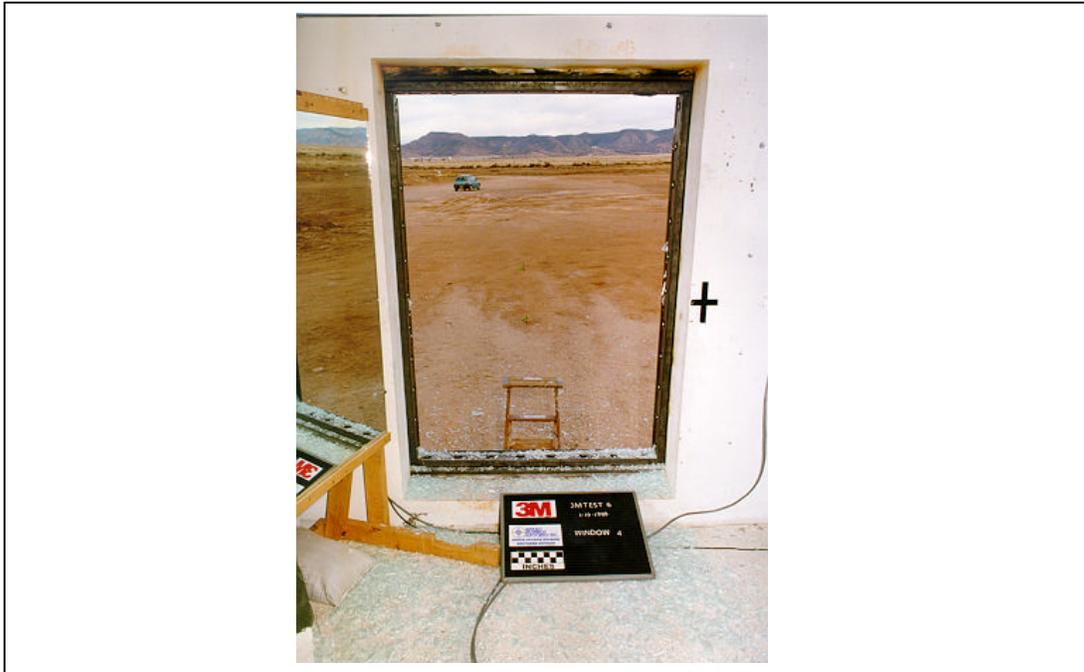
Figure A.210. Test 6. Posttest, interior view of window 4 (3M T6 POST 23.tif).

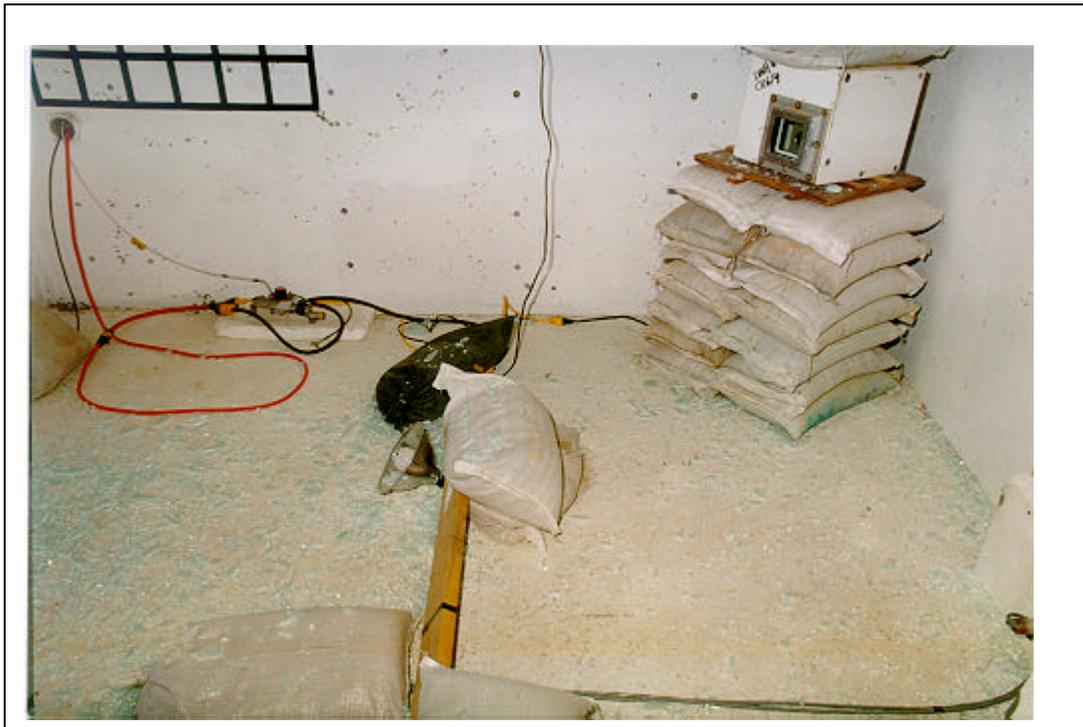
Figure A.211. Test 6. Posttest view of the South Structure floor (3M T6 POST 24.tif).

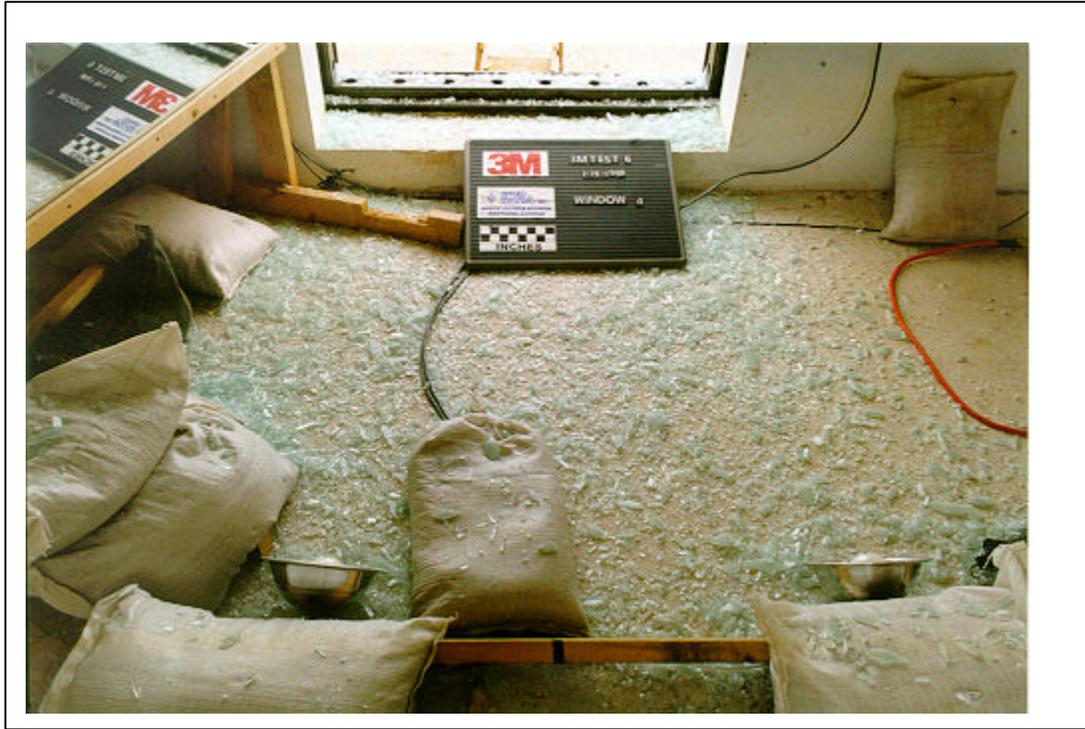
Figure A.212. Test 6. Posttest view of the South Structure floor (3M T6 POST 26.tif).
